# Indiana Classified Forest & Wildlands Forestry Best Management Practices Monitoring Results 1996-2019

**Indiana Classified Forest and Wildlands BMP Report**

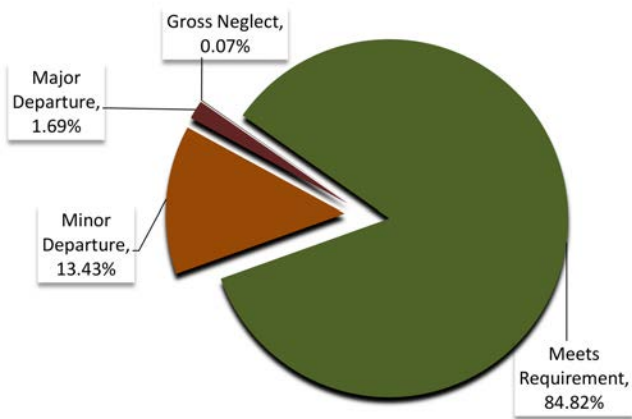
Figure 4. BMP Application for all 623 CLFW sites monitored from 1996 through 2019.

A figure of 84.82% of the BMPs were applied as directed in the BMP guidelines, and 13.43% had minor departures as defined in the monitoring sheet. There have been 408 major departures, which add up to 1.69% of all practices monitored. Of the total 623 sites monitored on CLFW sites, 16 practices scored “Total Negligence” for 0.07%, as shown in Figure 4.

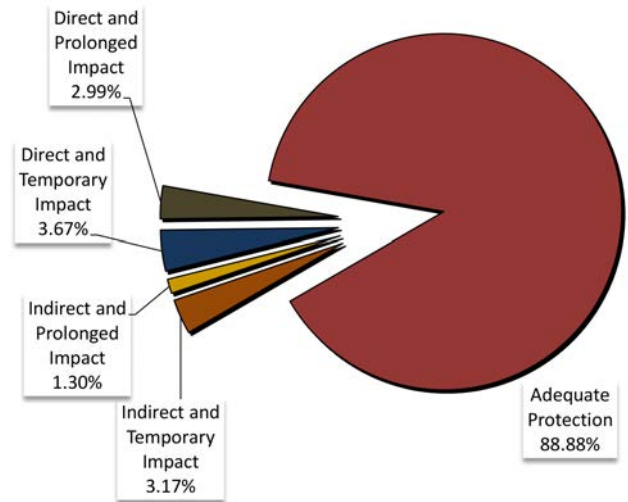
Figure 5. BMP Effectiveness for all 623 CLFW sites monitored from 1996 through 2019.

Effectiveness rates are used to evaluate the success of the BMPs applied to a site. The effectiveness rate for the 623 sites monitored is 88.88%. Indirect and temporary impacts to water quality were found 3.17% of the time. Indirect and prolonged impacts were found 1.3% of the time. Direct and temporary impacts occurred 3.67% of the time, and there were 2.99% direct and prolonged impacts to water quality. All of this is shown in Figure 5.

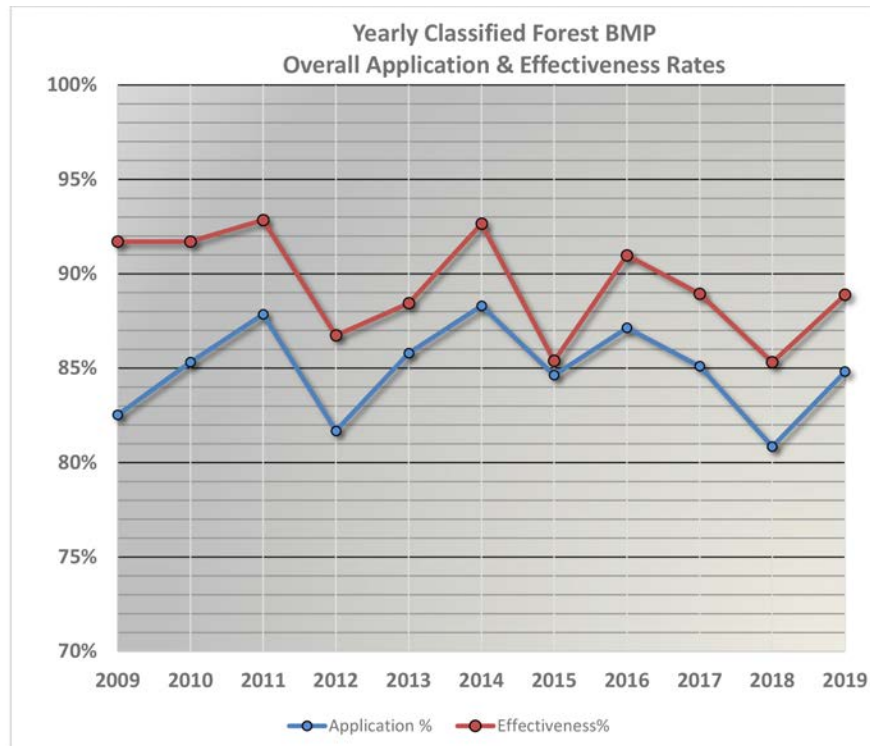
Figure 6. Yearly trends of overall BMP application and effectiveness scores on CLFW sites. These percentages are calculated for each year’s data separately, rather than being combined with the running totals from previous years.

Application and effectiveness rates of sites monitored vary from year to year, and no real positive or negative trend can be extrapolated. However, there are several conclusions one can draw from Figure 6. First, effectiveness rates are commonly higher than application rates. Second, the rates seem to generally mirror one another. Third, after two years of downward trending application and effectiveness, rates increased by 3% and 4% respectively.

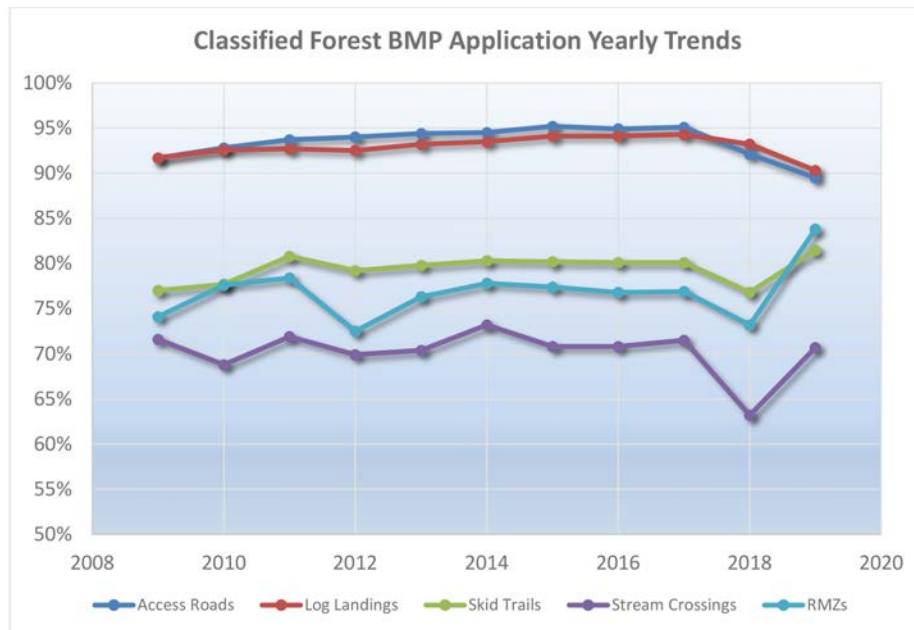
Figure 8. Yearly BMP application trends by BMP category.

Access roads and landings are areas of a timber harvest where machines concentrate much of their activity, including the use of tractor trailers, which cannot handle much variation in the terrain when traveling. Therefore, access roads and log landings are often well stabilized, well drained and located in areas that have established travel routes that avoid water bodies as much as possible. BMP application trends remain consistently high for access roads and log landings through the 23 years of monitoring. Skid trails are over rough ground that may have been traveled at some point in the past and then left alone, so they tend to be harder to engineer to drain correctly, given the trees, rough terrain and soil-structure variability. Since 2011, skid trails have had applications scores near 80%. Skid trails usually lead to stream crossings and RMZ areas and are close to the water bodies. This means there is an increased chance for an impact on water quality, regardless of whether there is an application problem. RMZ application has generally stayed in the mid- to high 70s. Stream crossings have the lowest application scores on CLFW lands, generally staying around 70%.

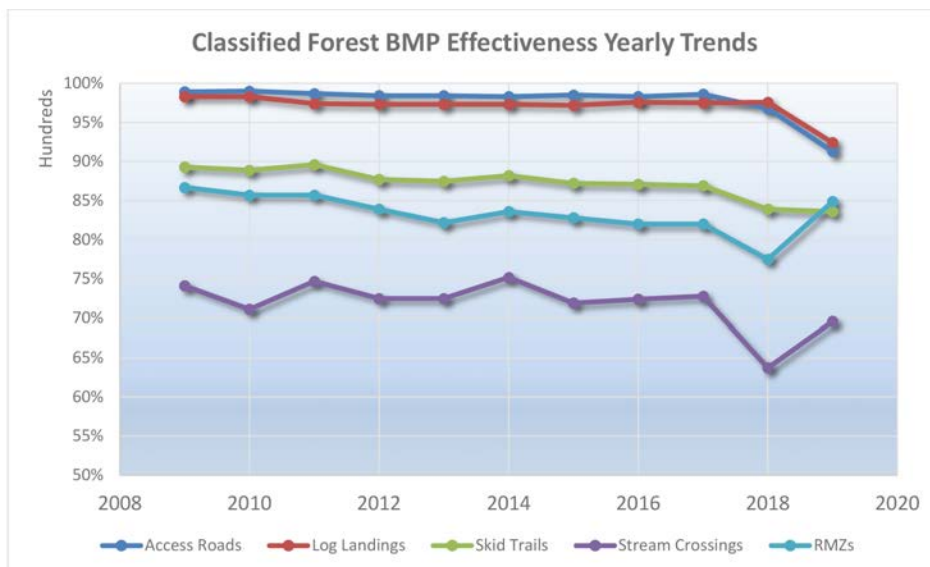
Figure 10. Overall BMP effectiveness yearly trends by BMP Category.

The BMP category effectiveness trends mirror the application trends, with effectiveness rates generally higher than application rates. As with application, effectiveness rates for access roads and log landings are consistently high, with effectiveness rates generally 5% or higher than application rates for both categories. RMZ and Skid trail application are similar in the mid 70% while skid trails application is about 5% above RMZ effectiveness, in the low 80%. Stream crossings came in last in both application and effectiveness, with application rates slightly lower than effectiveness. Due to the nature of stream crossings, regardless of whether or there are any errors in application, most impacts are direct to the water resources of the site, so any problems in this area are more likely to be direct impacts due to their proximity to water.

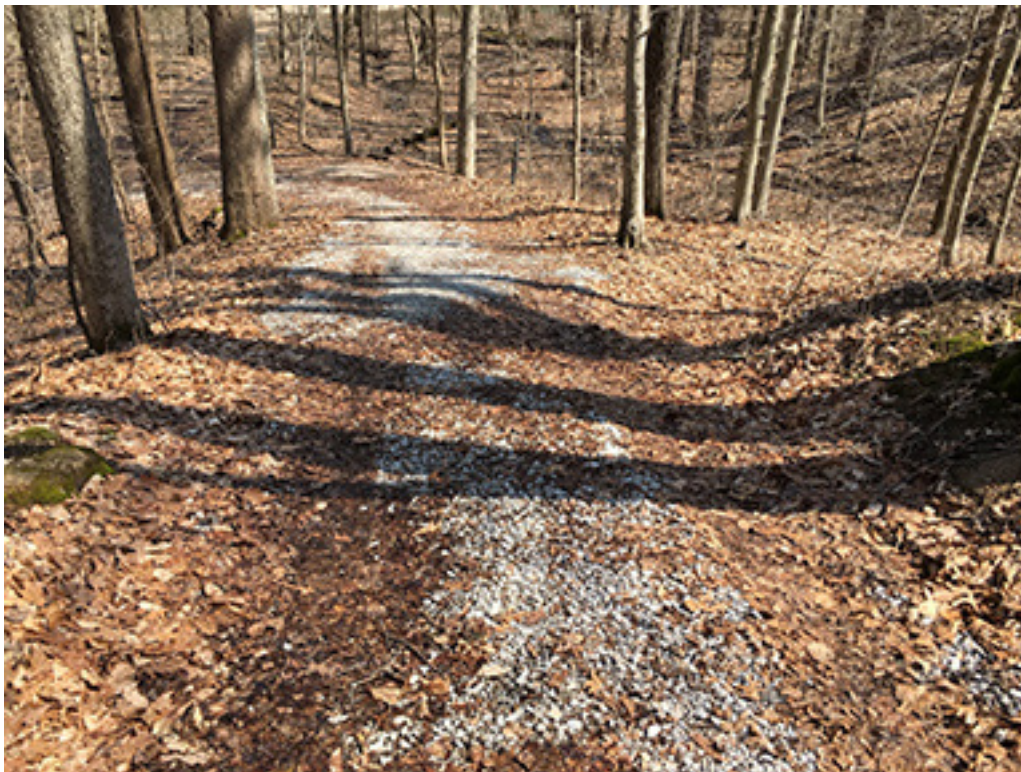
*Access road and water diversion.*

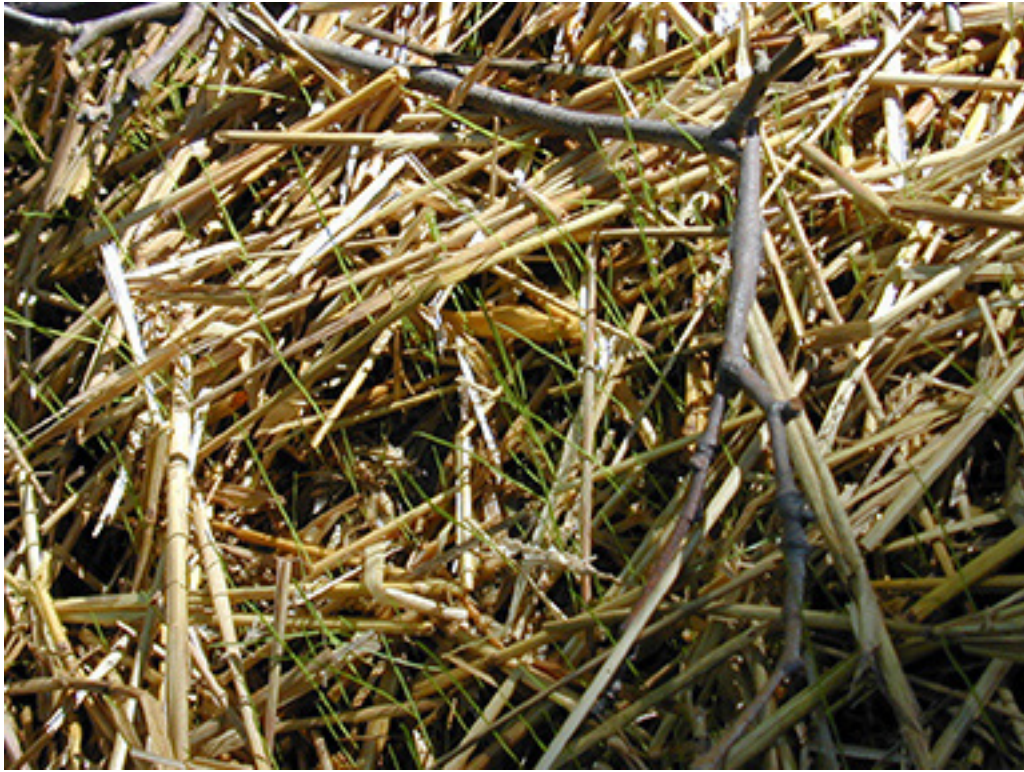
*Straw stabilizes soil and provides conditions for new seed to sprout.*

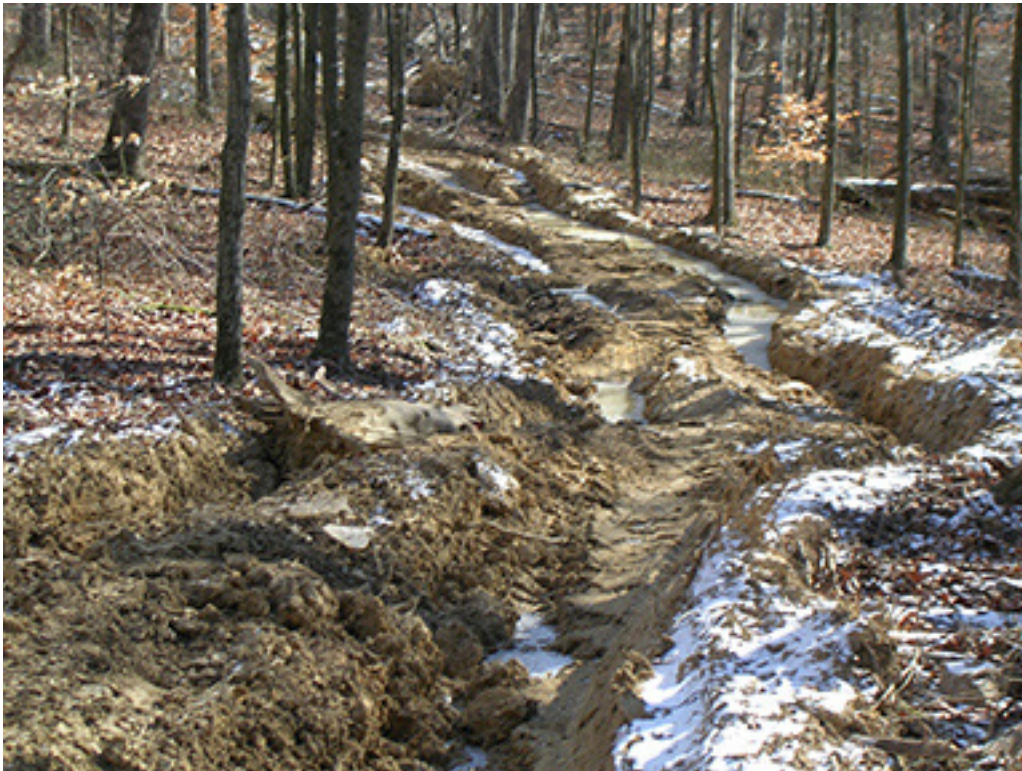
*Deep ruts through a private forest.*

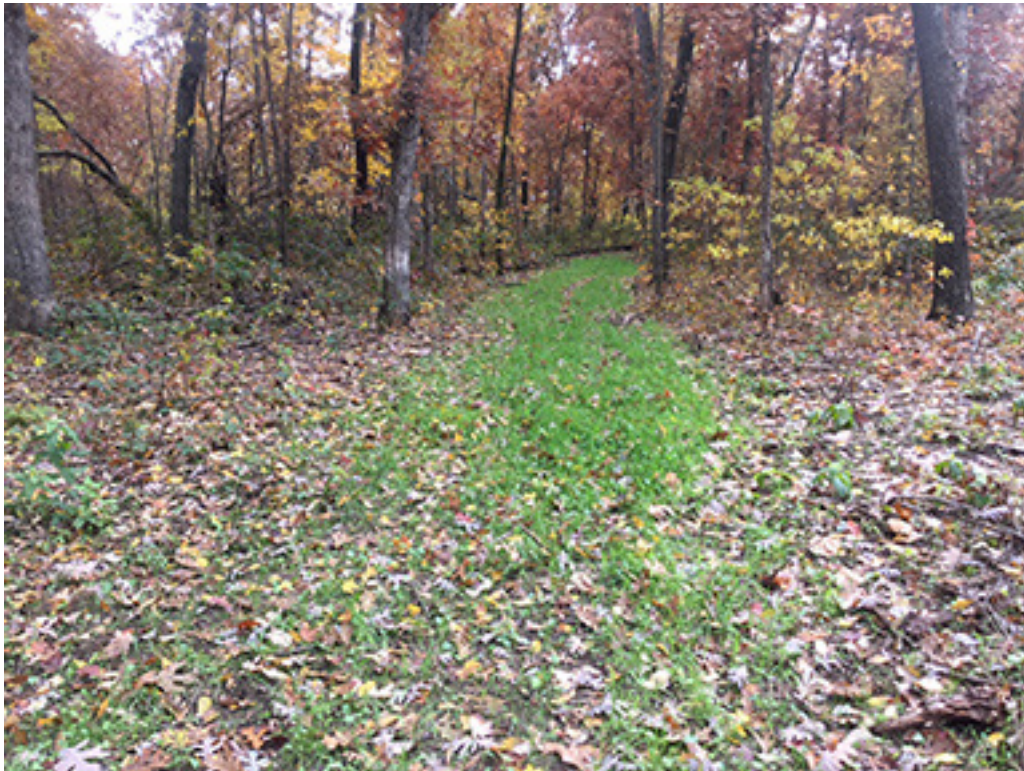
*Skid trail that has rapidly revegetated after a harvest due to seed application.*

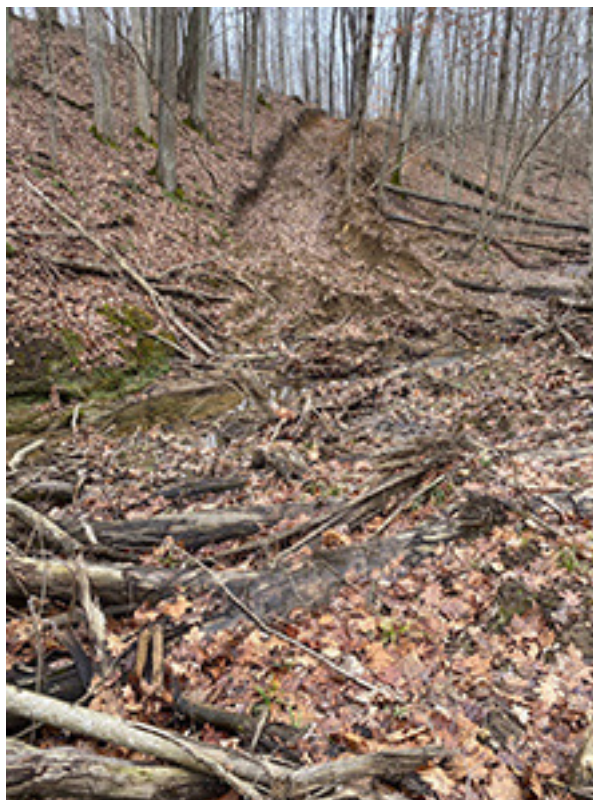
*There are multiple issues on this skid trail stream crossing. Logs used as corduroy to cross stream were not removed after the harvest was closed out, and there are no diversions on the skid trail coming down the hill. All runoff is being funneled right into the stream. A cut-in skid trail such as this should be avoided whenever possible.*

\* The difference in removal of temporary structures from a stream crossing after a harvest (generally corduroy logs) is over 20% lower for Classified Forest harvests than state forest sites. Importance of removal of these obstructions to stream flow needs to be emphasized to landowners and loggers.

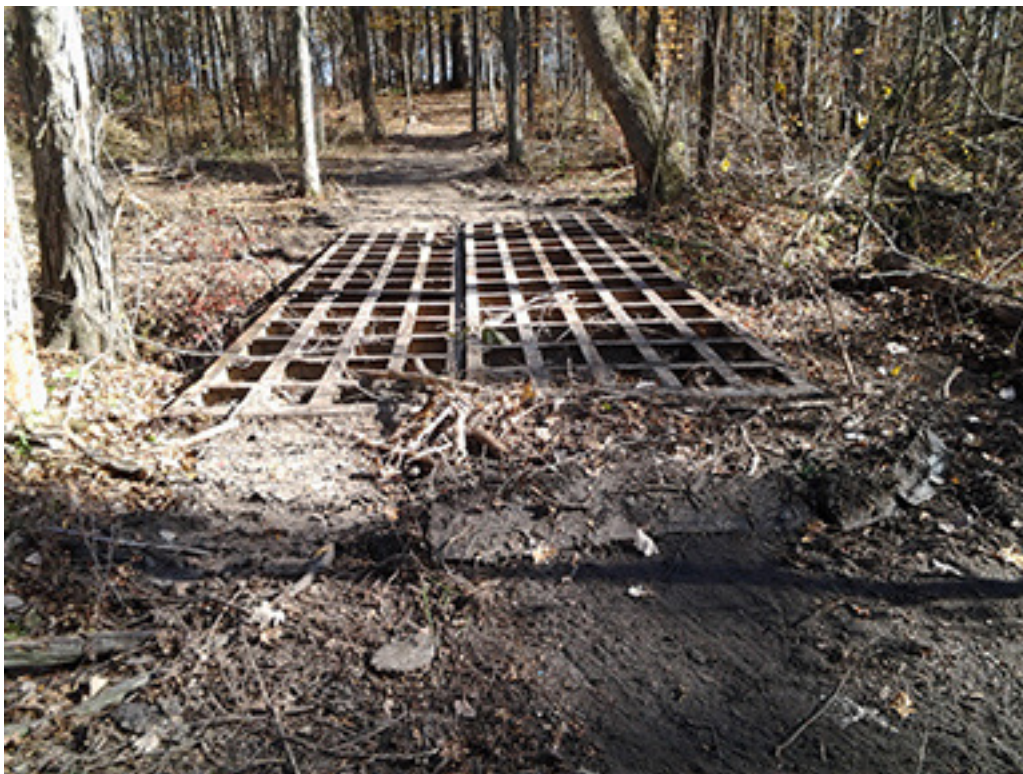
*A metal grate bridge provides a perfect crossing of this unmapped intermittent stream.*

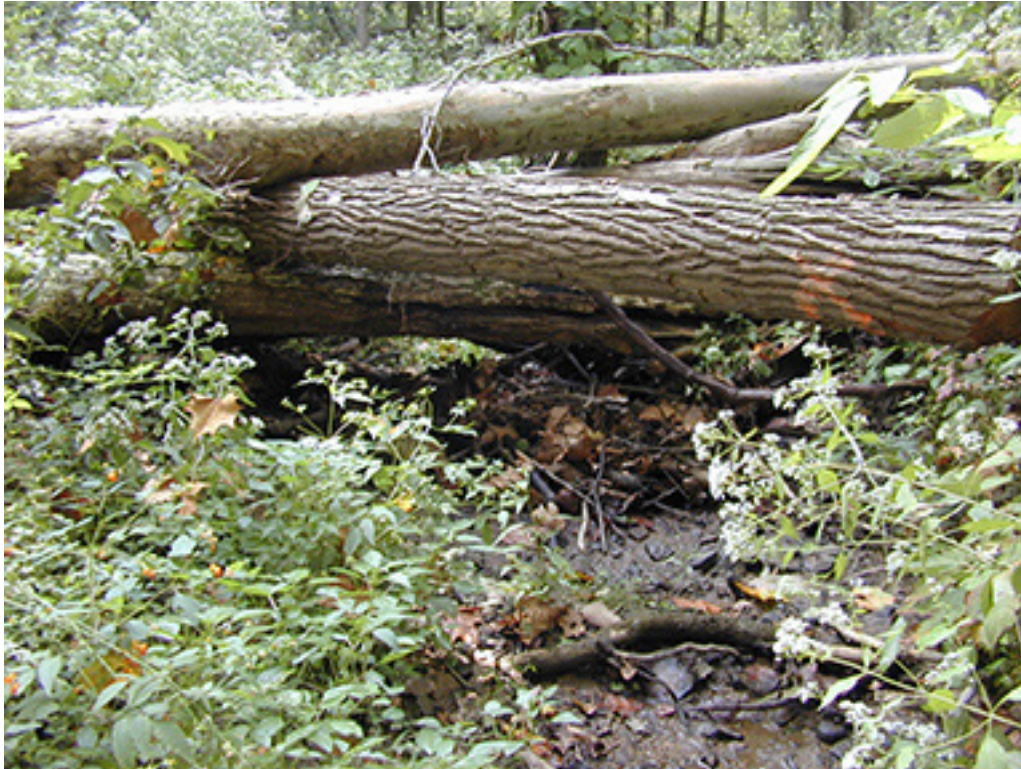
*Harvest debris left in a stream, causing additional debris build up and blockage of flow.*

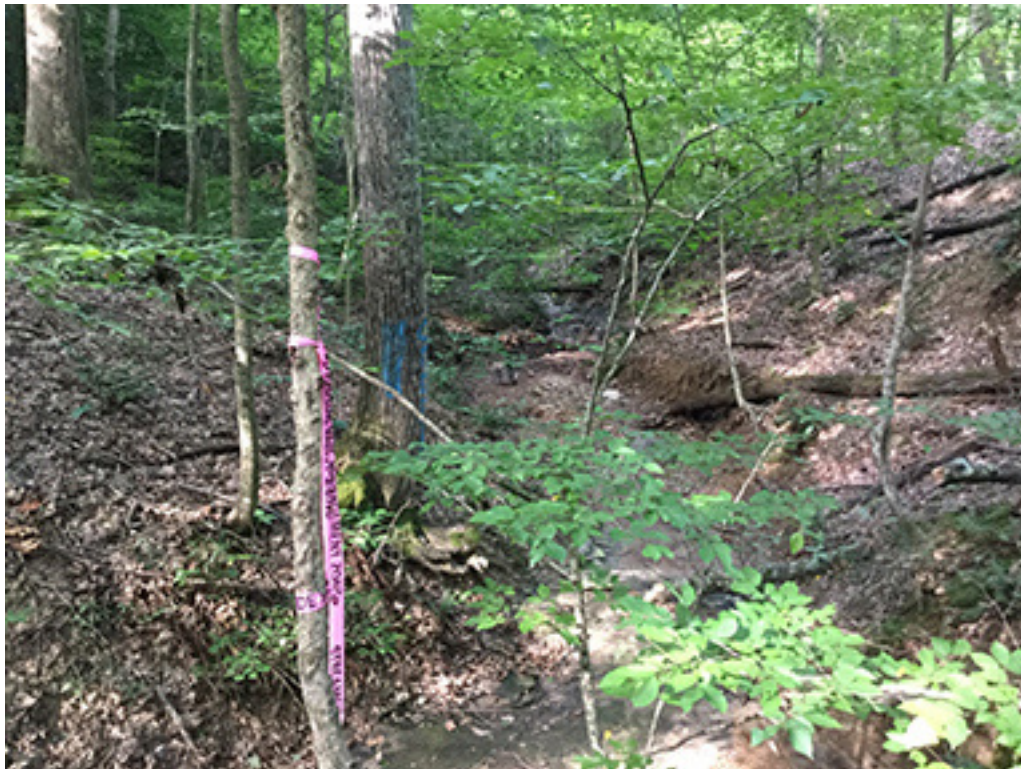
*Great marking of riparian management zone.*

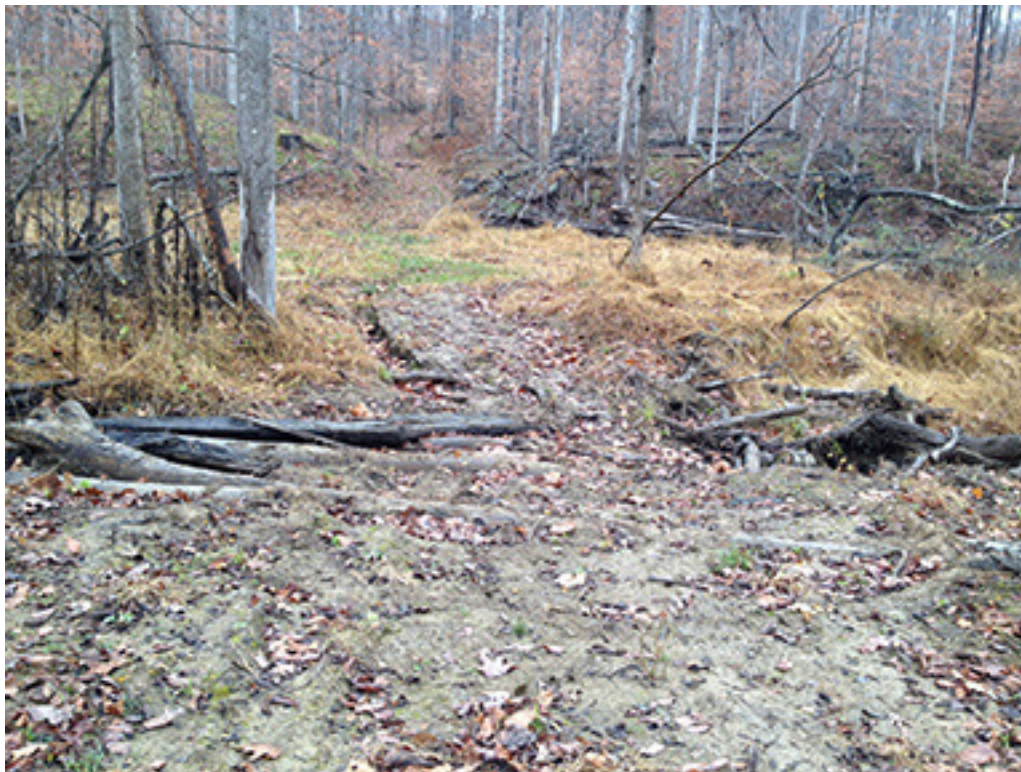
*Logging debris in a stream can obstruct stream flow, leading to the stream carving out a new bank, which results in erosion and sedimentation directly into the stream. This occurs 20% more on private lands compared to state forest lands.*
