**AML Site 1820  
Buttermilk Highwalls  
Patoka Township, Pike County, Indiana**

Indiana Department of Natural Resources, Division of Reclamation, Abandoned Mine Land  
Program

## AML Site 1820, Buttermilk Highwalls

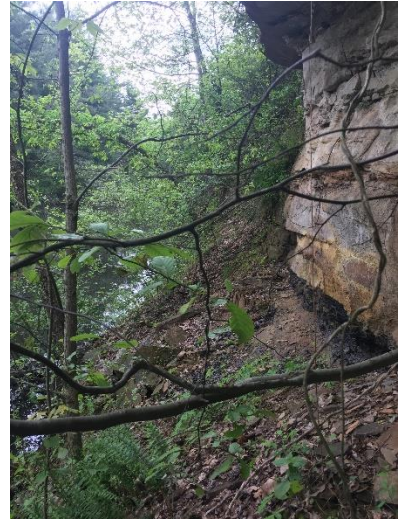
The western highwall of Whitney Pit prior to construction.

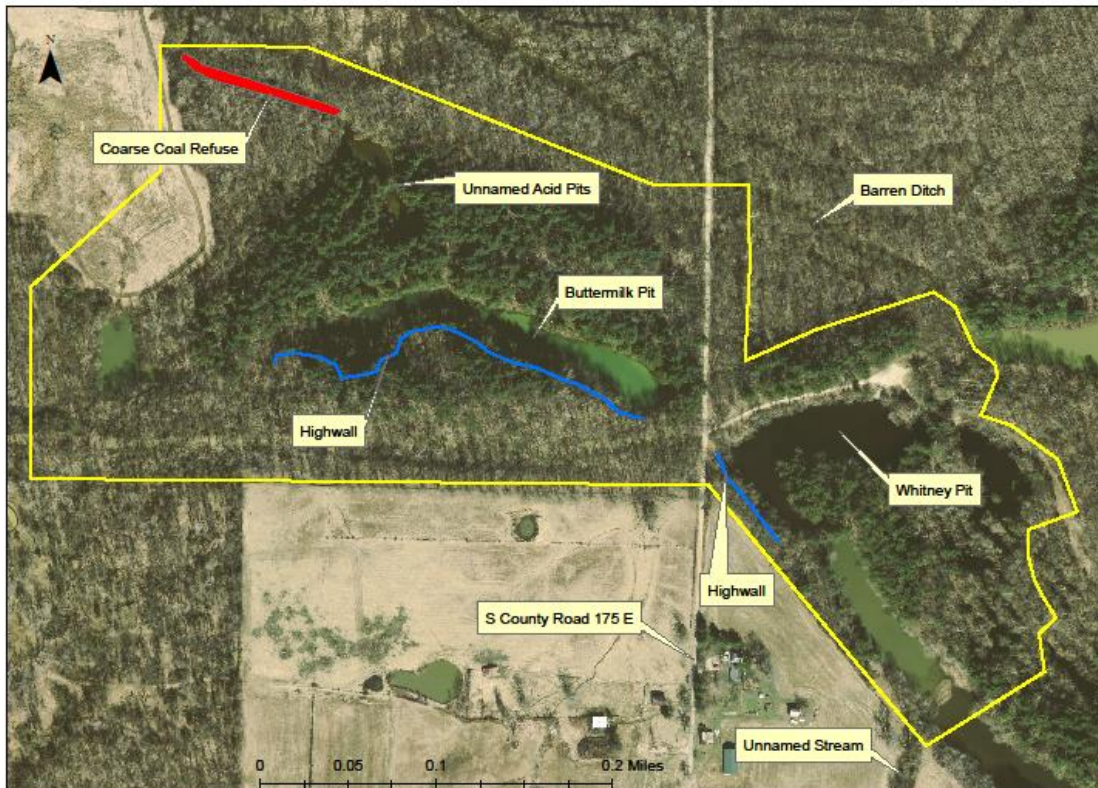
Map of AML Site 1820, Buttermilk Highwalls prior to construction showing the location of the highwalls, pit lakes, receiving stream and coal refuse at the site.

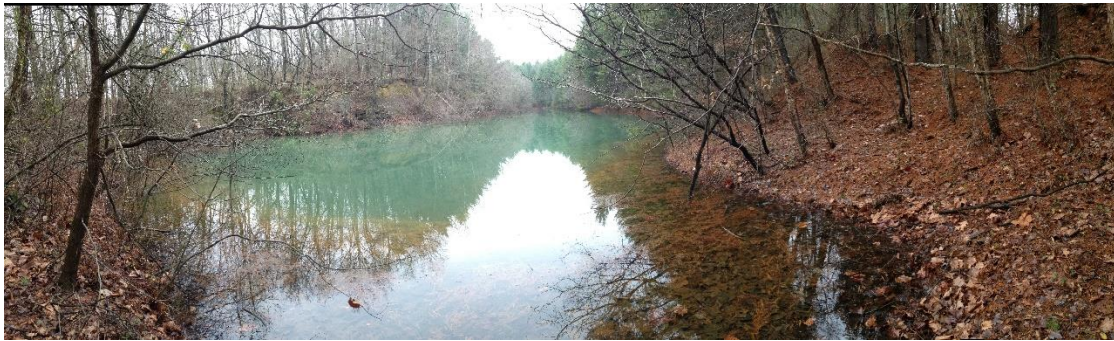
Buttermilk Pit prior to construction. Water in the pit lake had low alkalinity concentrations and was visibly discolored by suspended iron oxides.

The site was also plagued by acid mine drainage (AMD) issues. Buttermilk Pit contained net-acid water with visible suspended iron oxides and a low alkalinity concentration of 7 mg/L as  $\text{CaCO}_3$ . Two smaller ponds north of Buttermilk Pit contained stronger acid mine drainage with pH values between 3 and 4.

Furthermore, the Buttermilk Highwalls project eliminated AMD-impacted pit lakes at the site by amending potentially acidic spoil with limestone and properly disposing of coarse coal refuse found at the site. These water bodies were replaced with an equivalent amount of water and wetland acreage with good water quality, thus providing better wildlife habitat at the site.

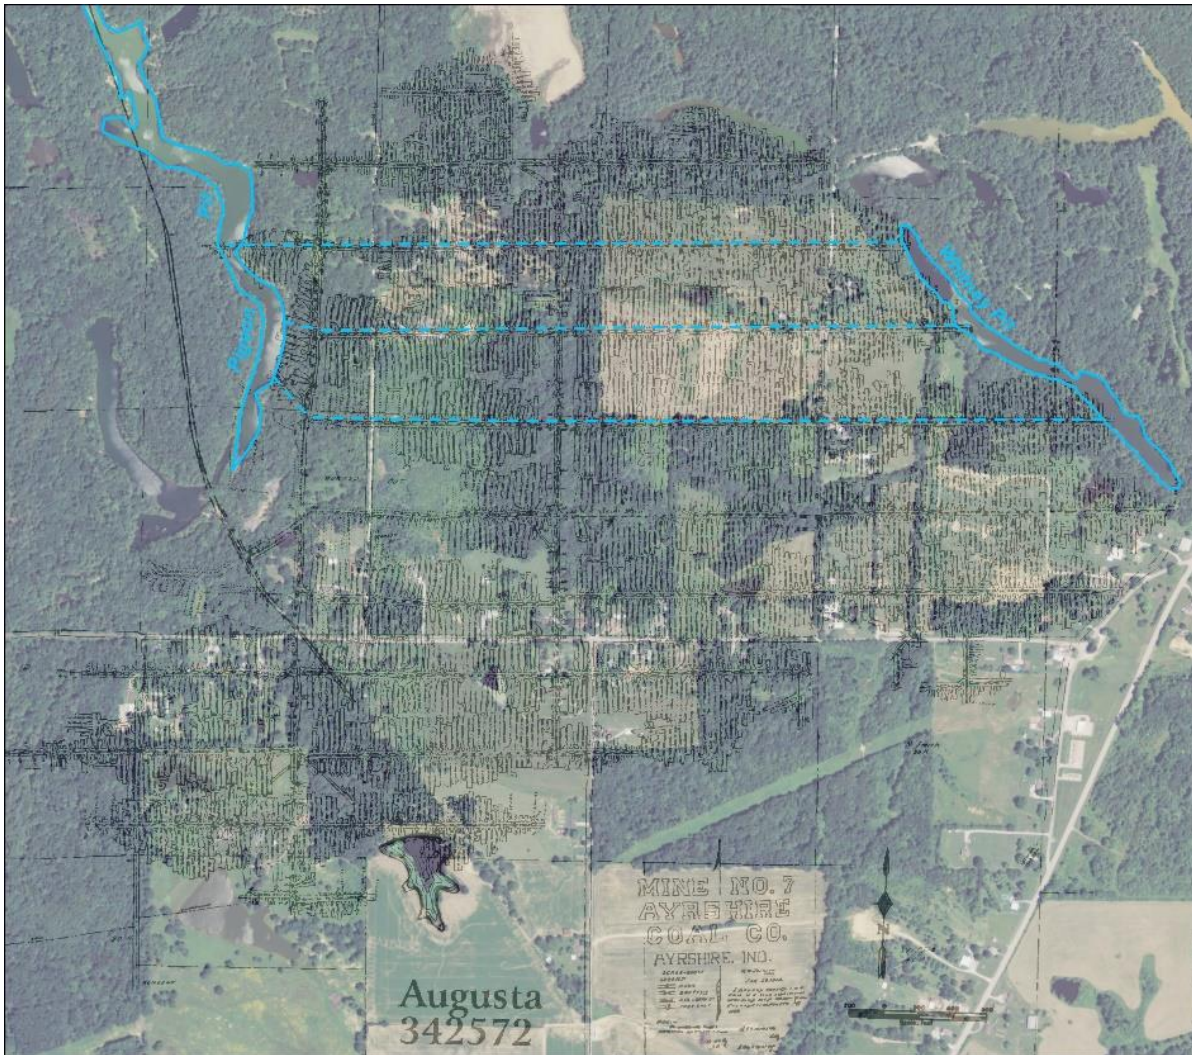
The hydraulic connection was established by previous observations of pit lakes in the area, including coordinated pool levels between Whitney Pit, Buttermilk Pit and Pigeon Pit, the latter which was reclaimed in 2016. Hydrologic conductivity between the pit lakes was further corroborated by the observation of iron-rich subsurface discharges into the pit lakes during periods of wet weather. Fluctuations in the mine pool were likely a contributing factor for the prevalence of mine subsidences in the area.

Map of Whitney and Pigeon Pits superimposed with a map of the Ayrshire #7 underground mine. The mine void created a direct connection between the two pits, which created a substantial challenge during the reclamation of Pigeon Pit in 2016 as part of the Sugar Ridge #2 project. Buttermilk Pit (unmarked, upper center right of map) was also hydrologically connected to the mine, although the response to that pit to pool level changes in the mine was not as abrupt.

underground mine workings by establishing two well-defined outlets for the mine pool. The two outlets, both of which were set at 427 feet above sea level, discourage directional flow through the mine void and ensure that the mine void remains permanently flooded. As a result, oxygen input into the mine void is reduced, which will mitigate future problems with AMD. Stabilizing the mine pool is also expected to attenuate further subsidence of the mine void, thus mitigating a future source of public safety hazards on the surface.

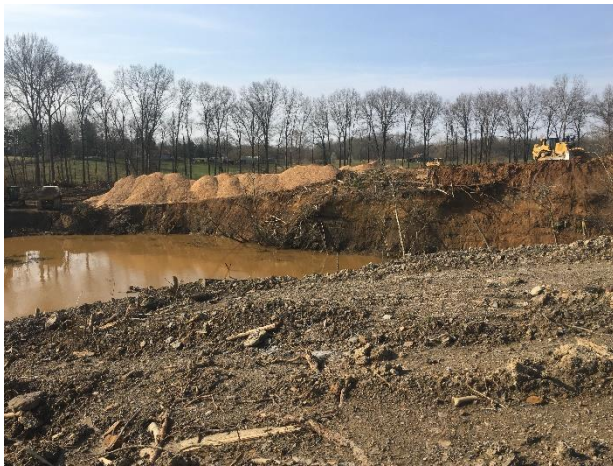
Buttermilk Pit highwall during construction.

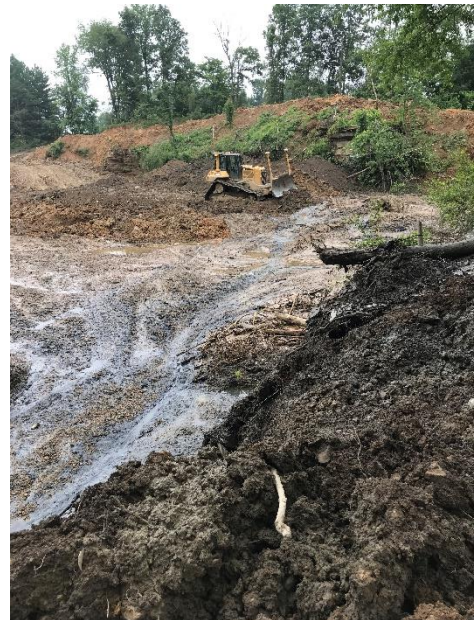
The flooded Ayrshire #7 mine posed a serious challenge to drawing down the level of Whitney Pit, which was required in order to complete the project. The mine entrances were below the surface in Whitney Pit, and their exact locations had to be determined by careful observation of water movements at the highwall side of the pit lake during pumping. Once the locations of the mine entrances were established, fill was placed over the entrances in order to stop outflow from the mine workings so that the project could continue. This placement of fill into water created a large volume of mud that had to be displaced during the highwall backfill process.

Whitney Pit highwall during construction.

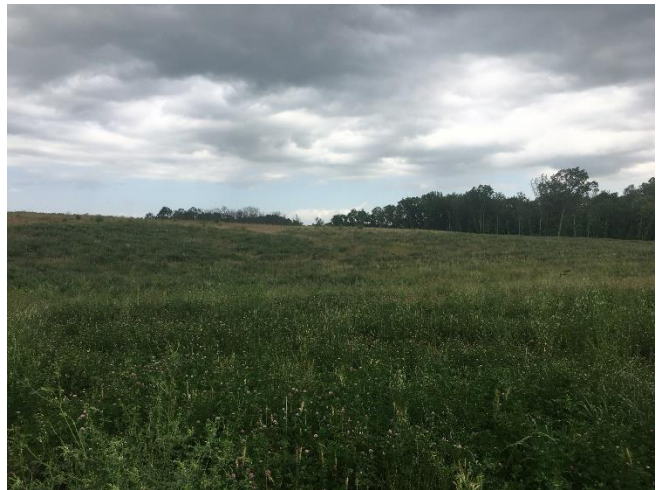
Completed reclamation of Buttermilk Pit highwall. The pits on this side of the project, which were contaminated with AMD, were eliminated and replaced with new water bodies of good water quality on a one-to-one basis with respect to area.

As a result of the Buttermilk Highwalls project, two dangerous highwalls totaling 1,615 linear feet, both of which were in close proximity to a public roadway on a public property designated for recreational use, were eliminated, thus ensuring safe conditions for visitors to the site. The highwalls were both backfilled to a stable 4:1 slope. The grading conformed to geomorphic design to the best extent practicable in order to minimize erosion of the new grades by mimicking natural drainage topography.

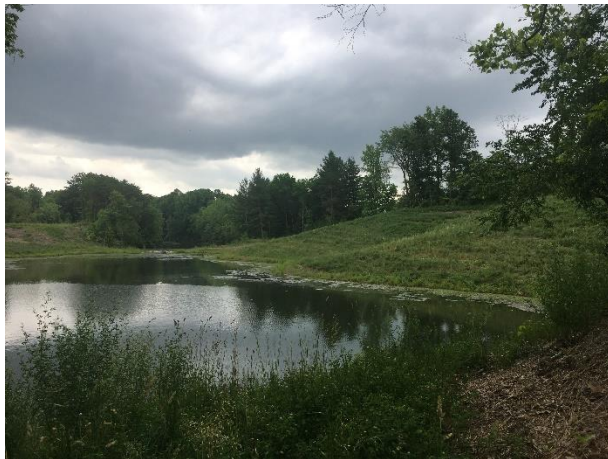
Completed reclamation of Whitney Pit western highwall. The highwall was backfilled to a 4:1 slope.

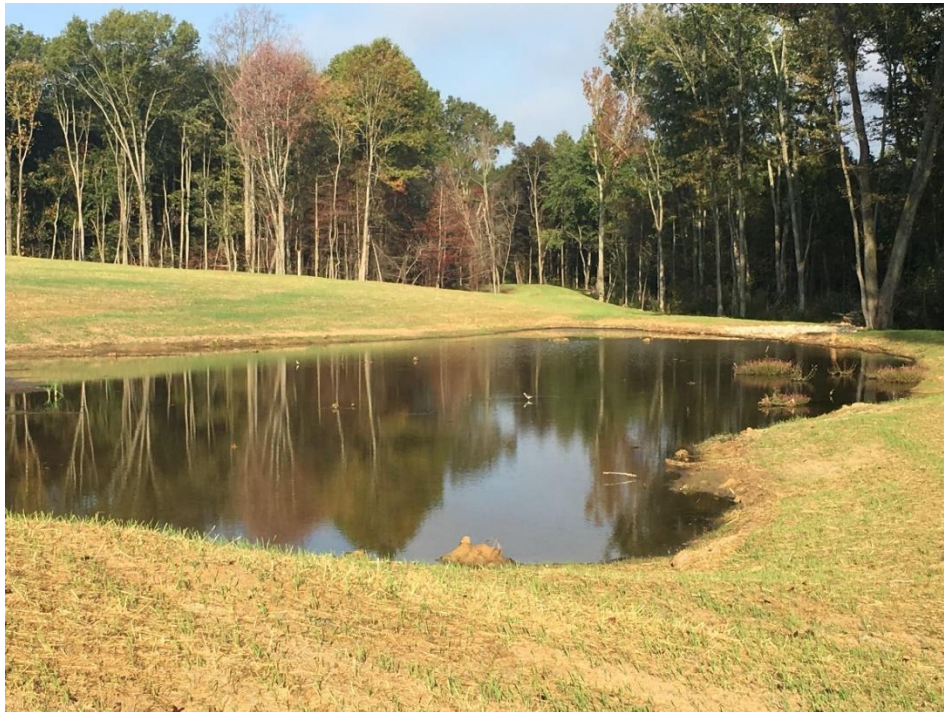
Completed reclamation of the Buttermilk Pit side of the project. The AMD-contaminated pits on this side of the project were replaced with water bodies of good water quality.
