Re: RED FLAG INVESTIGATION

Des. Number 1601072, State Project

Added Travel Lane Project

US 36

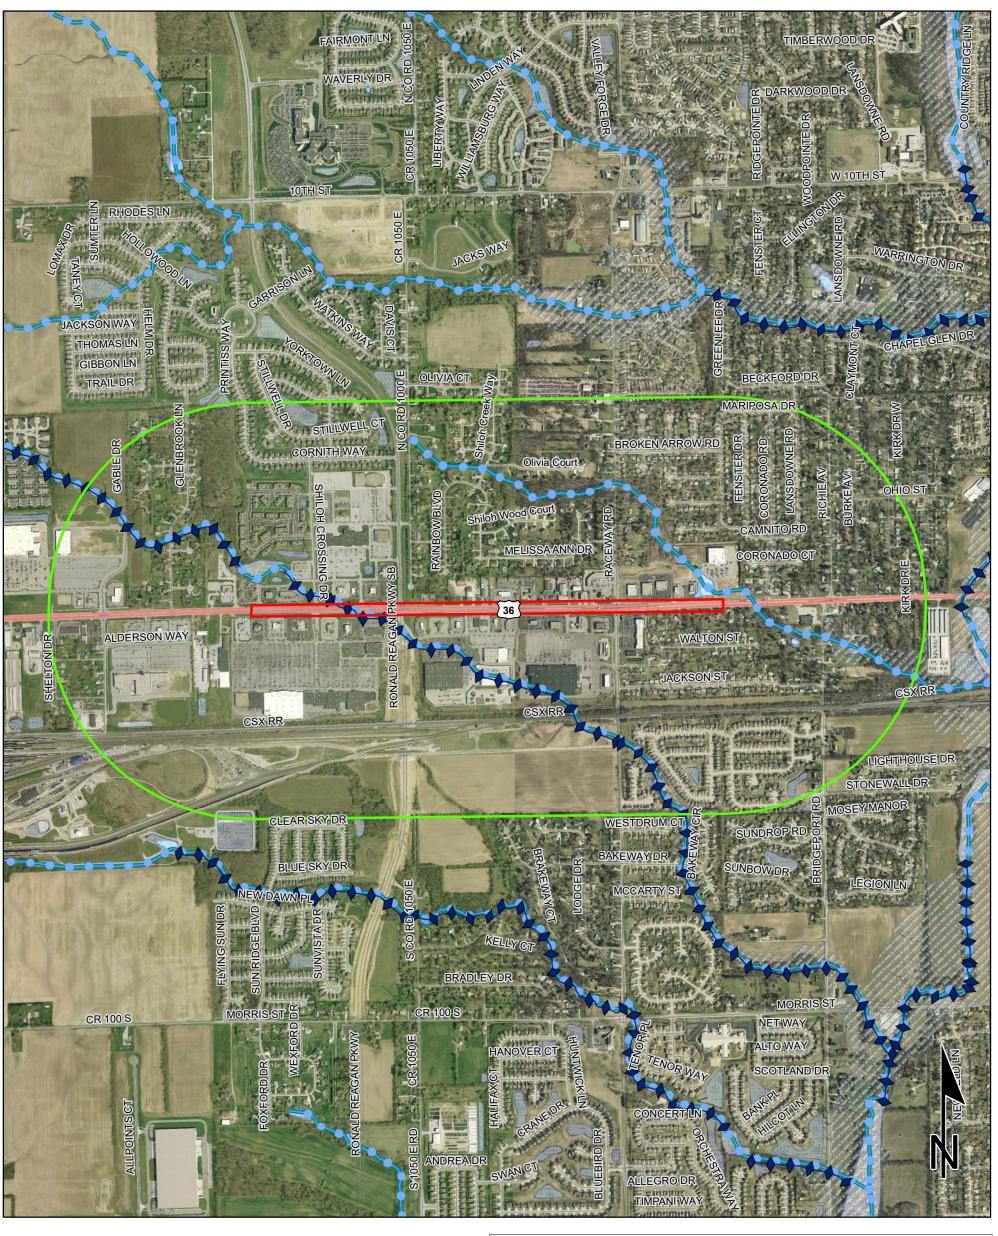
Red Flag Investigation - Water Resources **US 36 Added Travel Lanes** Des. Number 1601072, Road Project Avon, Hendricks and Marion Counties, Indiana

Indiana Department of Environmental Management (IDEM) 303d Listed Streams and Lakes (Impaired): Two IDEM 303d Listed Streams are located within the 0.5 mile search radius. One IDEM 303d Listed Stream, Avon Creek, transects the project area. Avon Creek is listed as impaired for Escherichia coli (E. coli). Workers who are working in or near water with E. coli should take care to wear appropriate personal protective equipment (PPE), observe proper hygiene procedures, including regular hand washing, and limit exposure.

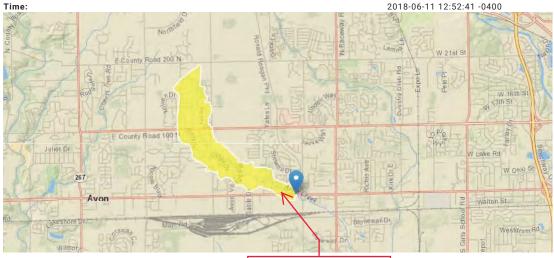
Parameter Code	Parameter Description	Value	Unit
DRNAREA	Area that drains to a point on a stream	1.031	square miles
T2INDNR	Average transmissivity (ft2/d) for the full depth of unconsolidated deposits from InDNR well database.	686	square feet per day
LOWREG	Low Flow Region Number	1729	dimensionless
K2INDNR	Average hydraulic conductivity (ft/d) for the full depth of unconsolidated deposits from InDNR well database.	20	ft per day
QSSPERMTHK	Index of the permeability of surficial Quaternary sediments computed as in SIR 2014-5177	78.62	dimensionless
LC01FOREST	Percentage of forest from NLCD 2001 classes 41-43	6.1	percent
BFREGNO	BFREGNO	1566	dimensionless
BSLDEM10M	Mean basin slope computed from 10 m DEM	1.31	percent
CONTDA	Area that contributes flow to a point on a stream	1.031	square miles
CSL10_85	Change in elevation divided by length between points 10 and 85 percent of distance along main channel to basin divide - main channel method not known	19.5	feet per mi

Avon Creek is an intermittent stream that flows in a northwest to southeast direction flowing under US 36. This stream exhibited Ordinary High Water Mark (OHWM) characteristics of 82 inches in width and 8 inches in depth, as measured by a break in vegetation. The gradient of this stream is 20.3 ft/mile and the drainage area is 1.03square miles. The substrate for Avon Creek predominately consisted of gravel and sand. Avon Creek has moderate quality, crayfish were observed in the stream. Based on these criteria and its connectivity to the White River, a Traditionally Navigable Waterway (TNW), this stream is likely to be considered a *Waters of the United States*.

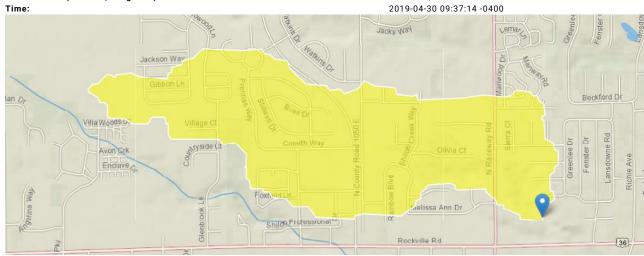
Parameter	Description Description	V-1	11-14
Code	Parameter Description	Value	Unit
DRNAREA	Area that drains to a point on a stream	0.655	square miles
T2INDNR	Average transmissivity (ft2/d) for the full depth of unconsolidated deposits from InDNR well database.	933	square feet per day
LOWREG	Low Flow Region Number	1729	dimensionless
K2INDNR	Average hydraulic conductivity (ft/d) for the full depth of unconsolidated deposits from InDNR well database.	20	ft per day
QSSPERMTHK	Index of the permeability of surficial Quaternary sediments computed as in SIR 2014-5177	110.46	dimensionless
LC01FOREST	Percentage of forest from NLCD 2001 classes 41-43	2	percent

Parameter Code	Parameter Name	Value	Units	Min Limit	Max Limit
DRNAREA	Drainage Area	0.655	square miles	2.99	828
K2INDNR	Avg_Hydraulic_Conductivity_Full_Depth	20	ft per day	6.36	45.9
QSSPERMTHK	Permeability_Index	110.46	dimensionless	43.8	5400
LOWREG	Low Flow Region Number	1729	dimensionless		
General Flow Statistics I	Disclaimers [Harmonic Mean Central Region 2016 5102]				
	arameters is outside the suggested range. Estimates were extr	apolated with unknov	wn errors		
One or more of the pa	· · · · · · · · · · · · · · · · · · ·	apolated with unknow	wn errors		
One or more of the pa	arameters is outside the suggested range. Estimates were extr	apolated with unknov	wn errors Value	Unit

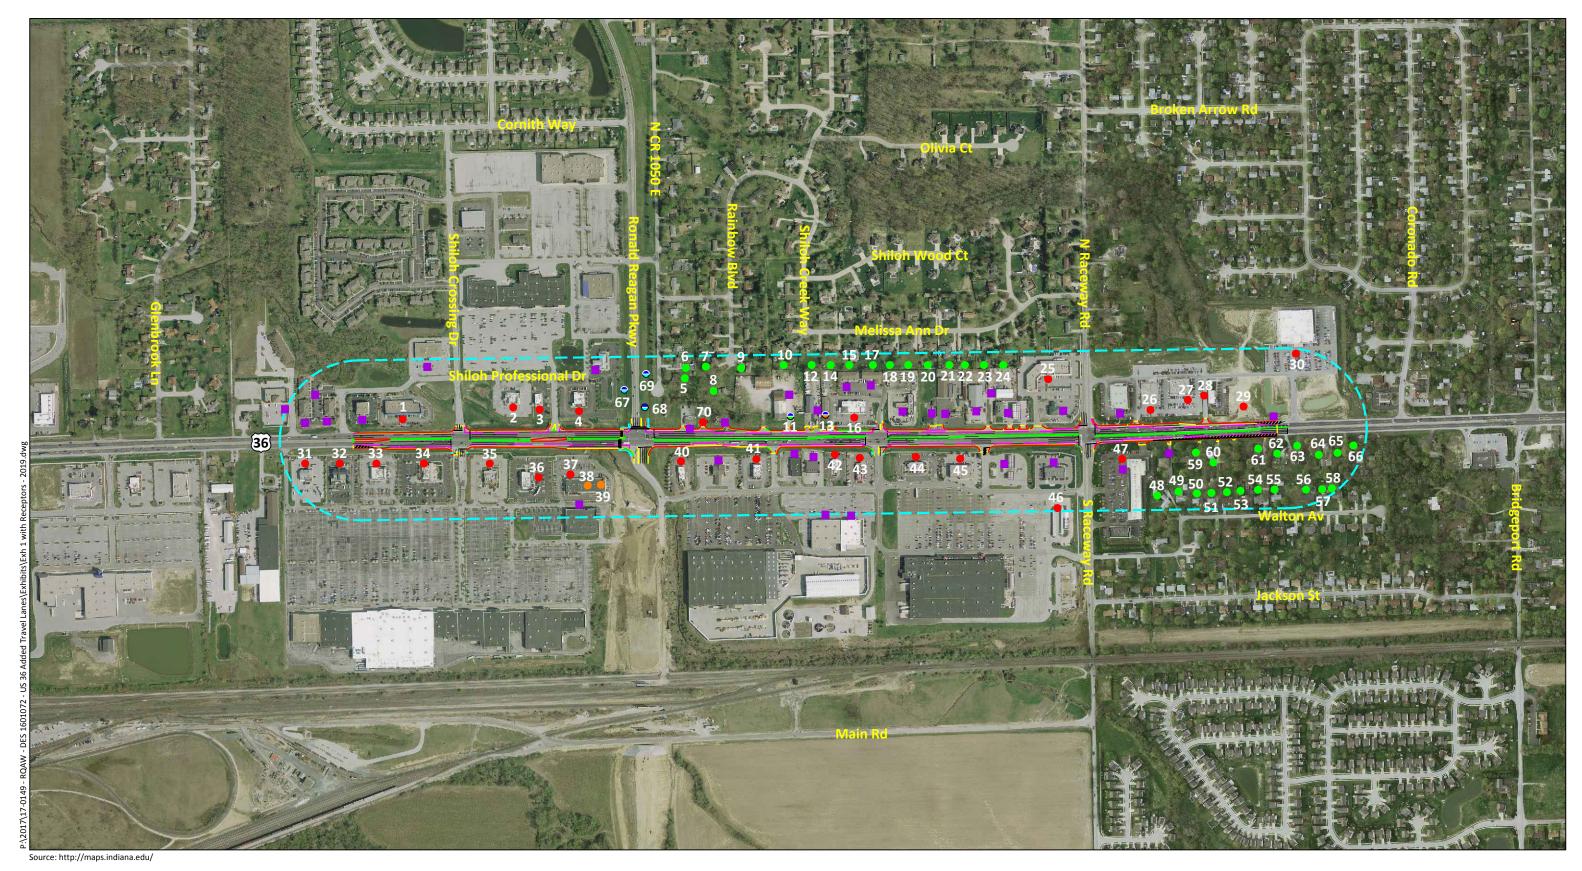
Exhibit 1 - Receptors and Sampling Locations

Noise Analysis US 36 Added Travel Lanes Indianapolis, Hendricks County, Indiana
