Minor Projects PA Project Assessment Form

Project Designation Number: 1701457

Project Description: Bridge Replacement over Toddy's Branch, 0.35 miles east of SR 250

**A Phase Ia Archaeological Literature Review and
Reconnaissance Survey for the Proposed Replacement of
the SR 62 Bridge over Toddy's Branch (Des 1701457) that
is 0.35-miles East of SR 250 in Shelby Township,
Jefferson County, Indiana**

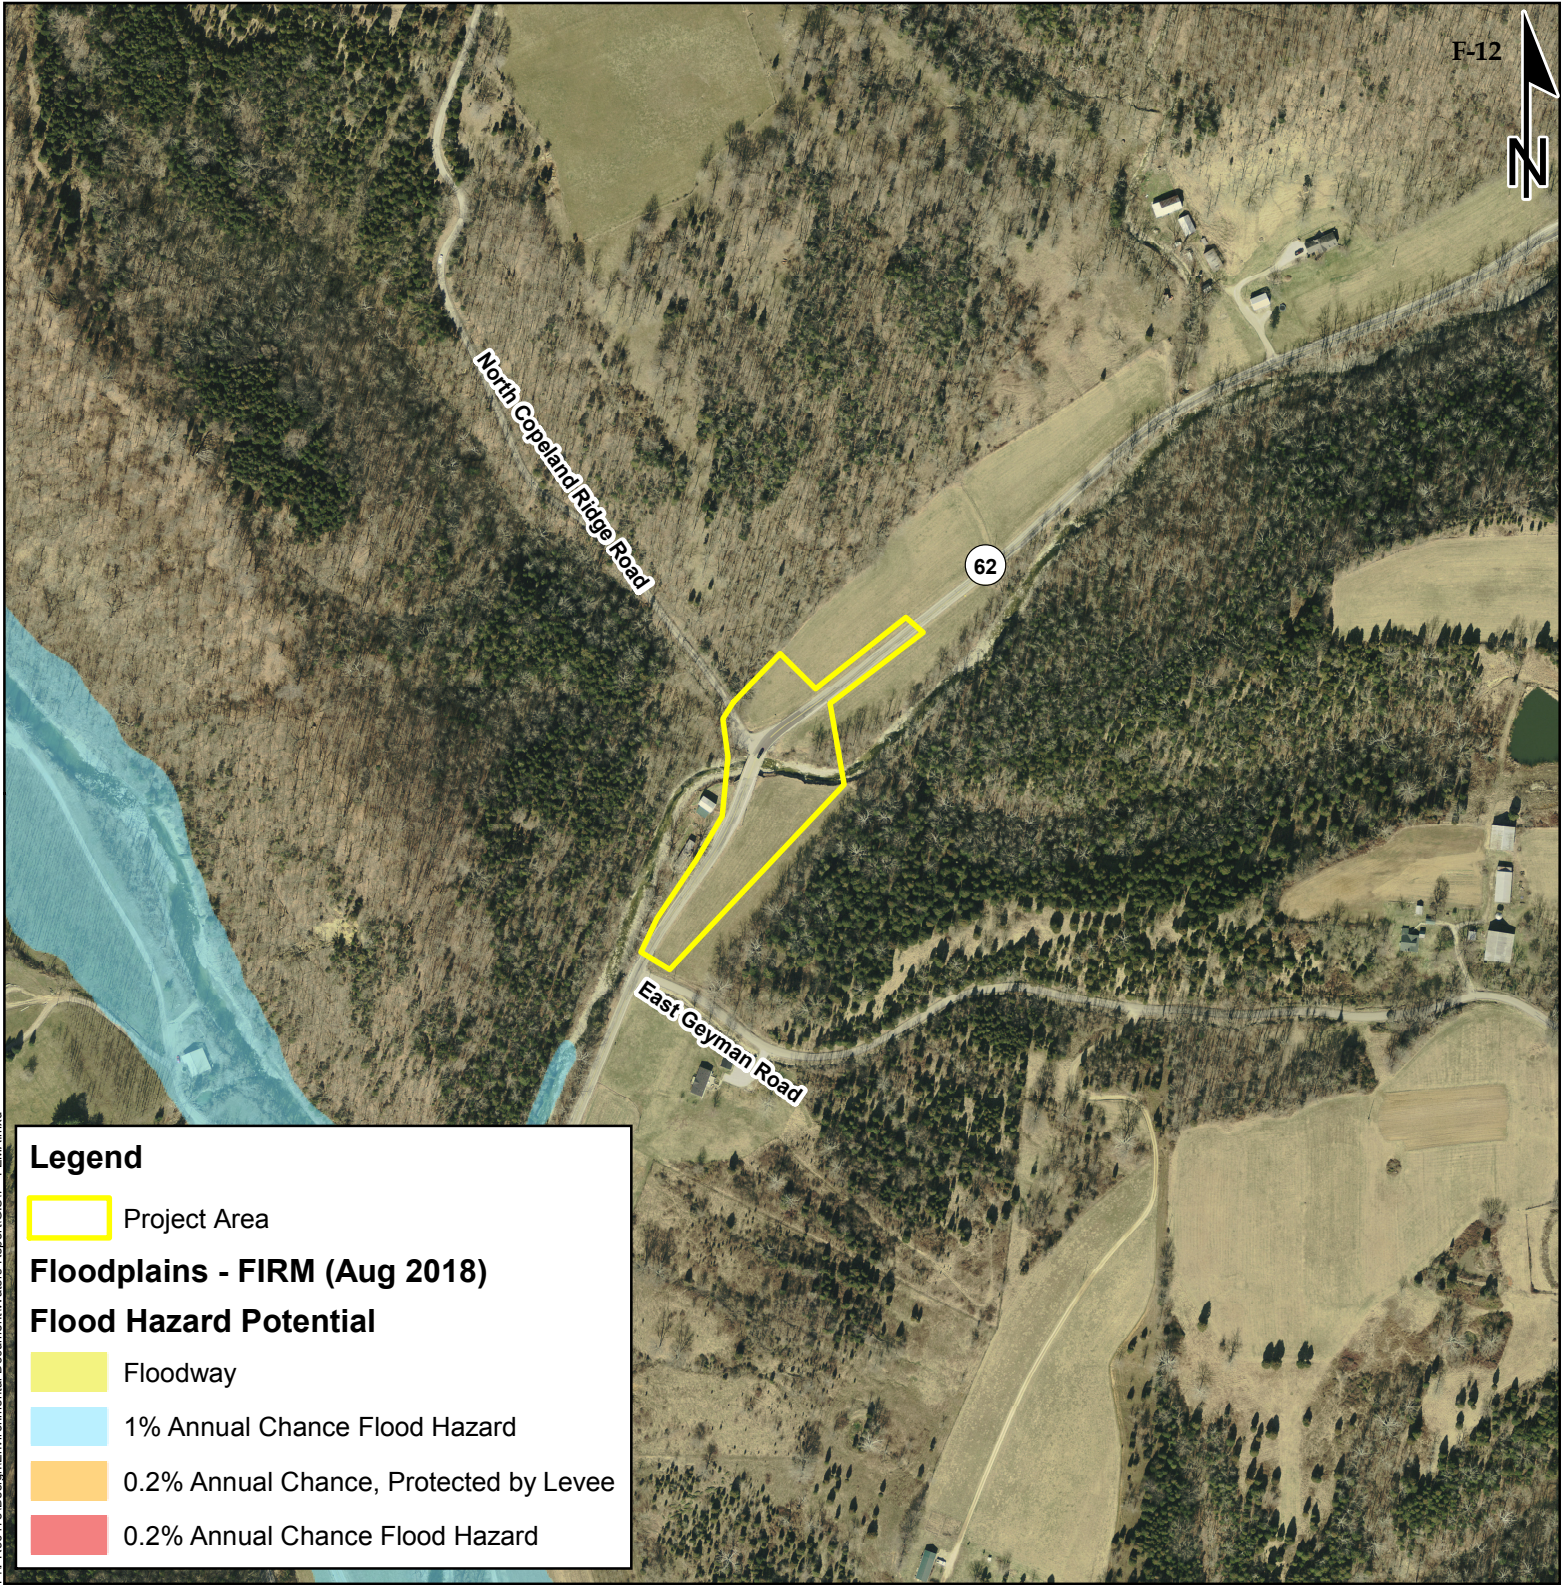
FEMA Flood Hazard Map

Flood Hazard Potential

1% Annual Chance Flood Hazard

0.2% Annual Chance Flood Hazard

The project location appears on Flood Insurance Rate Map (FIRM) panel 18077C0180C (effective 04/02/2015). The project area is shown within Zone X, indicating that it is in an area of Minimal Flood Hazard.
