Des 1800269
Appendix E
Red Flag Investigation

Re: RED FLAG INVESTIGATION
DES 1800269, State Project
Small Structure Replacement
SR 250 over Bear Branch, 4.61 Miles East of SR 129
Switzerland County, Indiana

**Waters Report
SR 250 over UNT to Bear Branch
Switzerland County, Indiana
Small Structure Project, CV 250-078-51.30
Des. No. 1800269**

Des 1800269 involves the replacement of the existing culvert (CV 250-078-51.30), which carries an unnamed tributary (UNT) to Bear Branch under SR 250 in Switzerland County, Indiana. The existing culvert is a temporary structure placed following the failure of the original structure and consists of two 36-inch diameter corrugated metal pipes. The original structure was a 4-foot by 3.2-foot three-sided concrete structure with a length of approximately 30 feet. The proposed project will replace the existing temporary structure with a 5-foot by 4-foot reinforced concrete box with a length of approximately 68 feet. Wing walls will be constructed at the inlet and outlet of the structure. The existing guardrails in the project area may be replaced and extended. Ditch grading may occur on the north and south side of the roadway.

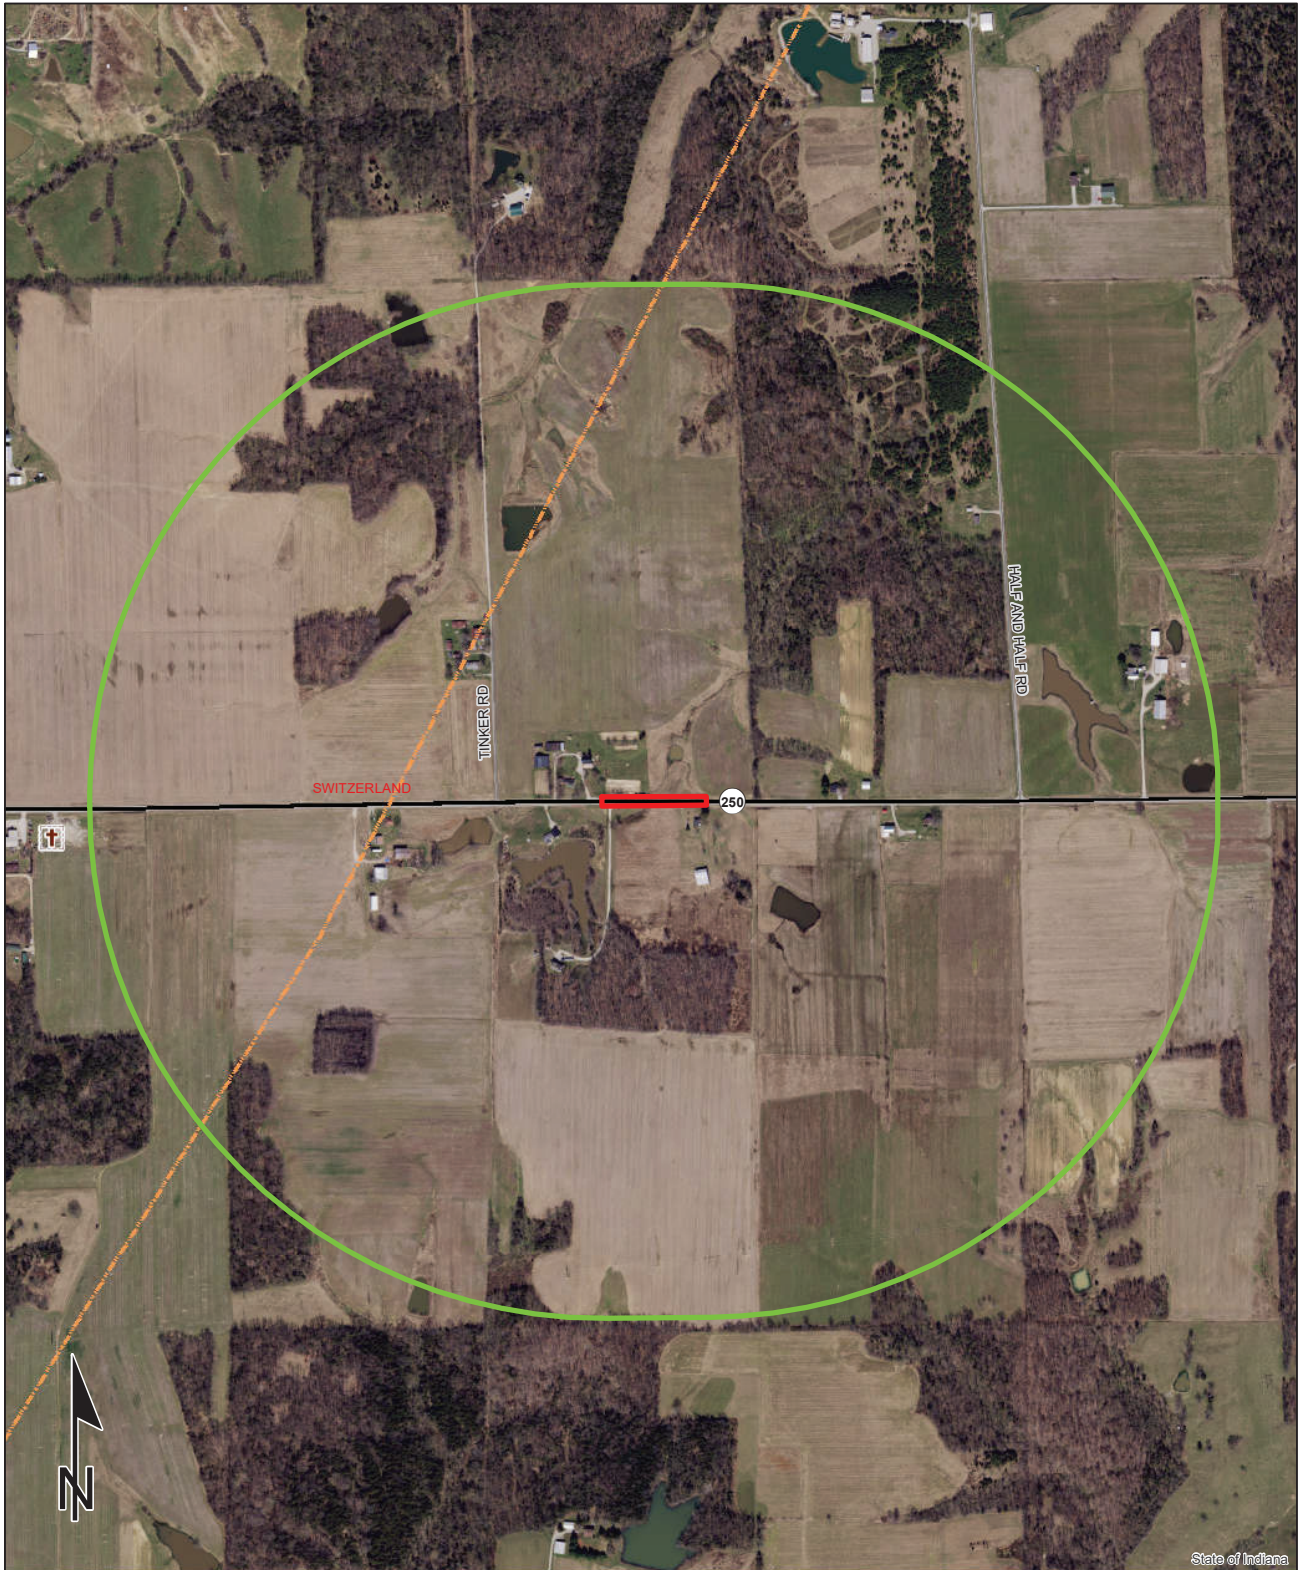
Red Flag Investigation - Infrastructure
 SR 250, 4.61 Miles East of SR 129
 Des. No. 1800269, Small Structure Project
 Switzerland County, Indiana

Pipelines: One (1) pipeline segment is located within the 0.5 mile search radius. The nearest segment, owned by Texas Gas Transmission Corp., is located approximately 0.18 mile northwest of the project area. No impact is expected.

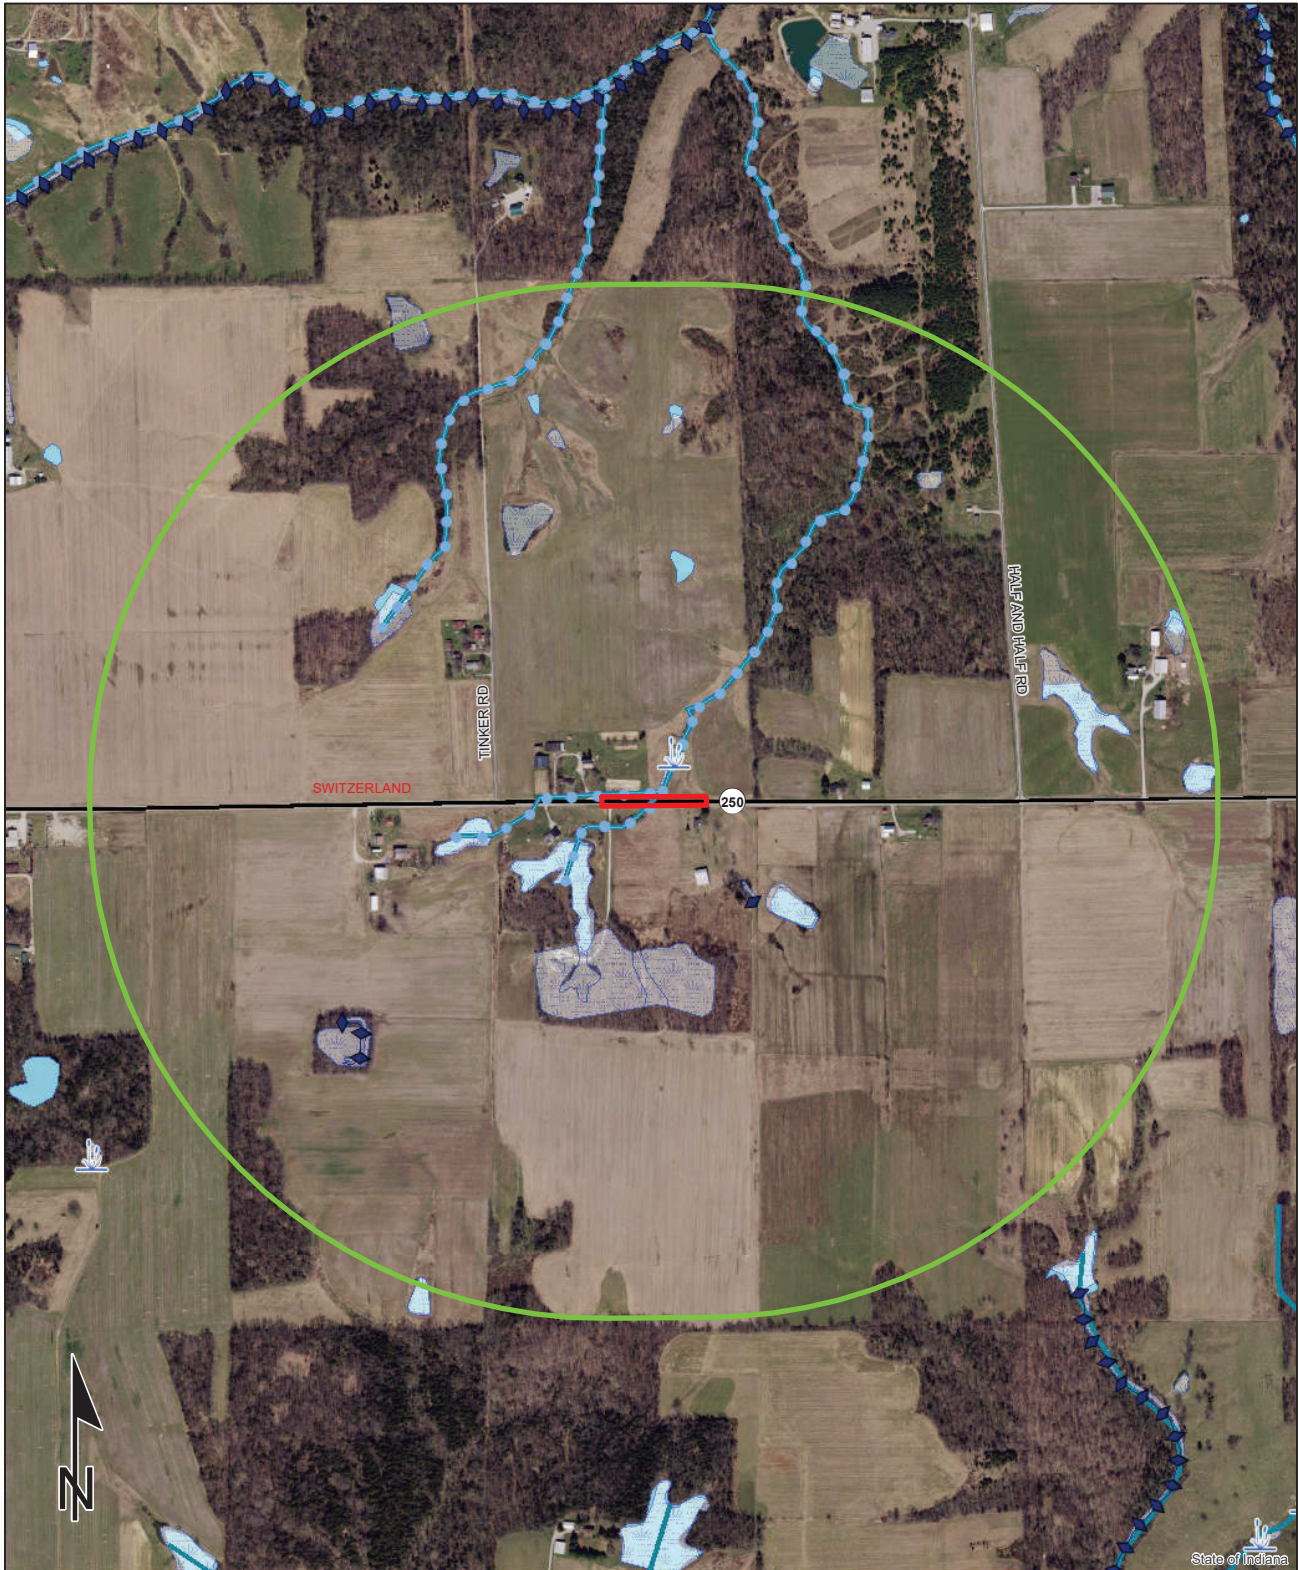
Red Flag Investigation - Water Resources
 SR 250, 4.61 Miles East of SR 129
 Des. No. 1800269, Small Structure Project
 Switzerland County, Indiana

NWI – Points: One (1) NWI point is located within the 0.5 mile search radius. The nearest NWI point is located approximately 0.04 mile north of the project area. No impacts are expected.

NWI – Lines: Two (2) NWI lines are located within the 0.5 mile search radius. The nearest NWI line is located approximately 0.09 mile southeast of the project area. No impacts are expected.

IDEM 303d Listed Streams and Lakes (Impaired): Four (4) IDEM 303d Listed Streams are located within the 0.5 mile search radius. Three (3) impaired stream segments, all associated with Bear Branch, are located within and adjacent to the project area. Bear Branch is listed as impaired for Impaired Biotic Communities (IBC) and *E. coli*. Concerning IBC, Best Management Practices (BMPs) will be used to avoid further degradation to the stream. Workers who are working in or near water with *E. coli* should take care to wear appropriate PPE, observe proper hygiene procedures, including regular hand washing, and limit personal exposure.

Rivers and Streams: Seven (7) stream segments are located within the 0.5 mile search radius. Three (3) stream segments associated with Bear Branch are located within and adjacent to the project area. A Waters of the US Report will be prepared and coordination with INDOT ESD Ecology and Waterway Permitting will occur.

NWI – Wetlands: Twenty-seven (27) NWI wetlands are located within the 0.5 mile search radius. One (1) wetland is located within the project area. A Waters of the US Report will be prepared and coordination with INDOT ESD Ecology and Waterway Permitting will occur.

Lakes: Eleven (11) lakes are located within the 0.5 mile search radius. The nearest lake is located approximately 0.06 mile southwest of the project area. No impacts are expected.

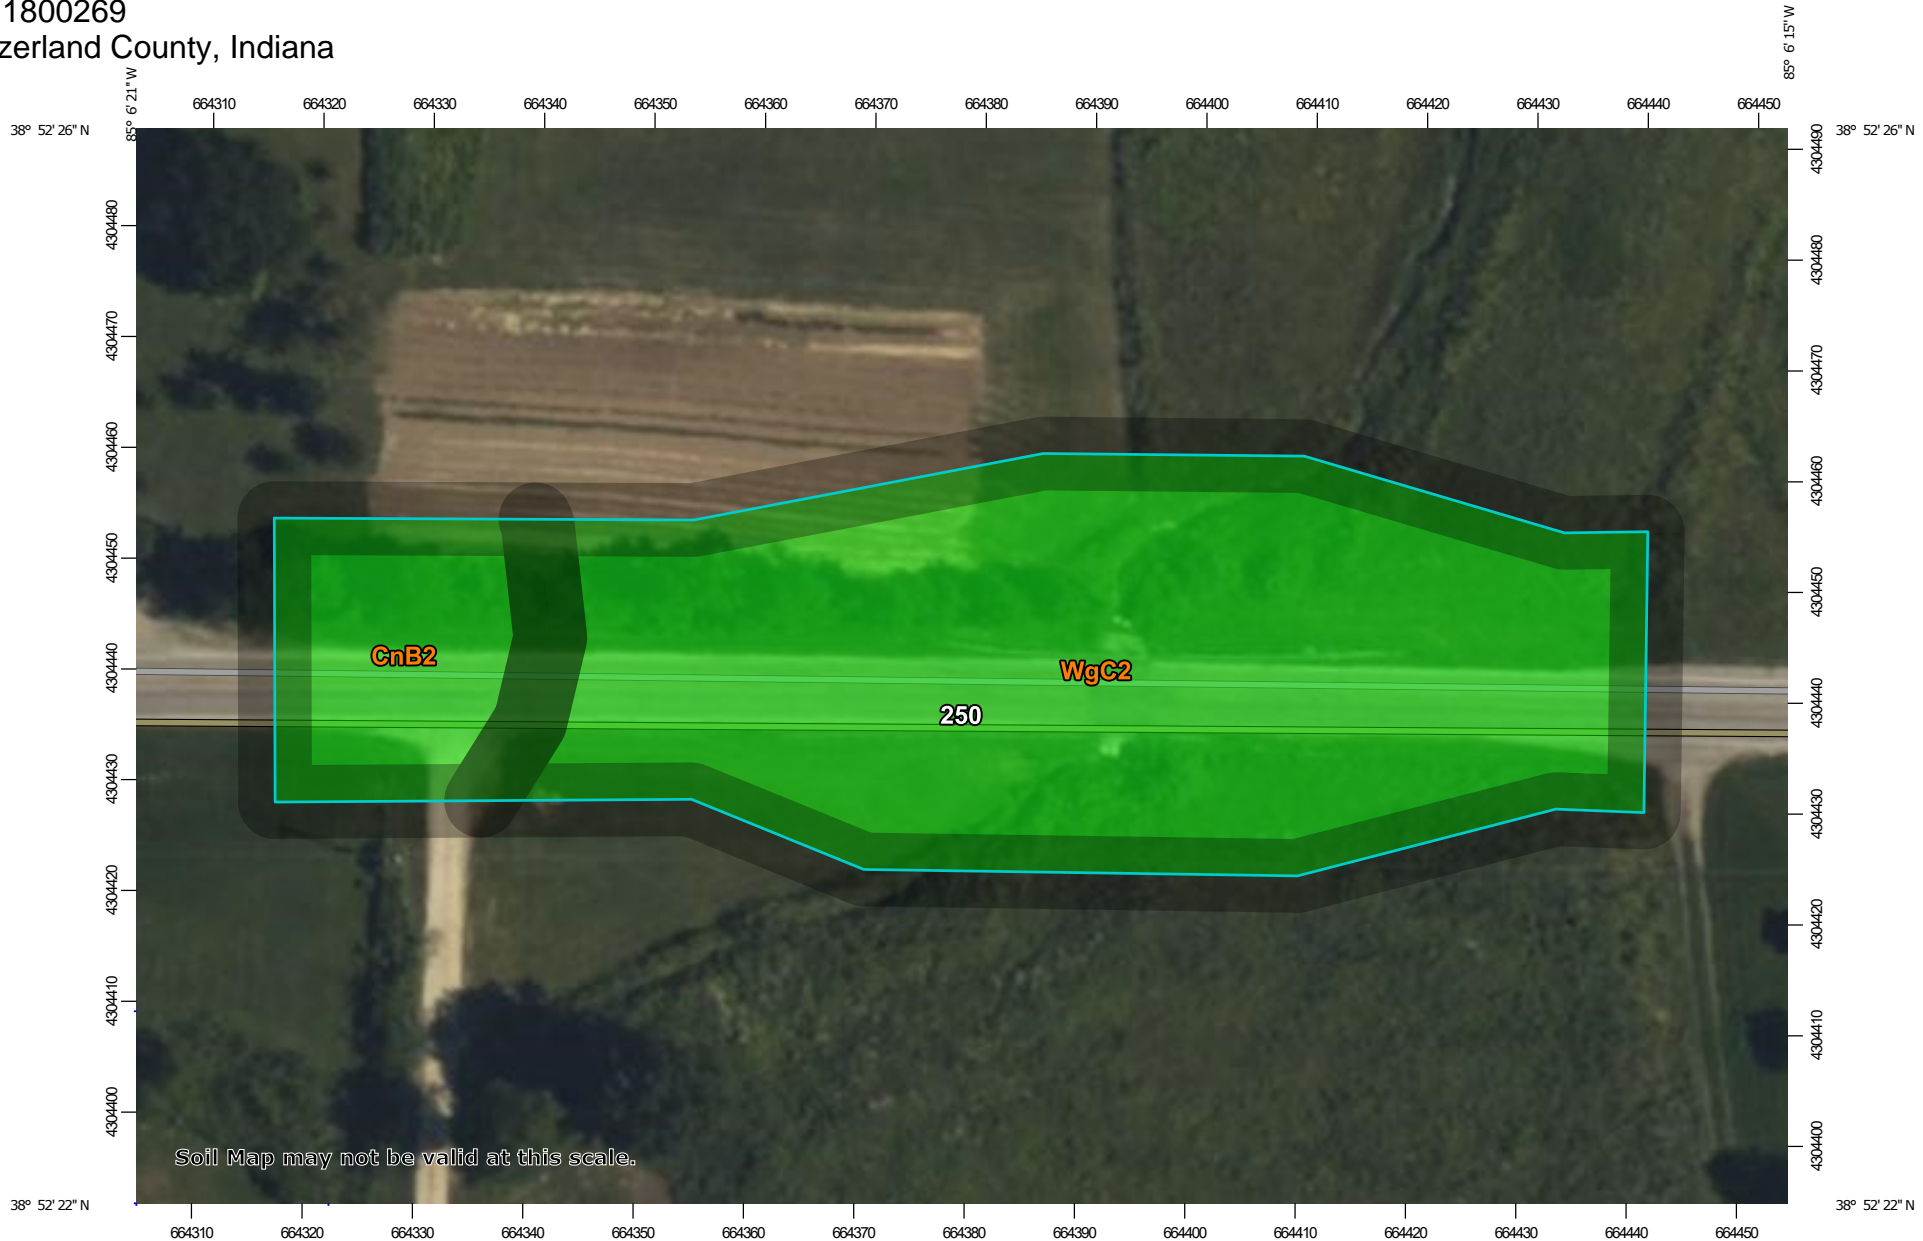
Soil Map
 Small Structure Project
 Des 1800269
 Switzerland County, Indiana

- **Soils:** According to the Switzerland County Soil Survey, soils mapped within the investigated area include:

Soil Name	Map Abbreviation	Hydric Range
Cincinnati silt loam, 2-6% slopes, eroded	CnB2	0
Weisburg silt loam, 6-12 percent slopes, eroded	WgC2	0

Map unit symbol	Map unit name	Rating	Acres in AOI	Percent of AOI
CnB2	Cincinnati silt loam, 2 to 6 percent slopes, eroded	0	0.1	15.5%
WgC2	Weisburg silt loam, 6 to 12 percent slopes, eroded	0	0.8	84.5%
Totals for Area of Interest			1.0	100.0%

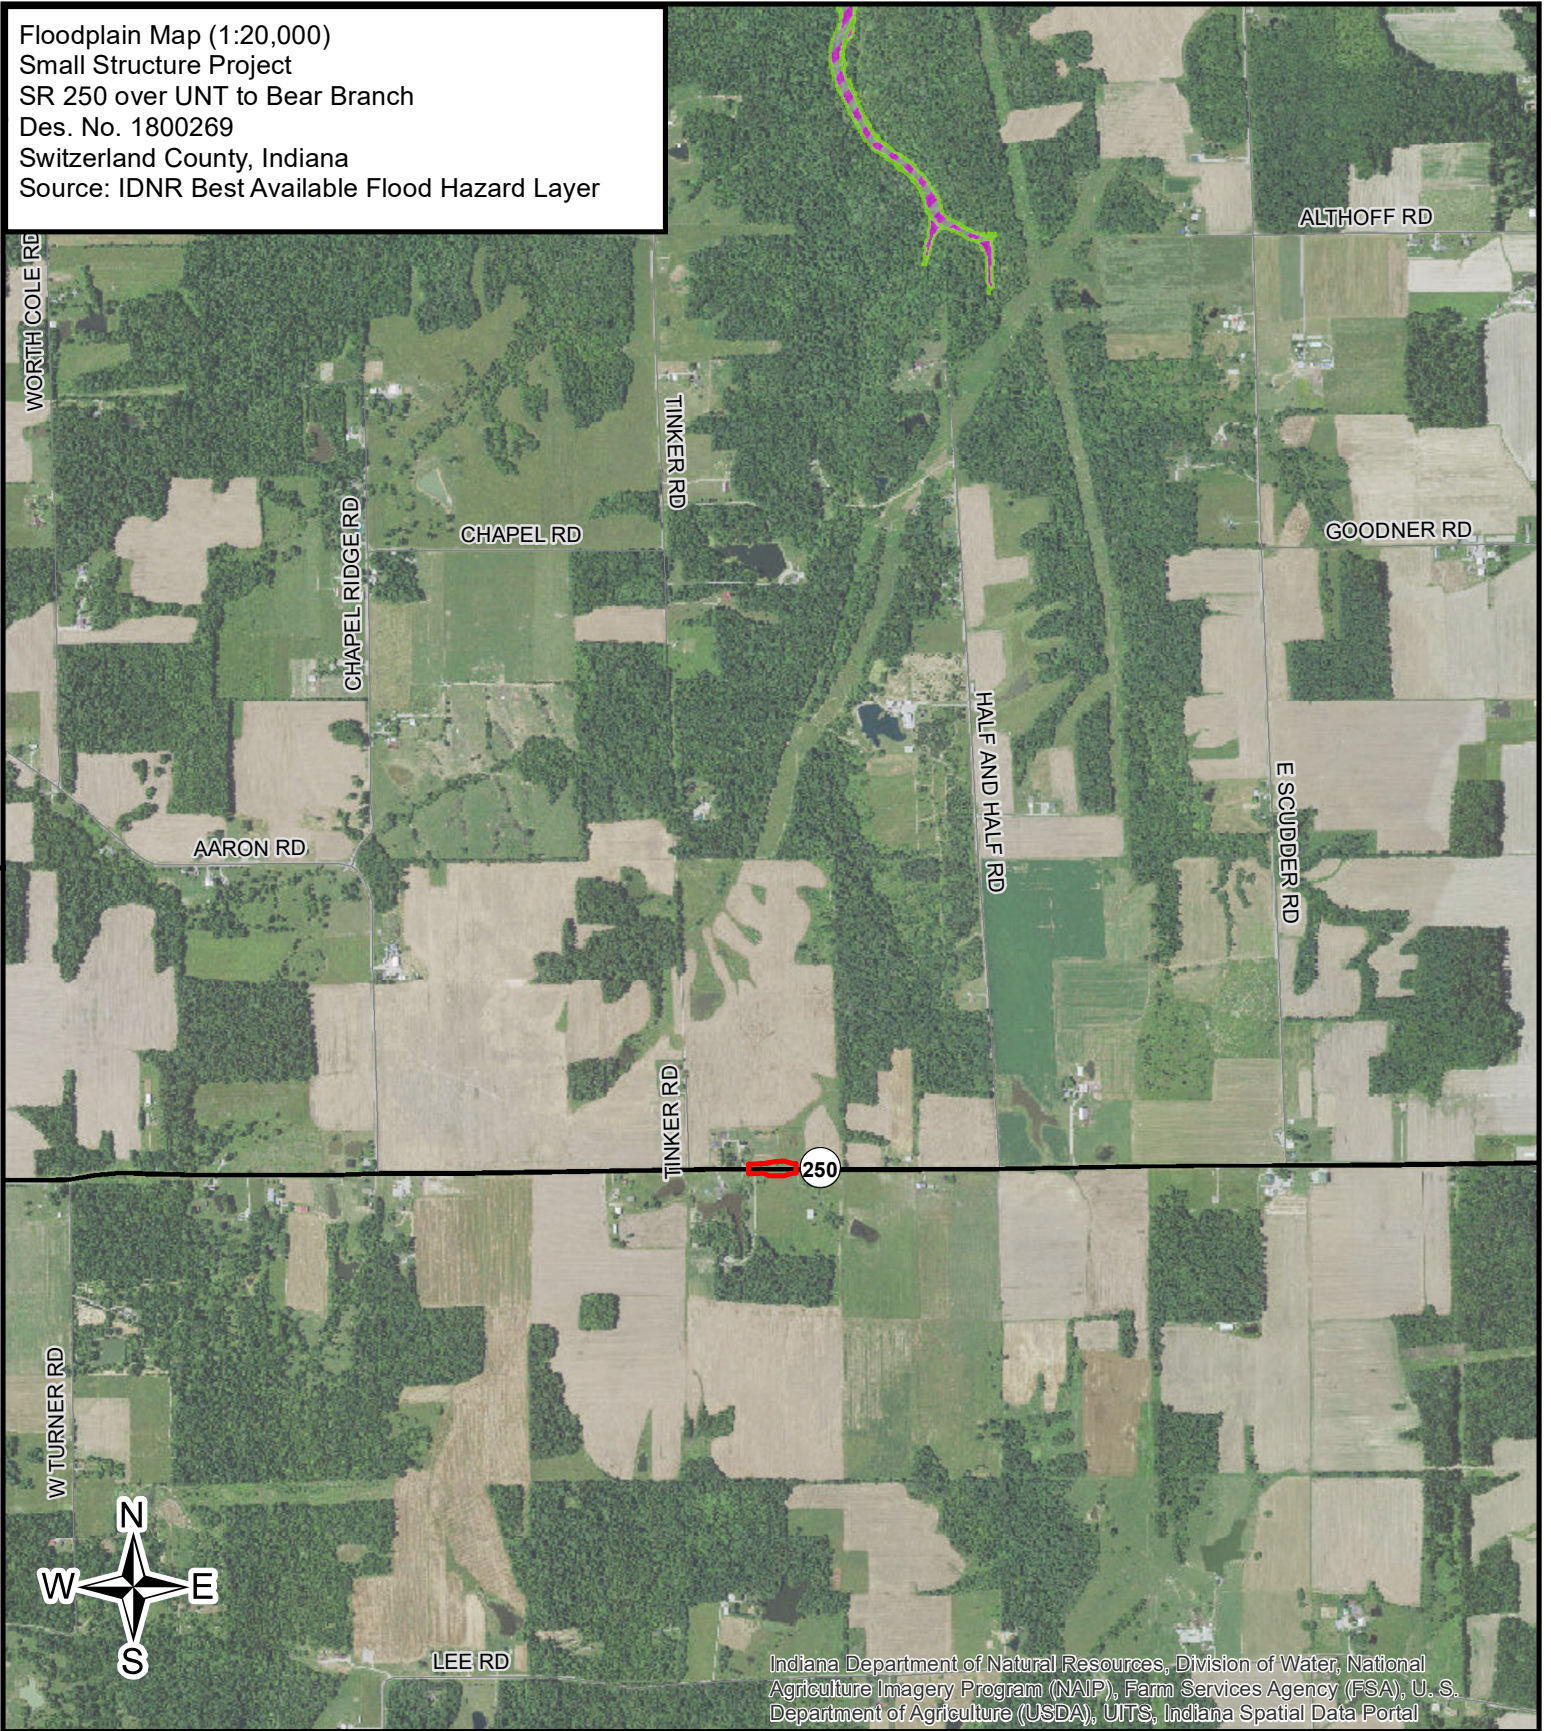
Floodplain Map (1:20,000)
 Small Structure Project
 SR 250 over UNT to Bear Branch
 Des. No. 1800269
 Switzerland County, Indiana
 Source: IDNR Best Available Flood Hazard Layer

- **Hydrology:** According to the Indiana Department of Natural Resources (IDNR) Best Available Flood Hazard Layer (see attached Floodplain Map), the project area is not mapped within a floodplain. Based on the National Hydrography Dataset (NHD) (see attached NWI and NHD Flowlines Map), two (2) stream flowline segments are present in the investigated area. One (1) stream flowline segment is associated with UNT to Bear Creek and is mapped flowing through the project area. One (1) stream flowline segment is mapped on along the north side of SR 250 in the northwest quadrant of the structure.

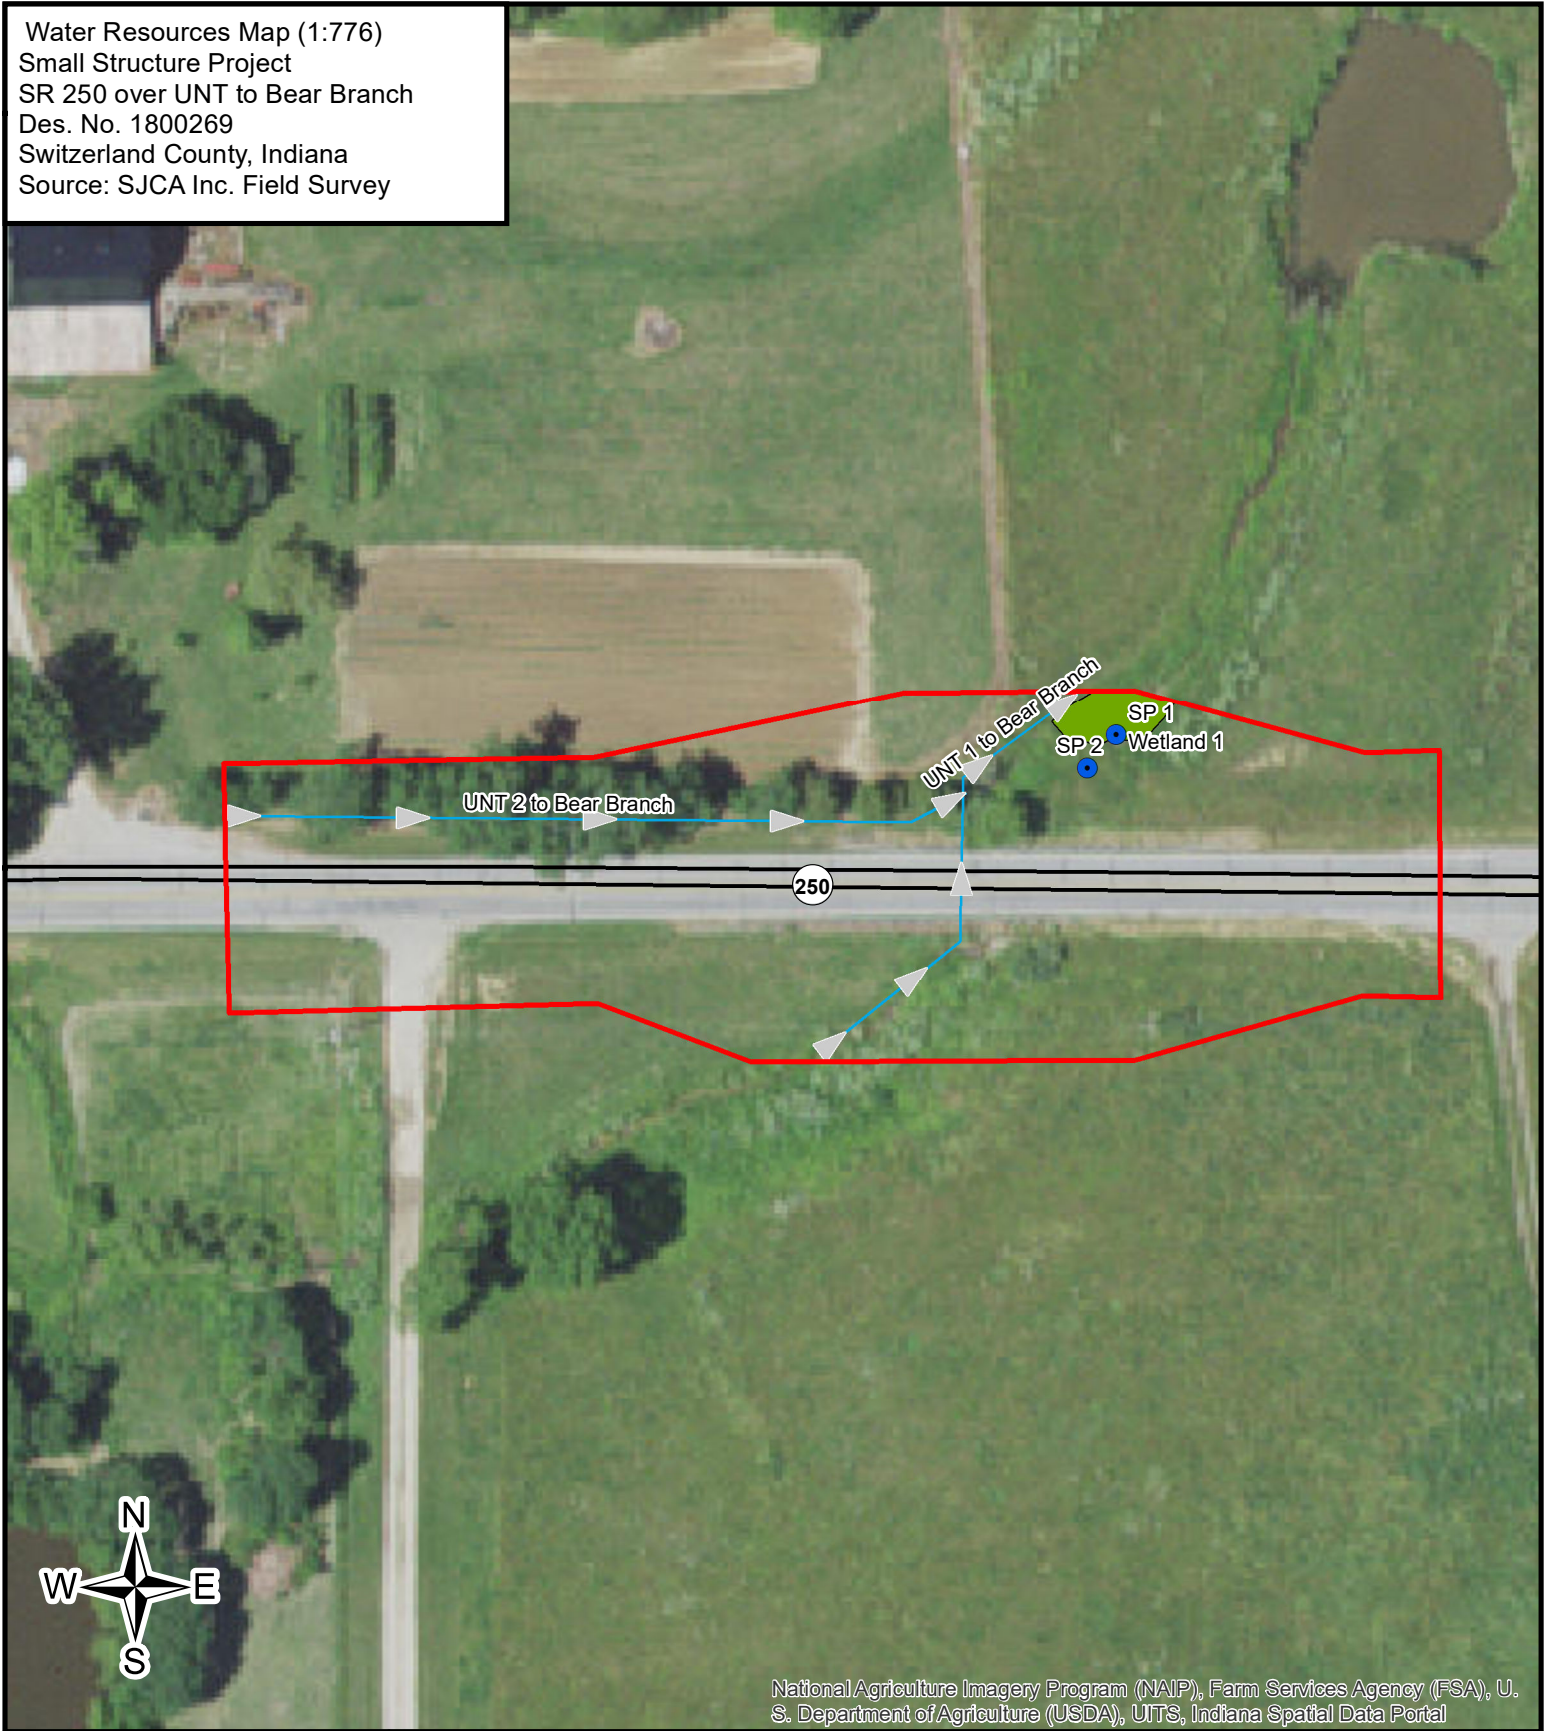
Water Resources Map (1:776)
 Small Structure Project
 SR 250 over UNT to Bear Branch
 Des. No. 1800269
 Switzerland County, Indiana
 Source: SJCA Inc. Field Survey

The investigated area included roadside right-of-way, maintained lawn, and an uncultivated area of rolling hills and associated depressions. Hydrology within the investigated area is influenced by roadway runoff and drainage from the landscape. The investigated area is located within the Bear Creek subwatershed. According to the NWI map and USGS topographic map, there are no wetlands mapped within or adjacent to the investigated area. Two (2) streams are mapped within the investigated area. The presence of the two (2) streams, both unnamed tributaries (UNT) to Bear Branch, was confirmed during the site visit. One (1) wetland, **Wetland 1**, was identified during the site visit.

Two streams, **UNT 1 to Bear Branch** and **UNT 2 to Bear Branch**, were observed within the investigated area during the site visit.

The site investigation identified two streams and one wetland within the investigated area. Wetland 1 is located in a depressional area northeast of the structure outlet. UNT 1 to Bear Branch flows through the project structure, and UNT 2 to Bear Branch is located on the north side of SR 250 west of the project structure. UNT 1 to Bear Branch is likely a Water of the US due to its intermittent flow conditions and connectivity to the Ohio River approximately 16.5 miles northeast of the investigated area. Wetland 1 is likely a Water of the US due to its proximity and connectivity to UNT 1 to Bear Branch. UNT 2 to Bear Branch was determined to be an ephemeral roadside drainage feature. INDOT acknowledges that UNT 2 to Bear Branch would likely not meet the definition of a Waters of the US. However, INDOT is requesting that the USACE take jurisdiction of UNT 2 to Bear Branch. Every effort should be taken to avoid and
