County Washington Route SR 60 over South Fork Blue River Des. No. 1700173

# FHWA-Indiana Environmental Document CATEGORICAL EXCLUSION / ENVIRONMENTAL ASSESSMENT FORM GENERAL PROJECT INFORMATION

Bridge Replacement Project

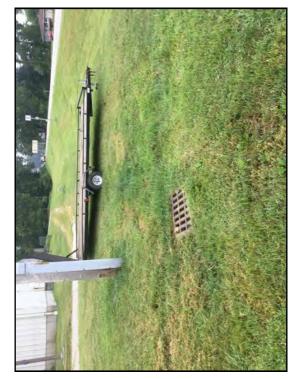
3. View of drain, looking southeast.

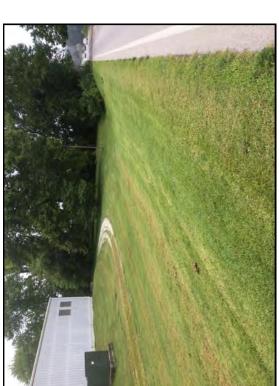
5. View of S.R. 60 ROW and RSD 1, looking southeast.

Two roadside ditches (RSD) were identified within the project study limits (Appendix F, page F-11). RSD 1 is located in the northeast quadrant and RSD 2 is located in the southeast quadrant. These features did have cut channels as they got closer to South Fork Blue River, possibly due to the field and road runoff; however, in areas where there was no debris accumulation, there was predominantly upland vegetation present within the ditch. No OHWM was observed in either of these features, so they are likely non-jurisdictional.

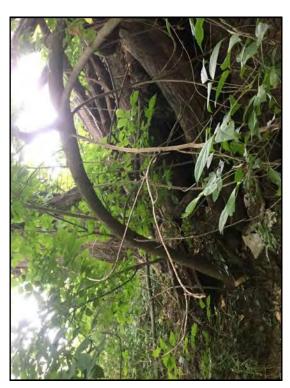
7. View of RSD 1, looking southeast.

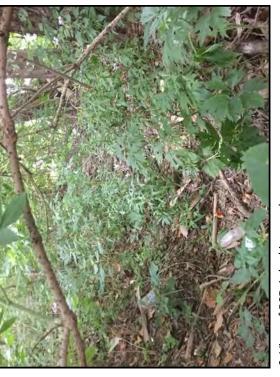
6. View of RSD 1, looking northwest.

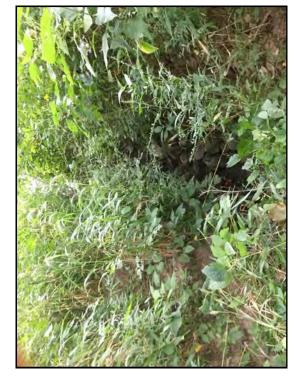
8. View from Culvert 1, looking southeast.

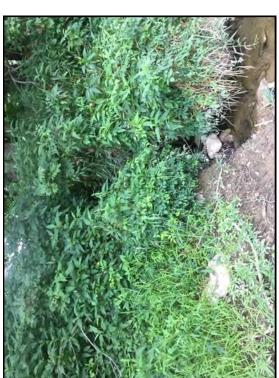
9. View of Culvert 1, looking northwest.

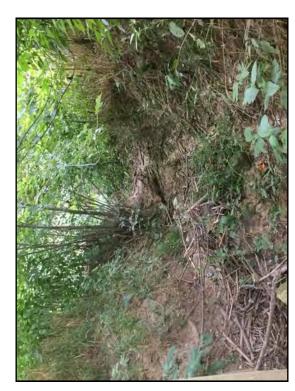
15. View of RSD 2, looking northwest.

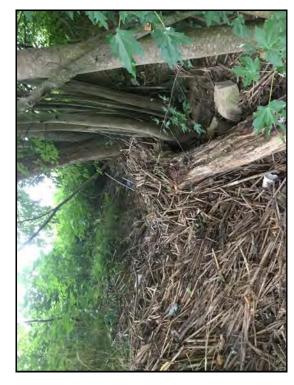
16. View of RSD 2, looking southeast.

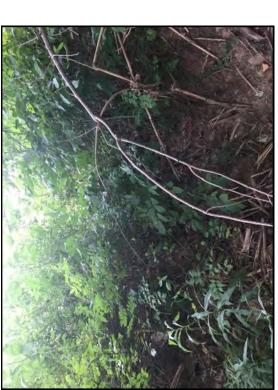
17. View of RSD 2, looking southeast.

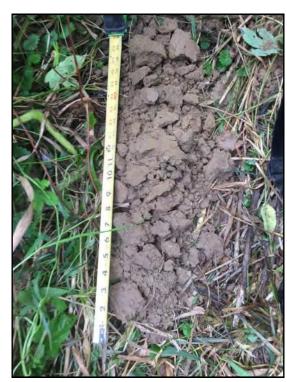
39. View of SP-1, soil profile.

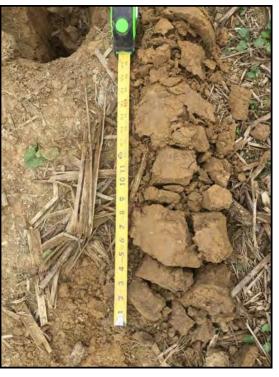
42. View of SP-2, soil profile.

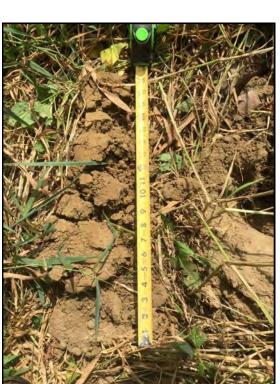
45. View of SP-3, soil profile.

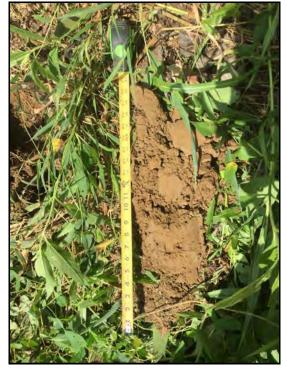
48. View of SP-4, soil profile.

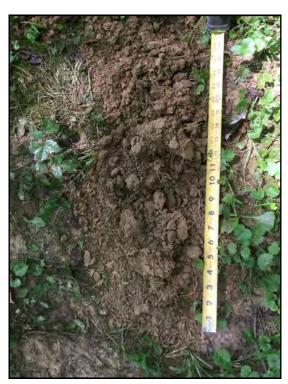
51. View of SP-5, soil profile.
