Categorical Exclusion

Project Designation Number: 1600886

Route Number: SR 234

Project Description: Small Structure Replacement, 1.56 miles east of US 41

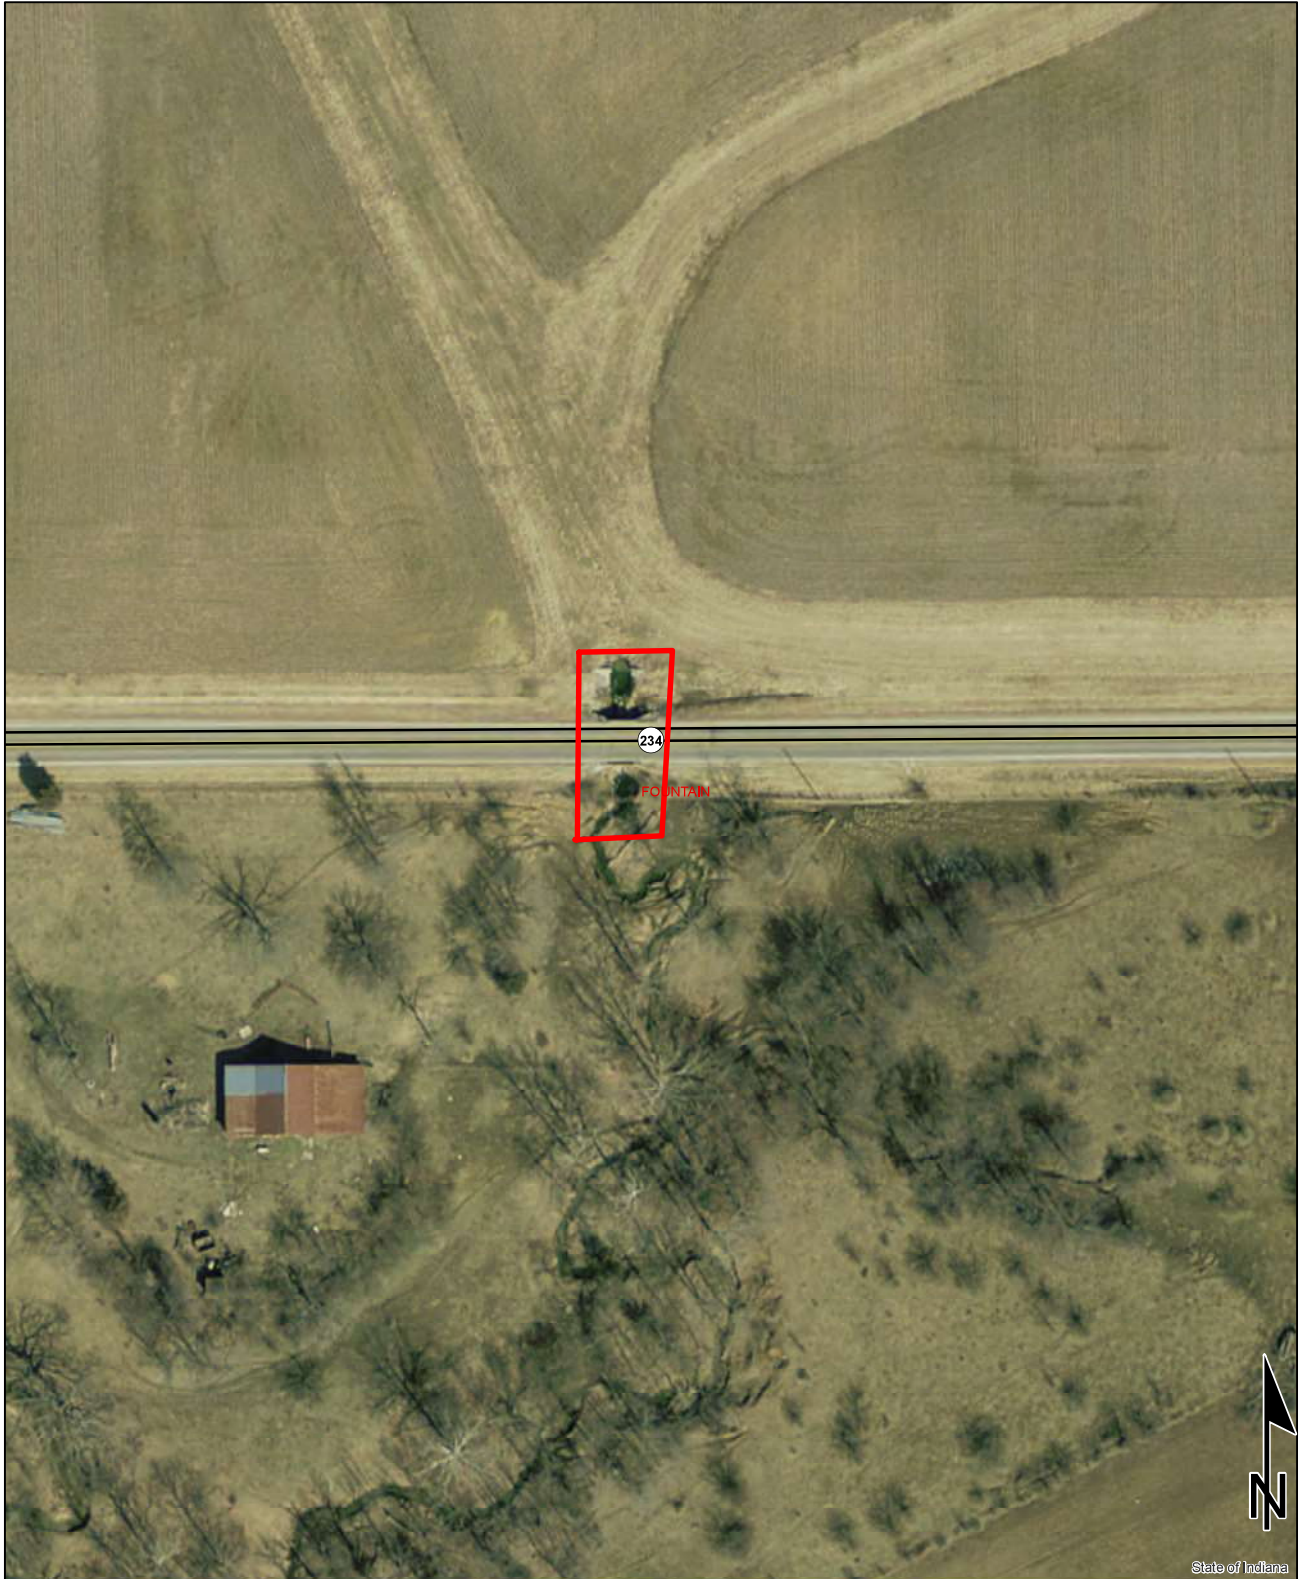
Project Location
SR-234 at RP 18+14 1.56 miles E of SR-41
1600886 , Small Structure Replacement
Fountain County, Indiana

Project Area

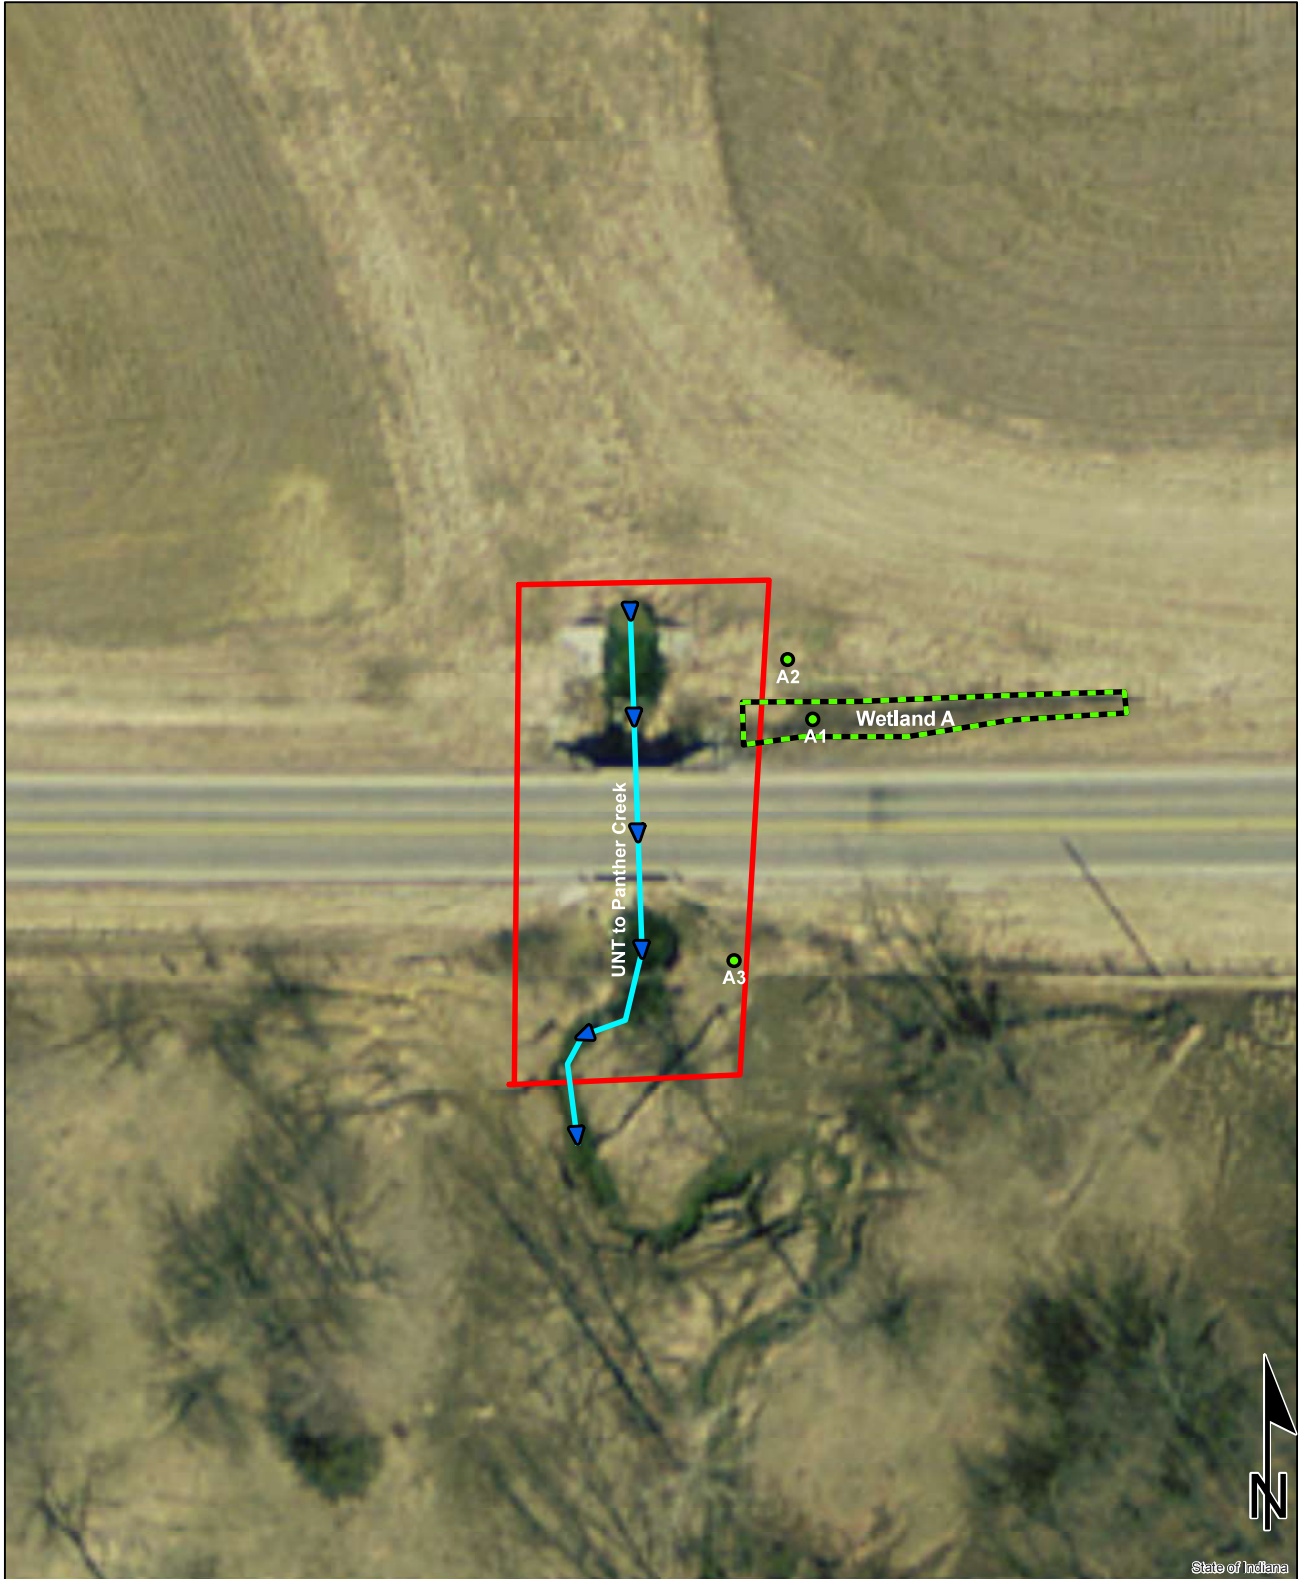
Field Identified Water Resources
 SR-234 at RP 18+14, 1.56 miles E of US-41
 DES No. 1600886 Small Structure Replacement
 Fountain County, Indiana

- Determination Points
- ▶▶▶▶▶ Likely Jurisdictional Waterway
- Delineated Wetlands
- Project Area

One or more waterways were observed in the investigated area. A UNT to Panther Creek flows south beneath the structure. The UNT is not a mapped blue line stream, and due to that reason the closest point upstream (.160 miles north from the project area) was selected via StreamStats. This point showed the drainage area at this location as being 0.129 square miles. However, the engineers report states that the drainage area is 0.35 square miles at the project area. This is an intermittent stream that exhibits an ordinary high water mark (OHWM) width (13') and depth (2') measured approximately 10' south of the structure. This stream seems to follow an irregular pattern and would be considered to have moderate sinuosity as it twists and turns around south of the structure. The substrate was considered to be silty within the project area and agricultural and livestock fields surrounds the stream and structure. Also livestock was observed within 100 yards of the stream indicating that a lot of the water entering into this stream is runoff from these fields. Due to all of these factors this stream would be considered to be of poor quality. Due to the presence of an OHWM and distinct bank characteristics, the UNT to Panther Creek is likely to be considered a jurisdictional waterway. This UNT to Panther Creek was the only stream identified within the review area. The project area is 0.17 stream miles north of the convergence with Panther Creek and the UNT to Panther Creek. Panther creek continues to flow to the south for approximately 2.15 stream miles until it converges with Sugar Mill Creek. Sugar Mill Creek flows 8.61 miles to the south/southwest until it converges with Sugar Creek which is a traditional navigable waterway.

One or more wetlands were observed in the investigated area. A wetland (Wetland A) was identified in the northeast quadrant of the existing structure, approximately 15ft. east of the existing structure. *Conium maculatum* (Poison Hemlock) and *Phalaris arundinaceae* (Reed Canary Grass) dominated this quadrant, and both are facultative wet species. Two data points were taken in this area: A1 and A2. Data point A1 exhibited wetland vegetation and notably saturated soil. The type of soil found at A1 was a loamy gleyed matrix starting at 8 inches from the surface. The first 8" of soil was clay loam and it did not exhibit any redox features. This wetland is considered to be of poor quality because it appears to be formed by runoff from nearby fields and the roadway. The wetland also contains a sizeable amount of reed canary grass. Data point A2 did not pass the dominance test for vegetation and did not exhibit any indicators of a wetland. Data point A2 was determined not to be within a wetland. A third data point A3 was performed on the southeast quadrant due to hydrophytic vegetation being present. No hydric soil or wetland hydrology was present at this site and therefore no wetlands were determined to be in

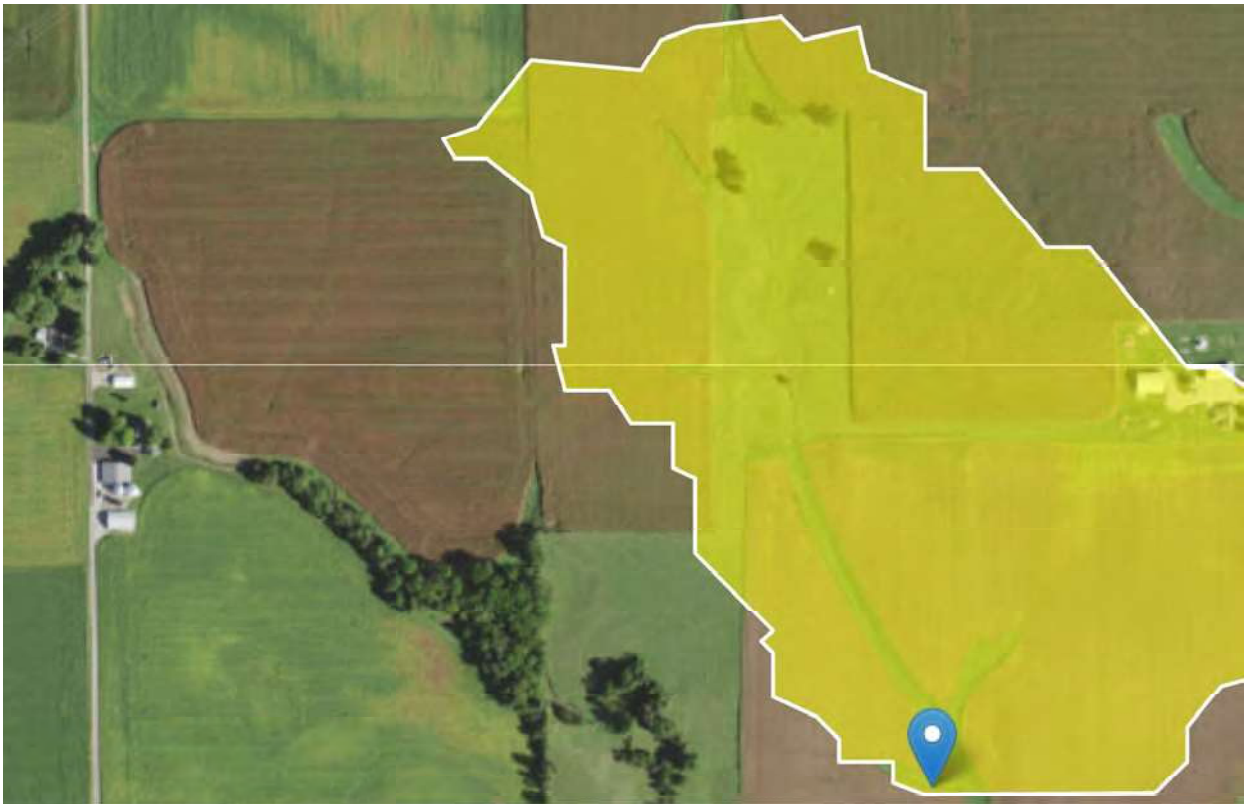
USGS Stream Stats Map
Des. No. 1600886
SR-234 at RP 18+14

Parameter Code	Parameter Description	Value	Unit
DRNAREA	Area that drains to a point on a stream	0.129	square miles

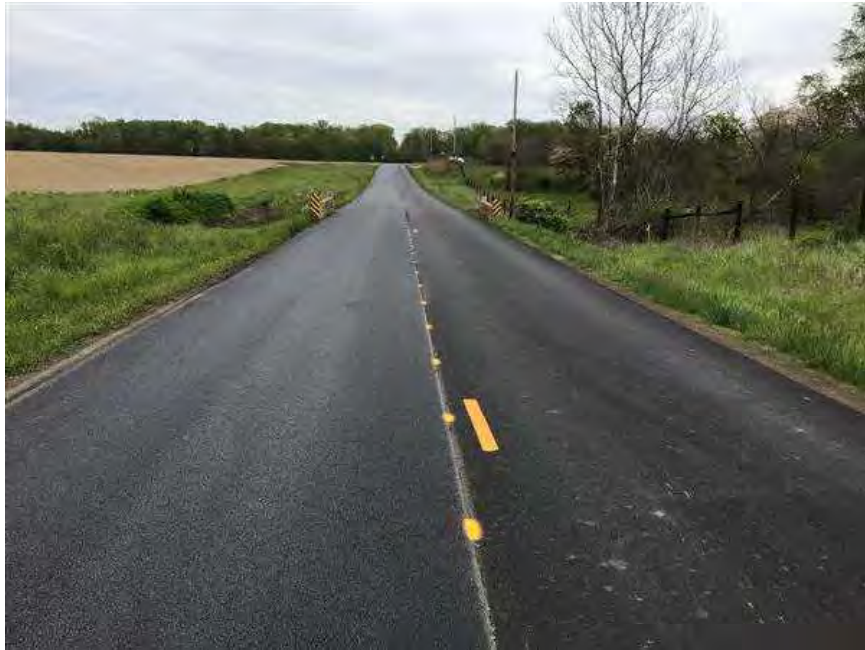
2020 Inspection, The structure is in overall very poor condition.M.H.

(62) Culvert Rating Comments: *Adjusted overall rating to '3' based on core of slab that indicates it is crumbled with poor strength. The wing walls and coping have severe spalling. There is severe spalling at the south end of the structure with exposed steel beams.*

(59.01) Superstructure Comments: *Adjusted overall rating to '3' based on core of slab that indicates it is crumbled with poor strength. There is severe spalling at the south end of the structure with exposed steel beams. The encased steel beams are exposed at the south corners with heavy rusting. The coping has heavy amount of spalling with section loss.*

(60.01) Substructure Comments: *There is a moderate amount of cracking with some areas of efflorescence on the abutments. Also the northeast and southwest ends of the abutments have spalling.*

(61.01) Channel and Channel Protection Comments: *The water flows from the north to the south. There is a large area of scour at the south end of the structure. Also the concrete apron on the south end is broken up and water flows under it.*

Scheduled to be replaced under contract B-39957, Des.# 1601095, with a letting date of 10/2020.
