5.16.1 Introduction

5.16.2.1 Underground Storage Tank (UST) and Leaking UST (LUST) Properties

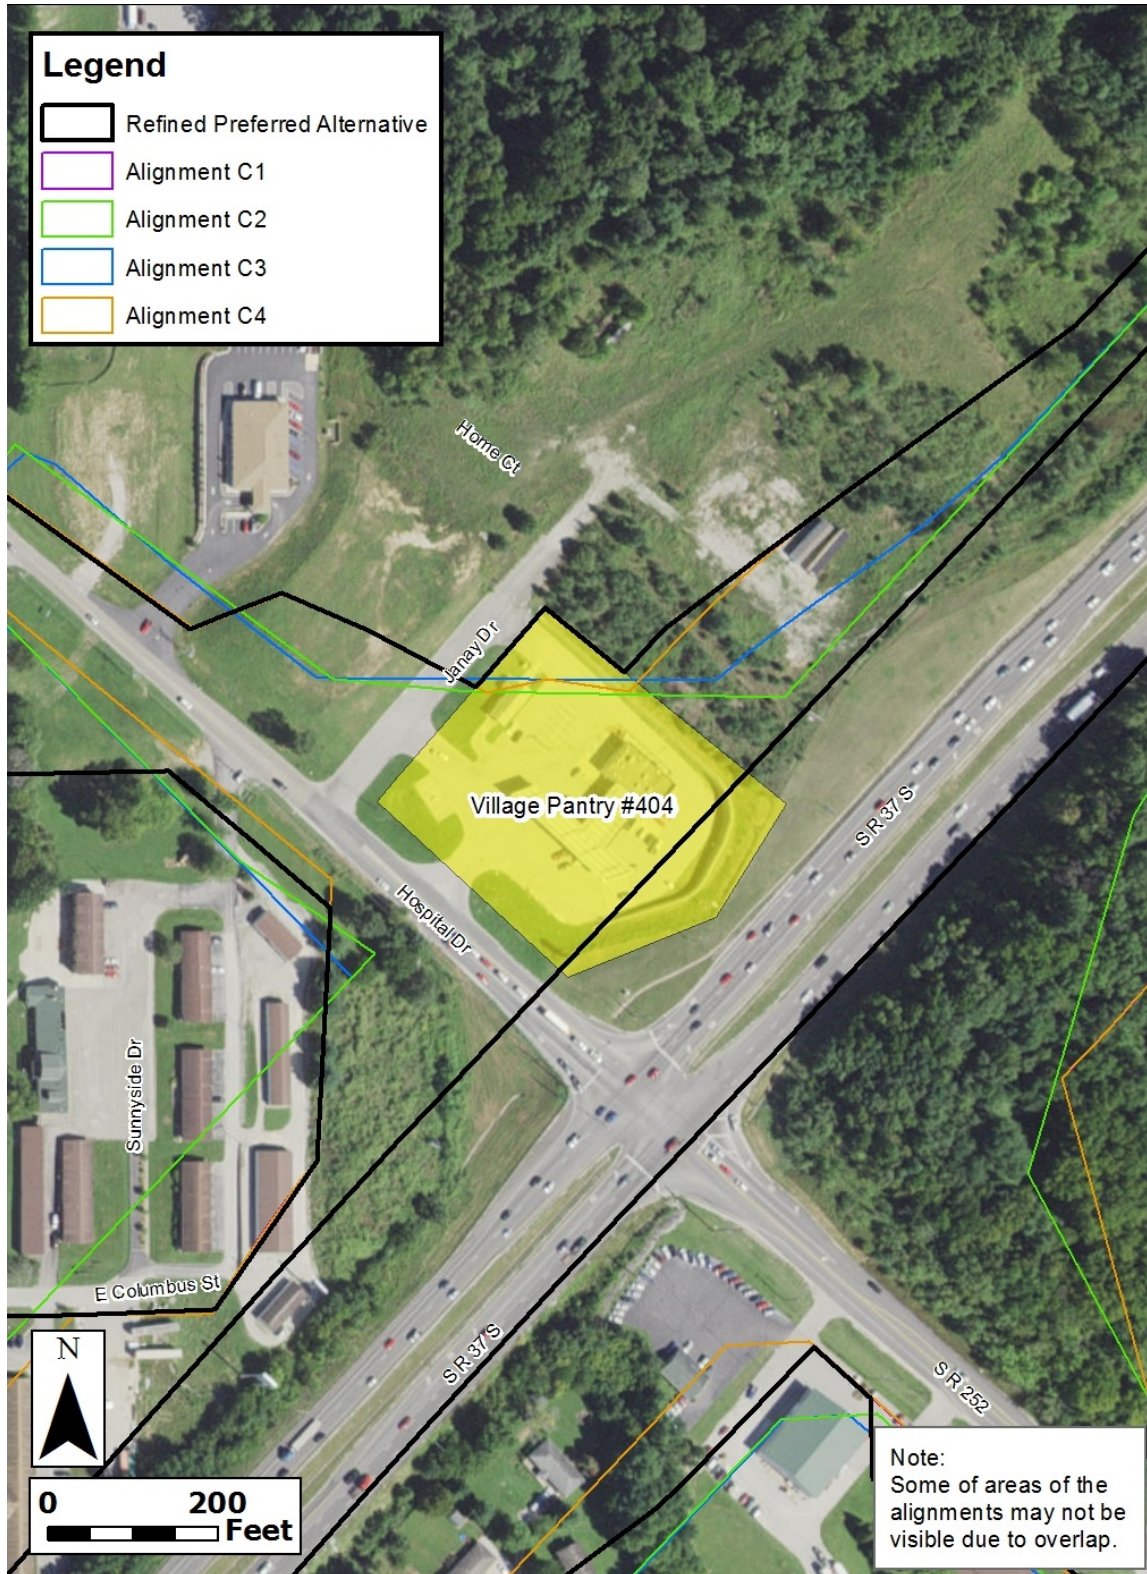
Figure 5.16-18: Property of Concern No. 33 – Village Pantry #404

The site is located at the southwest corner of Birk Road and Grand Valley Boulevard, east of SR 37. The property is listed in the UST database under Facility ID 24849. The property currently has three active USTs, two tanks containing gasoline and one tank containing diesel fuel that were reportedly installed in July of 2001. The property was also listed in the EDR Historical Auto Stations in 2004. According to the most recent UST Inspection Report available on the IDEM VFC, dated January 28, 2016, the UST system was in compliance and no violations were reported. The site was noted to be an active retail petroleum station during the site reconnaissance. It should be noted that since the original investigation, the site is no longer an active retail petroleum station and is currently operating as a Los Tres Caminos, a Mexican restaurant.

Due to the type of operations, field observations at the site, and the location of the UST system within the proposed alignments, a Phase II subsurface investigation is warranted in the proposed construction areas.
