**Lake Diagnostic Study
Lake James, Snow Lake, Big Otter and Little Otter Lakes
Steuben County, Indiana**

Prepared by:

Aquatic Enhancement & Survey, Inc.
P.O. Box 1036
Angola, IN 46703

October 24, 2006

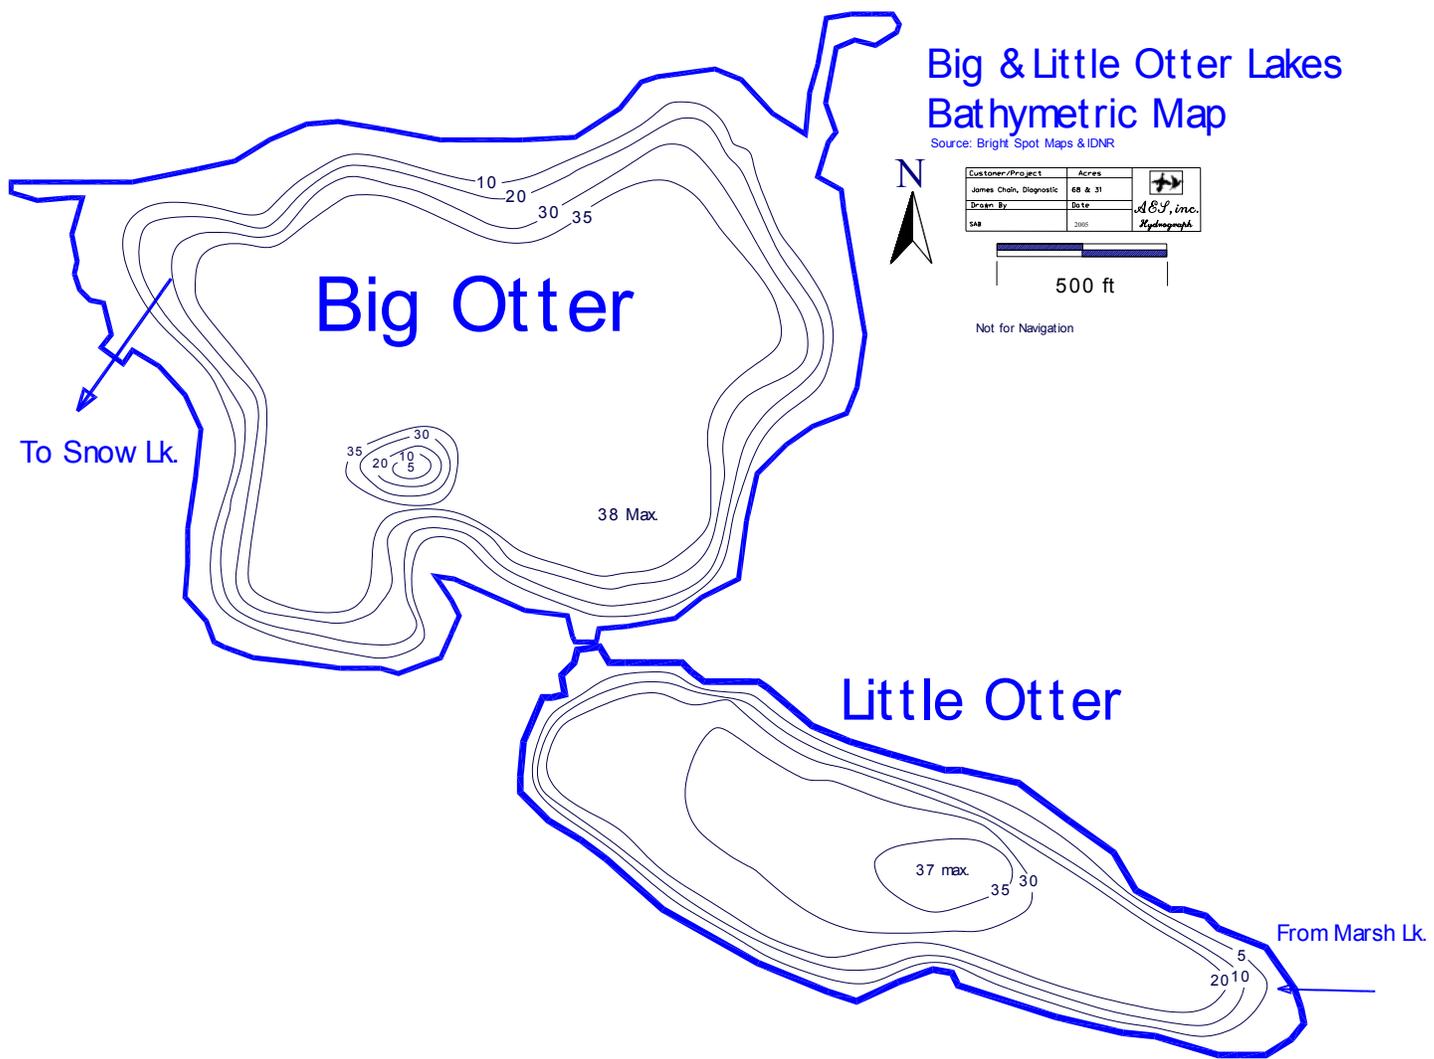
Little Otter lake has a relatively simple morphometry with few shoreline and bottom contour irregularities. (see fig. 15) Its surface area is approximately 31 acres. With a mean depth of 6.4 meters (21 feet) and a maximum depth of 11.28 meters (37 feet) Little Otter Lake is slightly deeper than most northeast Indiana lakes of its size. It's characterized by a very limited littoral area. The littoral shelf around Little Otter is relatively narrow, being less than ten meters wide in most places and sand, silt, or marl bottomed. Wetland shorelines drop off immediately into deep water along much of the west end of the lake. The exception is at the east end of the lake near the Follet Creek inlet where a thick clay and silt sedimentation has taken place building a gradually sloping littoral shelf. Little Otter Lake has a relative depth of 2.84 percent and contains approximately 643 acre-feet (210 million gallons) of water. The maximum length of Little Otter Lake is 733 meters (2406 feet). Little Otter's maximum width (perpendicular to the maximum length) is 228 meters (749 feet). The length of Little Otter's shoreline is approximately 1733 meters (5686 feet). Little Otter's Shoreline Development is 1.39. Little Otter Lake has only a moderate potential for biological productivity in terms of shoreline irregularities due to a moderately short length of interface between the terrestrial and aquatic habitats for the size of the lake.

Figure 15 Big and Little Otter Lakes Bathymetry

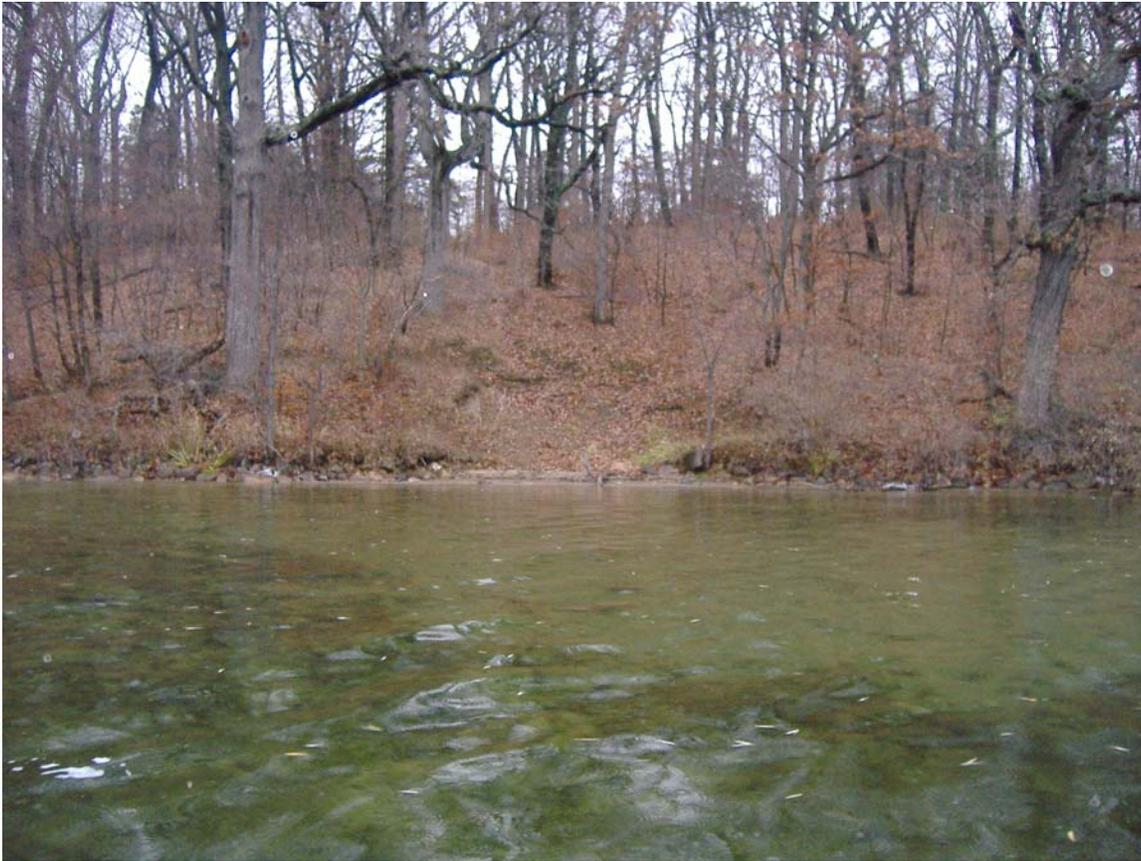
are assets from a water quality standpoint and should be encouraged. As an added benefit Canada geese that cause problems for residents at the lake can be deterred by an uncut strip of vegetation along the shoreline. This acts to provide a barrier to accessing lawns for grazing. On December 11, 2005 237 Canada Geese were noted to be using the James Upper Basin during partial ice cover. Several mated pairs of geese were also noted on the chain in the spring of 2005. In areas where possible, leaving an emergent vegetation or uncut buffer strip can help alleviate problems with grazing Canada Geese. Shoreline erosion was relatively minor across all shoreline types on the James Chain with the exception of some steep banked crumbling spoil deposit areas near the mouth of North Snow Bay and some steep eroded shoreline areas at Pokagon State Park. (fig. 16)

Figure 16 Sediment from Erosion along the Pokagon Shoreline Leaves its Signature in a Plant Free Area on the Lake Bottom

vegetation, and encouraging the establishment of tall vegetated shoreline buffer strips along James Chain Lakes' edges will help to prevent the development of shoreline erosion in the future. In areas requiring shoreline armoring the use of glacial stone should be encourage over concrete, wooden, or steel seawalls. Emergent vegetation plantings can also be used in combination with glacial stone to provide further buffering of wave energy in some areas. Refacing of concrete seawalls with glacial stones can also help absorb wave action. A single refacing with glacial stones on concrete seawalls is now allowed without IDNR permitting for this reason.

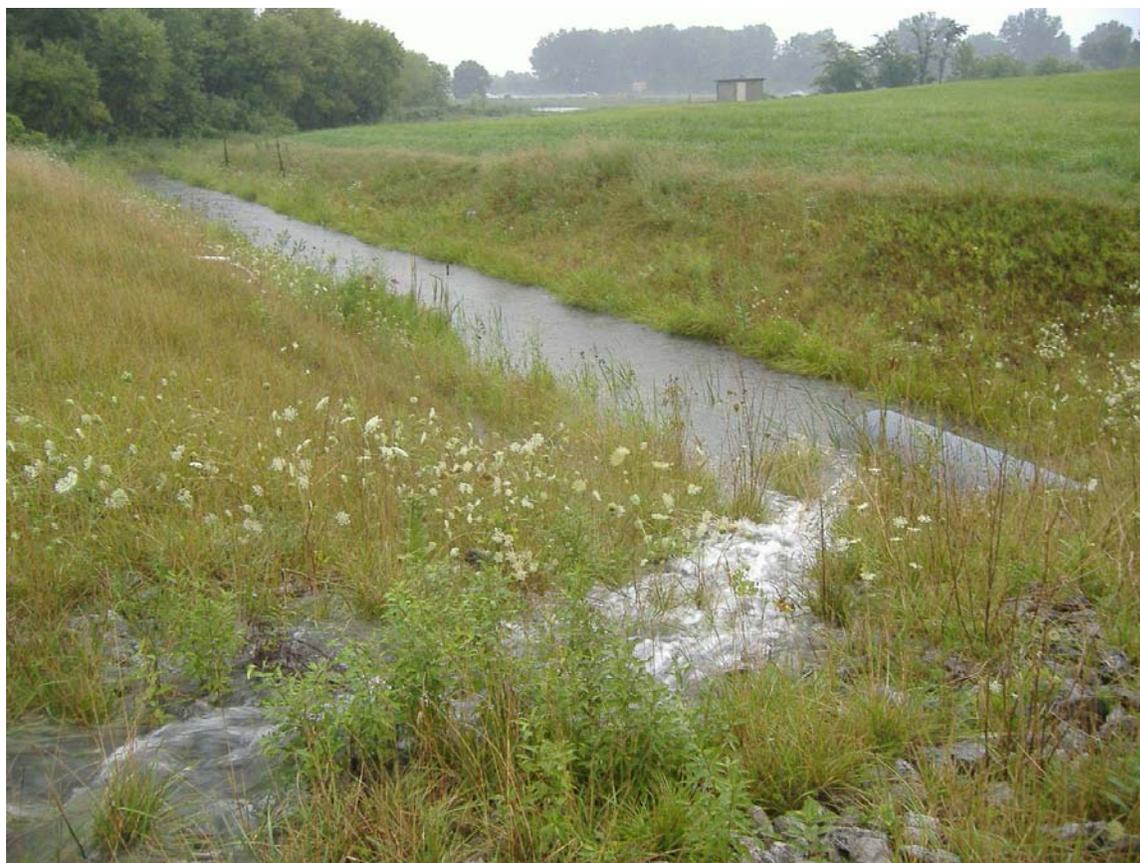
Figure 36 Most Ditchbanks along Croxton in the City of Angola are relatively stable and well vegetated or protected with limestone.

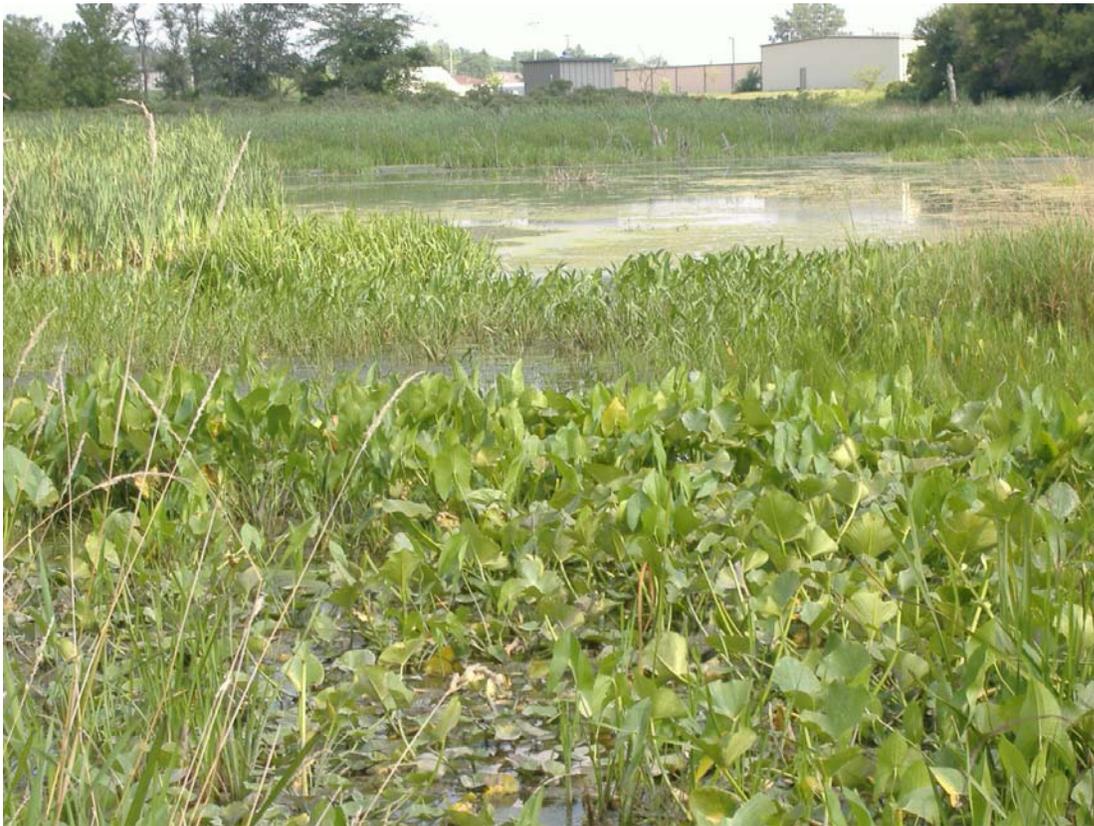
Figure 37, A constructed wetland in the Croxton Ditch drainage just East of Interstate 69 is a restored remnant of Croxton's original headwater marsh delineated on the 1831 surveyor's map. Purple loosestrife (an invasive non-native plant common in the lower part of the watershed) has apparently not yet colonized Croxton this far upstream from the lakes.

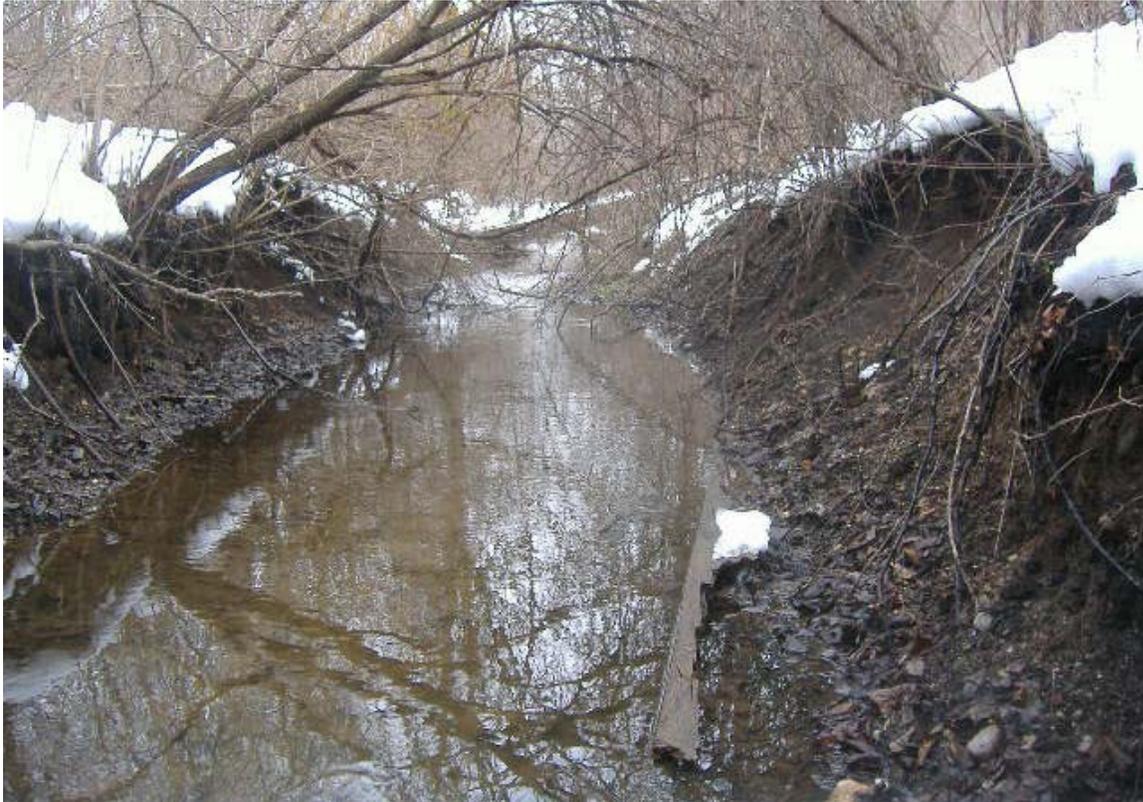
On the West Side of Interstate 69 Croxton Ditch picks up highway drainage and flows northwest passing adjacent to several residences. In this reach Croxton also runs through a previously channelized streambed. Evidence of channel instability and erosion begins to increase considerably in this reach. (fig. 38,39) After passing beneath County Road West 200 North Croxton runs in a Southerly direction through a mixed forested, scrub shrub wetland. The streambanks are not well vegetated in this stretch due to shading from trees shrubs, and some erosion is evident. Approximately 2000 feet downstream of Interstate 69 Croxton Ditch is joined by Sowle Lateral (running from the east) and turns to run in a southwesterly direction. Beyond this point the watershed is dominated by a golf course and its associated housing community. Approximately 450 feet downstream from the junction with Sowle Lateral another small tributary ditch joins Croxton ditch running from the north. (fig. 40) This ditch follows a more or less strait course parallel to Croxton from County Road 200 north and probably

Figure 38, Approximately 1200 feet Downstream of Interstate 69 Severe bank erosion is evident along Croxton Ditch

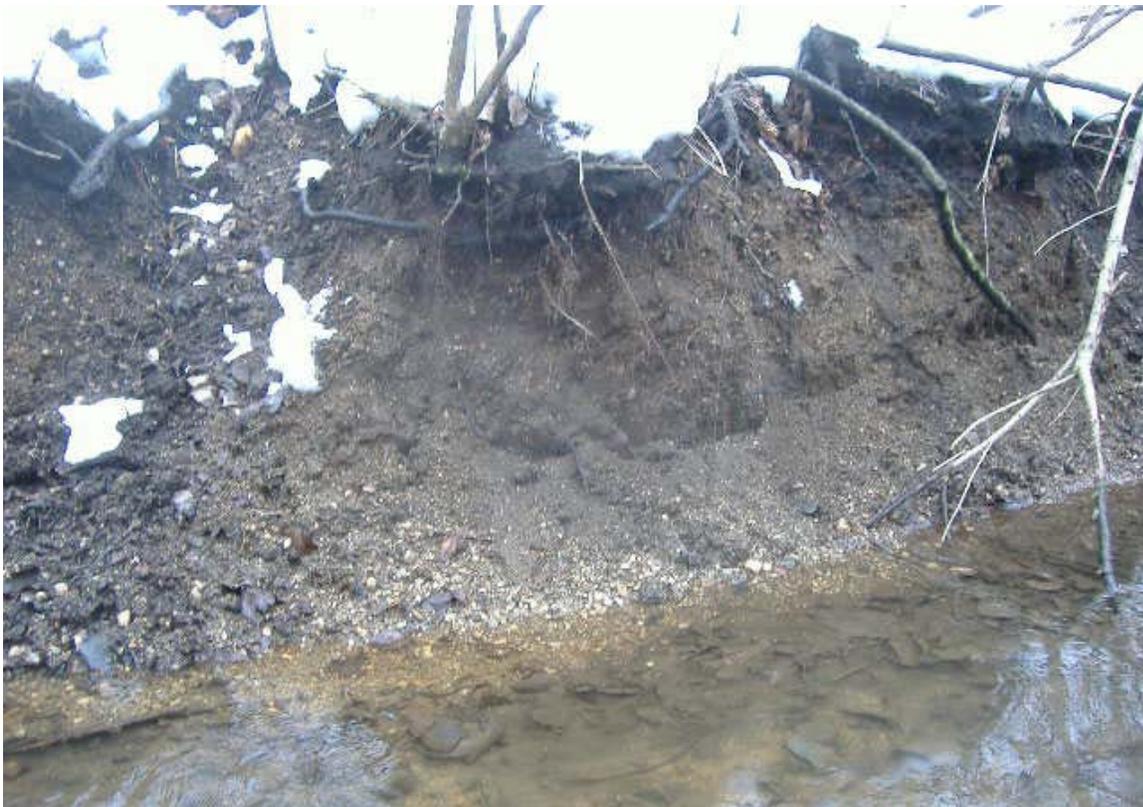
Figure 39 Sediment crumbles from the Croxton streambank between Interstate 69 and the Lake James Country Club

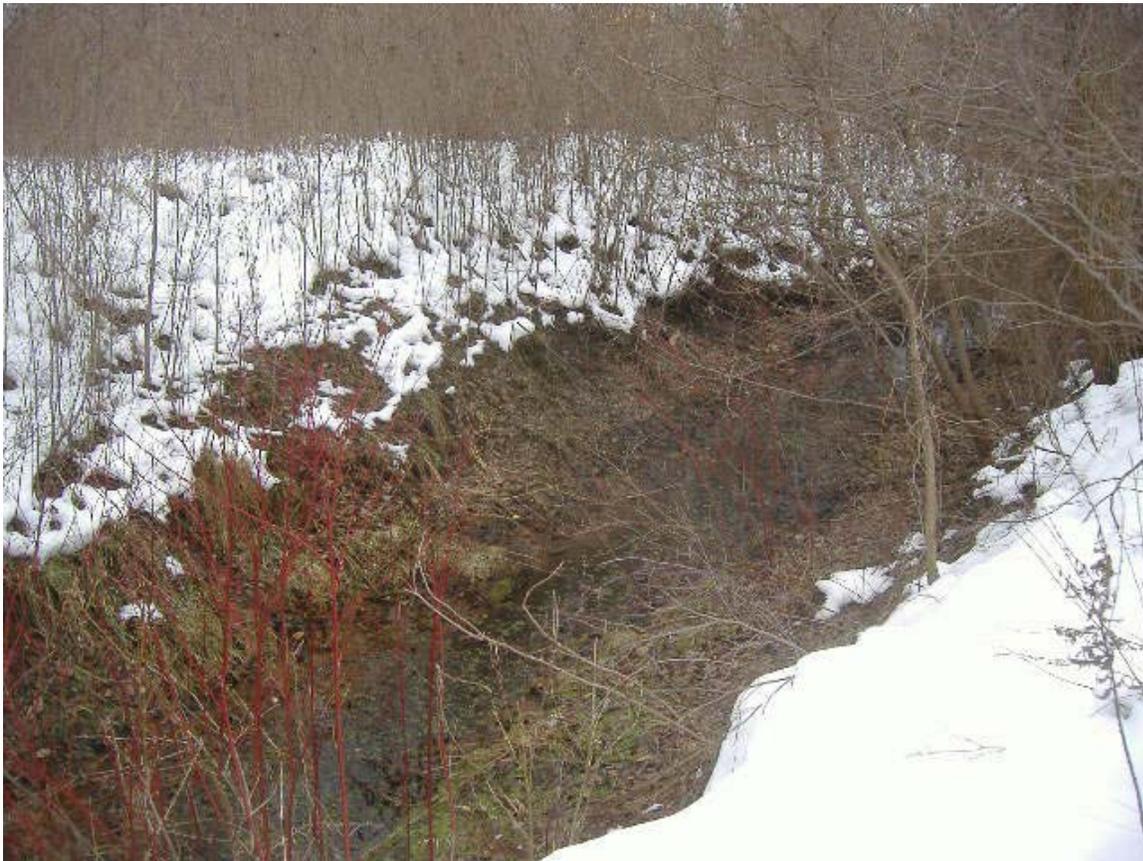
was installed to help facilitate drainage of now idle/forested former wetlands between the two drainages. This ditch also receives groundwater seepage from higher ground on the edge of the adjacent golf course. Parts of this ditch show bank erosion as well.

Figure 40, Small tributary ditch that parallels Croxton running south from 200 North, joining Croxton 2450 feet south of 200 North.

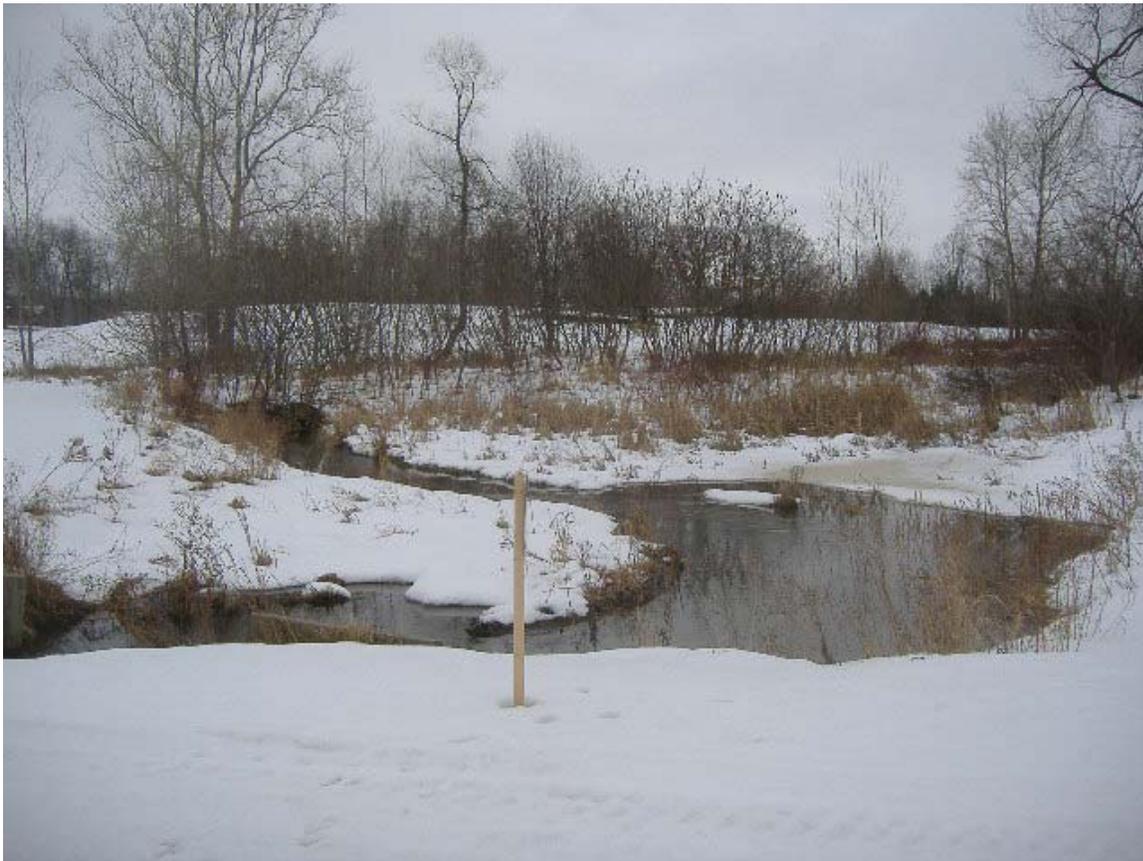
Just downstream from joining with this ditch Croxton Ditch takes a meander through a small impoundment that has filled with sediment. (fig. 41,42) Purple loosestrife plants become very common along the streams edge downstream from this point. Exploring options for restoring or enhancing prior converted wetlands and streambed and restoring the function of the small impoundment in this drainway will be recommendations of this report. Future work should look at the best way to establish a streambed through this area capable of handling expected flows while remaining relatively stable and minimizing the transport of sediment and associated nutrients downstream to Lake James. Given time Croxton ditch would carve it's own more stable streambed through this area by removing and transporting soil downstream to the Lagoon Park Channels at the southern tip of Lake James. The key will be to look for a feasible way to foster this process while minimizing the sediment transport.

Figure 41 A small impoundment that appears to have become filled with sediment from the upstream eroding reach of Croxton Ditch. Purple loosestrife appears to have settled in this area but not seen upstream of this reach.

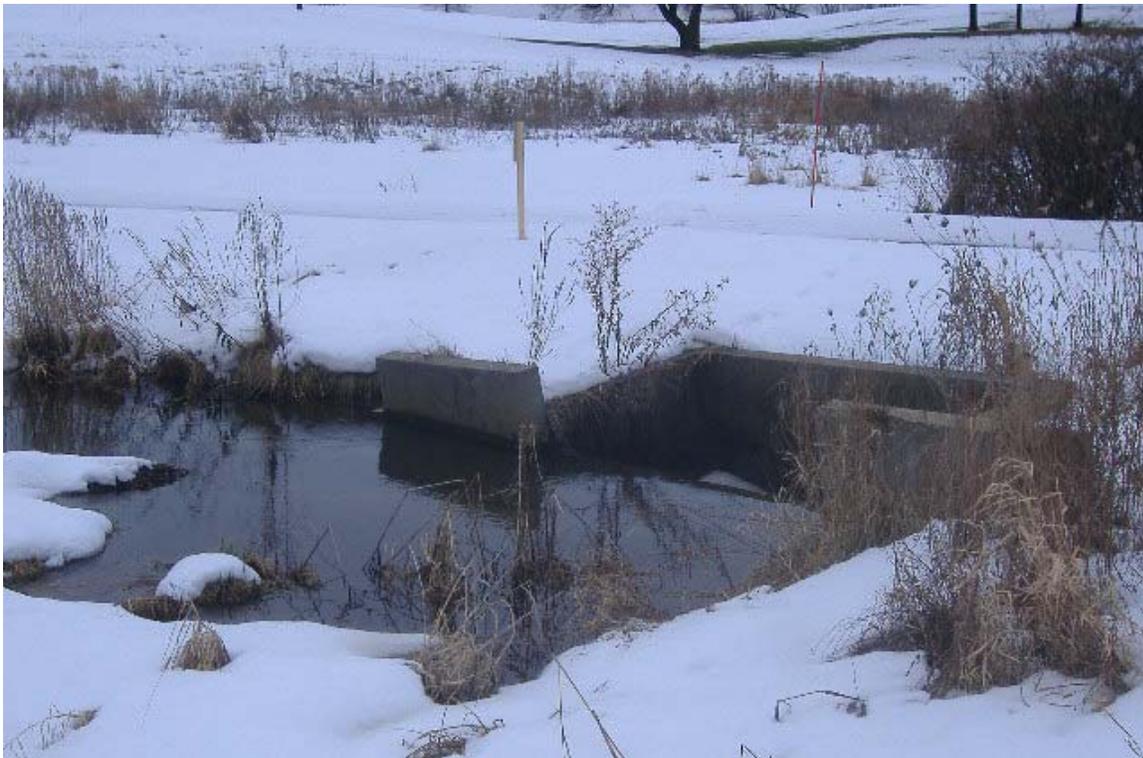
Figure 42, A concrete overflow sets the pool level in this small pond and appears to have settled somewhat

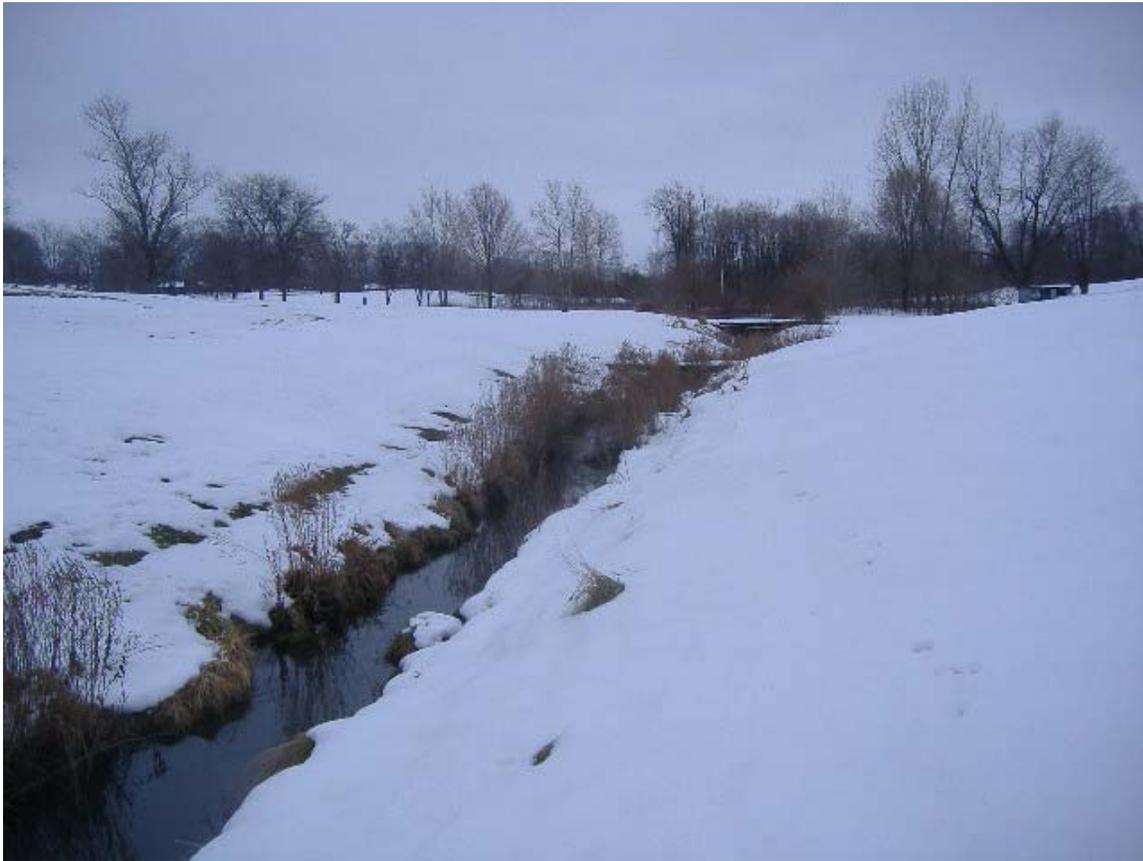
After passing through the small impoundment Croxton Ditch runs in a strait northwest direction across the golf course that surrounds much of the lower drainage area. (fig 43) A small connected excavated pond lying just to the south of the stream serves as an irrigation draw for the golf course. The streambanks in this reach show some evidence of crumbling and instability, but are well vegetated above the waterline. A series of rockpiles probably act to moderate flow, but the streamflow is beginning to breach one of the rockpiles by eroding the bank. Purple loosestrife plants are numerous along this reach.

Figure 43, Croxton runs northwest across a golf course that along with associated housing additions occupies much of the lower watershed. Purple loosestrife is abundant along this reach.

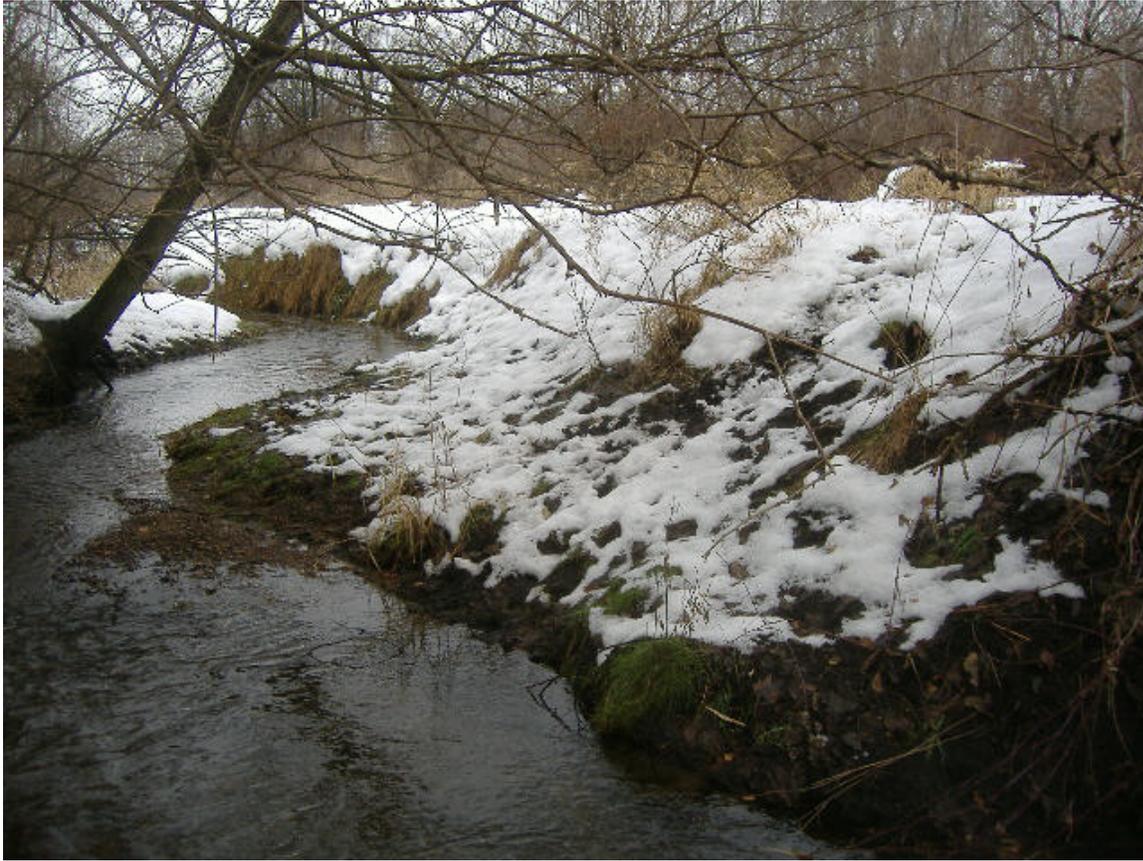
At approximately 1500 feet upstream from Lake James Croxton Ditch turns slightly more northerly. The stream runs through a mixed scrub shrub/emergent wetland with excavation/channelization spoils having been piled to build up the East bank. Some instability and erosion is evident in this area with areas of both the west bank and previously removed spoils on the east bank eroding. (fig. 44) Opportunities for wetland or streambank restoration in this area should be explored. The James Chain associations should work with the Steuben County Drainage Board to explore options.

Figure 44 As Erosion occurs along the lower reach of Croxton Ditch previously removed spoils on the east bank rejoin the stream.

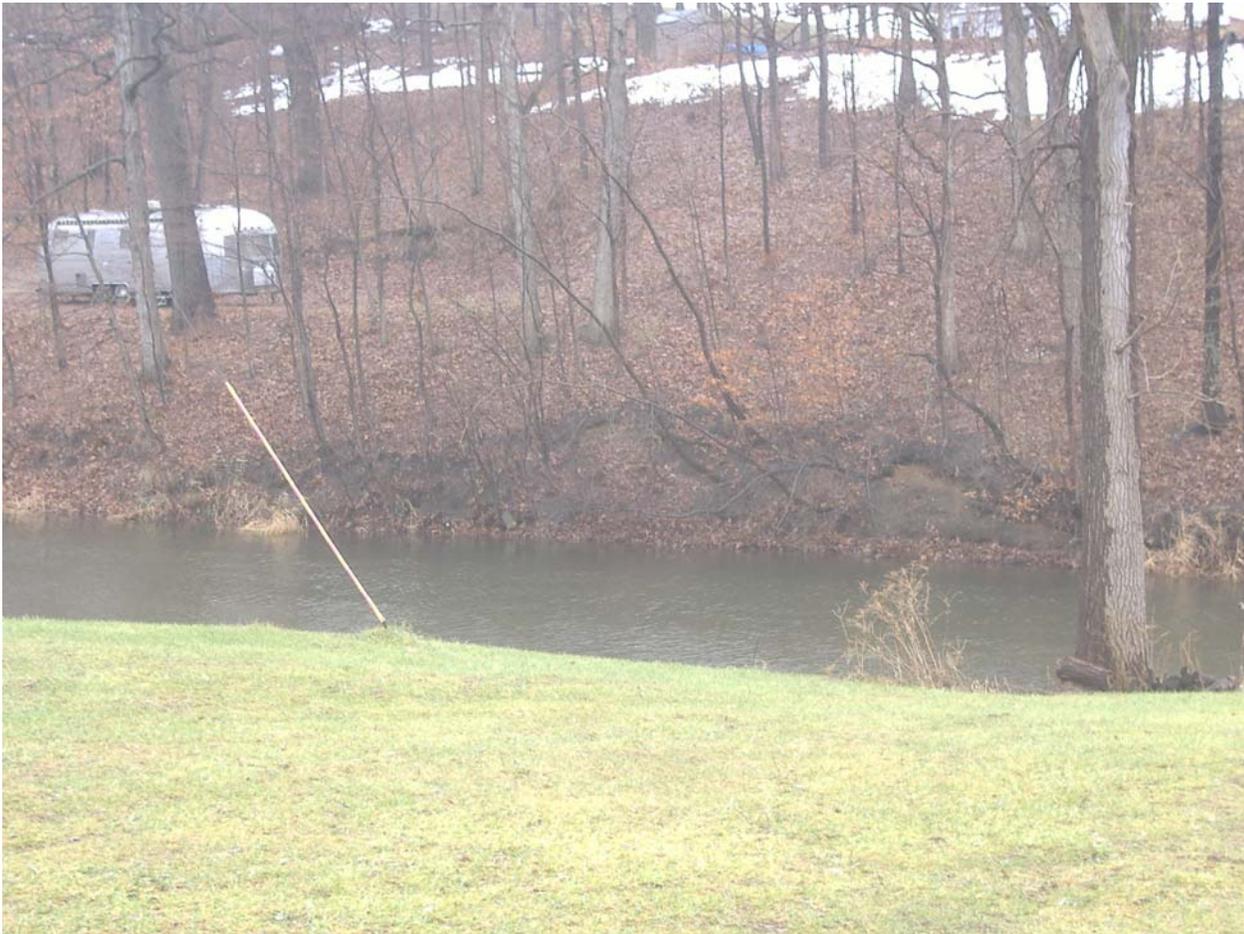
Figure 51 Some Bank Crumbling is Occurring Along Follet Creek Near I-69

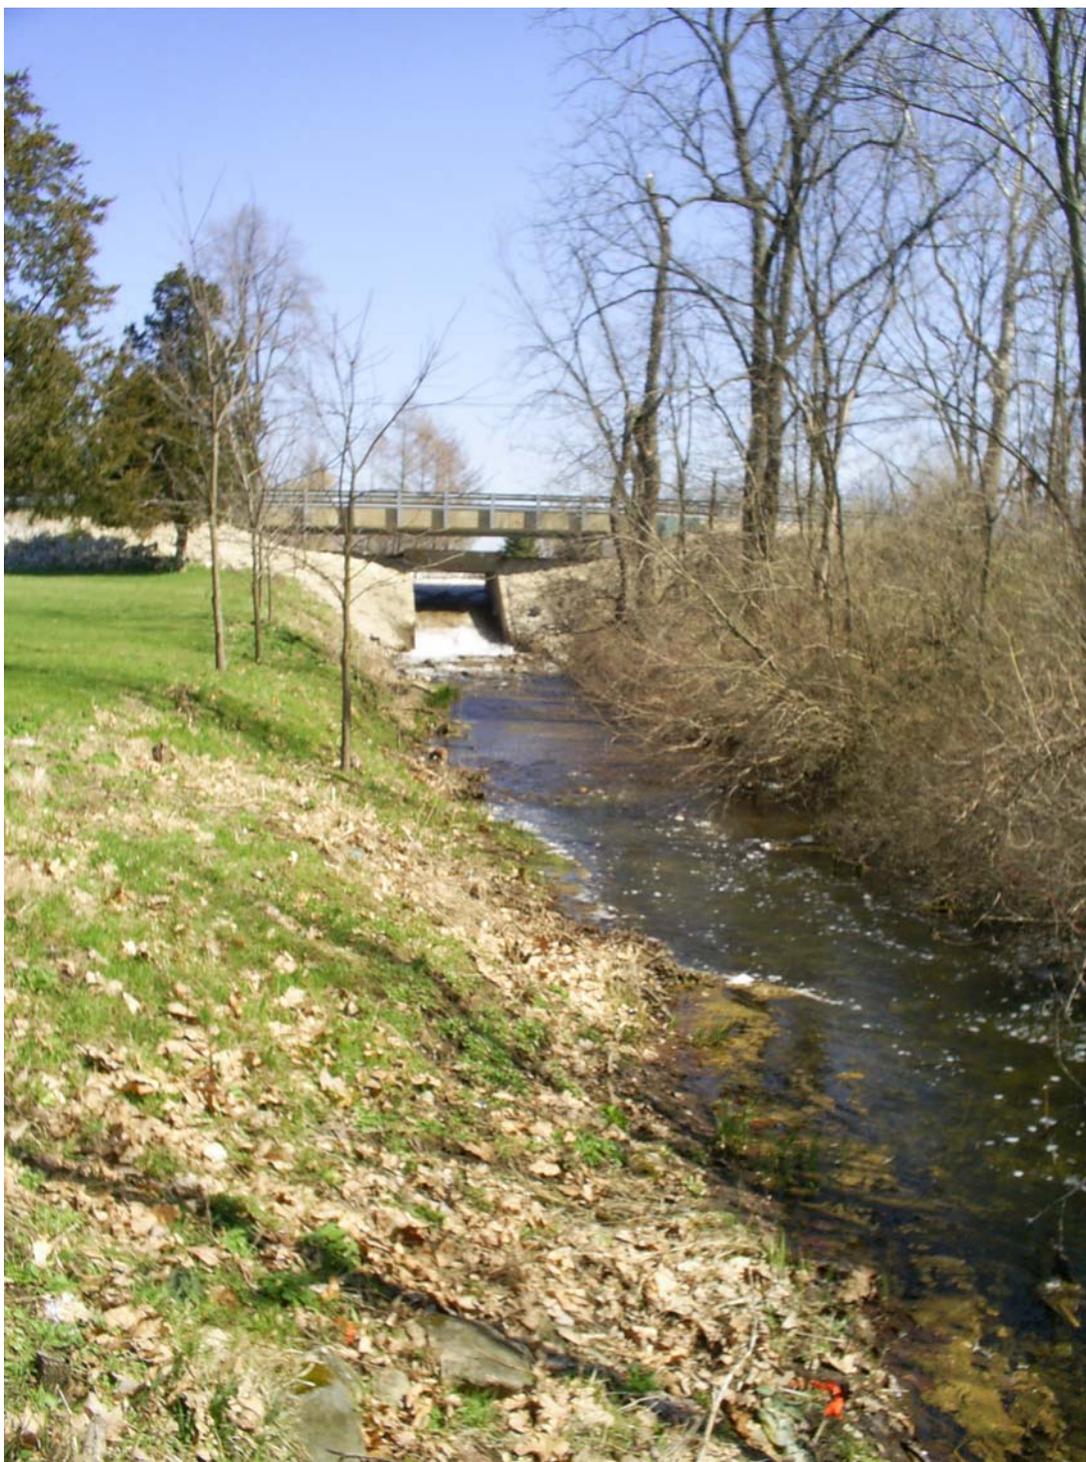
Figure 55 Banks are vegetated but show some signs of erosion in the initial reach of Crooked Creek

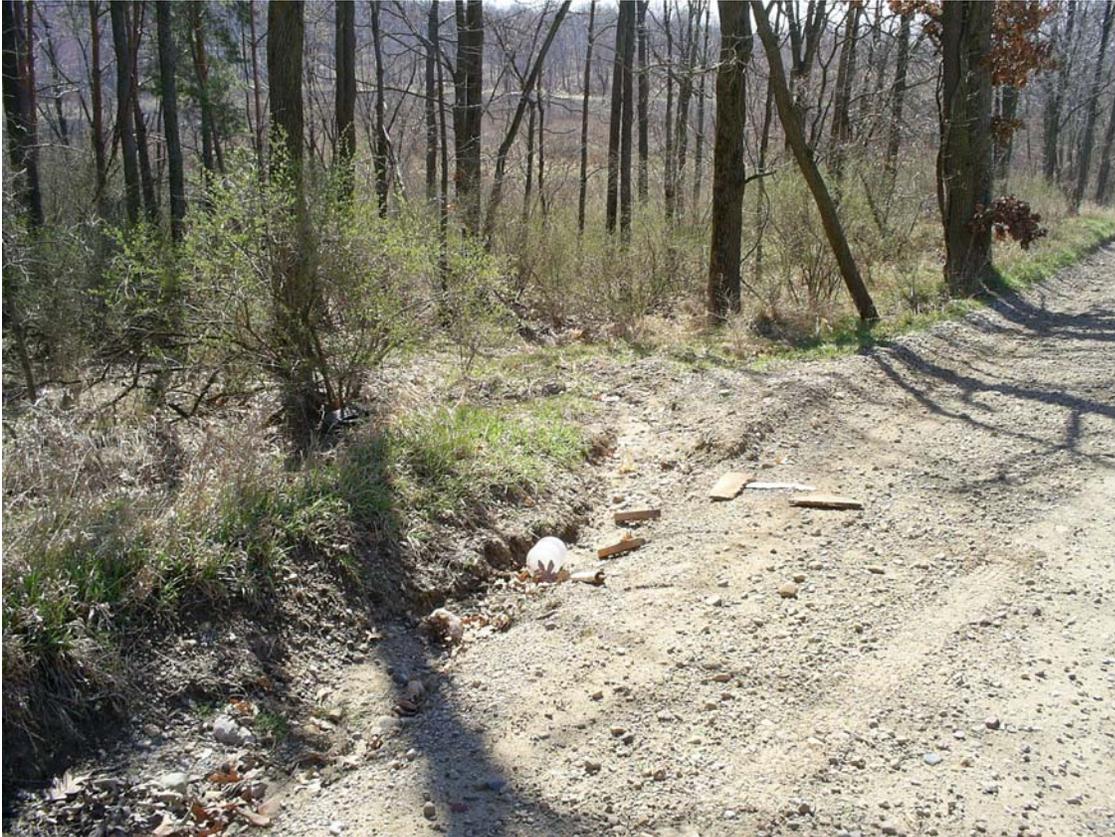
Figure 58 Erosion of CR 175W into the Crooked Creek Wetland Corridor

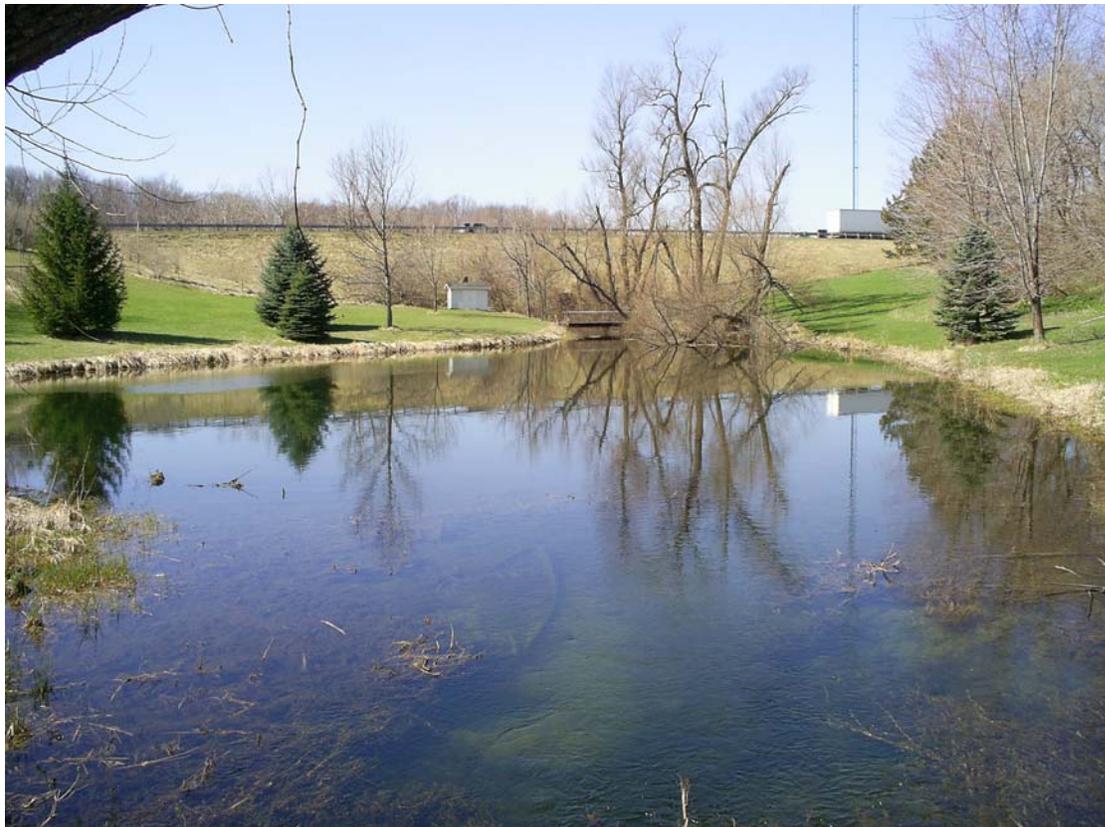
Figure 59 Small Impoundment in Crooked Creek at CR 150, Just Upstream of the 80/90 Toll Road

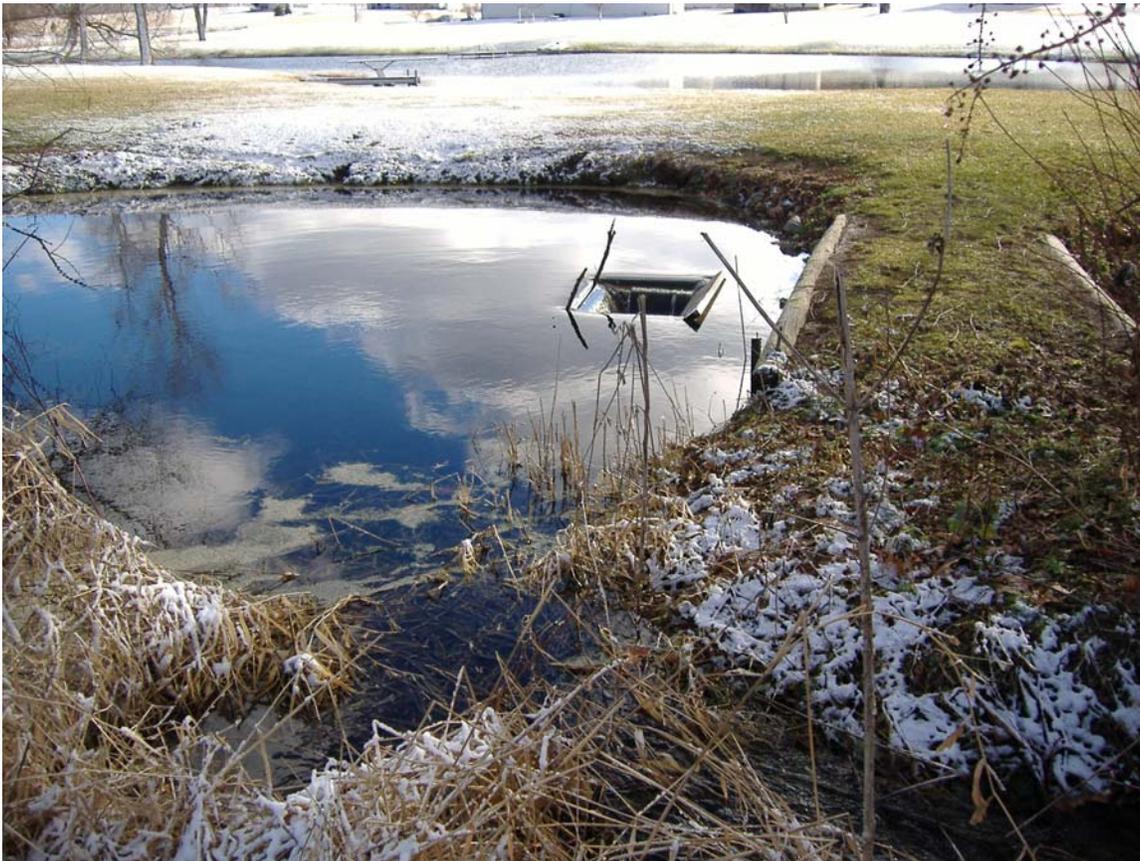
Figure 63 A small impoundment that currently sets the water level in an impounded Walter's Lakes Drain marsh
