***Pleasant and Riddles Lakes
Aquatic Vegetation Management Plan
2007-2011***

February 22, 2006

Prepared by:
Aquatic Control, Inc.
PO Box 100
Seymour, Indiana 47274

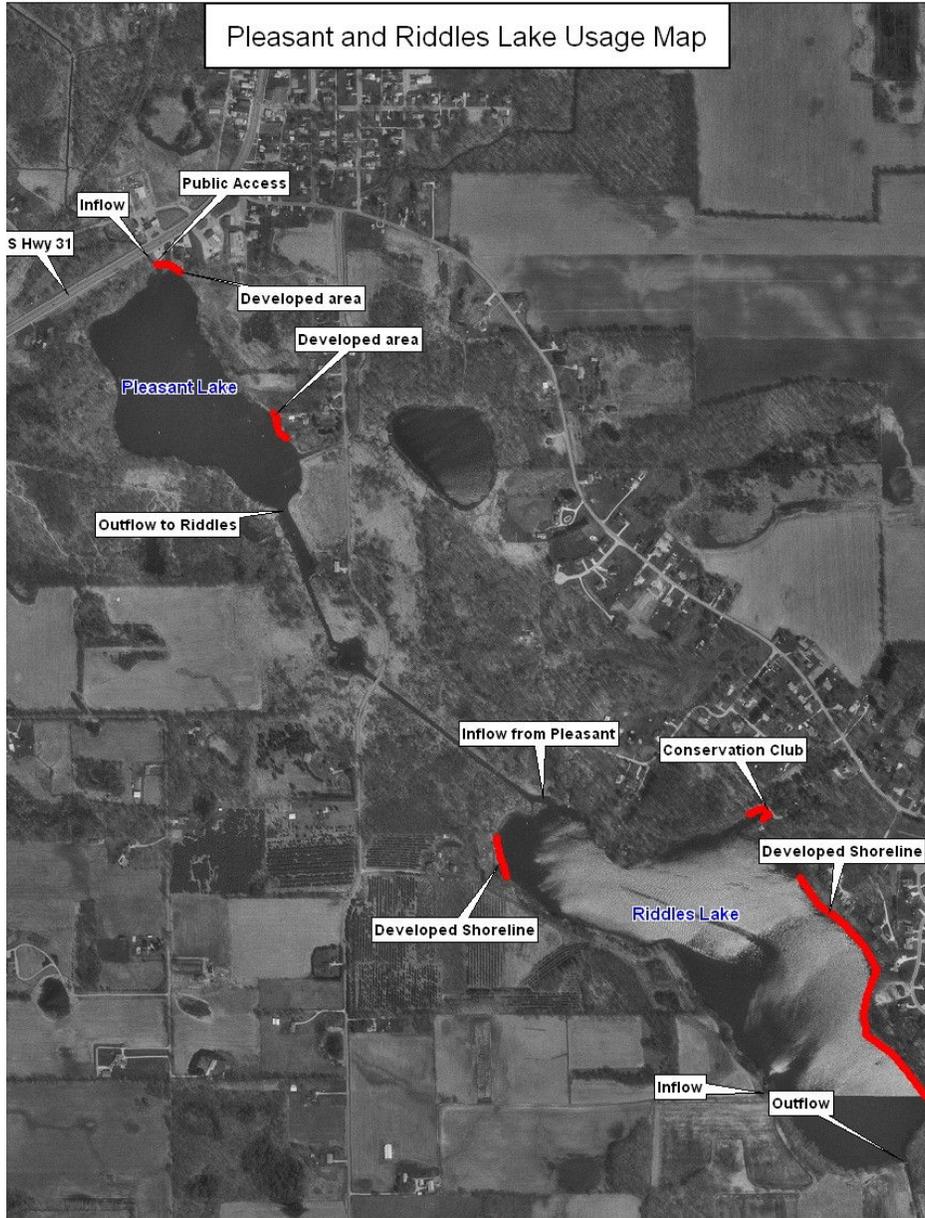
Figure 2. Pleasant and Riddles Lakes Usage Map

A public access site is located along the western shore of Pleasant Lake (Figure 2). Boating and fishing are the primary activities on Pleasant and Riddles lakes. High speed boating is not allowed on either lake. However, lake users should keep in mind that boating even at slow speeds could potentially fragment and distribute Eurasian watermilfoil. Large boats with a deep draft can produce a wake that affects aquatic plants, even at slow speeds. Some boats sit lower and push more water at slow speed than when they are up on plane. The majority of boaters on the lakes are fishing or cruising (JFNew, 2006). Unlike most northern Indiana Lakes, Pleasant and Riddles lakes have limited development along the shoreline (Figure 2). Approximately 10% of Pleasant Lake and 25% of Riddles Lake are developed. At a recent public meeting, lake users indicated that 94% used the lake for fishing, 50% for boating, 37% for swimming, 6% for drinking, and none of the respondents used the lake for irrigation (survey included only 16 individuals).

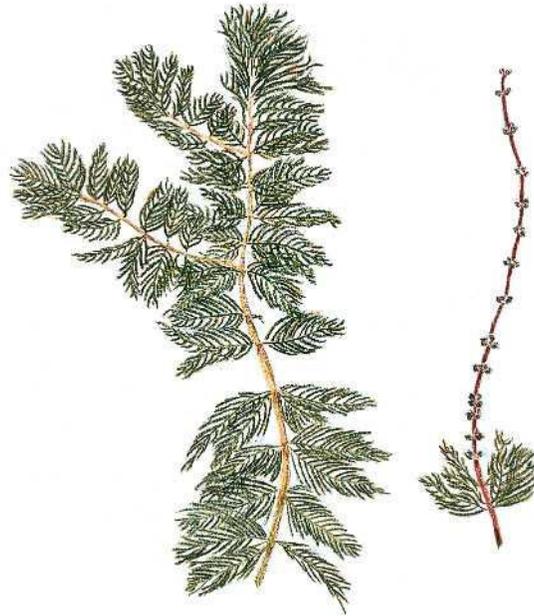
Figure 3. Illustration of Eurasian watermilfoil (Illustration provided by Applied Biochemist).

Eurasian watermilfoil is an exotic invasive species of submersed vegetation that was likely introduced into our region prior to the 1940's (Figure 3). This species commonly reaches nuisance levels in Indiana Lakes. Once established, growth and physiological characteristics of milfoil enable it to form a surface canopy and develop into immense stands of weedy vegetation, outcompeting most submersed species and displacing the native plant community. These surface mats can severely impair many of the functional aspects of waterbodies such as maintenance of water quality for wildlife habitat and public health, navigation, and recreation. Furthermore, a milfoil-dominated community can greatly reduce the biodiversity of an aquatic system and negatively impact fish populations (Getsinger et. al., 1997).

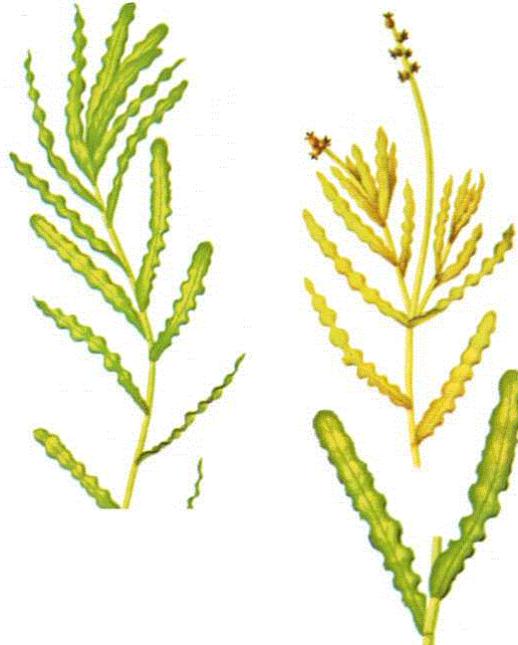
Figure 4. Illustration of curlyleaf pondweed (Illustration provided by Applied Biochemist).

Curlyleaf pondweed is an invasive exotic submersed species that was likely introduced in the early 1900's. It is present in many Indiana natural lakes and manmade impoundments. Curlyleaf pondweed's wavy serrated leaves give it a rather unique appearance (Figure 4). Richardson's pondweed (*Potamogeton richarsonii*) is probably the only species that it can be easily confused with. Curlyleaf pondweed has the tendency to create dense surface mats in the spring and early summer. These mats can interfere with recreation and limit the growth of native species. Another problem associated with this species is caused by its summer die-off that tends to lead to algae blooms. The summer die-off also tends to lessen the impact of this species on lake recreation.

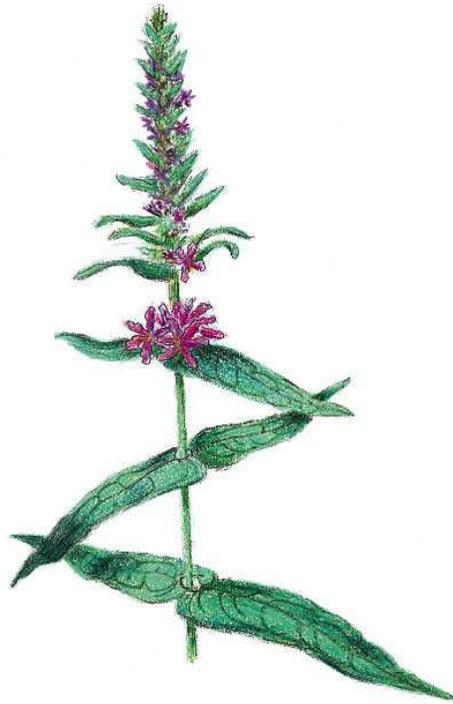
Figure 5. Illustration of Purple Loosestrife (Illustration provided by Applied Biochemist).

Purple loosestrife is an exotic invasive species of emergent vegetation that has invaded many wetlands and lake margins throughout Indiana (Figure 5). This species was introduced from Eurasia and became established in the estuaries of northeastern North America by the early 1800's. The impact of purple loosestrife on native vegetation has been disastrous, with more than 50% of the biomass of some wetland communities displaced. Impacts on wildlife have not been well studied, but indicate serious reduction in waterfowl and aquatic furbearer productivity (Thompson et. al., 1987).

As mentioned when discussing goal number one, purple loosestrife can be detrimental to native wetland species. Control of this species may be funded by LARE depending on availability and prioritization of funds. However if this species is discovered on one's property, it will be important to individual homeowners to dig up and remove the entire plant. An illustration of this species was included in Figure 5 located on page 9 of this plan.

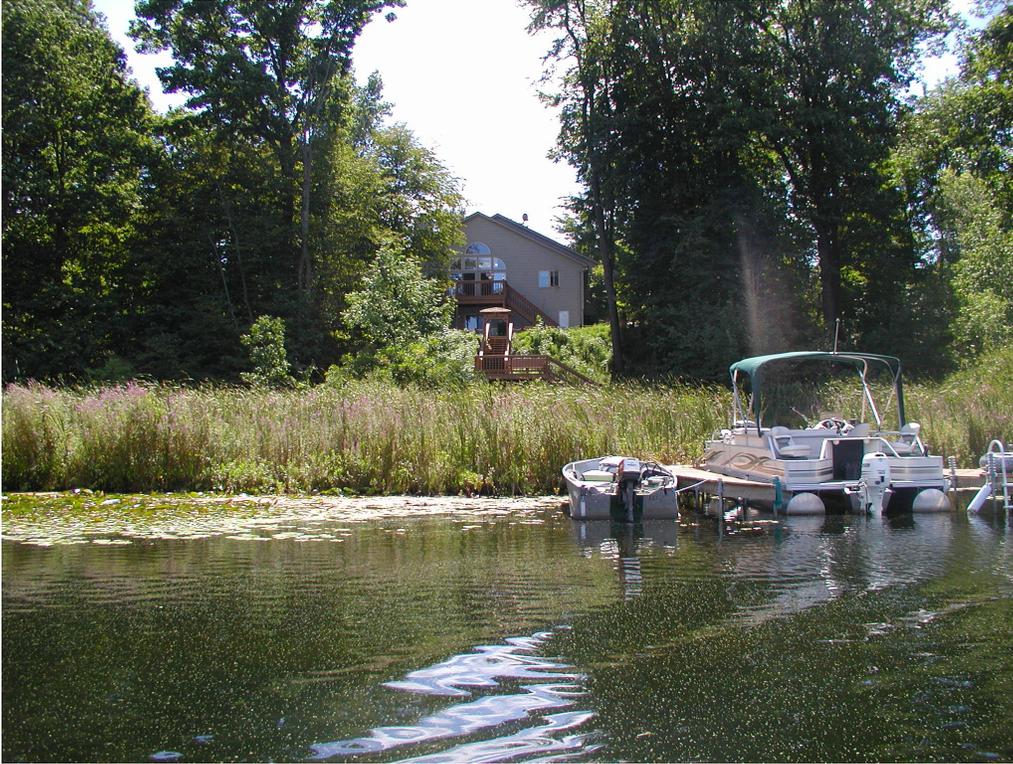
Figure 17. Crooked Lake, emergent plant community along developed shoreline, June 2006.

Pleasant and Riddles lakes contain an abundant and relatively diverse rooted floating and emergent plant community. This community serves several beneficial purposes to Pleasant and Riddles Lake that includes reducing erosion, providing fish and wildlife food and habitat, and filtering excessive nutrients. This plant community is rather unique when compared to most other northern Indiana Lakes. Most of the lakes in northern Indiana have been developed and homeowners have removed this type of vegetation due to the belief that it negatively impacts property value and limits access to the lake. Rooted floating and emergent vegetation remain abundant in Pleasant and Riddles lakes due to the fact that there has been limited development. However, this beneficial vegetation has been removed in many of the areas that have been developed. New developments should be encouraged to leave this beneficial vegetation, and current property owners should be encouraged to allow this vegetation to grow along their shorelines. Figure 17 is an example of a developed shoreline on Crooked Lake in Steuben County. This home site has allowed native vegetation to flourish along their shoreline yet still has good lake access.

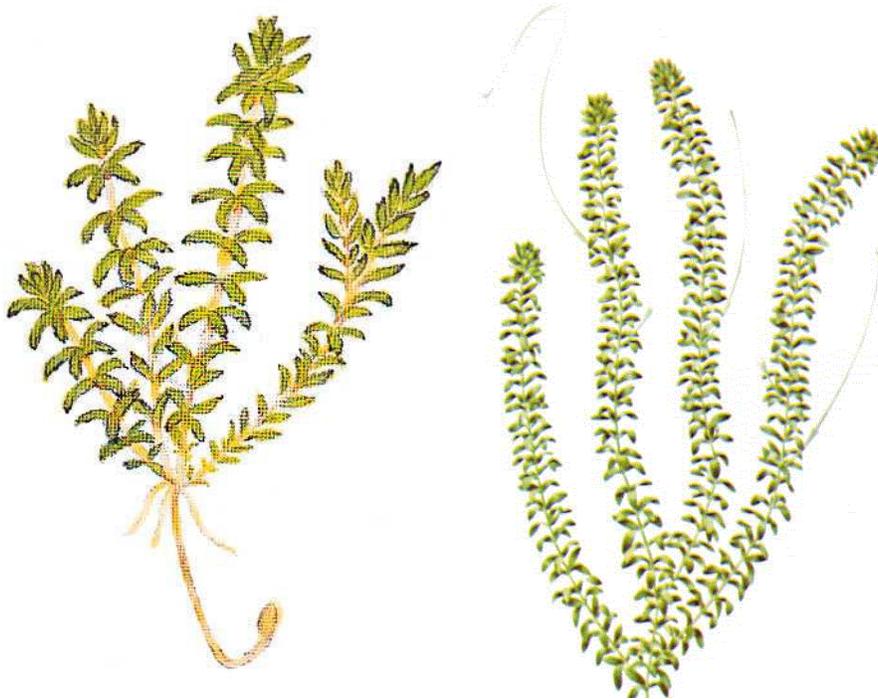
Figure 19. Illustration of Hydrilla on the left compared to native elodea on the right. Hydrilla typically contains five toothed leaves per whorl while native elodea typically has three leaves per whorl and the teeth are not visible on the leaves (Illustrations provided by Applied Biochemist).

Hydrilla, an extremely aggressive submersed aquatic plant species, has been recently discovered in Lake Manitou, which is located in north central, Indiana. Currently, it is believed that this plant is isolated in the Lake Manitou area, but much like Eurasian watermilfoil, this species has the ability to reproduce by fragmentation. This allows it to be spread easily from lake to lake. Hydrilla can be easily confused with native elodea. The best way to distinguish hydrilla is that it typically has five leaves along each whorl along with visible serrated edges along the leaf margin. It is very important that lake users understand the importance of thoroughly cleaning off their boats when entering and exiting Pleasant and Riddles lakes. Posting signs at the ramp will help reinforce this point. Warnings about this plant should also be sent to members of the Association. An illustration of hydrilla compared to native elodea follows in Figure 19.
