Aquatic Vegetation Management Plan Update 2009

Big Turkey Lake, LaGrange & Steuben County

Prepared for the Big Turkey Lake Improvement Association

Aquatic Enhancement & Survey, Inc.

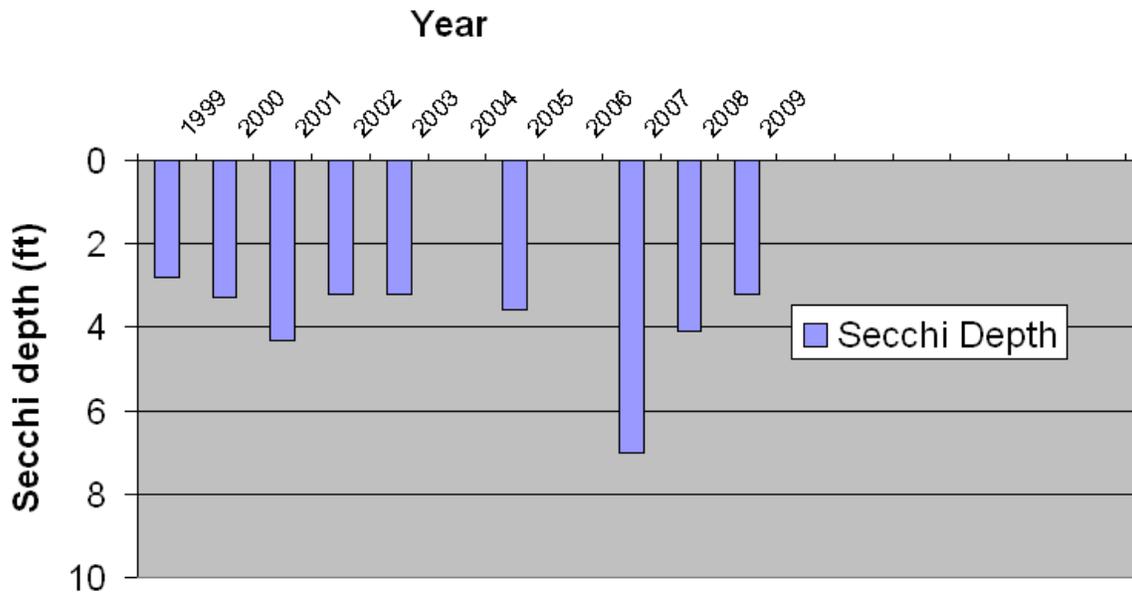
Figure 7. Big Turkey Secchi Data history (volunteer July/August mean through 2006 and AES August readings thereafter).

Water clarity was considered to be relatively low with a Secchi depth of 3.2 feet recorded. The 2009 clarity figure was consistent with the majority of summer measurements running back to 1999. The Secchi history for Big Turkey Lake is graphed in figure 7. Plants were found to a depth of 13 feet. Water clarity at Big Turkey Lake tends to be relatively good early in the season but declines substantially in mid to late summer. An exception occurred in 2007 when good water clarity seemed to last longer than normal. A Secchi measurement of seven feet was recorded in August of that season. This clarity seemed to have a very noticeable effect on the lake's plant community. During 2007, problems with mat-forming growths of variable watermilfoil were reported to have been much worse than normal. Curlyleaf pondweed growth
