**Ridinger Lake
Aquatic Vegetation Management Plan
2008 Update
Kosciusko County, Indiana**

February 18, 2009

Prepared by:
**AQUATIC
CONTROL**
PO Box 100
Seymour, Indiana 4727

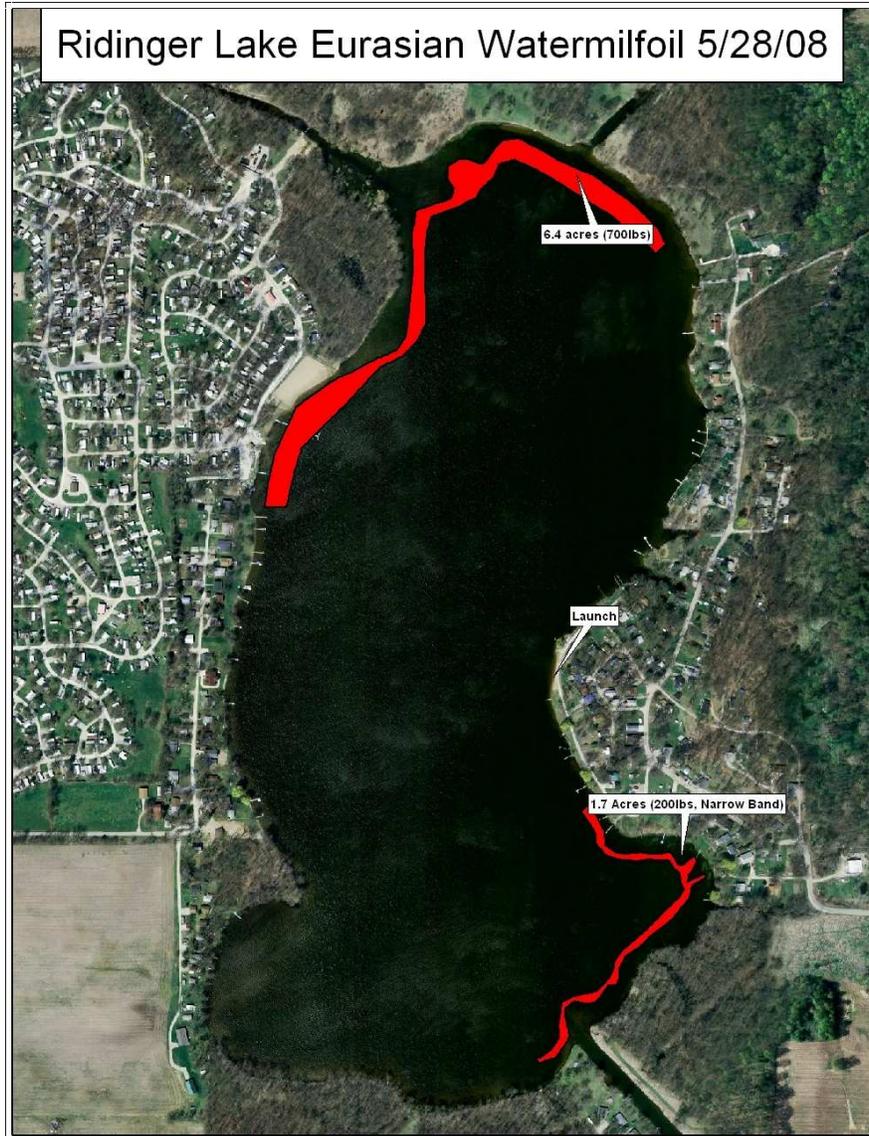
On May 28, 2008 a pretreatment invasive species mapping survey was completed on Ridinger Lake. A Secchi disc reading was taken and was found to be 6.0 feet. The survey revealed that 8.1 acres of Eurasian watermilfoil (Figure 1) existed within Ridinger Lake. The largest bed of Eurasian watermilfoil was found on the northwestern shore of the lake and covered 6.4 acres. A smaller narrow bed of Eurasian watermilfoil (1.7 acres) was found on the southeastern side of the lake.

Figure 1. Pretreatment Eurasian watermilfoil beds, Ridinger Lake, May 28, 2008.

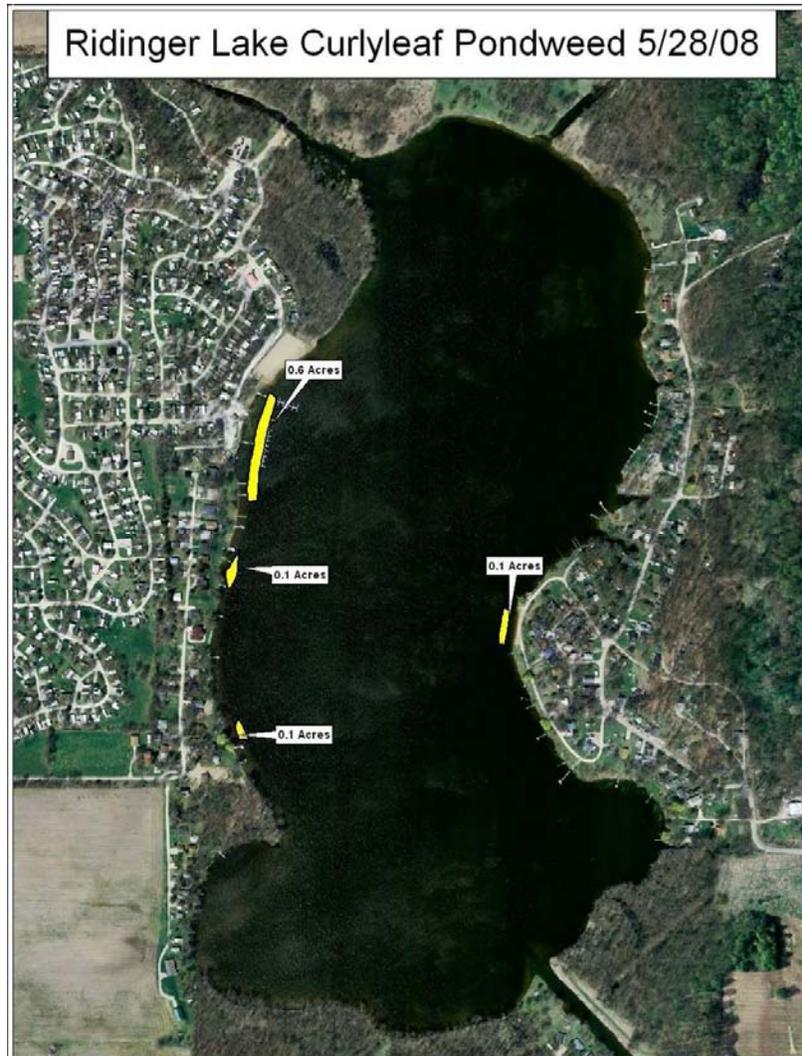
Curlyleaf pondweed was also found growing in 0.9 acres of Ridinger Lake (Figure 2). The biggest bed of curlyleaf (0.4 acres) was found along the western side of the lake. It appears that this species will not be a significant problem in Ridinger Lake.

Figure 2. Pretreatment curlyleaf pondweed beds, Ridinger Lake, May 28, 2008.

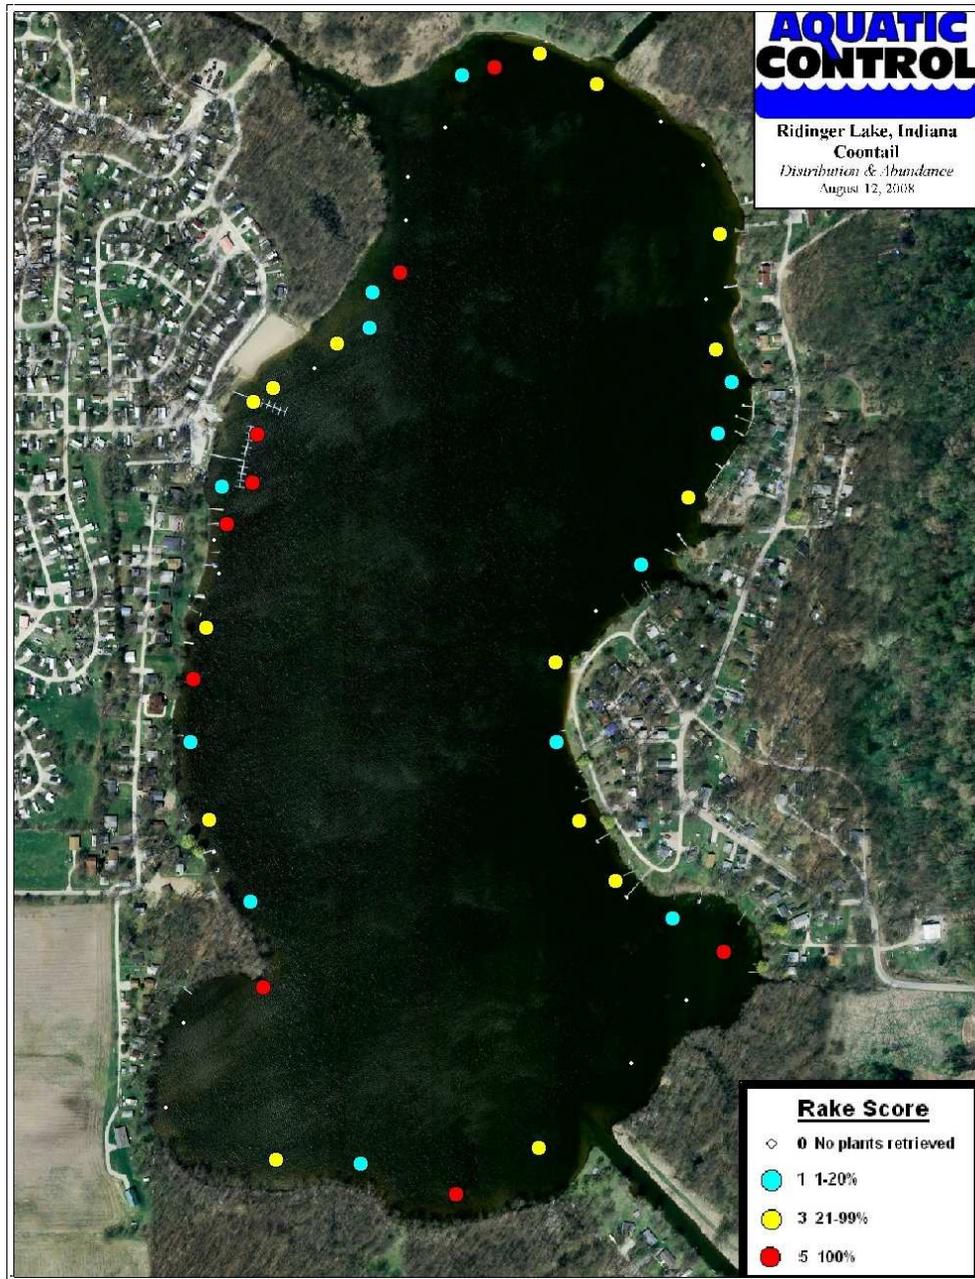
Common coontail was found at the highest percentage of sample sites (72.0%) for all depths (Figure 3). It was also the dominant species in depths greater than 5 feet. Slender naiad (*Najas flexillis*) was the second most frequently occurring species at the time of the Tier II survey. Slender naiad was found at 33% of the sites in all depths, and was the most abundant (46.7%) species found in depths from 0-5 feet (Figure 4). Chara (*Chara spp.*) had the third highest frequency of occurrence (40.0%), followed by leafy pondweed

Figure 3. Ridinger Lake, coontail distribution and abundance, August 12, 2008.

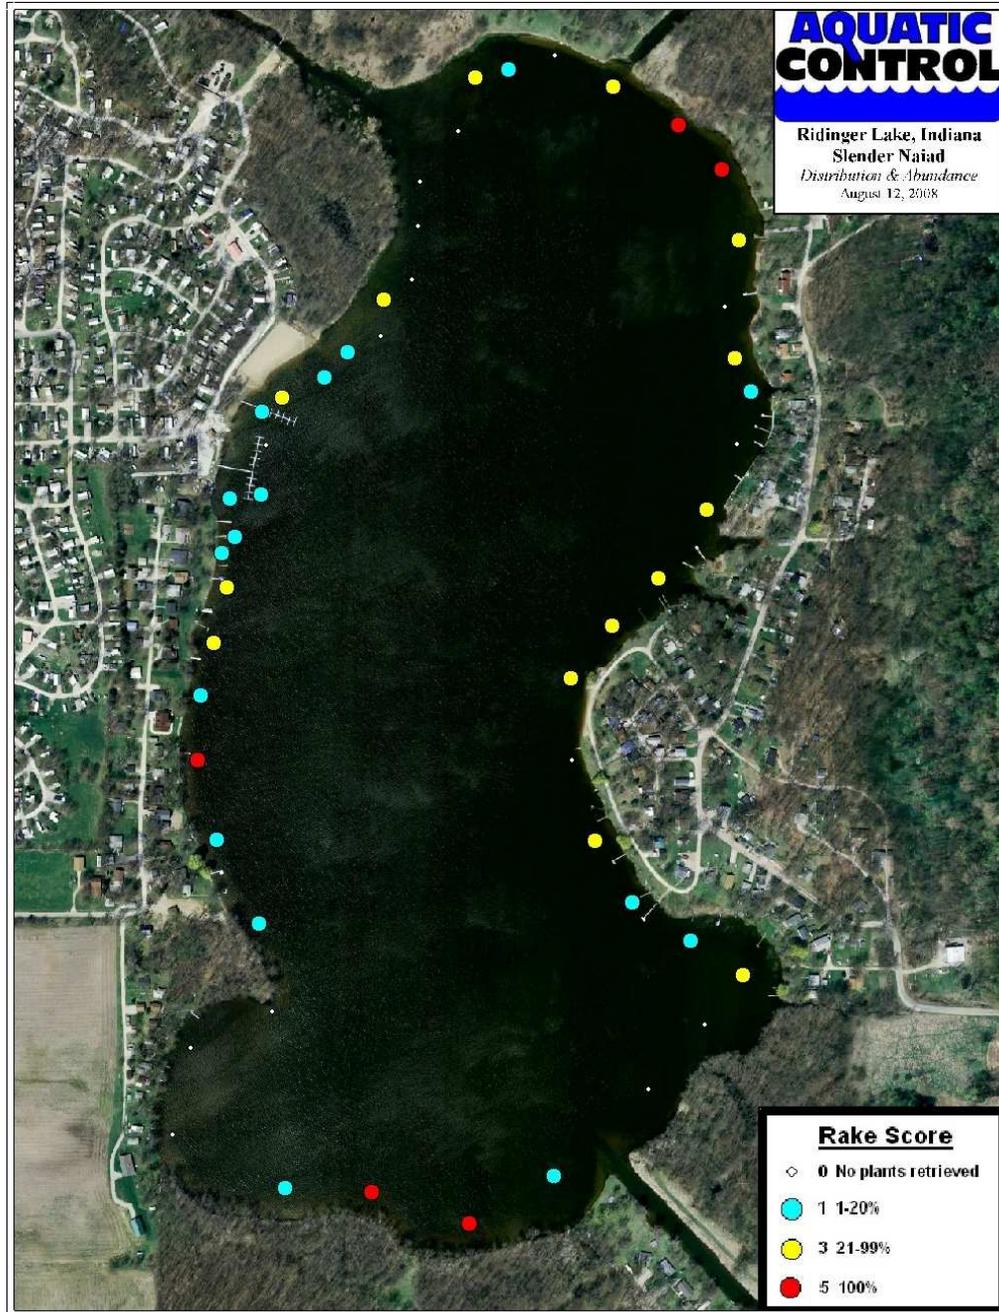
Figure 4. Ridinger Lake, slender naiad distribution and abundance, August 12, 2008.

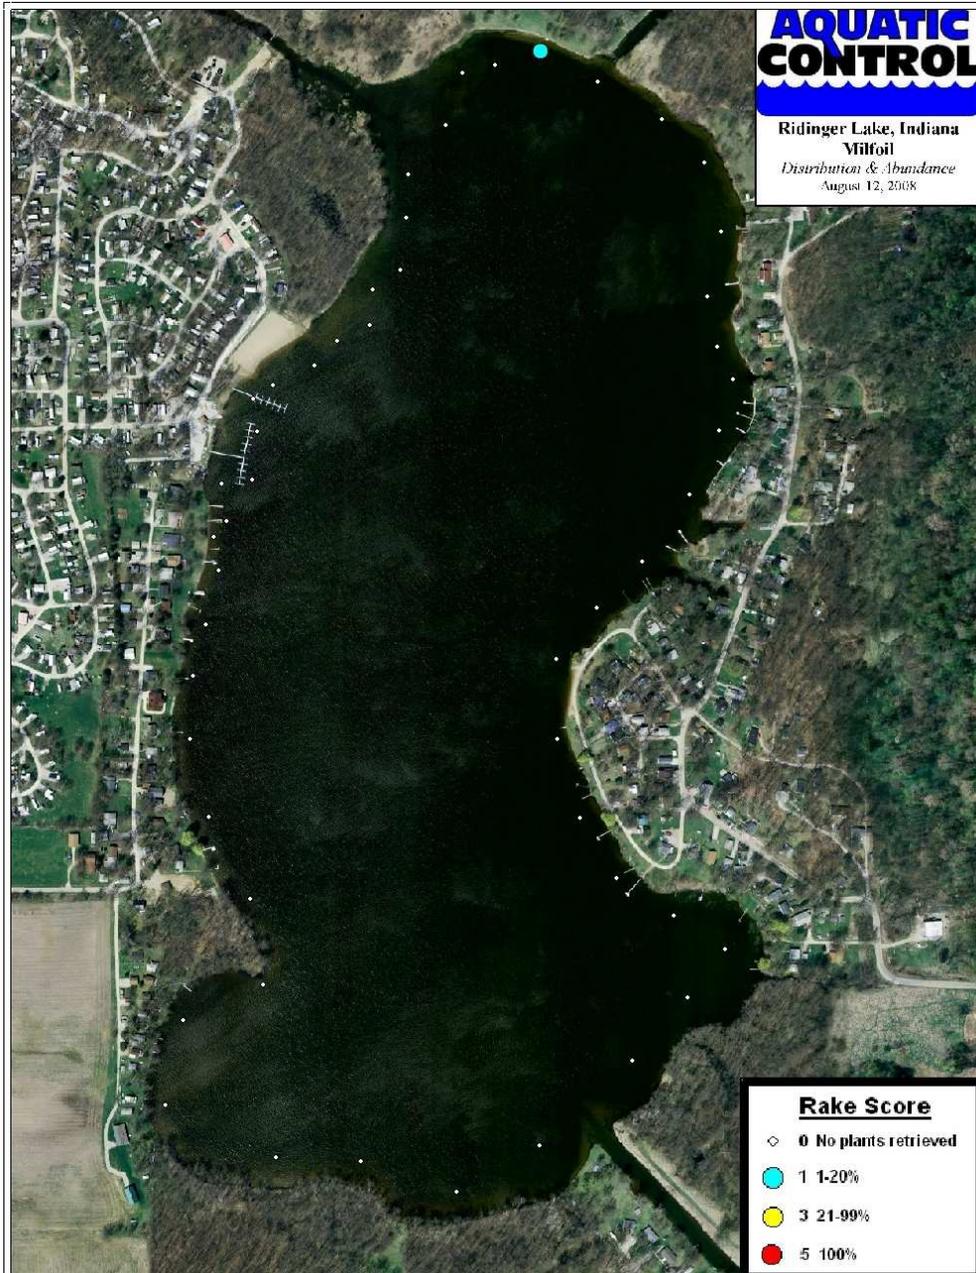
Figure 5. Ridinger Lake, Eurasian watermilfoil distribution and abundance, August 12, 2008.

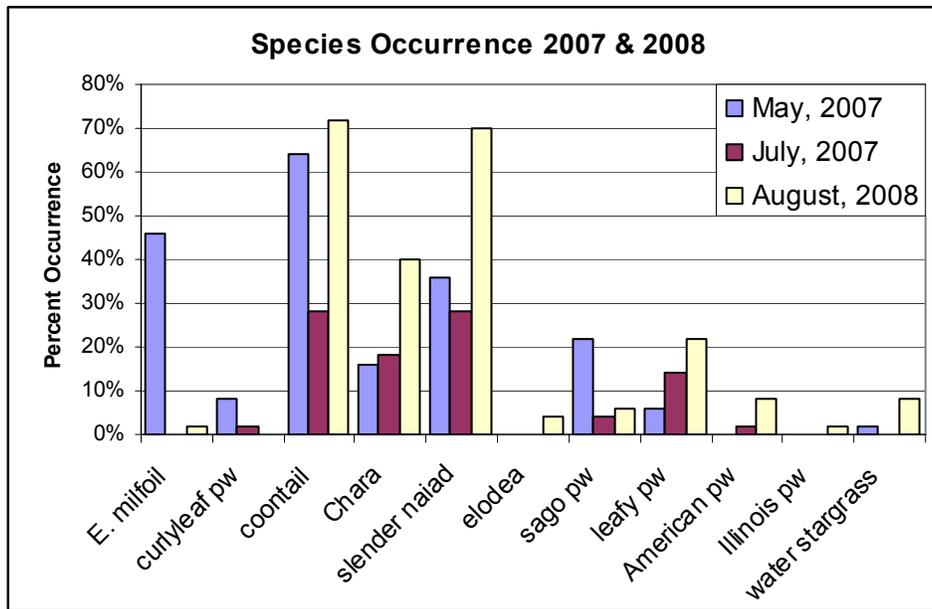
The goals of the vegetation management plan are to develop and maintain a stable and diverse native population while controlling invasive species, specifically Eurasian watermilfoil. Table 2 and Figure 6 illustrate the percent occurrence of all submersed vegetation collected in the 2007 and 2008 Tier II surveys and it leads one to believe that the goals of the plan are being achieved. Eurasian watermilfoil was found at 46.0% of the sites in the May 2007 Tier II survey and was not present during the summer post-treatment Tier II survey. Milfoil was found growing in 8.3 acres during the 2008 spring invasive survey and was only found at one site during the Tier II survey later in the

Figure 6. Ridinger Lake, species occurrence in 2007 and 2008. (data from Table 2.)

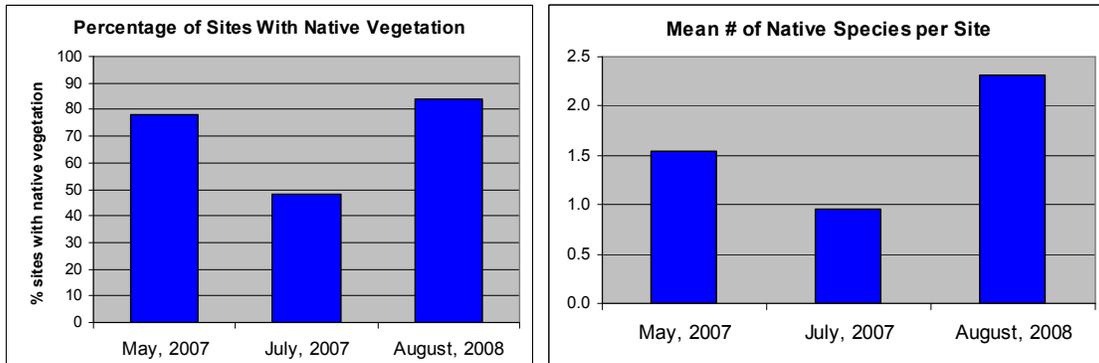
While Eurasian watermilfoil percent occurrence is being reduced, species like common coontail, chara, slender naiad, and leafy pondweed have all shown an increase in percent occurrence. In addition to the increases in individual species percent occurrence, the overall percentage of sites with native vegetation and mean number of native species per site has also increased over the past two years (Table 3 & Figure 7).

Figure 7. Ridinger Lake, percentage of sites with native vegetation and mean number of native species/site. (data from Table 3.)

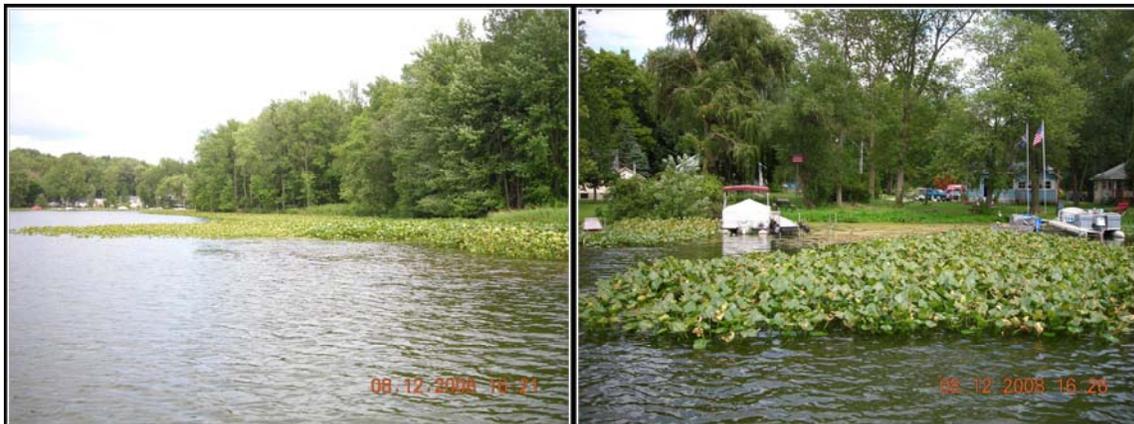
Figure 8. Ridinger lake spatterdock beds.

No surveys designed to document emergent or rooted floating vegetation were completed on Ridinger Lake in 2008. However, it was observed that this type of vegetation was relatively abundant in the few remaining undeveloped areas of the lake and along several developed shorelines. Spatterdock (*Nuphar spp.*) was the primary species making up these beds (Figure 8). These beds provide important spawning and nursery areas for young fish and should be protected.

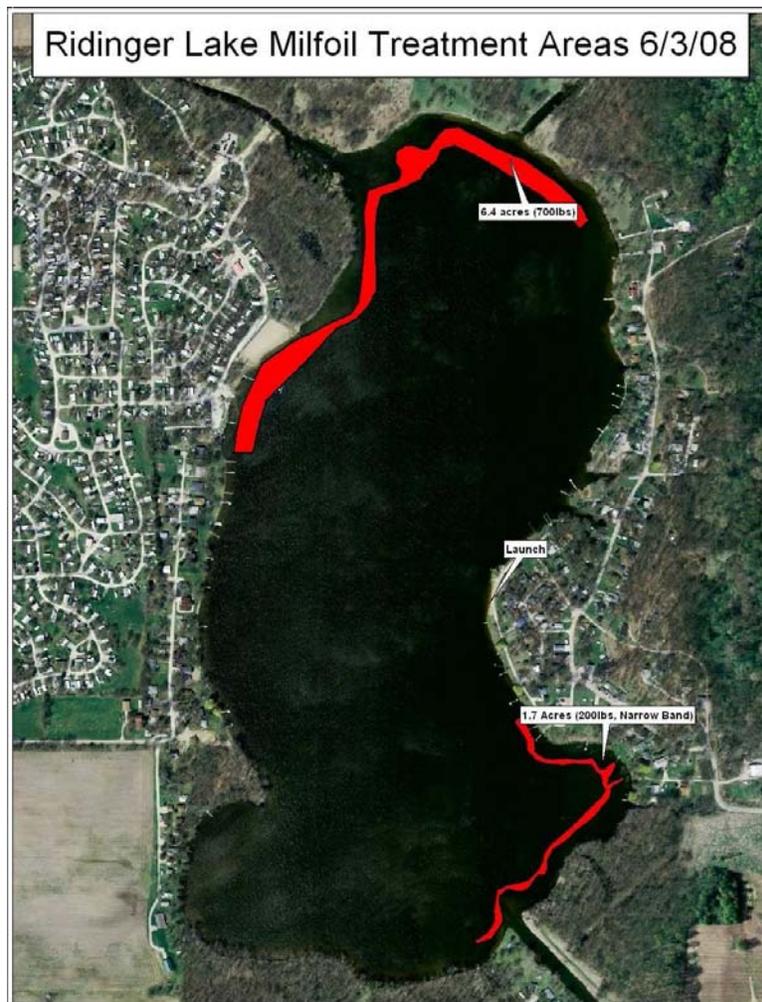
On June 3, Aquatic Control completed treatment of 8.1 acres of milfoil on Ridinger Lake (Figure 9). This treatment was funded by the RLPOA with matching grants from the LARE program. The treatment areas were determined from data collected during the May 28 invasive species survey. GPS coordinates from the invasive species survey were used during the treatment to insure the accuracy of the application. Granular 2,4-D (trade name: Navigate) was applied evenly over the impaired areas with granular spreaders. The treatment appears to have been effective. Milfoil was only found at one site during the summer Tier II survey following the application.

Figure 9. Ridinger Lake, milfoil treatment areas, June 3, 2008.

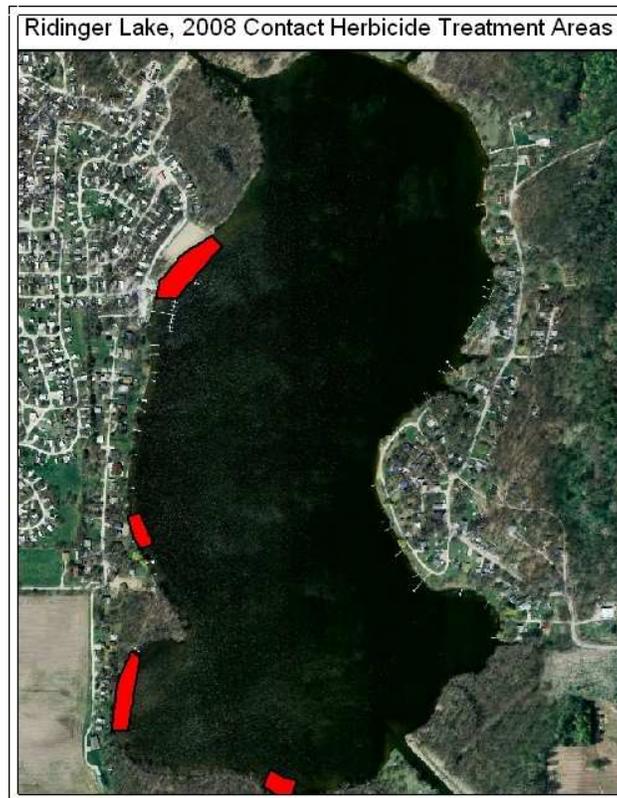
shore in high use areas. The applications were completed by Aquatic Weed Control of Syracuse, Indiana. These treatments were privately funded and are not part of the LARE program. Figure 10 shows the areas treated by Aquatic Weed Control in 2008. Areas 1-3 were treated on May 25, 2008. This treatment covered 2.06 acres of shoreline. The shoreline adjacent to the Yogi bear camp ground was treated on August 21, 2008.

Figure 10. Ridinger Lake, contact treatment areas May 21 and August 21, 2008. (information supplied by Aquatic Weed Control Inc.).

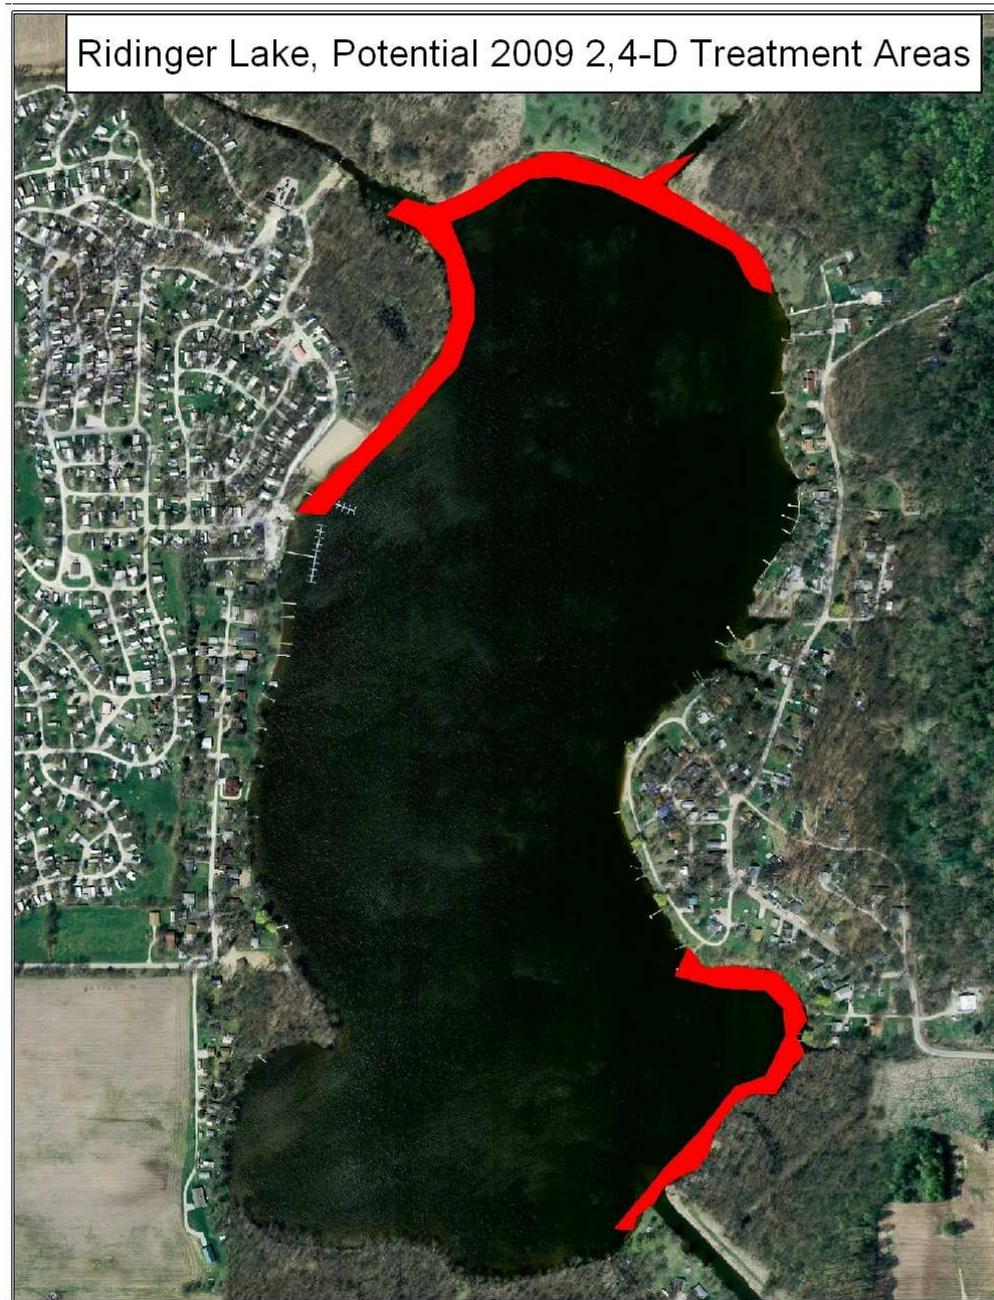
Selective milfoil treatments should be completed following the invasive species survey. Treatments completed in 2007 and 2008 have kept milfoil percent occurrence well below the original 10% occurrence objective. Based on this year's survey data and past treatments, it is recommended that the association should request enough funds to treat up to 10 acres of milfoil with 2,4-D aquatic herbicide (Figure 11). The maximum cost of such a treatment would be \$4,000.

Figure 11. Ridinger Lake potential milfoil treatment areas for 2009.

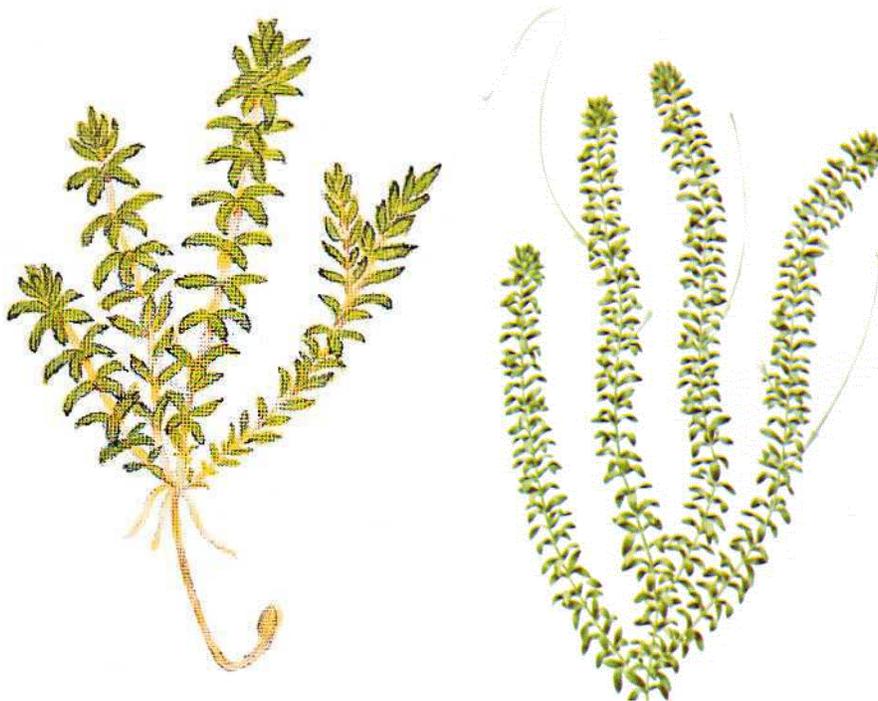
Another topic discussed at the public meeting was the recent discovery of hydrilla (*Hydrilla verticillata*) in Lake Manitou. Hydrilla is an invasive aquatic species that was originally discovered in Florida in the 1960's. There are many characteristics of hydrilla that make it a threat to Indiana waterways. This species can grow in lower light conditions than most native species, grows faster than most native species, and can shade out other species by forming a surface canopy. Hydrilla can be easily confused with native elodea. The best way to distinguish hydrilla from native elodea is that hydrilla typically has five leaves along each whorl along with visible serrated edges along the leaf

margin (Figure 11). What makes controlling the spread of hydrilla difficult is the fact that it can be spread by fragments. That is why it is vitally important that lake users remove all plants and sediment from their boats when entering and leaving the Ridinger Lake. At this time, hydrilla has not been discovered in Ridinger Lake. More information about controlling the spread of hydrilla can be found at www.protectyourwaters.net.

Figure 11. Illustration of hydrilla on the left compared to native elodea on the right. Hydrilla typically contains five toothed leaves per whorl while native elodea typically has three leaves per whorl and the teeth are not visible on the leaves. (Illustrations provided by Applied Biochemist).
