2010 Lake Manitou Aquatic Vegetation Management Plan Update Fulton County, IN March 1, 2011

Prepared for:
Indiana Department of Natural Resources
402 W. Washington St. Rm. W273
Indianapolis, IN 46204

Prepared by:
SePRO Corporation, Aquatic Control, Aquatic Weed Control, and ReMetrix

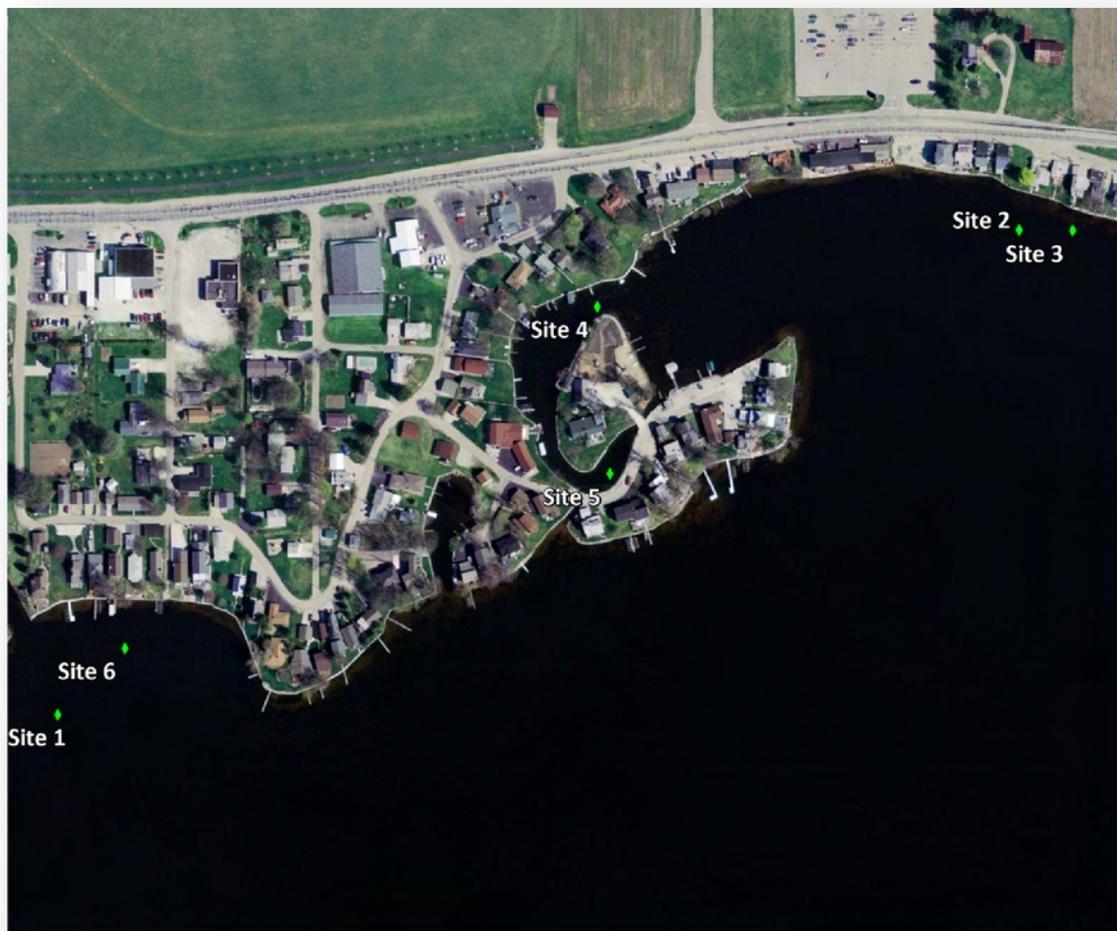
Figure 2.2.1. Location of the six permanent tuber sampling stations. Sites 1 through 5 were established May 2007. Site 6 was established May 2008. Note: Site 1 was abandoned in 2010 since no tubers had been collected there for the two prior seasons.

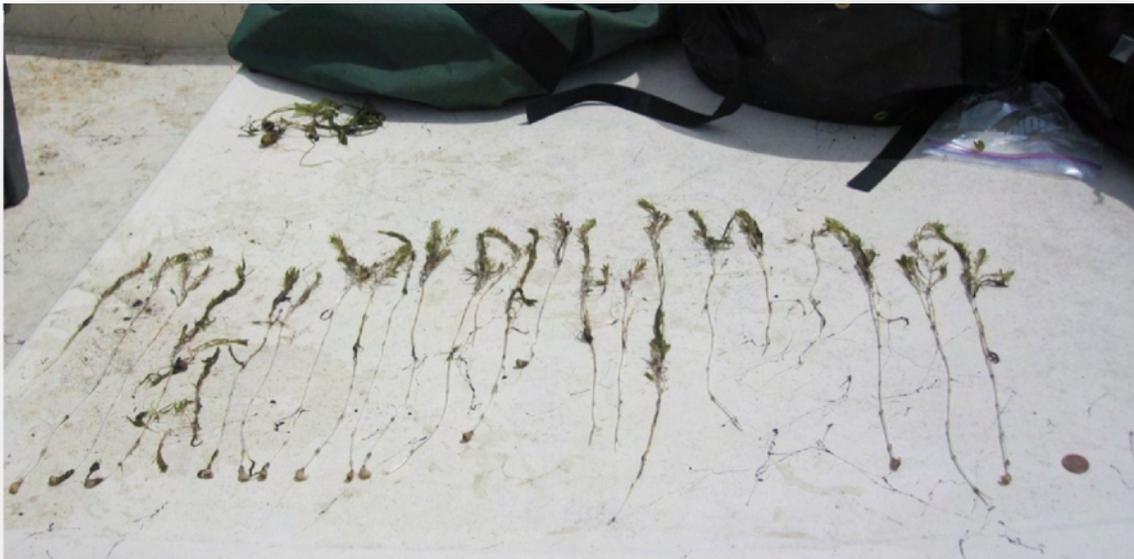
Figure 2.2.2. Hydrilla collected on June 9, 2010 via brief dive survey of permanent tuber sites.

In an effort to become more familiar with Lake Manitou and get a “hands-on” look at lake-bottom conditions, Dr. Mark Heilman used snorkeling gear to make observations of the lake bed at several of the permanent tuber sampling stations on June 15, 2010. During this informal survey, Dr. Heilman observed numerous sprouted hydrilla plants emerging from the sediment, however all observed vegetative structures showed signs of severe fluridone injury and no stems appeared to remain viable.

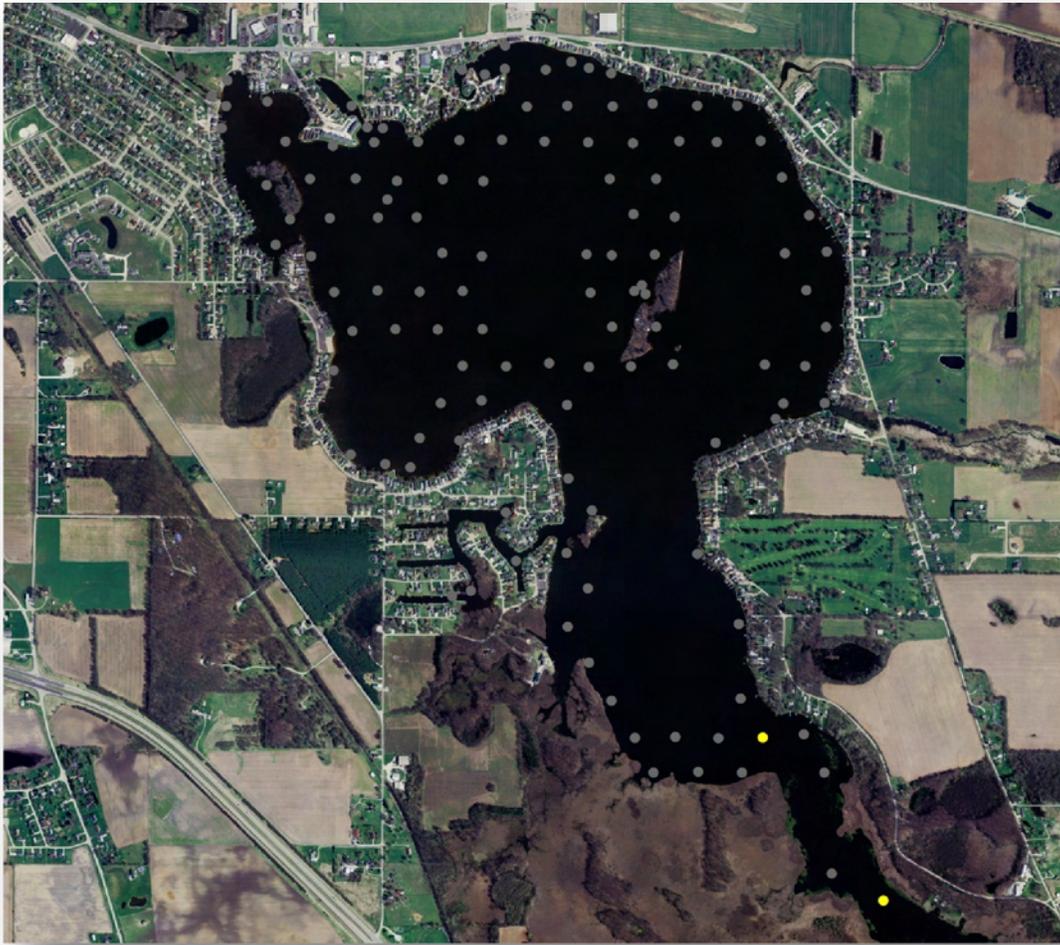
Figure 2.3.4. Lake Manitou, curlyleaf pondweed distribution, June 15, 2010.

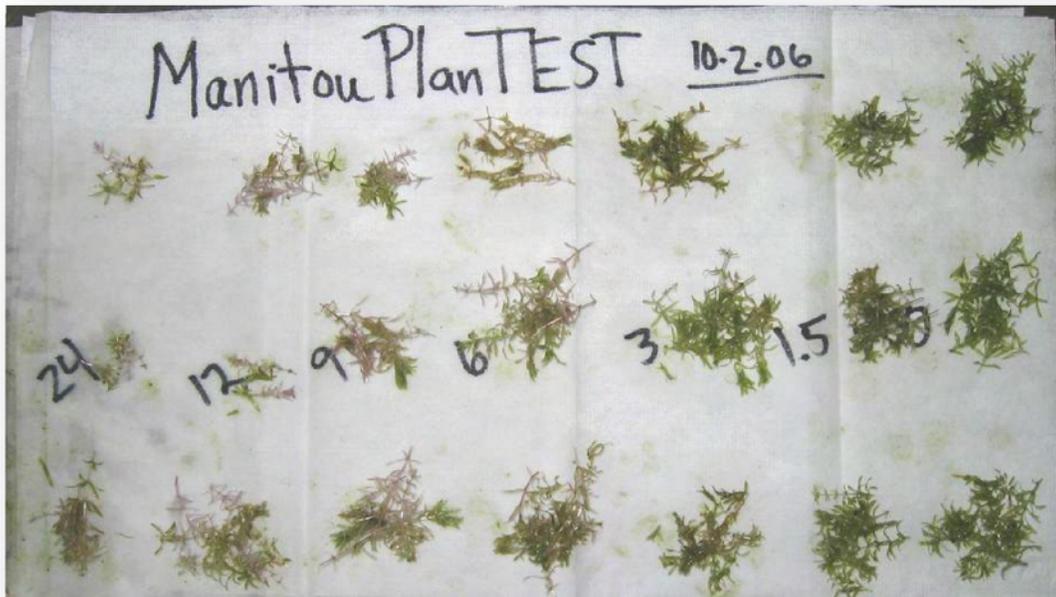
Figure 4.0.1. Lake Manitou hydrilla susceptibility to Sonar (PlanTEST).

SePRO collected hydrilla samples from Lake Manitou and conducted a PlanTEST at the SePRO Research and Technology Campus (SRTC) in Whitakers N.C. The PlanTEST is a proprietary test developed by SePRO Corporation that uses key biochemical parameters (Sprecher et al. 1998) to determine the plants inherent susceptibility to Sonar. The test was used to direct Sonar treatment recommendations by providing an indication of concentrations necessary for control. Plants were collected from Lake Manitou in September 2006 to conduct preliminary PlanTEST. The hydrilla in Lake Manitou responded favorably to Sonar under laboratory conditions (Figure 4.0.1). SePRO’s recommended treatment protocol was based on results of the initial/preliminary PlanTEST, extensive experience in hydrilla control throughout the U.S., and proprietary modeling of Sonar dissipation from various formulations.

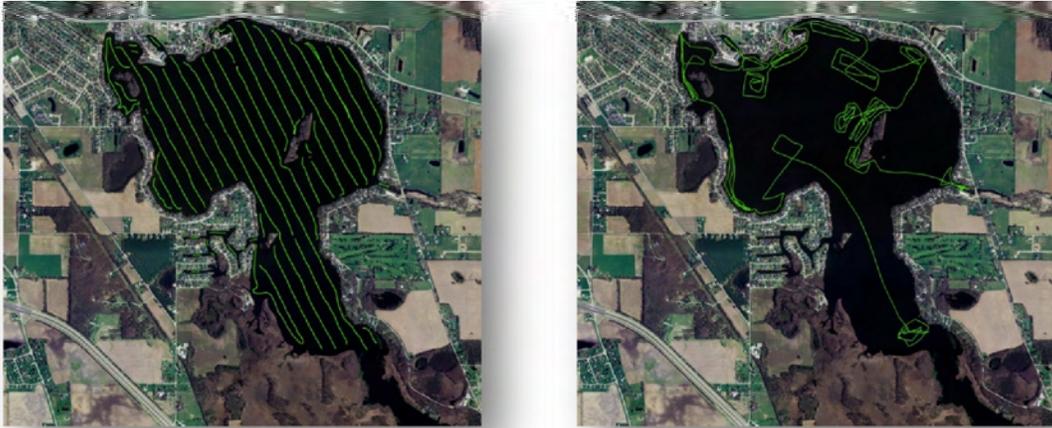
Figure 4.1.1. Initial application tracks for Sonar AS (left map) and Sonar PR (right map), May 7, 2010.

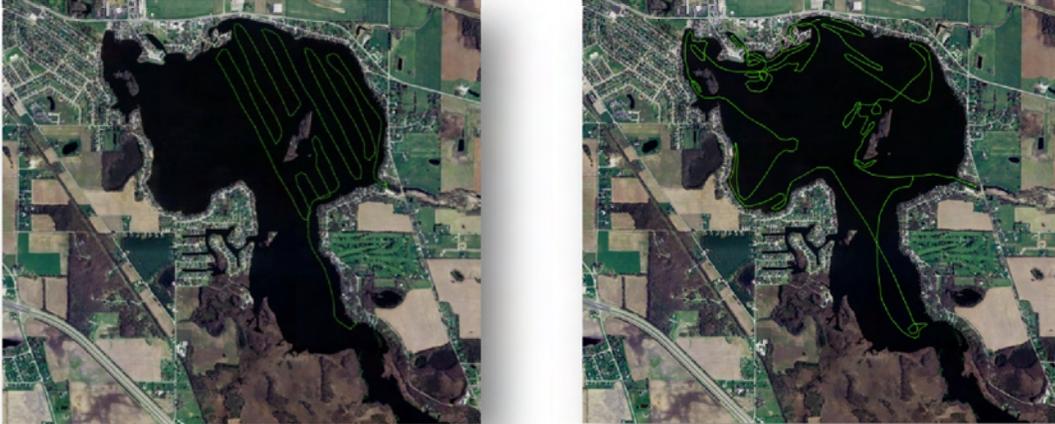
Figure 4.1.3. First “bump application” tracks for Sonar AS (left map) and Sonar PR (right map), June 29, 2010. The GPS hardware failed during the Sonar AS application, however Sonar AS was applied to the entire water body following similar transect lines as the initial Sonar AS application.

The first bump treatment was completed on June 29 (54 days after initial treatment) with a combination of Sonar AS and PR. The bump treatment was conducted when residues had dropped to a 3.3 ppb lake-wide average on June 21. Sonar AS was applied at concentration of 2.7 ppb and Sonar PR was applied at a concentration of 1.1 ppb. Sonar AS was applied evenly over the entire lake while Sonar PR was applied to the 19 previously selected locations. A thermocline had formed at 6 meters (Table 4.1.1). Figure 4.1.3 displays the actual application routes from the first bump treatment.

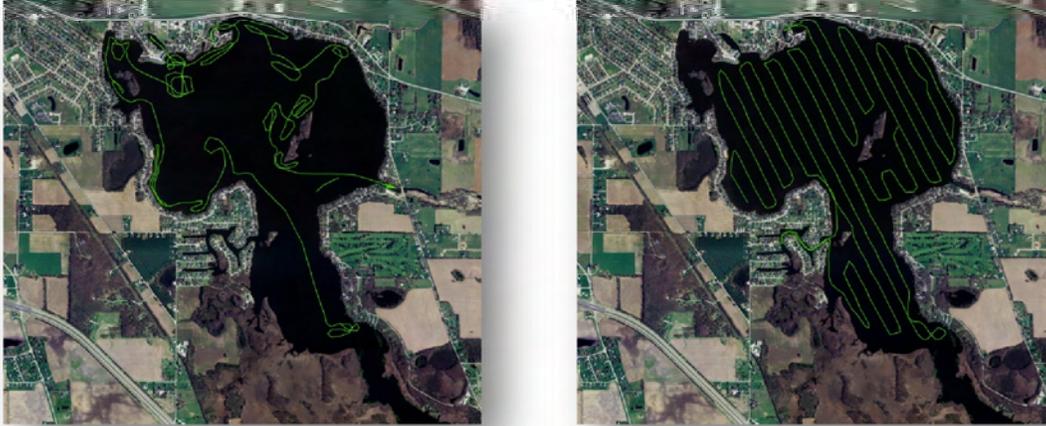
Figure 4.1.4. Second “bump application” tracks for Sonar PR on August 12, 2010 (*left map*), and Sonar AS on September 8, 2010 (*right map*).

The final Sonar PR application was completed on August 12th. Sonar PR was applied at a concentration of 1.1 ppb to the same predetermined areas. The lake-wide fluridone average was 4.2 ppb on August 3rd, so there was no need for a Sonar AS bump. Figure 4.1.4 displays the actual application routes from the final Sonar PR application.

FasTEST samples indicated that the fluridone concentration had dropped to a lake-wide average of 1.9 ppb by August 30th. A third and final bump treatment was completed on September 8th with Sonar AS. Sonar AS was applied at concentration of 3.1 ppb. There was no thermocline detected just prior to application (Table 4.1.1). It was somewhat early for the lake to have been destratified, but abnormally low temperatures and heavy winds had occurred for several days prior to application which may have led to lake mixing at the time of treatment. Figure 4.1.4 (right map) displays the actual application routes from the final bump treatment. Please see the following discussion on monitoring results for the final bump in Section 4.2.

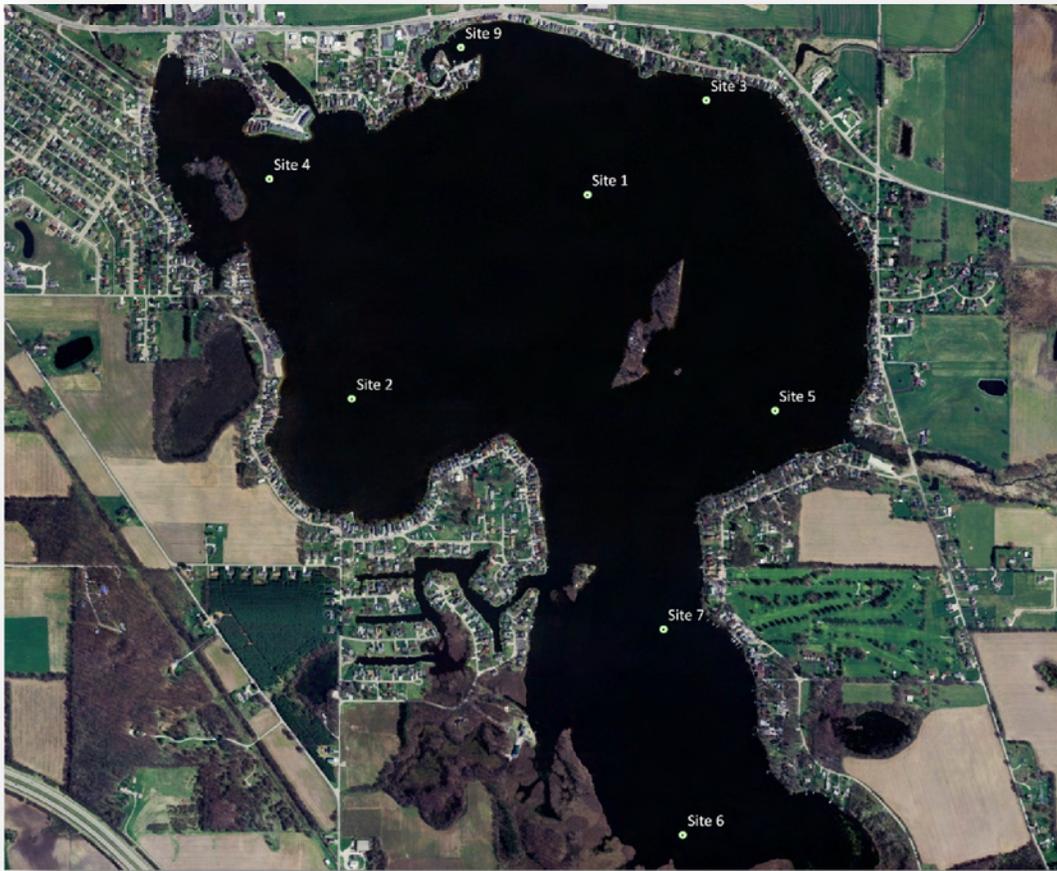
Figure 4.2.1. Permanent FastEST sample locations during 2010.

The FastEST was used to monitor fluridone concentration 3, 12, 31, 45, 60, 73, 88, 101, 115, 129, 144, 157, and 178 days following initial treatment. The FastEST ensured the target concentrations were achieved and maintained through October 15th. FastEST samples were collected from eight permanent stations located throughout Lake Manitou (Figure 4.2.1 & Table 4.2.1). Thirteen sets of surface samples were collected and results are summarized in Table 4.2.2, and Chart 4.2.1. Results indicate the concentration was maintained above 2.5 ppb for the majority of the 2010 growing season. The objective was to maintain >2.5 ppb until October 15th as it was determined that hydrilla would unlikely be able to sprout from a tuber and form a new tuber after that period.
