CENTER LAKE, KOSCIUSKO COUNTY
AQUATIC VEGETATION MANAGEMENT PLAN
UPDATE 2008

FEBRUARY 27, 2009

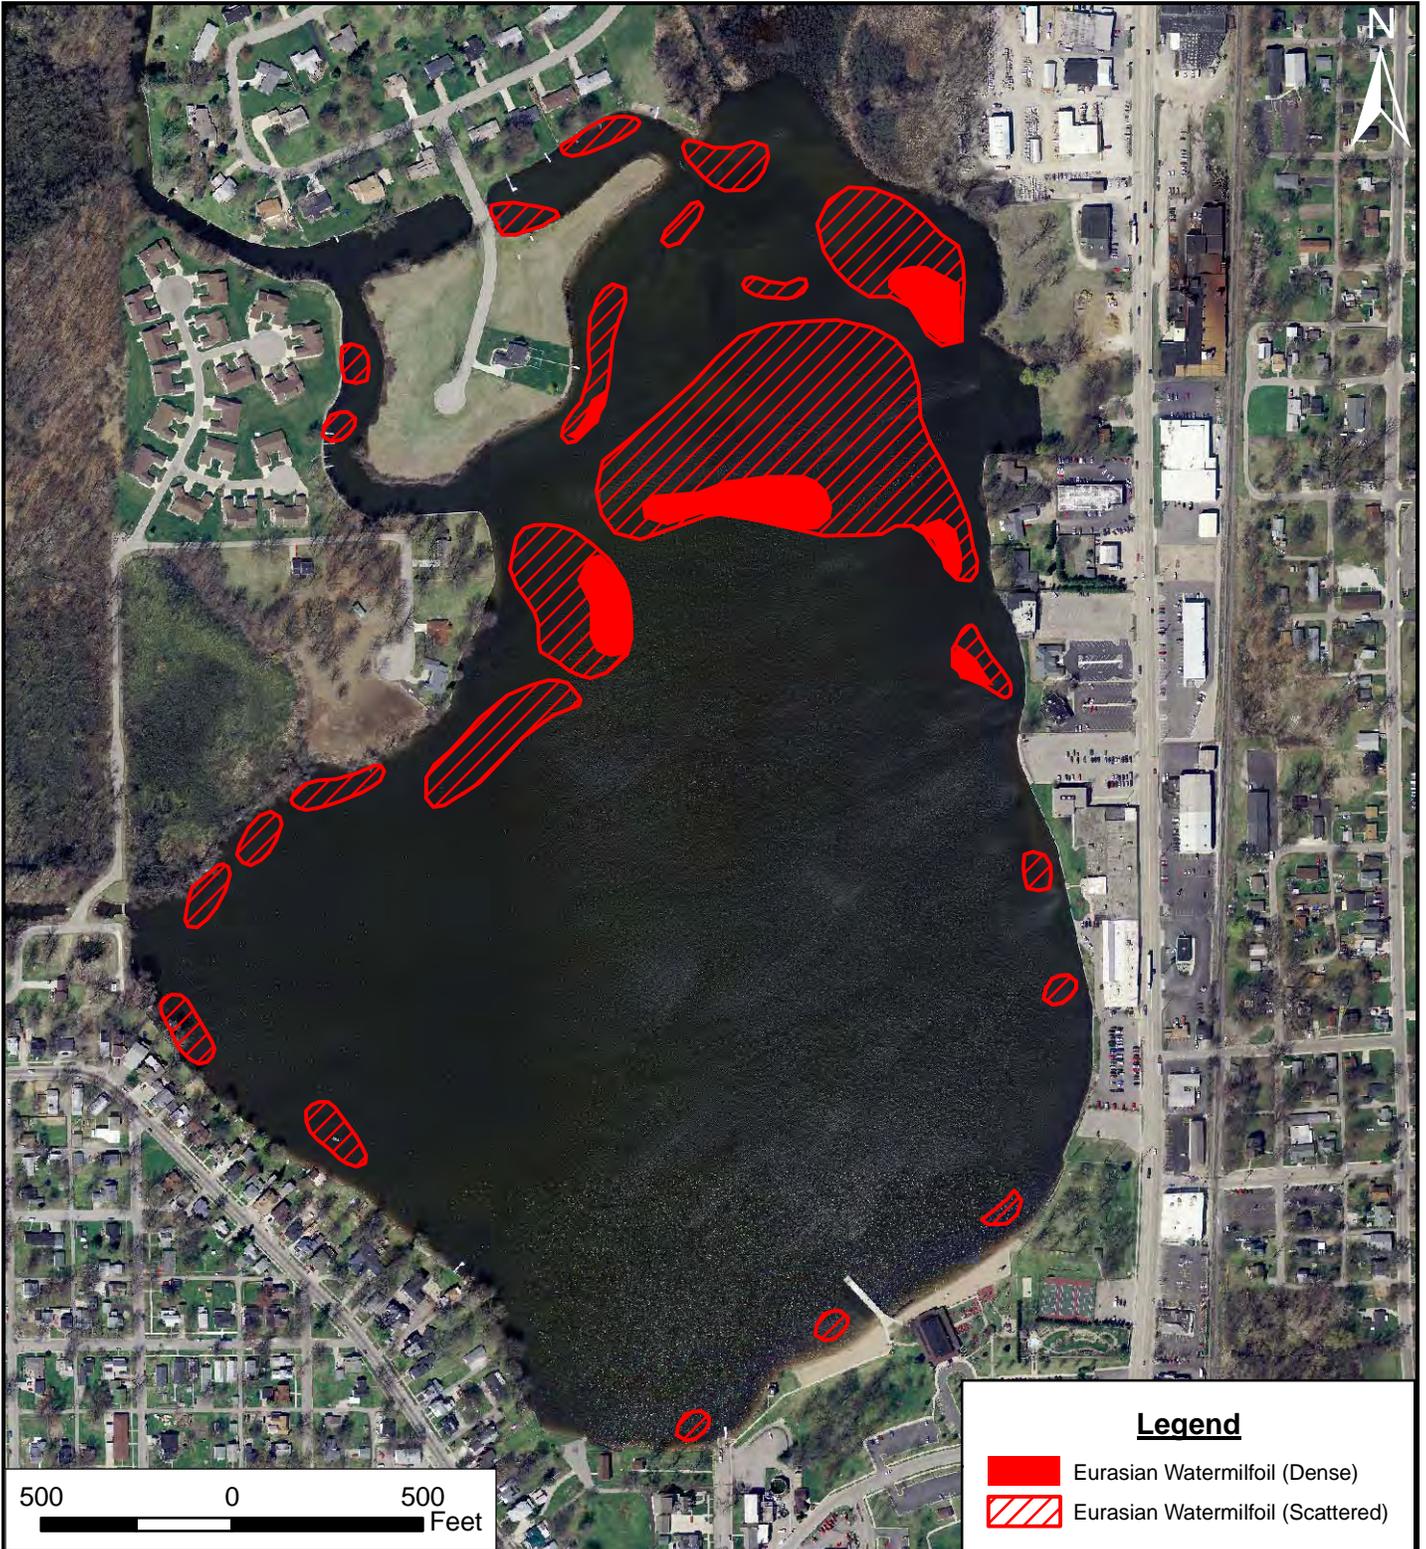
Eurasian Watermilfoil (Dense)

Eurasian Watermilfoil (Scattered)

TITLE:	Center Lake Exotic Species Map		
BASE LAYER:	Indiana Spatial Data 2006 Orthophotography		
CLIENT:	Center Lake Conservation Association 1212 Edgewater Drive Warsaw, IN 46580

Weed Patrol performed a vegetation survey on May 13, 2008 to identify areas where Eurasian watermilfoil was present within Center Lake (Figure 2). Renovate was used to treat 19 acres of Eurasian watermilfoil on May 29, 2008 based on the areas identified from the survey conducted on May 13th. The dosage of Renovate was 2.63 gallons per acre. Renovate is a systemic herbicide that is absorbed by the plant and transported to the root system and kills both the root system and the plant. Applications of Renovate were primarily in the northern portion of Center Lake at depths up to 10 feet (Figure 3). Treatments on Center Lake should be continued so Eurasian watermilfoil is maintained at a manageable level and recreational activities are not inhibited.

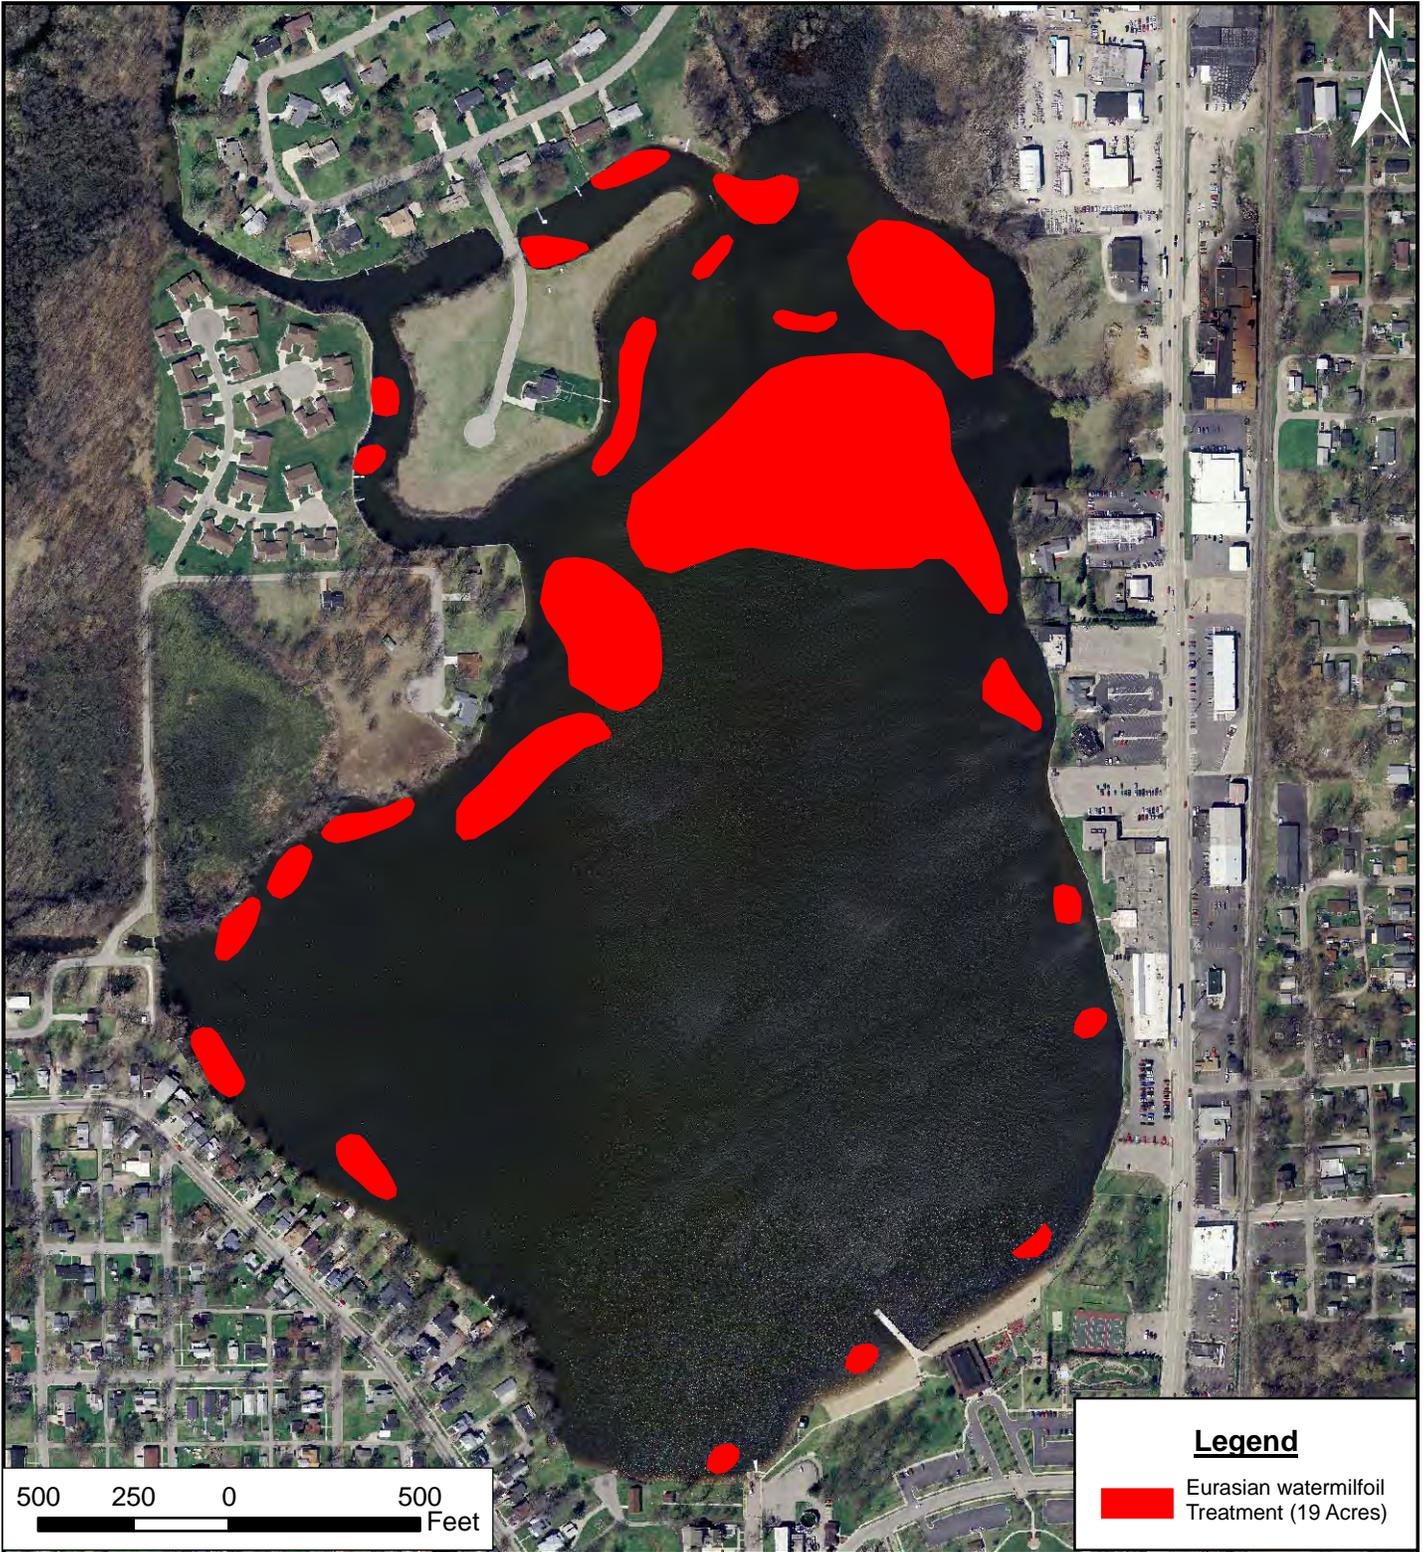
Eurasian watermilfoil Treatment (19 Acres)

TITLE: Eurasian Watermilfoil Treatment Areas - 2008		PROJECT AND SITE LOCATION: Center Lake Aquatic Plant Management Plan Update -2008		
BASE LAYER: Indiana Spatial Data 2006 Orthophotography		PROJECT No. 02218.05	FIGURE: 3	SHEET: 1 OF: 1
CLIENT: Center Lake Conservation Association 1212 Edgewater Drive Warsaw, IN 46580		QUADRANGLE: N/A	DATE: 5-29-08	SCALE: 1" = 500'

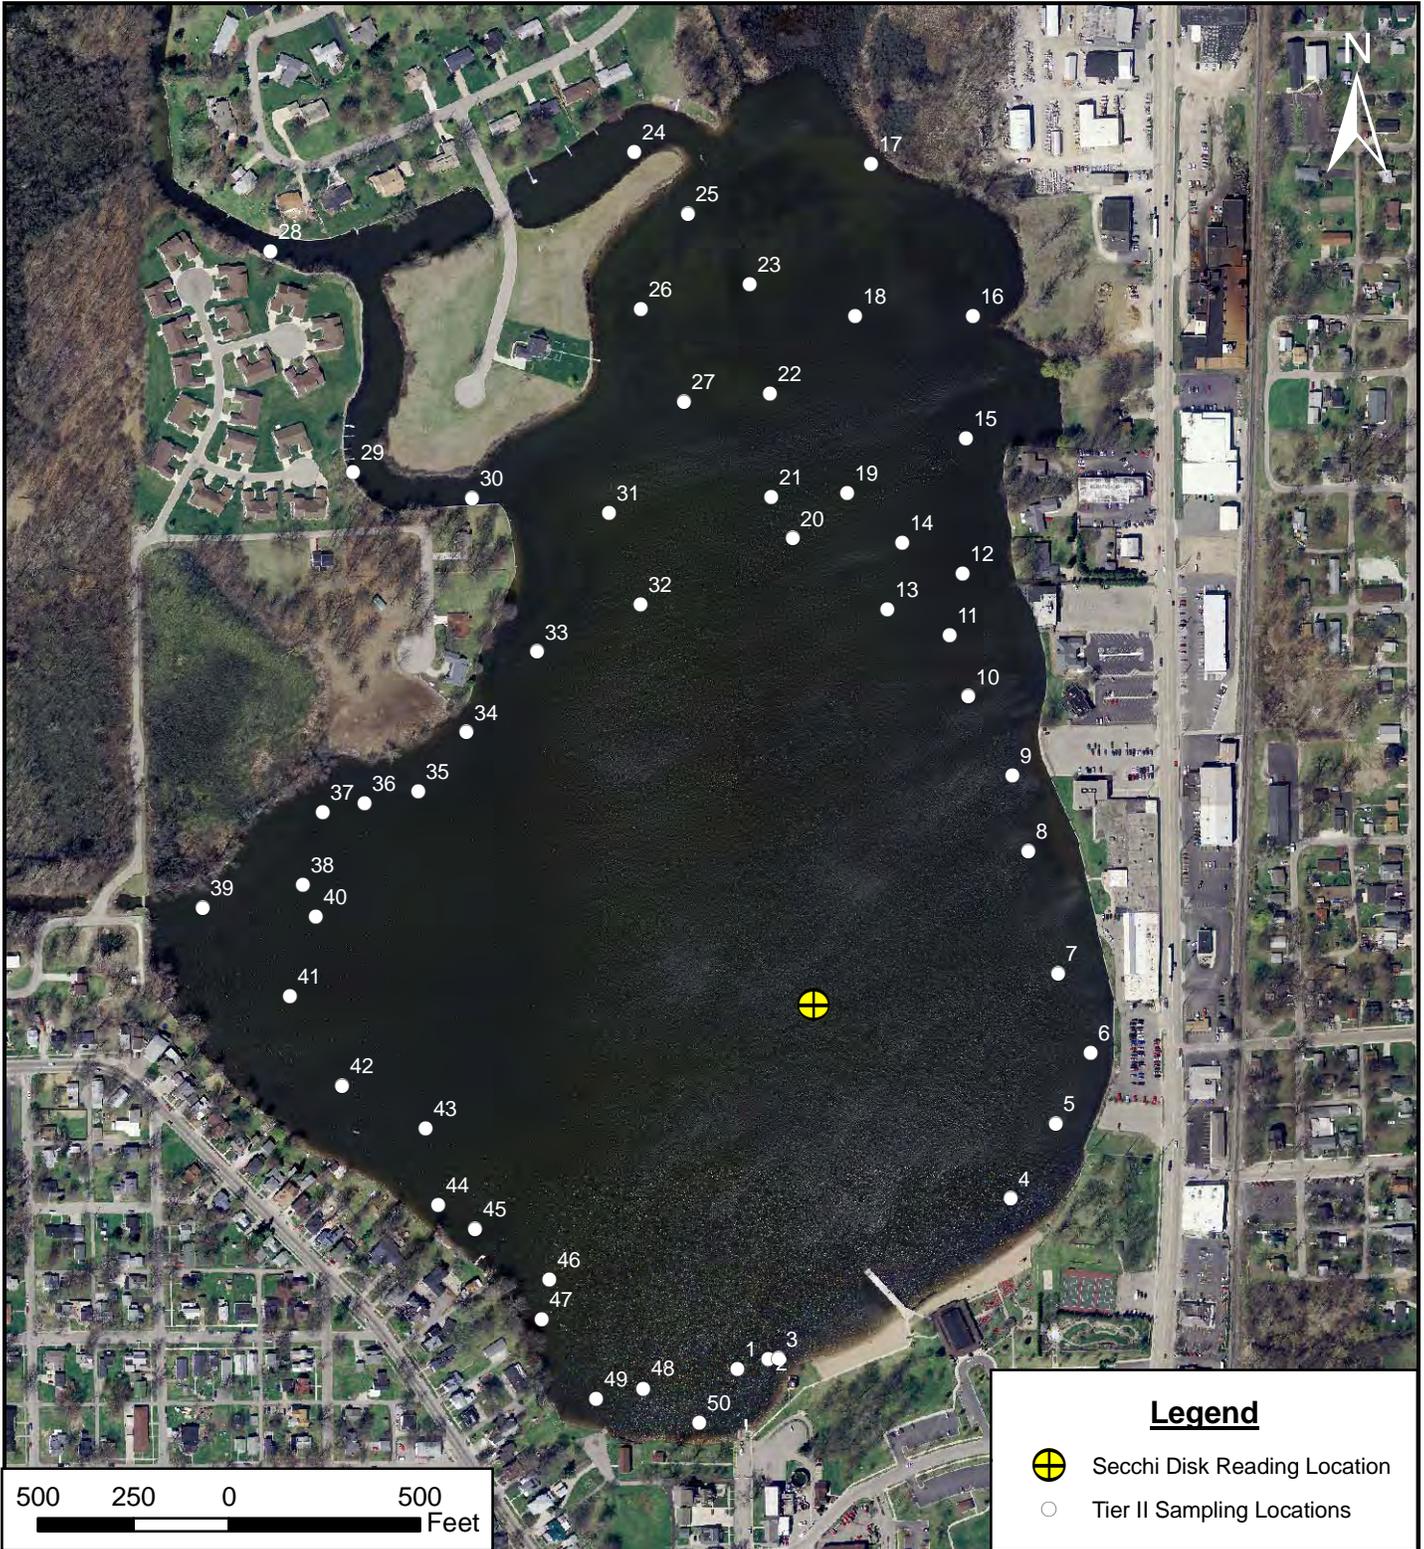
Secchi Disk Reading Location
-

Tier II Sampling Locations

<p>V3 Companies 7325 Janes Avenue Woodridge, IL 60517 630.724.9200 phone 630.724.9202 fax www.v3co.com</p>	TITLE: Tier II Sampling Locations		PROJECT AND SITE LOCATION: Center Lake Aquatic Plant Management Plan Update - 2008		
	BASE LAYER: Indiana Spatial Data 2006 Orthophotography		PROJECT NO. 02218.05	FIGURE: 4	SHEET: 1 OF: 1
	CLIENT: Center Lake Conservation Association 1212 Edgewater Drive Warsaw, IN 46580		QUADRANGLE: N/A	DATE: 8/26/08	SCALE: 1" = 500'

The Tier II survey completed on August 26, 2008 identified a total of six species within Center Lake with vegetation present up to a depth of 9 feet. A secchi disk reading was taken after sampling and was found to be at 12 feet (Figure 4). Sampling results for the species collected by rake are listed in Table 2. Species observed include spatterdock, white water lily and Eurasian watermilfoil.

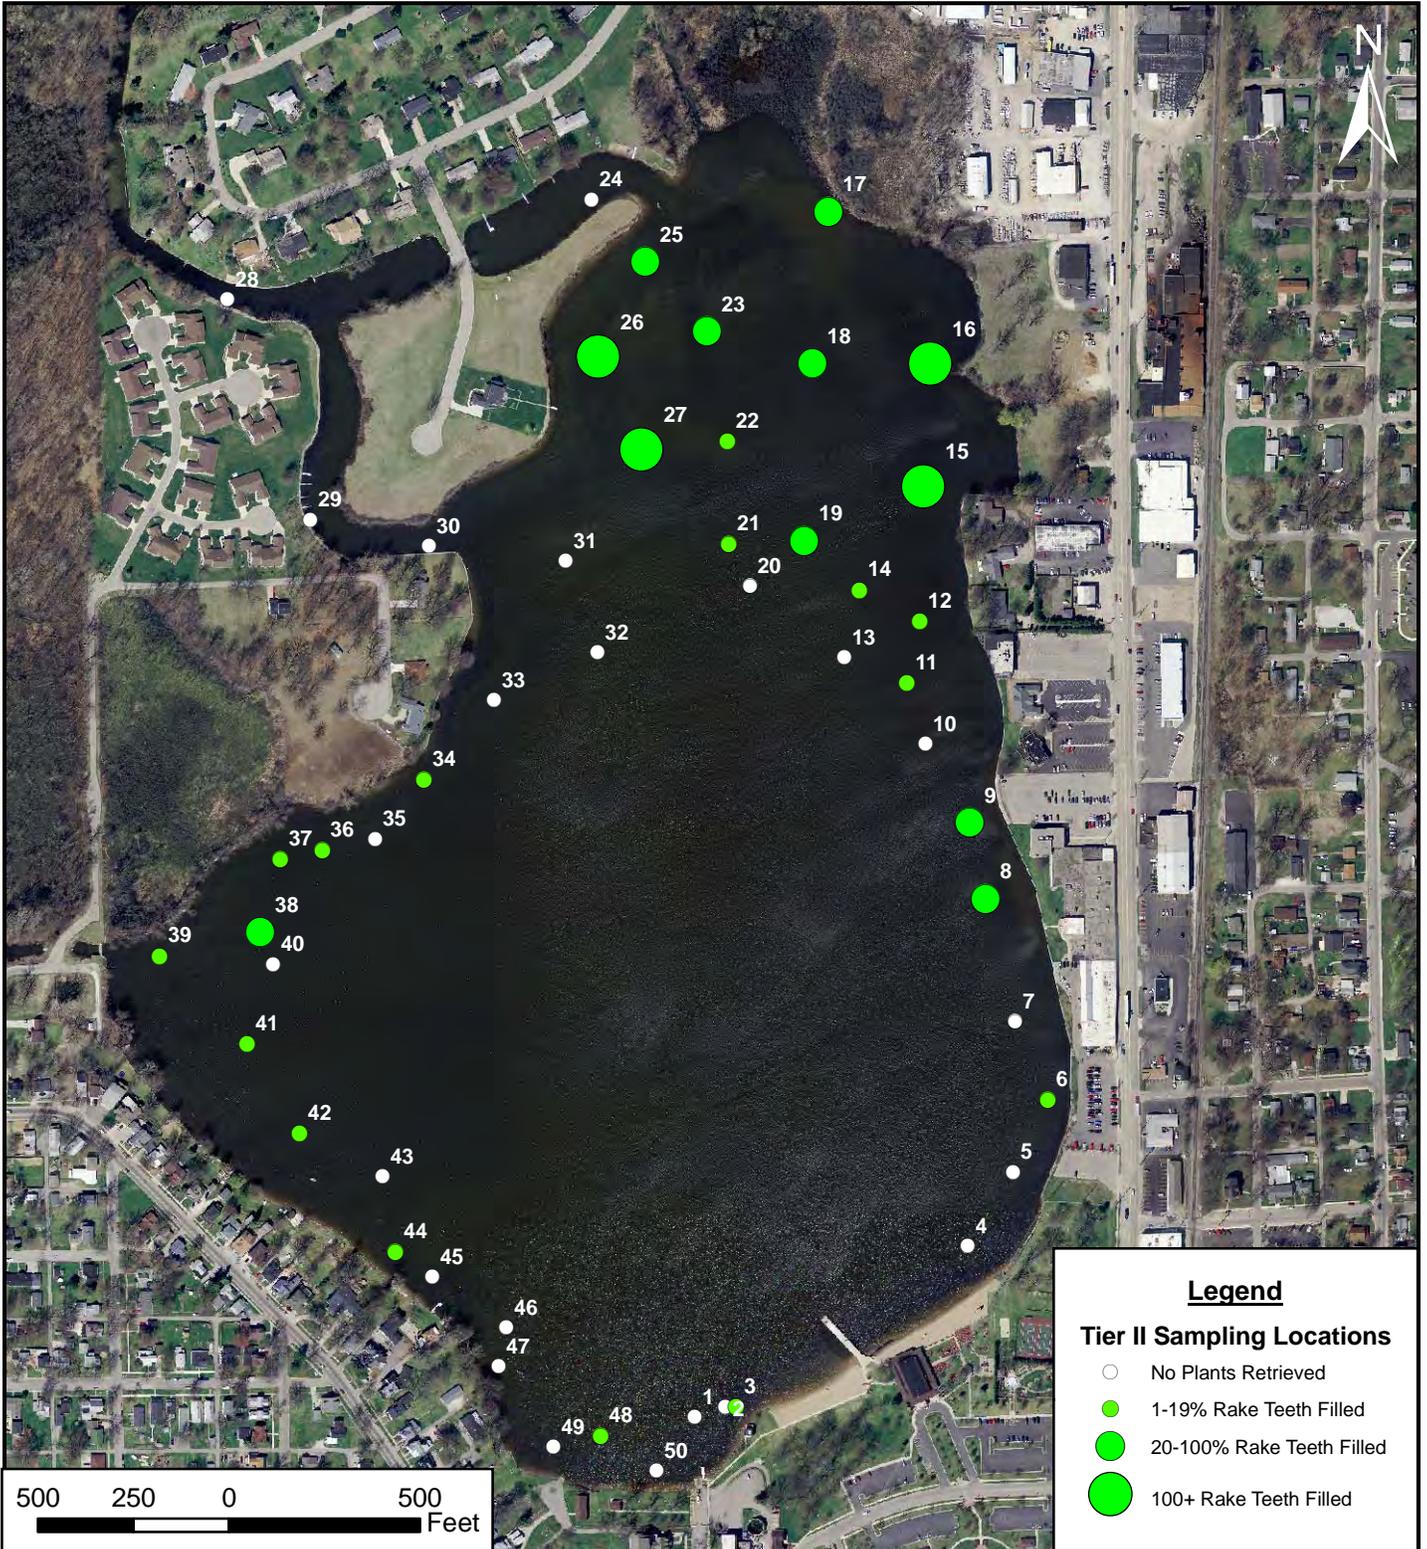
PROJECT NO. 02218.05	FIGURE: 5	SHEET: 1 OF: 1
QUADRANGLE: N/A	DATE: 8/26/08	SCALE: 1" = 500'

- No Plants Retrieved
- 1-19% Rake Teeth Filled
- 20-100% Rake Teeth Filled
- 100+ Rake Teeth Filled

TITLE:
**Post-treatment Distribution
and Abundance of Chara**

The results of the Tier II sampling effort identified chara as the most dominant species (23.6) which was present at 54% of sample sites (Figure 5). Sago pondweed ranked second in frequency of occurrence (38%; Figure 6) followed closely by slender naiad (36%). The 0 to 5 foot depth zone was the most diverse and had six native species. The most dominant species within the 0 to 5 foot depth zone was sago pondweed (24.3) followed by chara and slender naiad. Coontail's frequency of occurrence was 21.7% within the 0 to 5 foot depth zone and 29.4% in the 5 to 10 foot depth zone (Figure 7). Species observed within the vicinity of the sampling locations include spatterdock, white water lily and Eurasian watermilfoil. Eurasian watermilfoil was found within the vicinity of two sampling locations at depths of 2 and 3 feet (Figure 8).

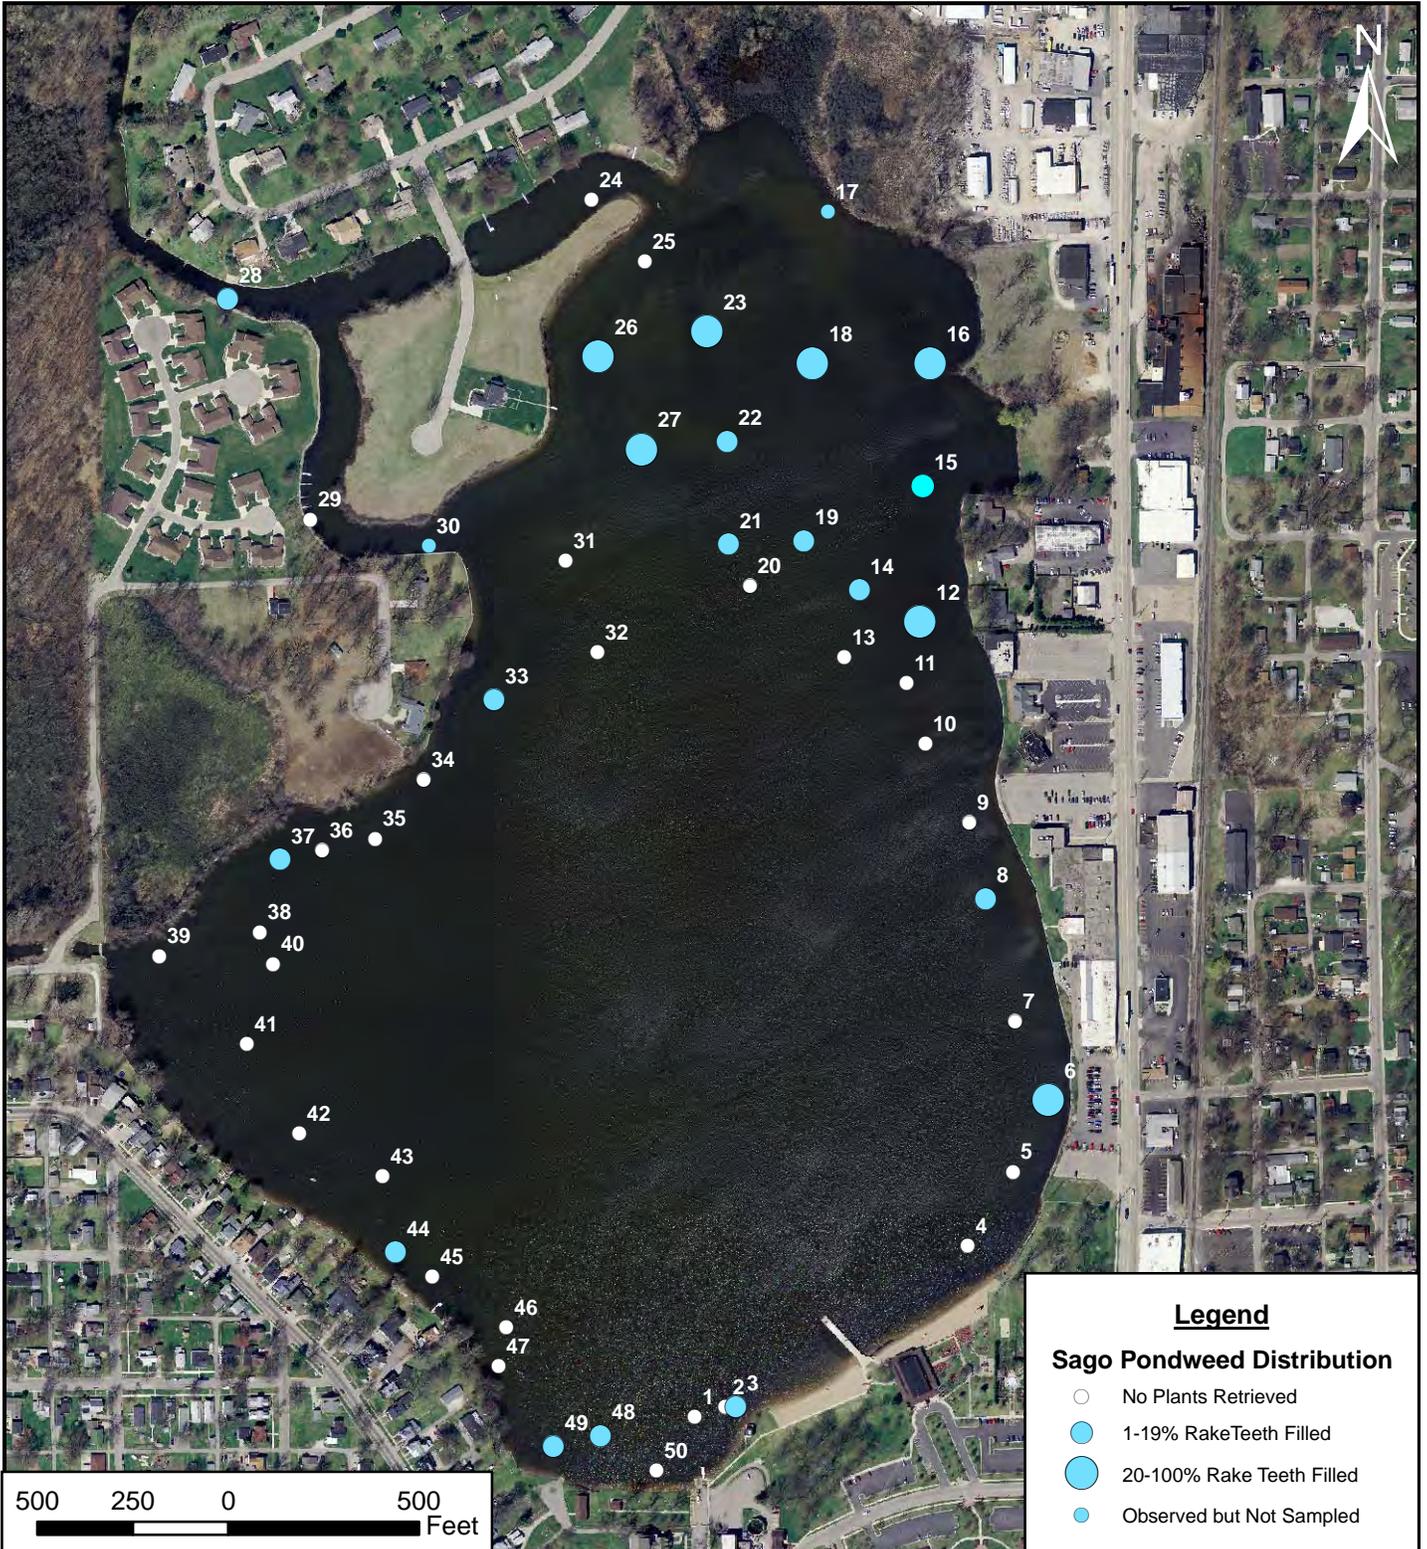
- No Plants Retrieved
- 1-19% Rake Teeth Filled
- 20-100% Rake Teeth Filled
- Observed but Not Sampled

TITLE: Post-treatment Distribution and Abundance of Sago Pondweed	PROJECT AND SITE LOCATION: Center Lake Aquatic Plant Management Plan Update -2008		
BASE LAYER: Indiana Spatial Data 2006 Orthophotography	PROJECT NO. 02218.05	FIGURE: 6	SHEET: 1 OF: 1
CLIENT: Center Lake Conservation Association 1212 Edgewater Drive Warsaw, IN 46580	QUADRANGLE: N/A	DATE: 08/26/08	SCALE: 1" = 500'

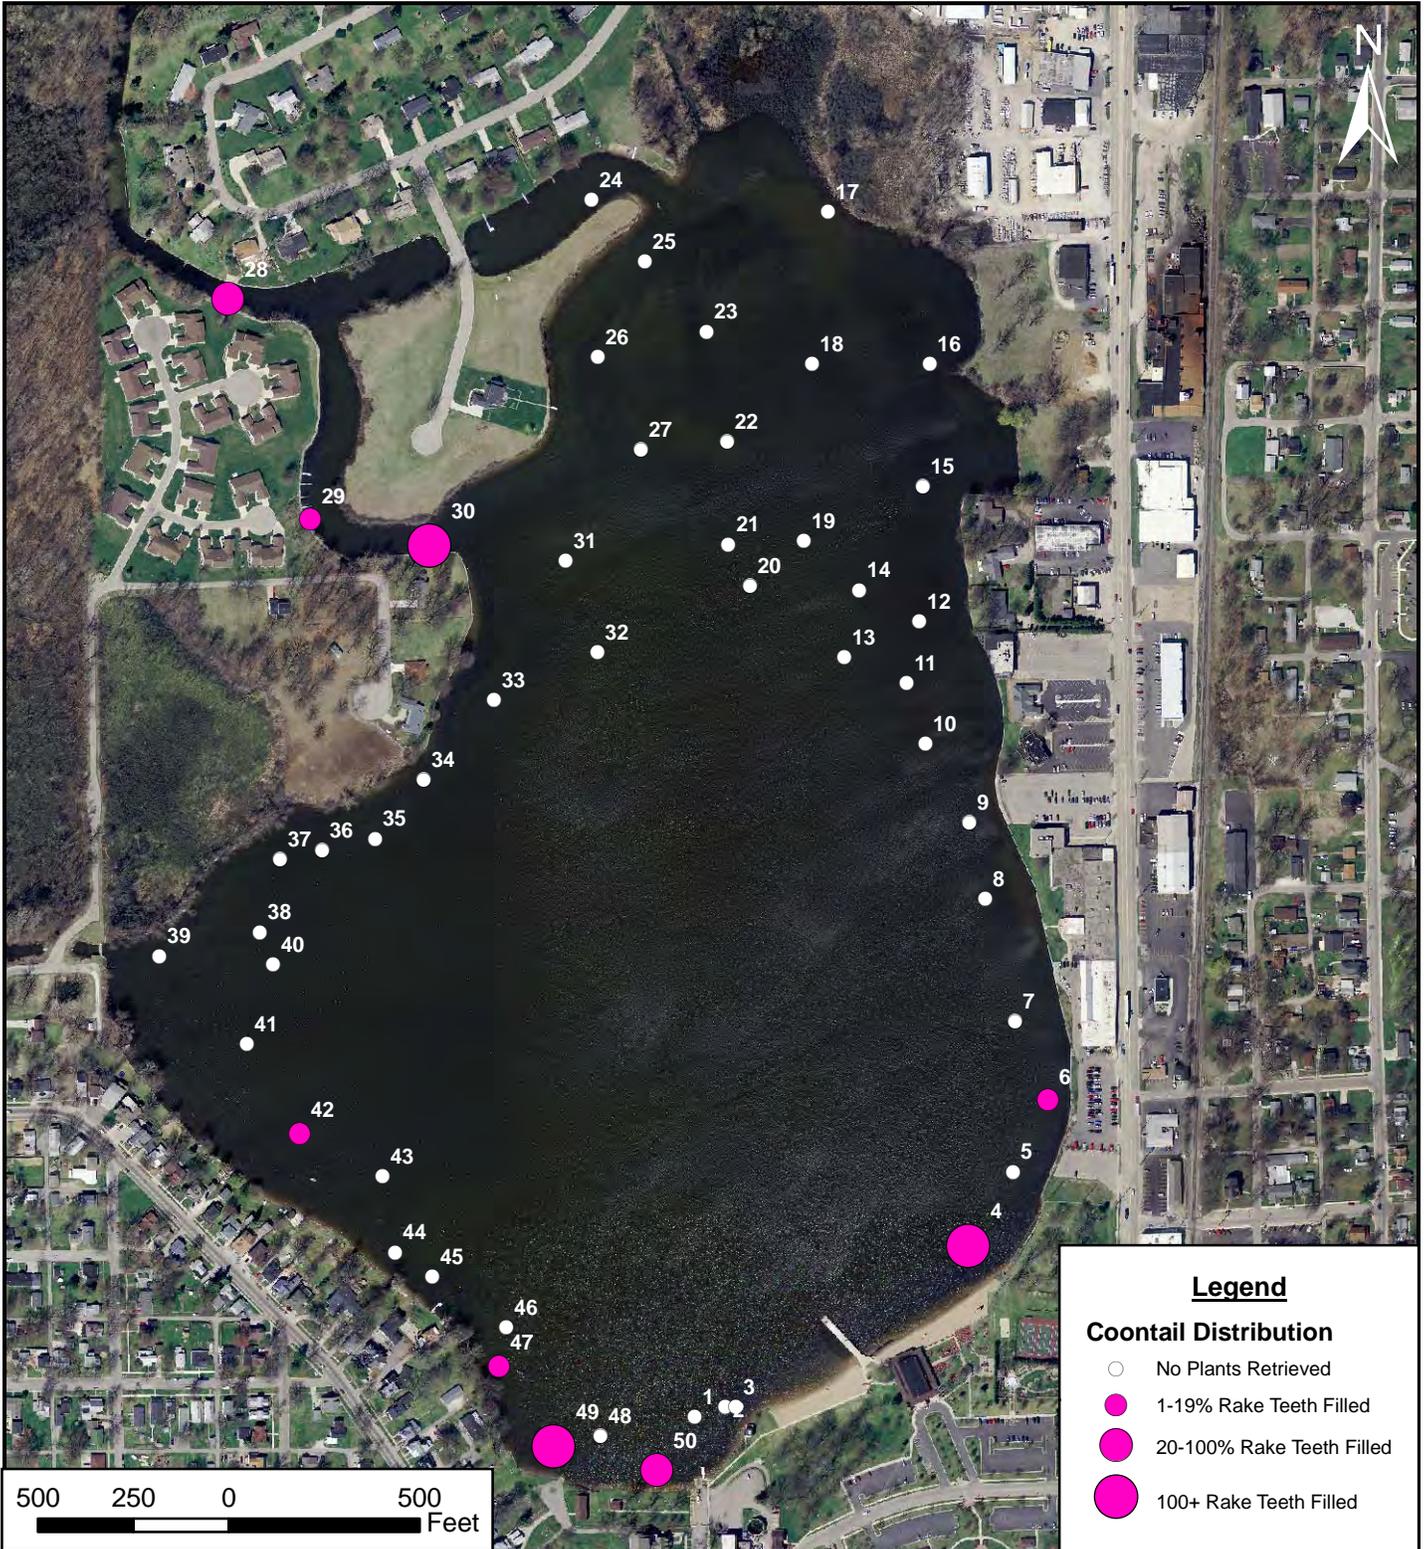
PROJECT AND SITE LOCATION: Center Lake Aquatic Plant Management Plan Update -2008		
PROJECT No. 02218.05	FIGURE: 7	SHEET: 1 OF: 1
QUADRANGLE: N/A	DATE: 08/26/08	SCALE: 1" = 500'

- No Plants Retrieved
- 1-19% Rake Teeth Filled
- 20-100% Rake Teeth Filled
- 100+ Rake Teeth Filled

TITLE: Post-treatment Distribution and Abundance of Coontail
BASE LAYER: Indiana Spatial Data 2006 Orthophotography
CLIENT: Center Lake Conservation Association 1212 Edgewater Drive Warsaw, IN 46580

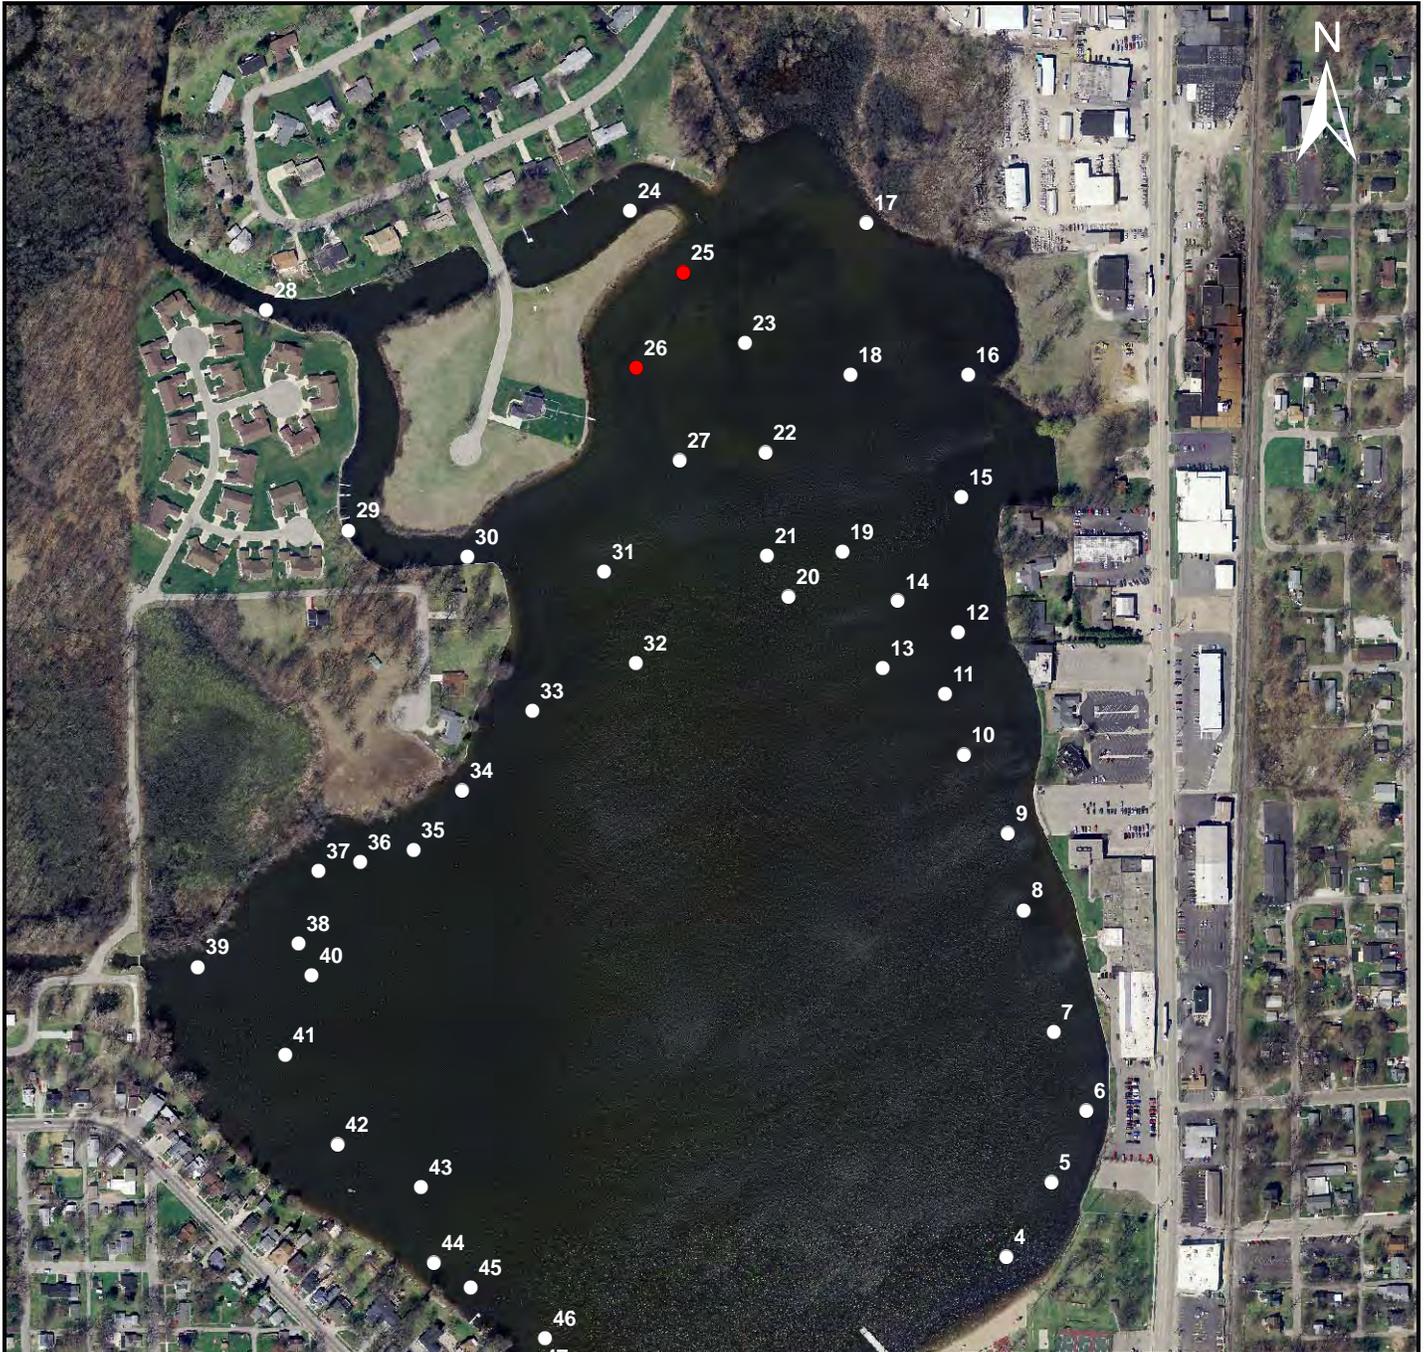
PROJECT AND SITE LOCATION:		
Center Lake Aquatic Plant Management Plan Update -2008		
PROJECT NO.	FIGURE:	SHEET: 1
02218.05	8	OF: 1
QUADRANGLE:	DATE:	SCALE:
N/A	8/26/08	1" = 500'

- No Plants Retrieved
- Observed but Not Sampled

TITLE:	Post-treatment Distribution and Abundance of Eurasian Watermilfoil
BASE LAYER:	Indiana Spatial Data 2006 Orthophotography
CLIENT:	Center Lake Conservation Association 1212 Edgewater Drive Warsaw, IN 46580

Eurasian watermilfoil is the primary nuisance exotic species within Center Lake. Eurasian watermilfoil was observed and not collected in both the 2007 and 2008 Tier II Studies. Eurasian watermilfoil was observed from one sampling location in 2007 and two sampling locations in 2008. Continued management efforts to maintain Eurasian watermilfoil at a low level is necessary to prevent it from becoming a dominant species at Center Lake.

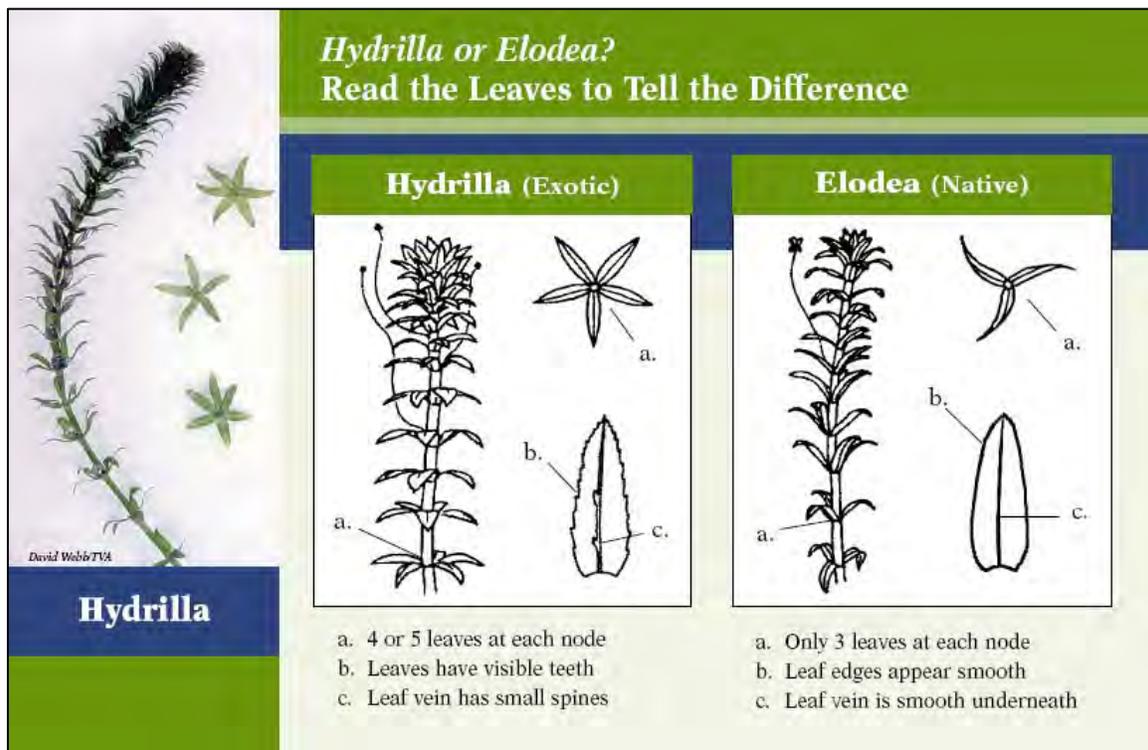
Figure 11: Illustration of Hydrilla compared to native elodea. (Illustrations provided by Michigan Sea Grant)

Hydrilla can be differentiated from the native elodea in that there are typically 3 leaves per whorl on the native elodea and there are as many as eight leaves per whorl in Hydrilla. Elodea is also smooth to the touch where as Hydrilla is rough. Figure 11 (Michigan Sea Grant 2007) demonstrates a means of comparative identification.

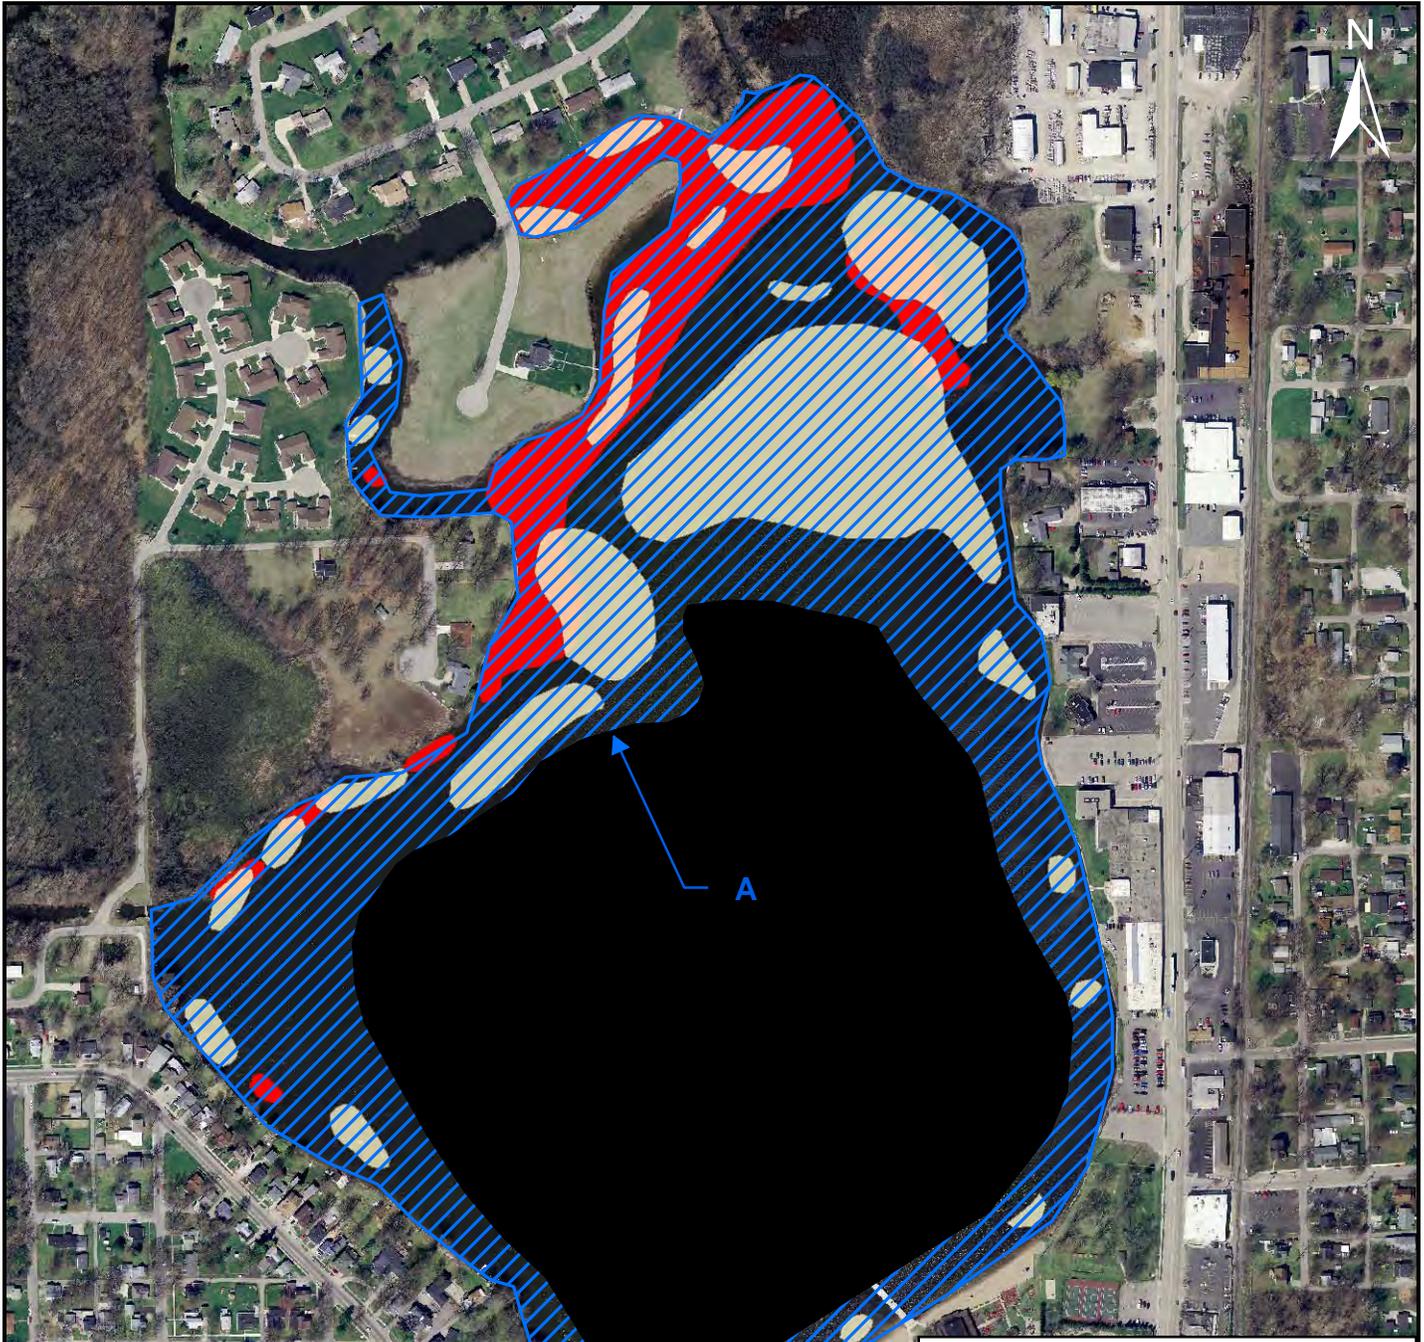
Up to 30 acres of Eurasian watermilfoil will be treated within the search and destroy area.

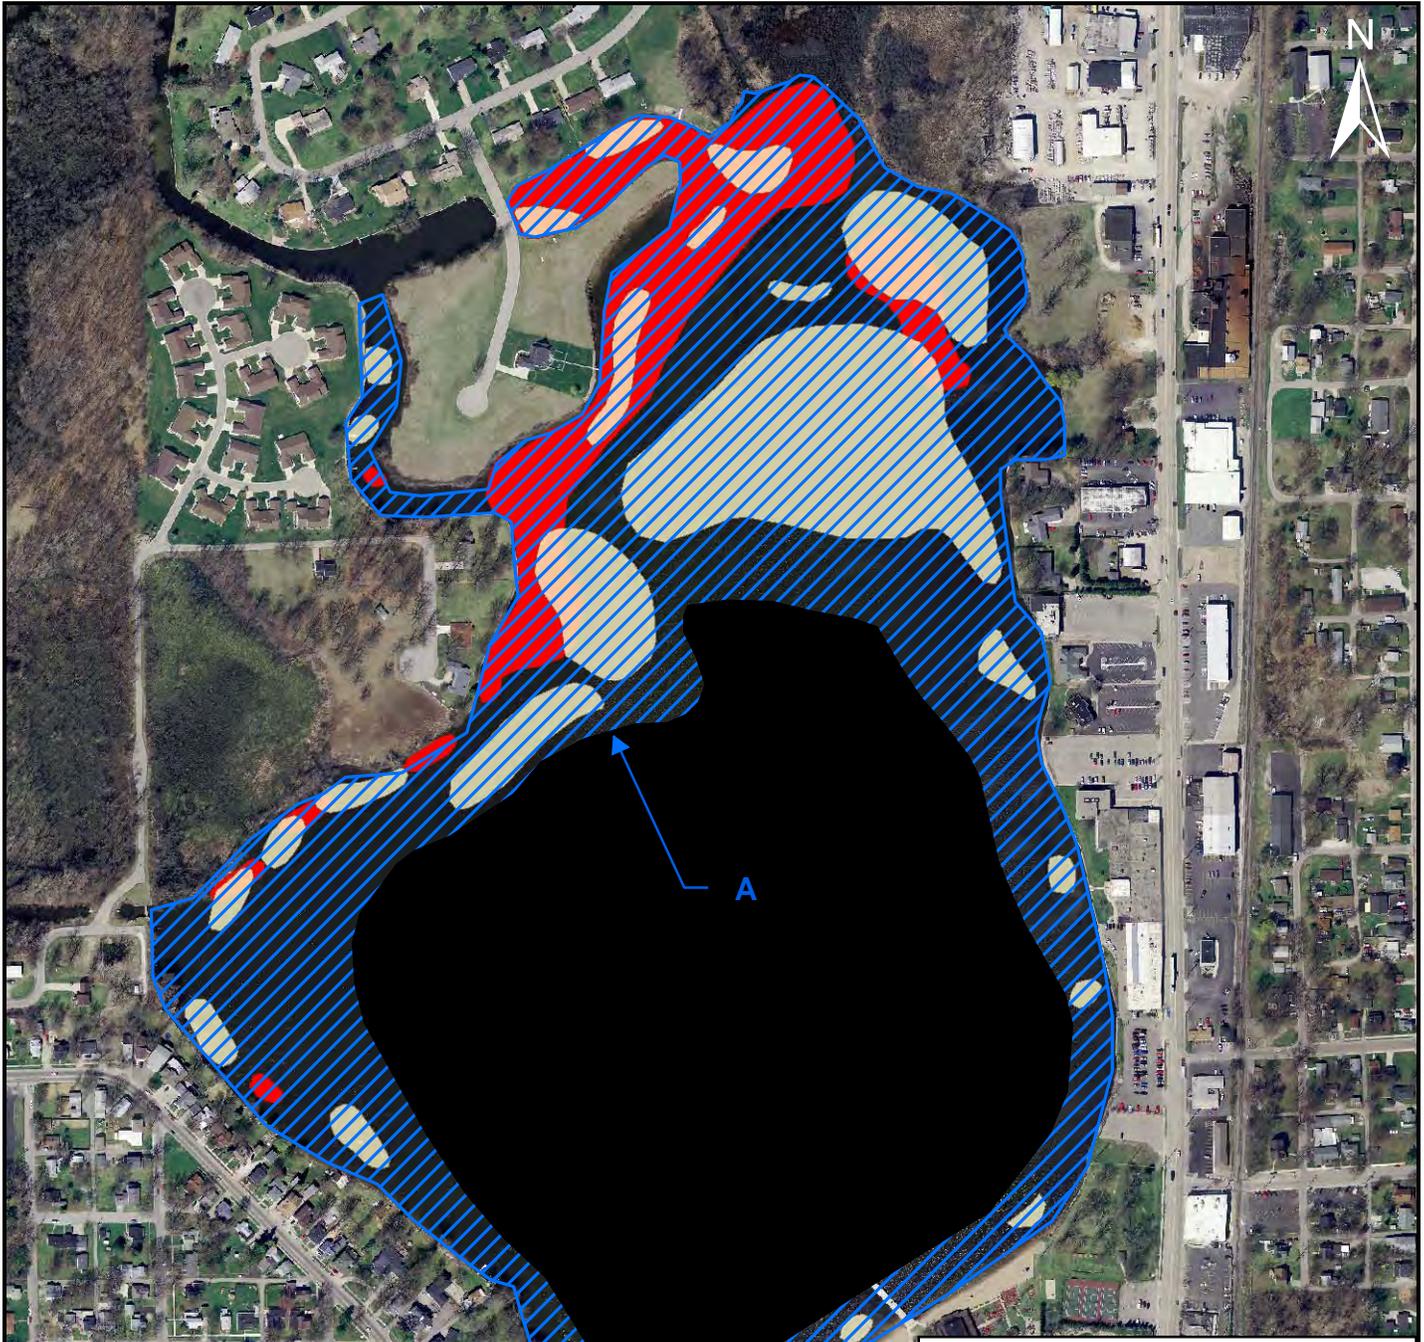
PROJECT AND SITE LOCATION: Center Lake Aquatic Plant Management Plan Update - 2008		
PROJECT NO. 02218.05	FIGURE: 12	SHEET: 1 OF: 1
QUADRANGLE: N/A	DATE: 10/30/08	SCALE: 1" = 500'

Up to 30 acres of Eurasian watermilfoil will be treated within the search and destroy area.

TITLE: Eurasian Watermilfoil Priority Treatment Area 2009
BASE LAYER: Indiana Spatial Data 2006 Orthophotography
CLIENT: Center Lake Conservation Association 1212 Edgewater Drive Warsaw, IN 46580
