Dewart Lake Aquatic Vegetation Management Plan 2008 Update

Kosciusko County, Indiana

December 15, 2008

Aquatic Weed Control

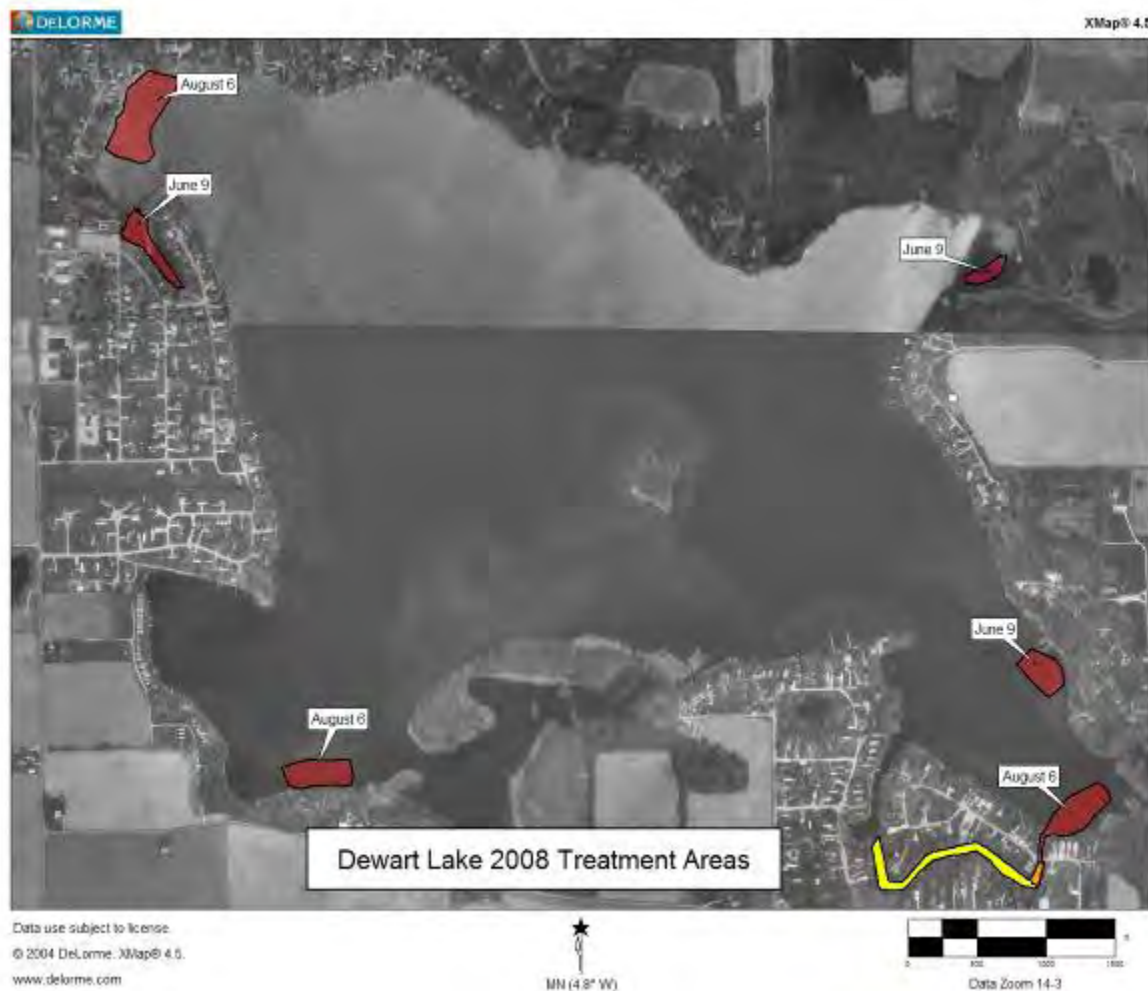
Figure 1: Dewart Lake Eurasian Watermilfoil Treatment Areas (shown in red)

The only area privately treated in Dewart Lake in 2008 was in the channel system encircling Blueberry Island in the southeast end of the lake. This channel was treated for algae only in 2007 and 2008. This area is outlined in yellow in Figure 1.

Eurasian watermilfoil started its return to the lake in 2008. Following visual inspection, four acres were treated with 2, 4-D on June 9, 2008 for EWM control. Nine more acres were treated with 2, 4-D for EWM control on August 6, 2008 using data collected in the late season tier II survey conducted on July 25, 2008.

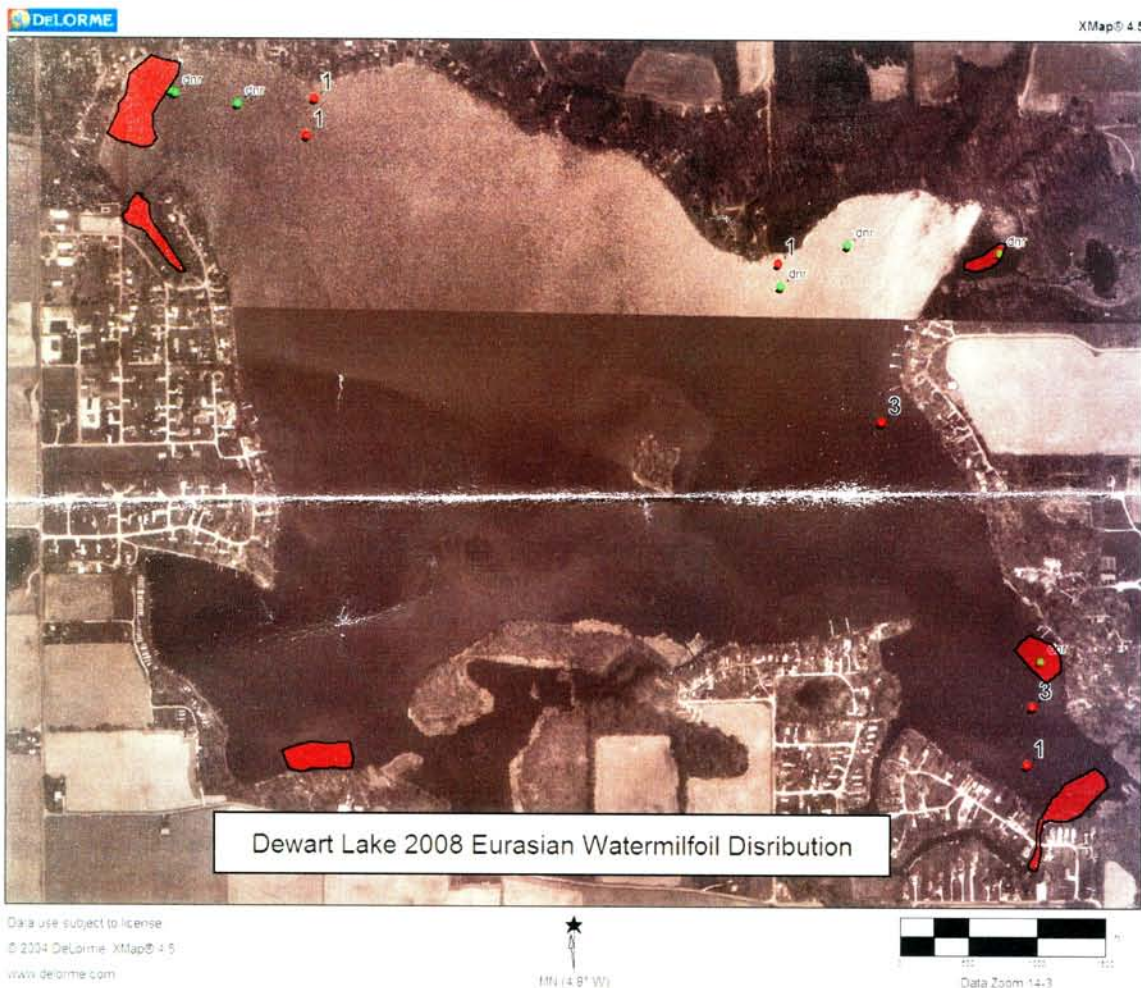
Figure 2: 2008 Eurasian Watermilfoil Distribution

Note: Numbered dots outside of the red treatment polygons represent locations where EWM was collected on the sampling rake but not visible from the boat. Some of these smaller isolated clumps were not treated in order to focus herbicide treatments on the most problematic areas of infestation.

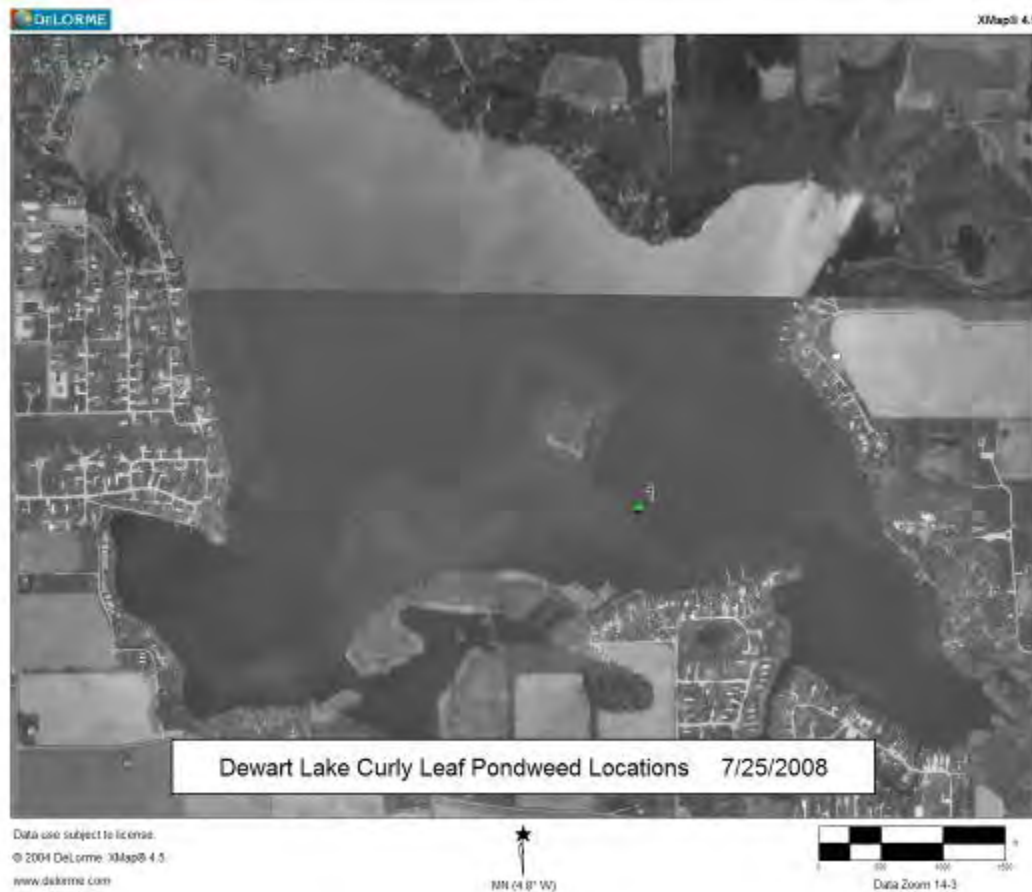
Figure 3: 2008 Curly Leaf Pondweed Locations

Figure 3 shows curly leaf pondweed locations in Dewart Lake in 2008.

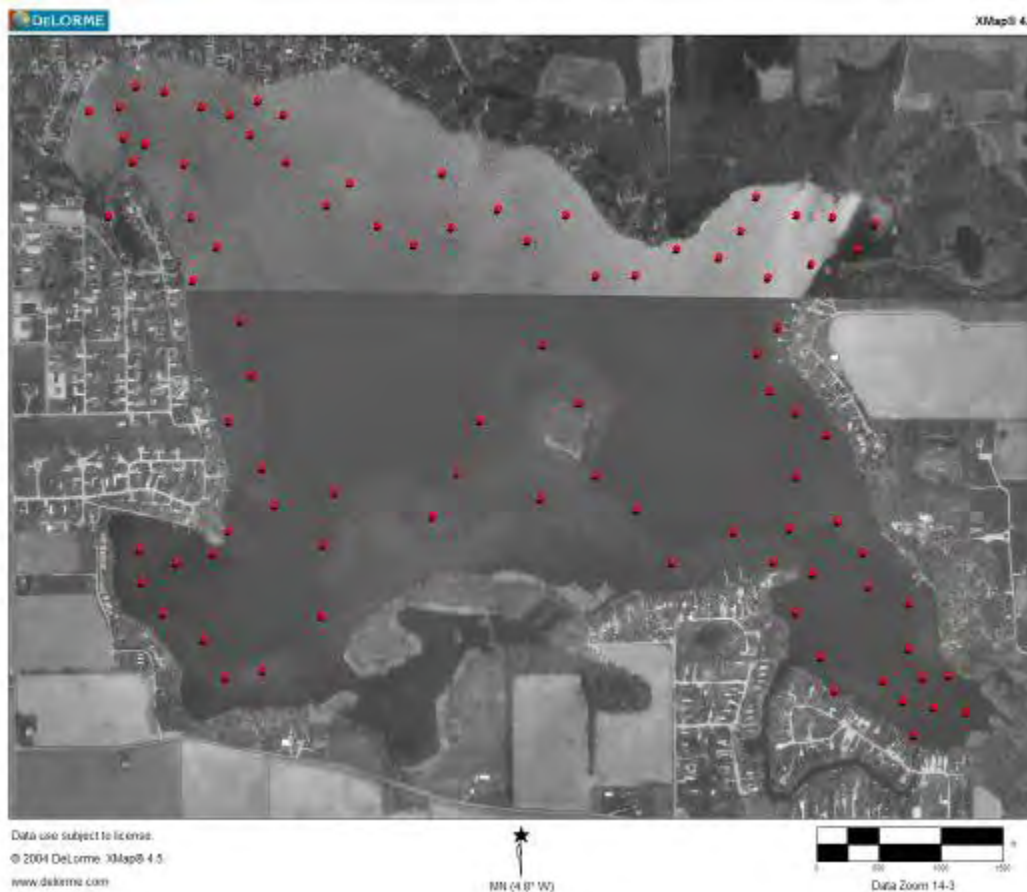
Figure 4: Dewart Lake Rake Sample Locations

A 2008 late season Tier II survey was conducted on July 25, 2008 by Aquatic Weed Control. Secchi depth was measured at 7.2 feet. Based on Dewart Lake's classification as mesotrophic and its 551 surface acres, ninety rake samples were divided between each 5 foot depth contour of the littoral zone. A total of 16 species of submersed aquatic plants were collected during this survey which is up from 13 species in 2007. Figure 4 shows the locations of all sample sites during the 2006, 2007, and 2008 Tier II surveys.

Dewart Lake is characterized by the IDNR as mesotrophic with 551 surface acres. Based on these characteristics, 90 sample sites are distributed between the 5 foot depth contours of the littoral zone of Dewart Lake. At this time, the current sampling strategy for Dewart Lake appears adequate, and no changes are recommended for 2008.

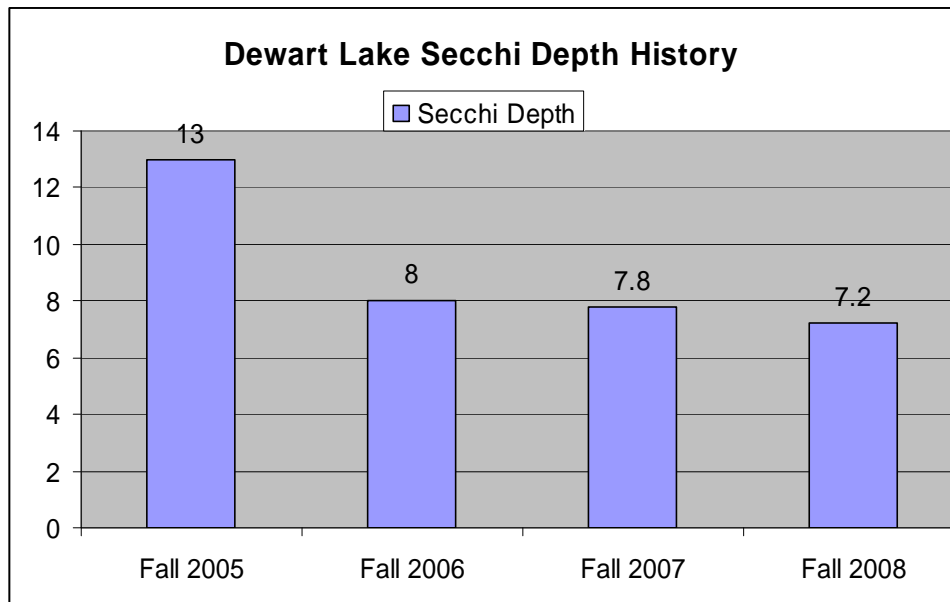
Figure 5: Dewart Lake Secchi Depth History

Secchi depth in Dewart Lake appears to have decreased over the past four years. Secchi depth was measured at 13.0 feet in fall of 2005 but has remained at 7 to 8 feet since then. It is unclear whether this decline could be linked to the Sonar treatment or other factors, but Secchi depth should continue to be monitored in the years to come. Figure 5 shows the recent Secchi depth history in Dewart Lake.

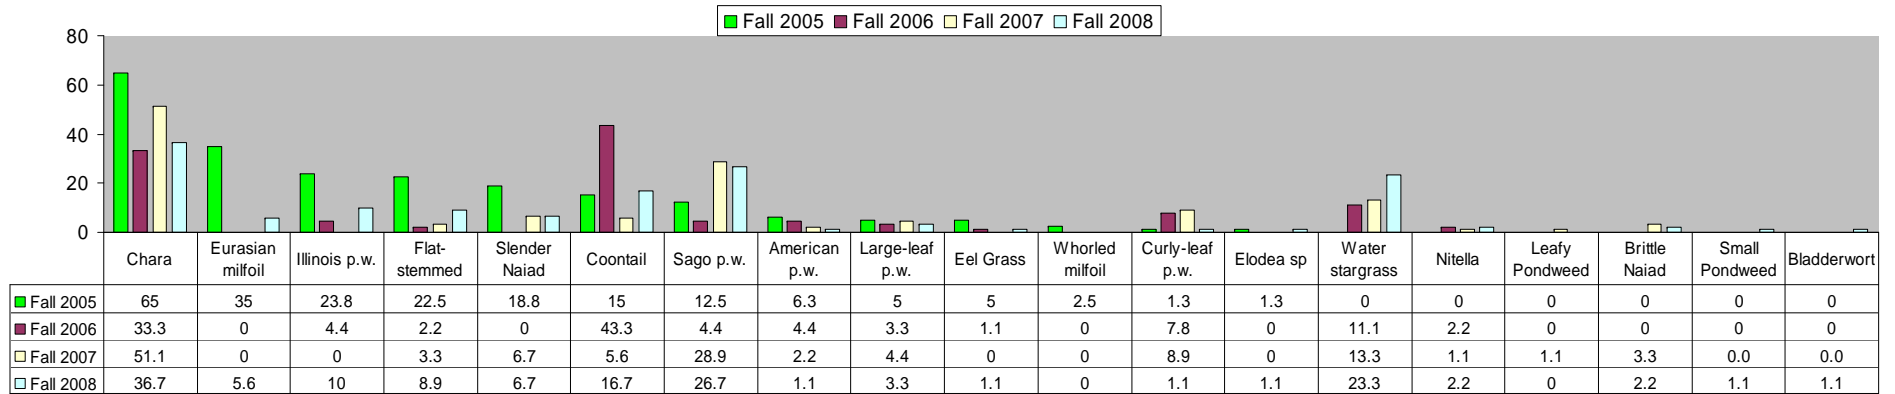
Figure 6: Dewart Lake Site Frequency Histories

Figure 6 shows site frequencies for every plant collected in fall of 2005, 2006, 2007, or 2008. Data from 2005 was collected before the whole lake Sonar treatment. Tier II survey protocol was changed in 2006, shifting more sample sites to deep water, and that change should be taken into consideration when viewing this information. Some plants like coontail and sago pondweed appear to be found more frequently in depths of 6 -10 feet than in depths of 0 – 5 feet. Before the change in protocol, Aquatic Weed Control took more sample sites in 0 – 5 feet of water.

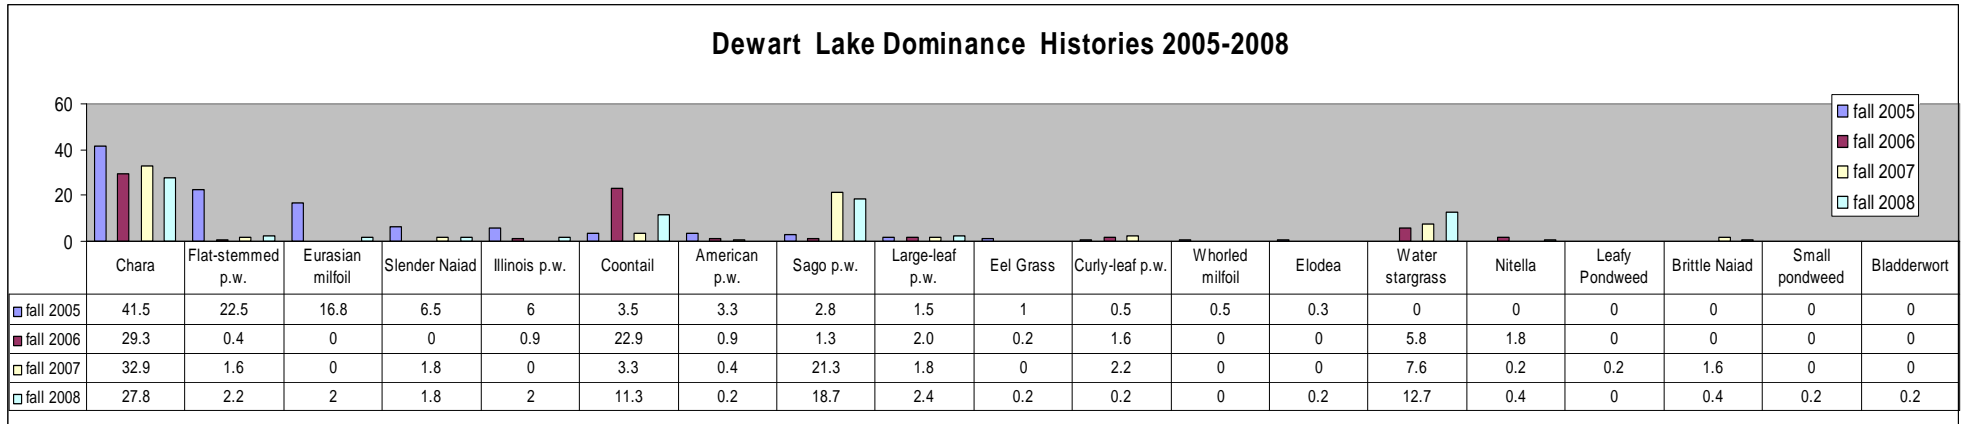
Figure 7: Dewart Lake Dominance Histories

Figure 7 tracks dominance values for each plant collected at Dewart Lake during its involvement in the LARE program. Trends are similar to sight frequency, with Eurasian watermilfoil dominance dropping to 0 after the Sonar treatment and remaining at 0 through the 2007 growing season. Dominance of many native plants dropped as well after the treatment, but most plants were near pre-treatment dominance values in 2008.

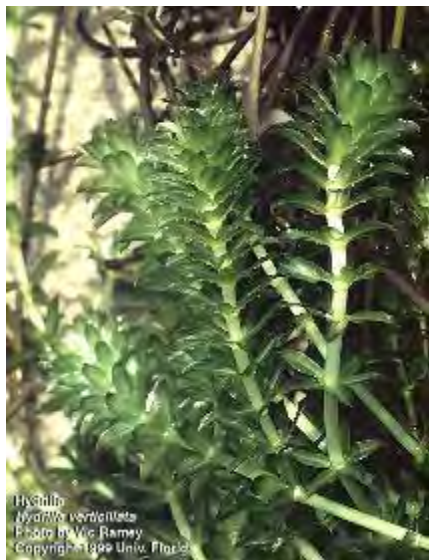
Hydrilla (*Hydrilla verticillata*) is an invasive aquatic plant species common throughout the southern United States. It is federally listed as a noxious weed and causes severe ecological

and recreational problems wherever it grows. It is considered to be much more destructive than other invasives like Eurasian watermilfoil and curly leaf pondweed because of its reproductive adaptations. It grows by fragmentation, as does Eurasian watermilfoil, but it also produces turions which can remain dormant in the sediment for 4 years or more (Van and Steward, 1990). It produces tubers at its root tips which can also reproduce after multiple years of dormancy. It can grow 1 inch each day and it quickly out-competes native plants. It forms dense beds that eliminate native plants, stunt fish populations, impede recreation and cause a drastic decrease in biodiversity (Colle and Shireman, 1980). Millions of dollars are spent each year for hydrilla maintenance each year in Florida alone.

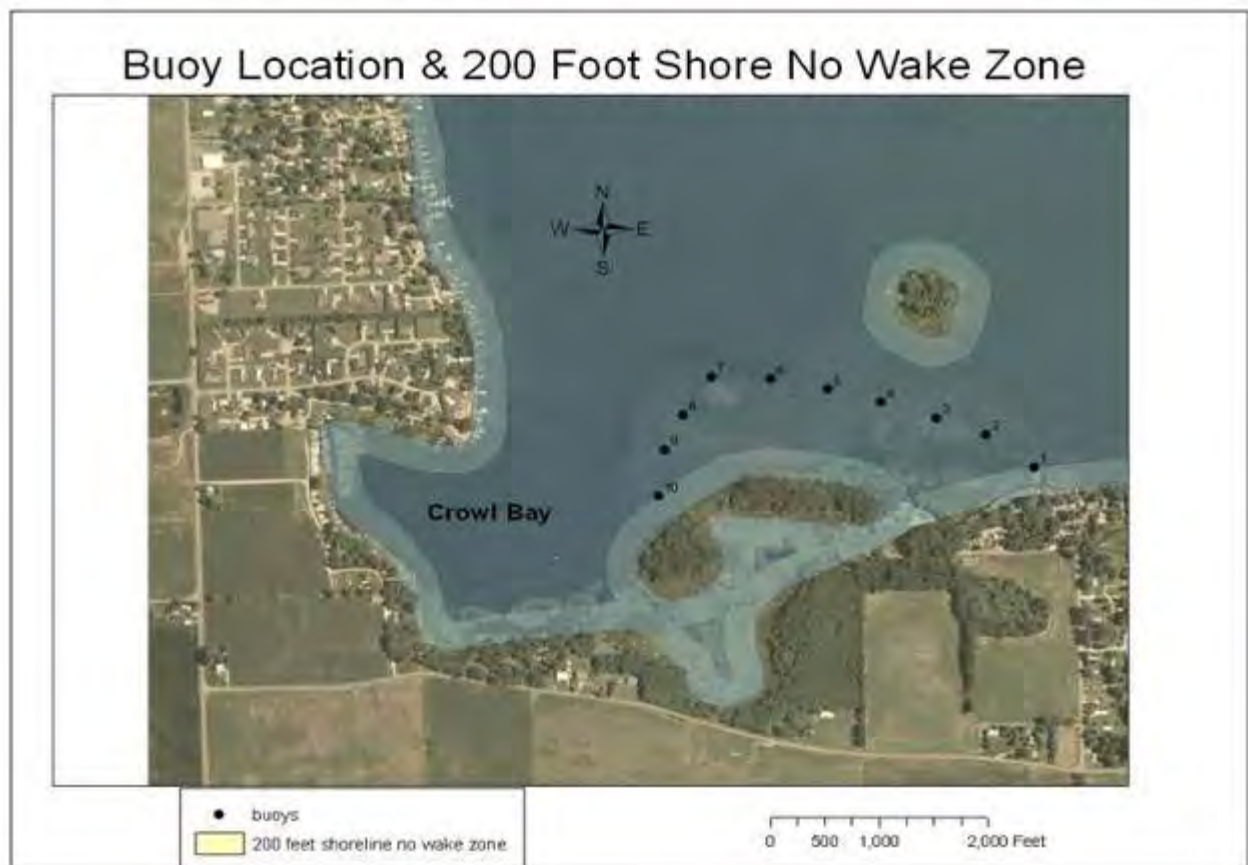
Figure 9: Dewart Lake No-Wake Zone Buoy Placement (DLPA, Online Posting)

In 2007, a no wake zone was established in the southwest corner of Dewart Lake. This no wake zone was established to protect shallow water emergent vegetation and the organisms that depend upon this vegetation for survival. In recent years, wave action and turbulence caused by boating activities has had a detrimental effect on plant beds along the south shore of the lake. Of special concern are off shore beds, primarily composed of hard-stem bulrush (*Scirpus acutus*) and cattails (*Typha sp.*). Ten no wake zone buoys were supplied by the IDNR and placed around these shallow water emergent plant beds to protect the beds while minimally restricting normal lanes of boat travel (DLPA, Online Posting). The following map is copied directly from the Dewart Lake Protective Association's website and identifies the locations of the buoys indicating the Dewart Lake No-Wake Zone. Although an ecozone has not officially been established, this figure shows the area where an ecozone may be established in the future.

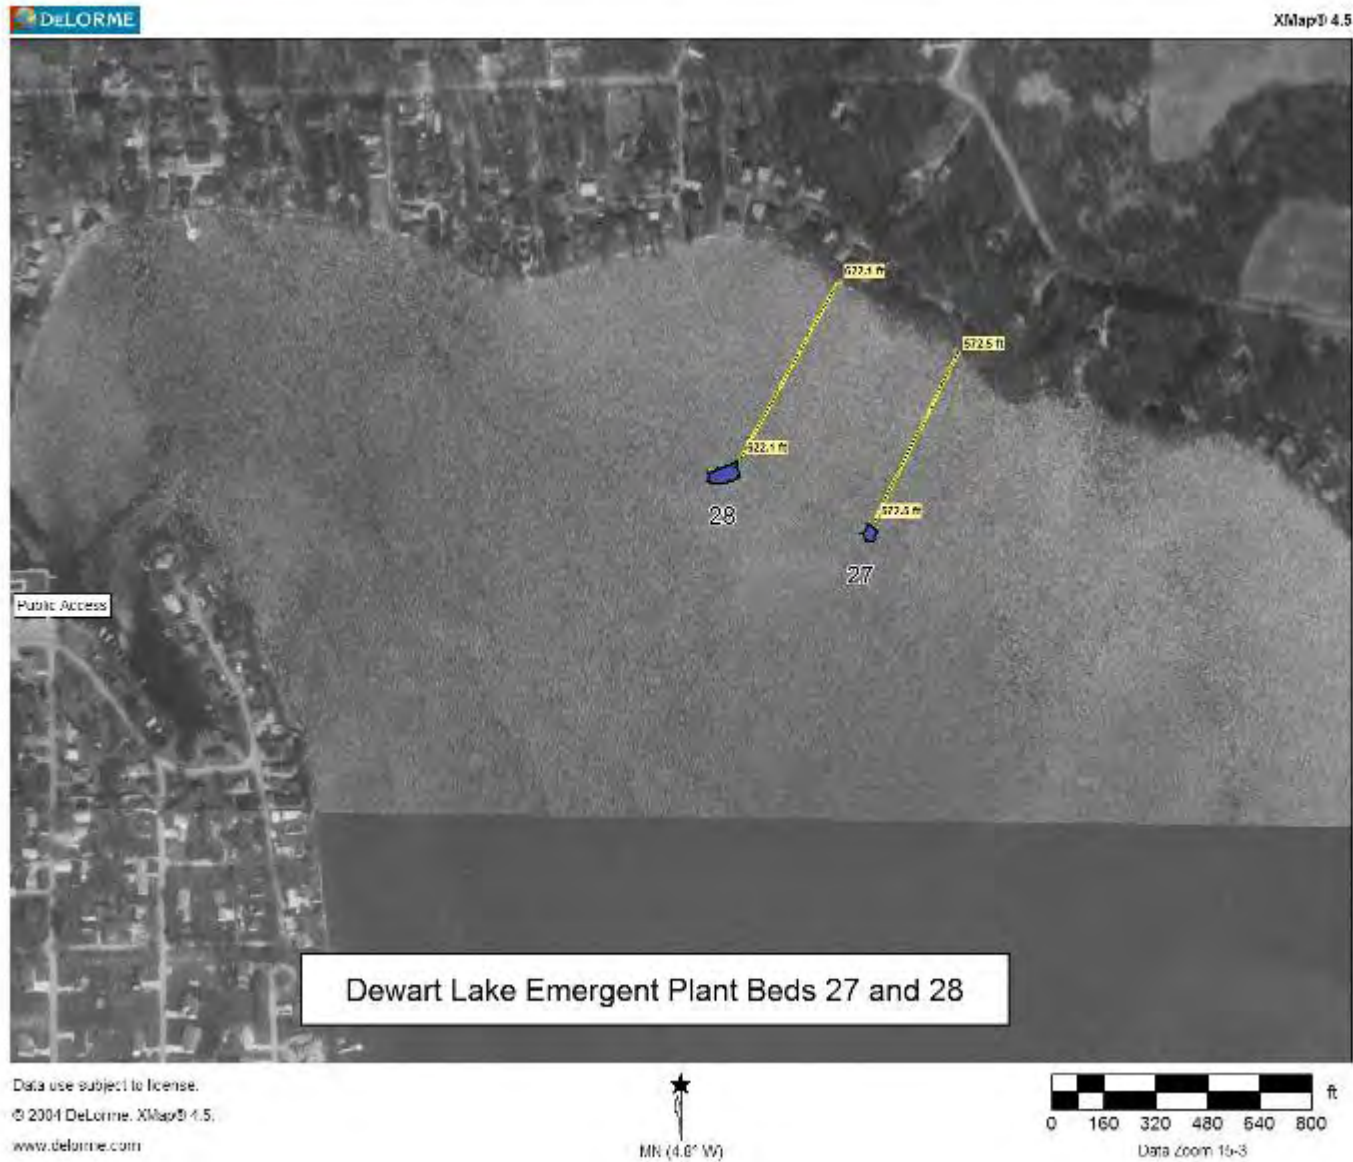
Figure 11: Emergent Beds 27 and 28

Note that beds 27 and 28 are absent from Figure 10. These are two small offshore bulrush beds in the northwest section of the lake. For readability purposes, these two beds are omitted from this figure to achieve greater zoom and more detail for the Dewart Lake proposed ecozone area. Beds 27 and 28 are described in Figure 11.

Description: Bed 27 is not located in the ecozone at the south end of the lake. It does not appear in Figure 10. It is one of two small bulrush stands in the northwest quarter of the lake. This small bed is approximately 186 yards from shore at the closest point.

Description: Bed 28 is also located in the northwest quarter of Dewart Lake. This small stand of bulrushes is approximately 215 yards from shore at the closest point. Even though this bed is not big, it is one of the most dense bulrush beds in Dewart Lake.

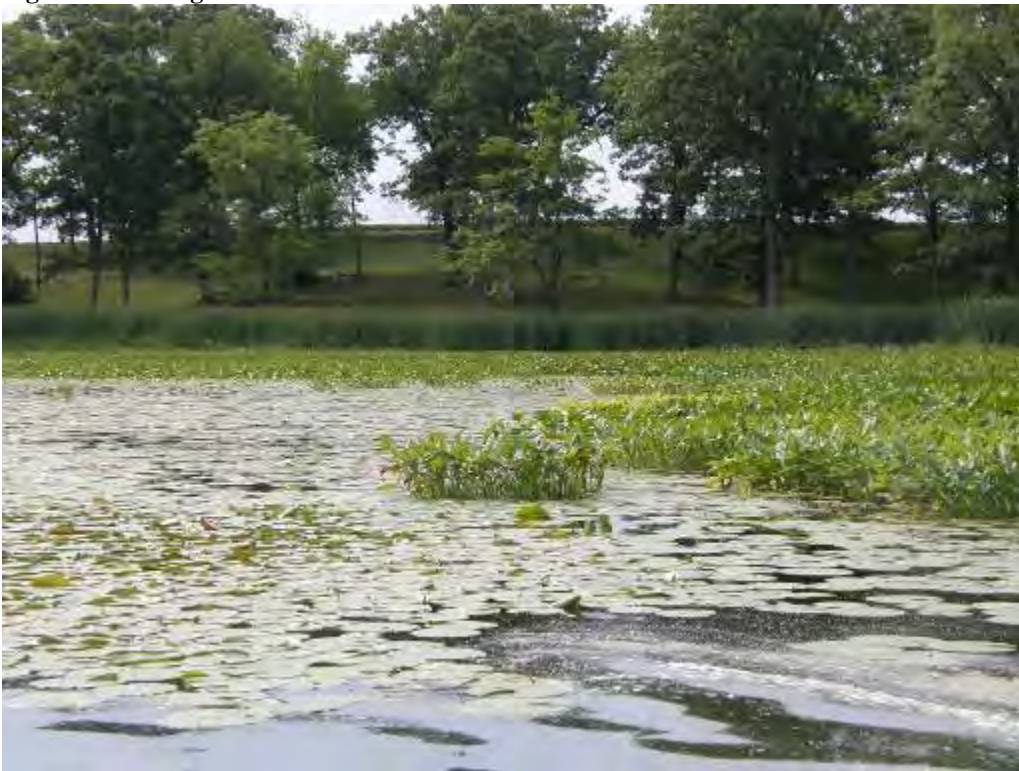
Figure 12: Emergent Bed 1

Description: This plant bed on the south side of Crowl Bay extends approximately 105 yard from shore near its center, while extending only 15 yards from shore at its west end. White lily is the most common plant in this bed although cattails, arrowhead, arrow arum, water willow and American pondweed are all abundant. The near shore area is dominated by cattails while the lakeward edge is dominated by white lily.

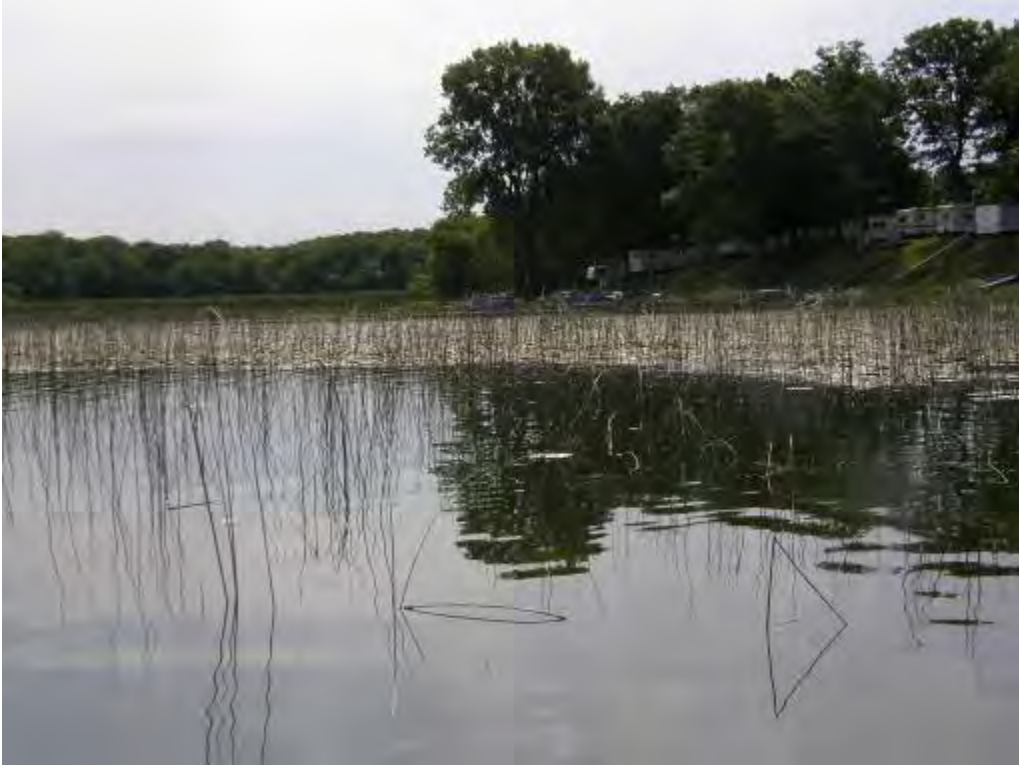
Figure 13: Emergent Bed 2

Description: This bed is adjacent to bed 1 but is dominated by bulrushes. White lilies are still common and are dispersed through the bulrushes. More sparse water willow is also present in this bed. This bed is slightly offshore and extends 95 yards into the lake.

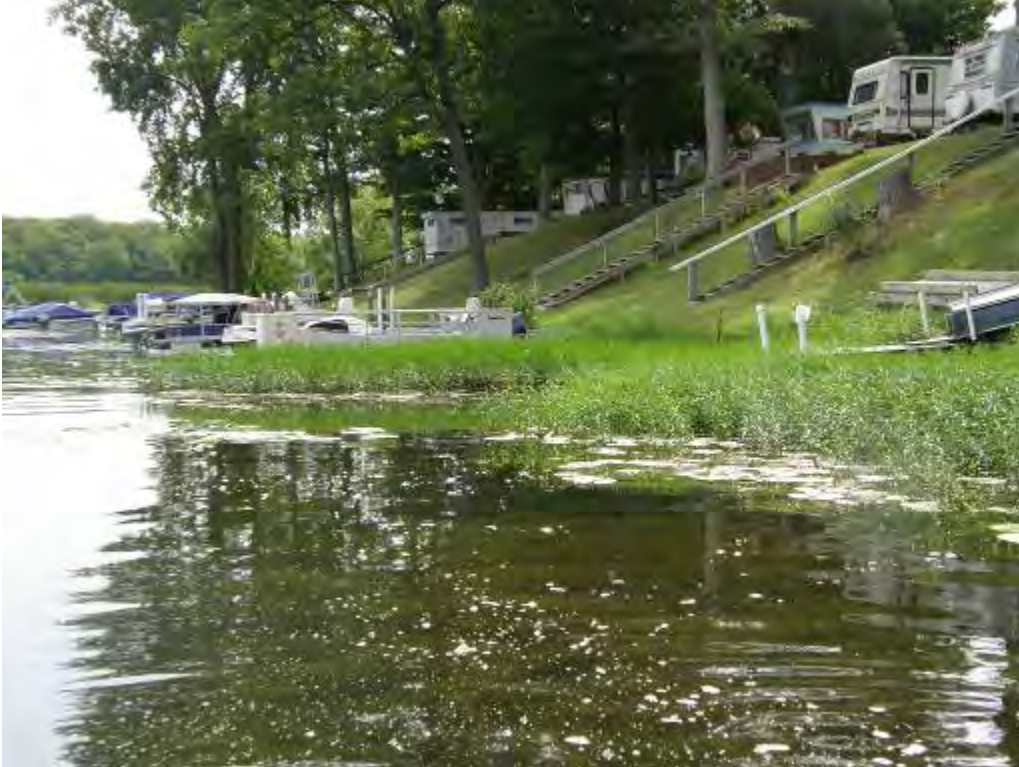
Figure 14: Emergent Bed 3

Description: Bed 3 is a narrow near shore bed along the campground on the south side of the lake. It extends approximately 8 yards into the lake from shore in most spots. Water willow is dominant although white lilies are common as well.

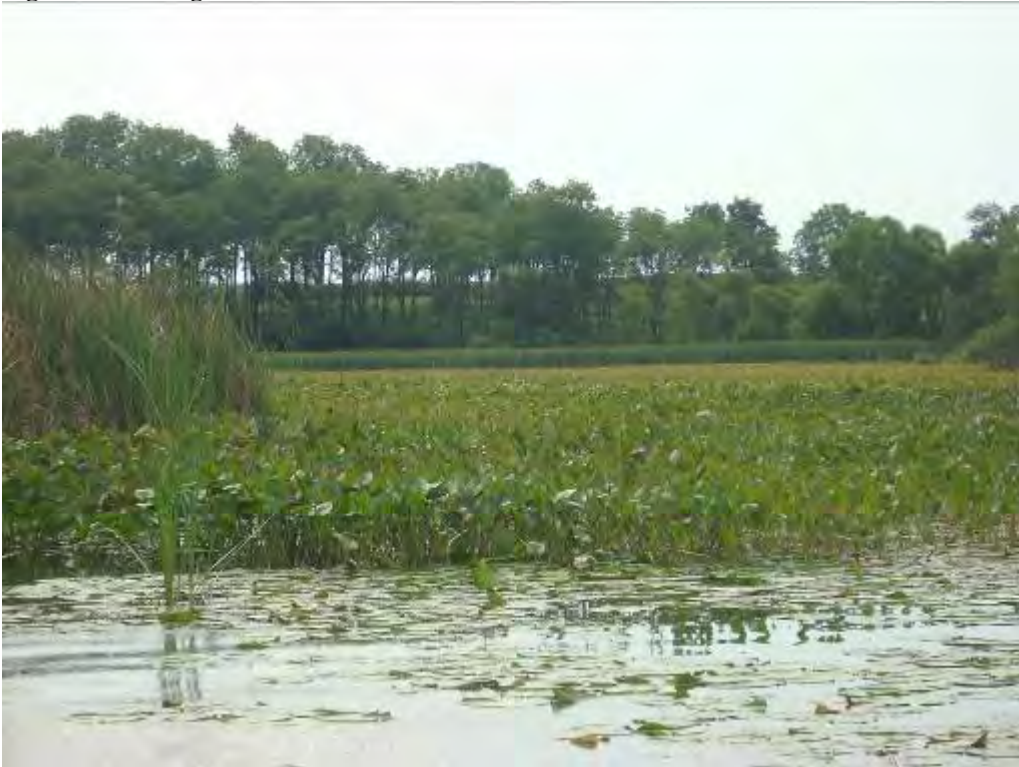
Figure 15: Emergent Bed 4

Description: This is by far the largest emergent plant bed on Dewart Lake. Much of this bed cannot be mapped with a boat since it is not navigable. The range from the lakeward edge to the trees in the background of the picture was 890 yards. Spatterdock appears dominant although cattails are very abundant around the shoreline of this bed. Pickerel weed, white lily, and American pondweed are all abundant. This large emergent bed should be protected if at all possible. Back corners of this bed were mapped using GIS software because vegetation inhibited the use of the rangefinder in many areas. Aerial photos from Delorme X-Map were used to map this bed. The photos were taken in 2003 during the growing season (leaf-on).

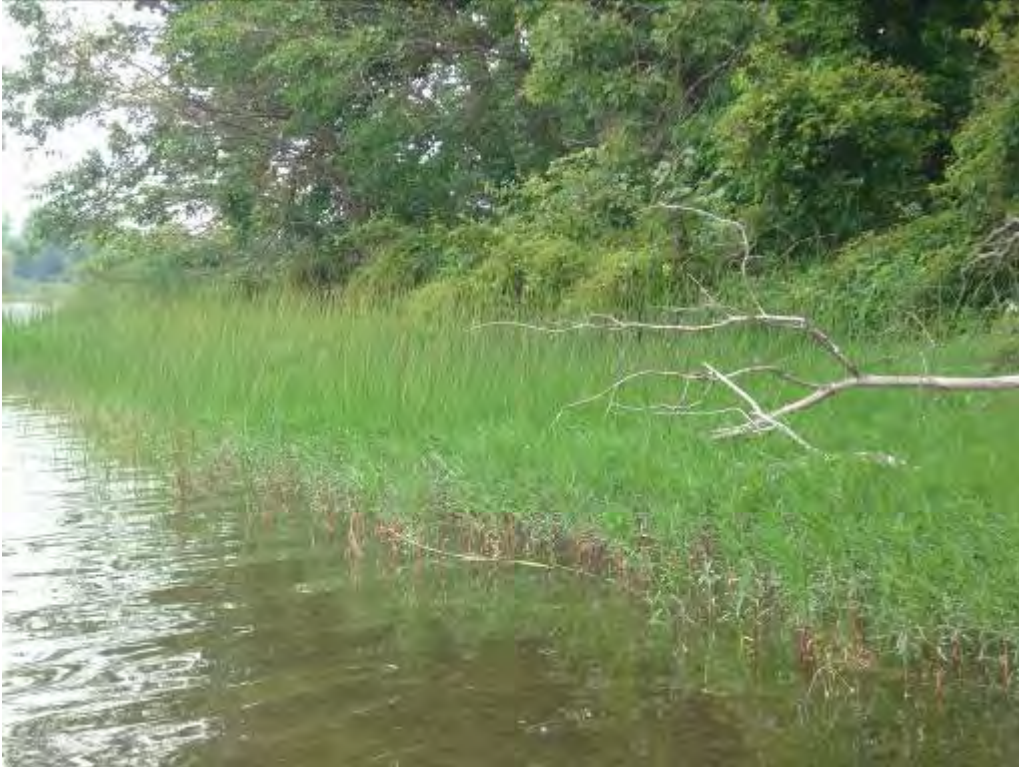
Figure 16: Emergent Bed 5

Description: Bed 5 is a narrow band of water willow and bulrushes. It is located along the peninsula on the south shore of the ecozone. Most of this bed extends 5 to 6 yards into the lake.

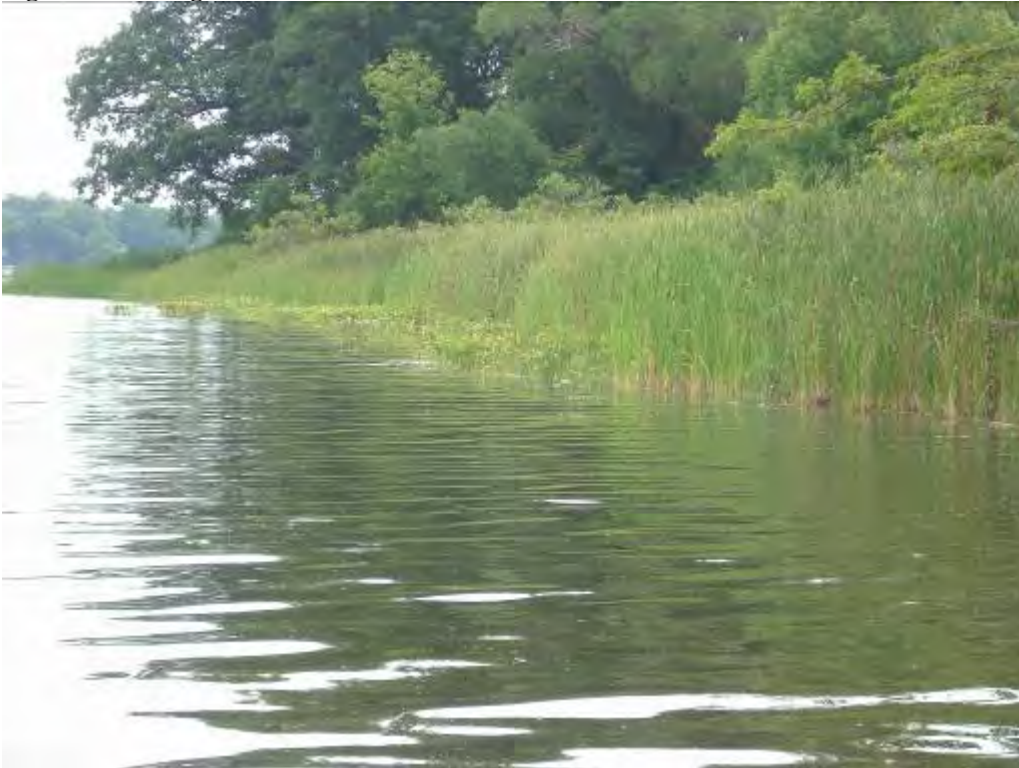
Figure 17: Emergent Bed 6

Description: This bed is adjacent to bed 5 but differs significantly in species composition. Cattails become dominant in this area along the peninsula on the south side of the ecozone. Cattails are dominant throughout the bed, and arrowhead and water willow are common on the lakeward edge of the bed.

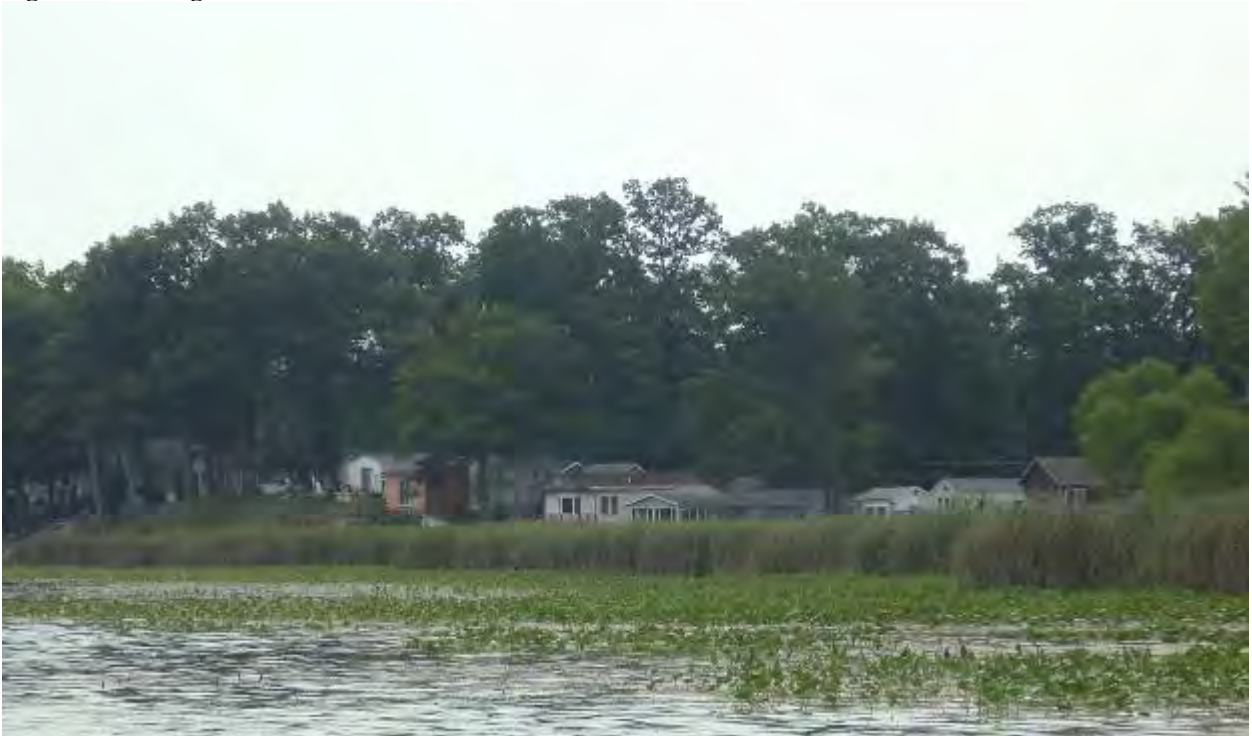
Figure 18: Emergent Bed 7

Description: Bed 7 is similar to bed 6 in the fact that cattails are dominant near shore. However this bed is much wider than bed 6 and has much more vegetation on the lakeward edge of the cattails. This bed extends as much as 68 yards from shore. White lilies, spatterdock, arrowhead and water willow are all abundant in this bed.

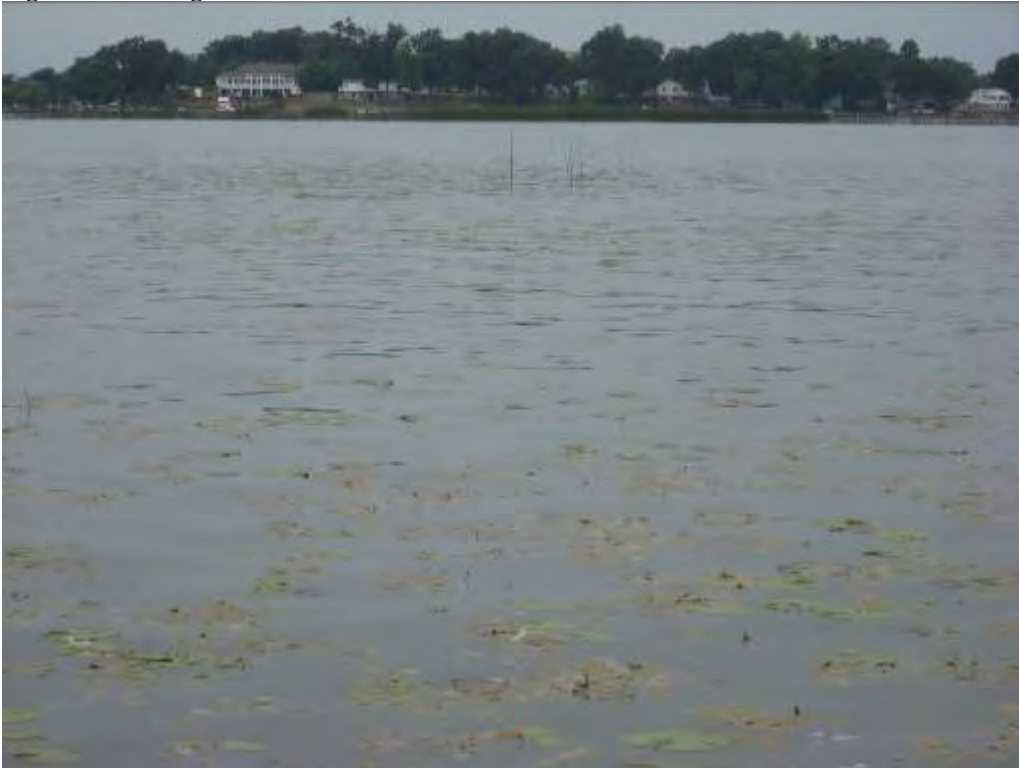
Figure 19: Emergent Bed 8

Description: Bed 8 is composed primarily of floating leaved plants although some bulrushes are present as well. American pondweed is the most dominant plant in the bed, and white lilies are common as well. This is an offshore bed and is approximately 62 yards wide from east to west.

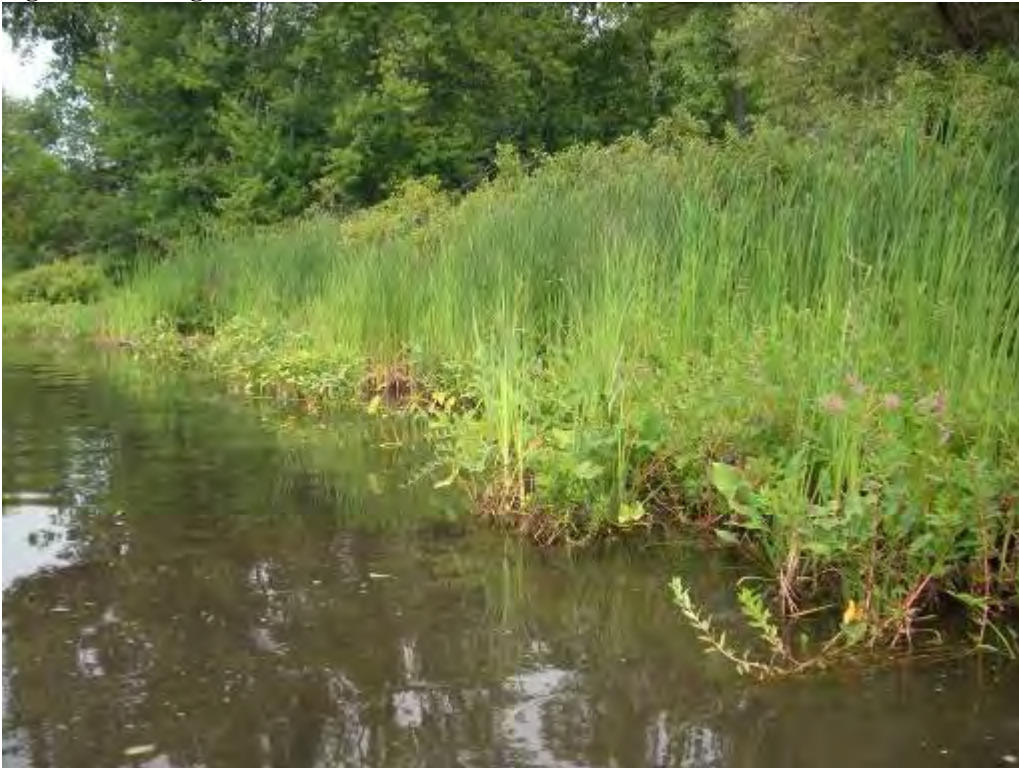
Figure 20: Emergent Bed 9

Description: This bed is located along the south shore of the island in Dewart Lake. Cattails are the dominant species in this bed. Water smartweed was present in this bed, along with arrowhead. Purple loosestrife (an invasive species) was also present in low abundance. This narrow plant bed only extended into the lake 2 to 5 yards from shore.

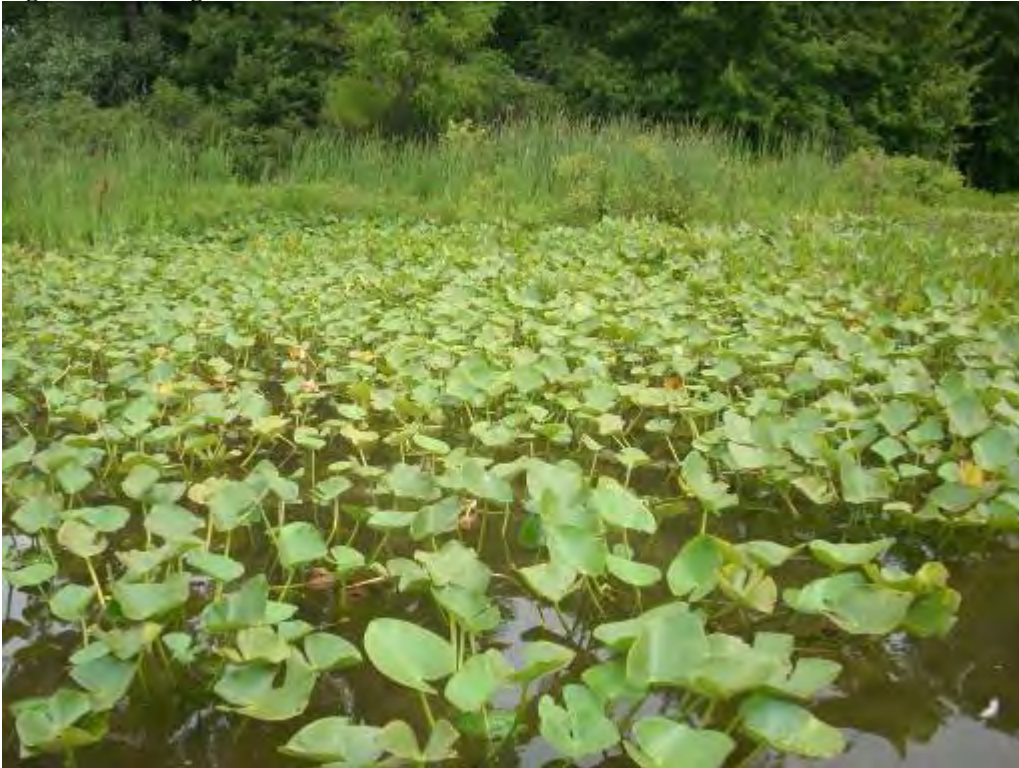
Figure 21: Emergent Bed 10

Description: Bed 10 is also located along the south shore of the island in Dewart Lake. Spatterdock is the dominant species. Six plant species were present in this bed including spatterdock, cattails, arrowhead, pickerel weed, purple loosestrife, and water smartweed. This bed extended 30 yards into the lake from shore at its thickest point.

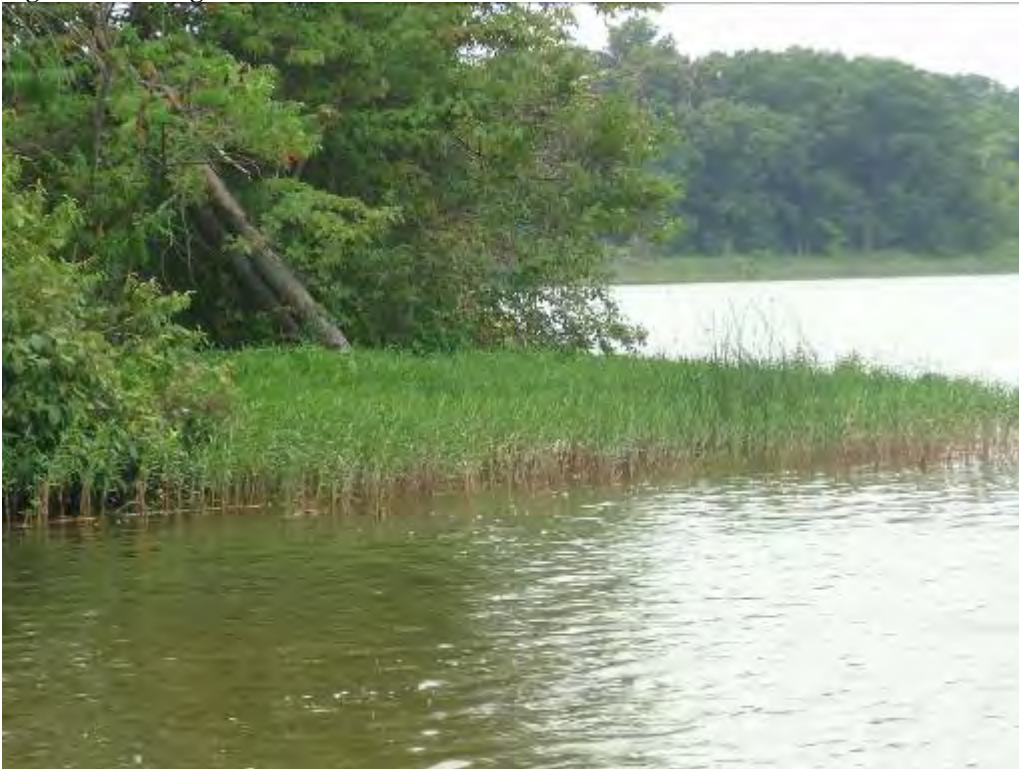
Figure 22: Emergent Bed 11

Description: This emergent bed is located along the west shoreline of the island in Dewart Lake. It is a narrow bed extending approximately 6 yards from shore. Water willow is the dominant species in this bed with some bulrushes being present as well.

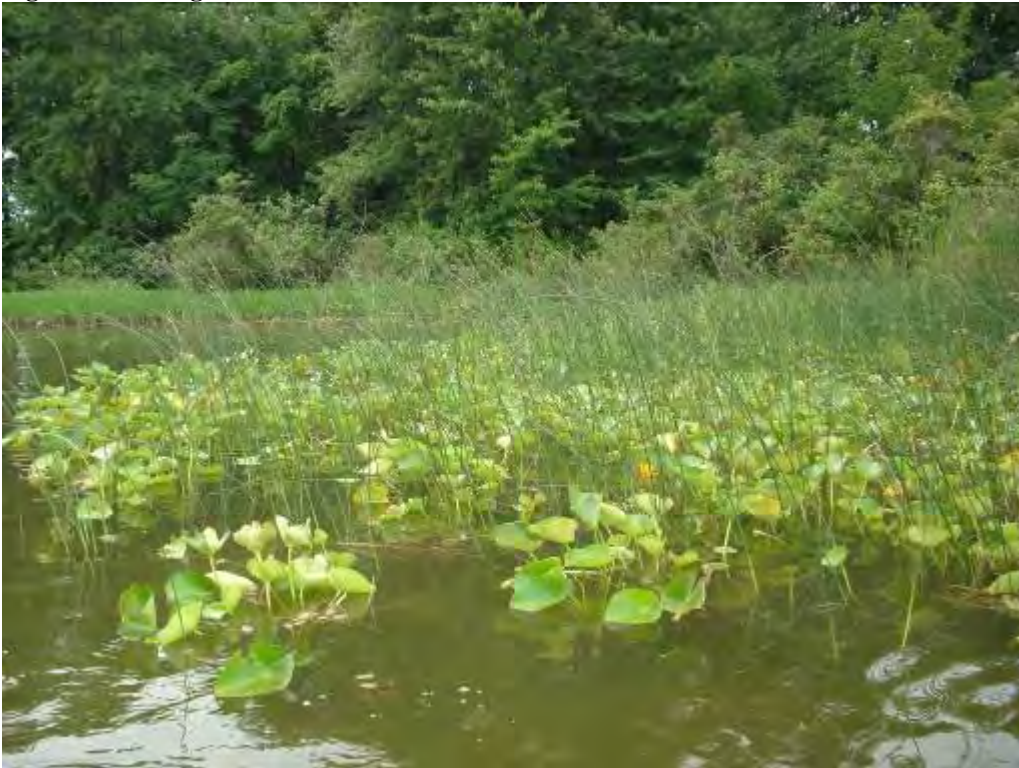
Figure 23: Emergent Bed 12

Description: This bed is located along the north shore of the island in Dewart Lake. At its thickest point, this bed extended approximately 40 yards into the lake. Six plant species were present including white lily, spatterdock, cattail, arrowhead, bulrush, pickerel weed, and purple loosestrife.

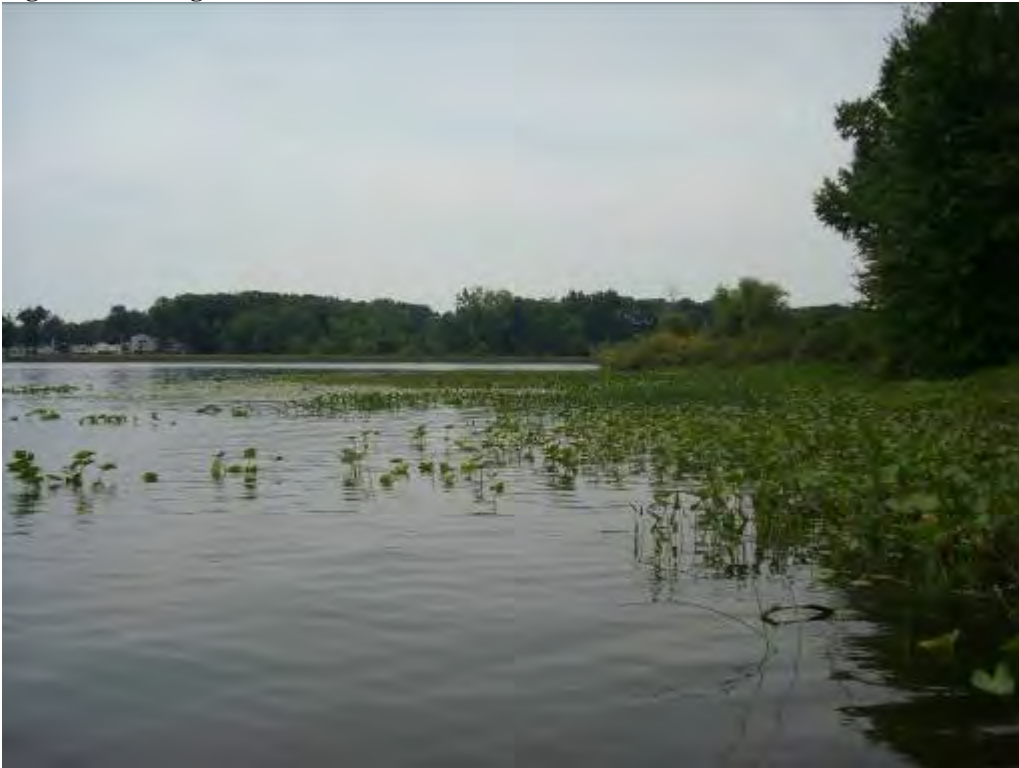
Figure 24: Emergent Bed 13

Description: This bed is located along the east shoreline of the island in Dewart Lake. At its thickest point, this bed extends approximately 44 yards into the lake. Although spatterdock is dominant, white lily, arrow arum, bulrush, and purple loosestrife are also present.
