Dewart Lake Aquatic Vegetation Management Plan 2008 Update

Kosciusko County, Indiana

December 15, 2008

Aquatic Weed Control

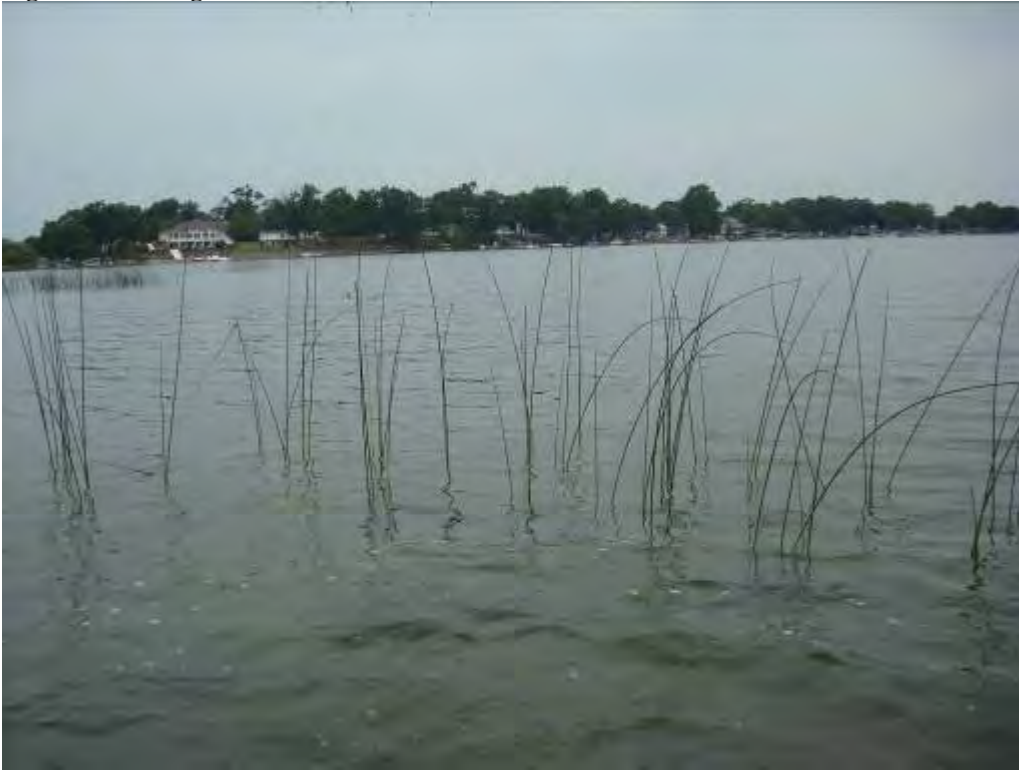
Figure 25: Emergent Bed 14

Description: This is a small, isolated, offshore cluster of hard-stem bulrushes in the ecozone area.

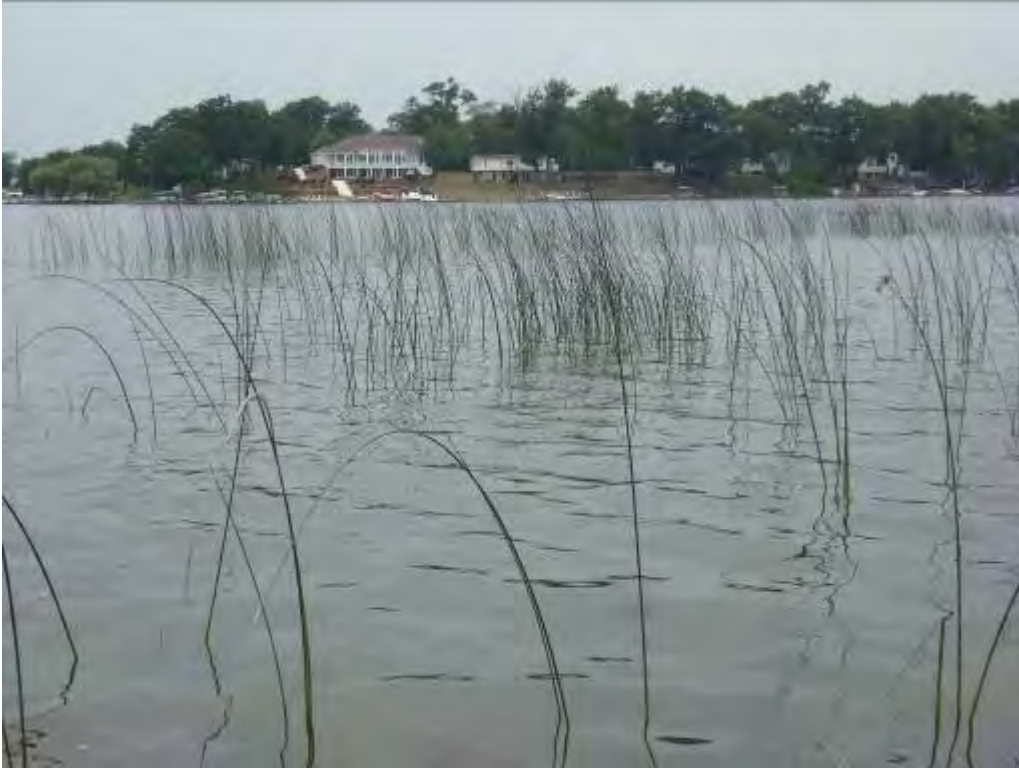
Figure 26: Emergent Bed 15

Description: Bed 15 is another isolated offshore clump of bulrushes in the ecozone.

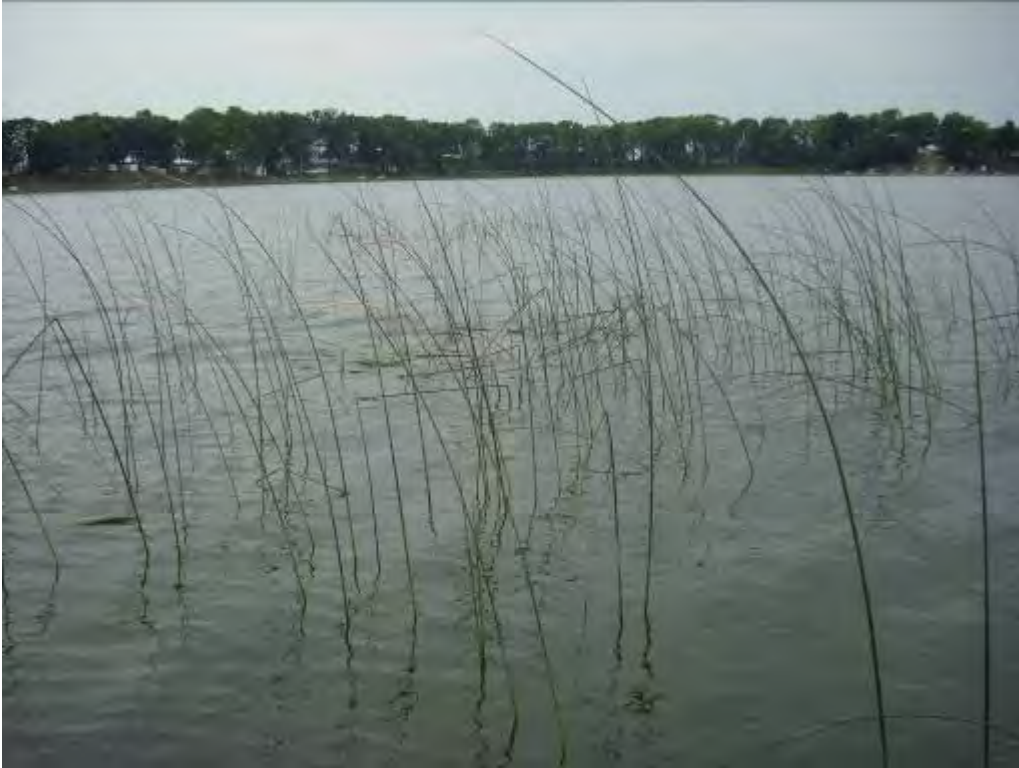
Figure 27: Emergent Bed 16

Description: Bed 16 is an offshore clump of bulrushes in the ecozone.

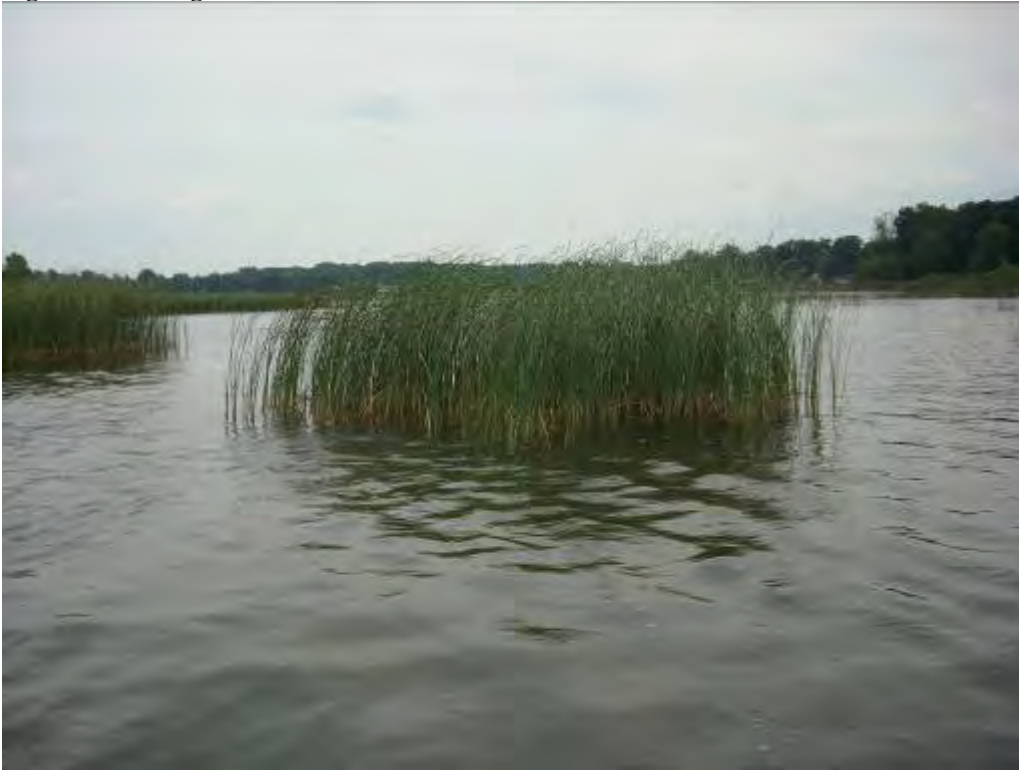
Figure 28: Emergent Bed 17

Description: Bed 17 is an offshore clump of cattails in the ecozone. This clump of cattails is approximately 10 feet by 10 feet and is in the middle of sparse bulrush beds.

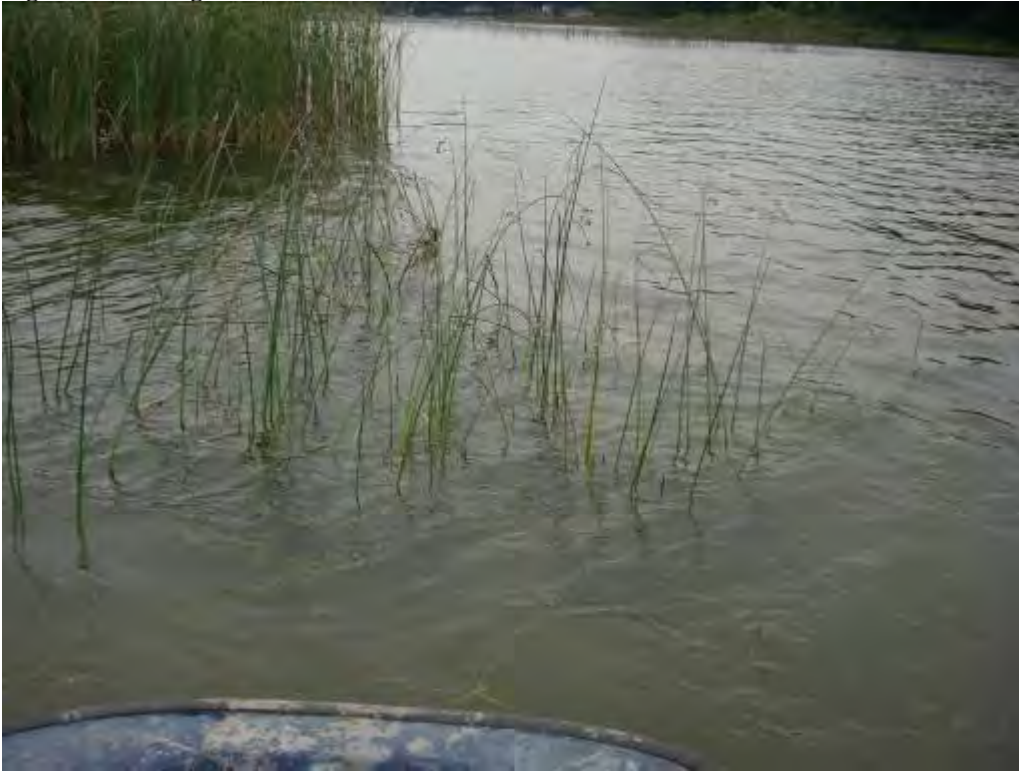
Figure 29: Emergent Bed 18

Description: Bed 18 is a very small offshore stand of bulrushes adjacent to bed 17.

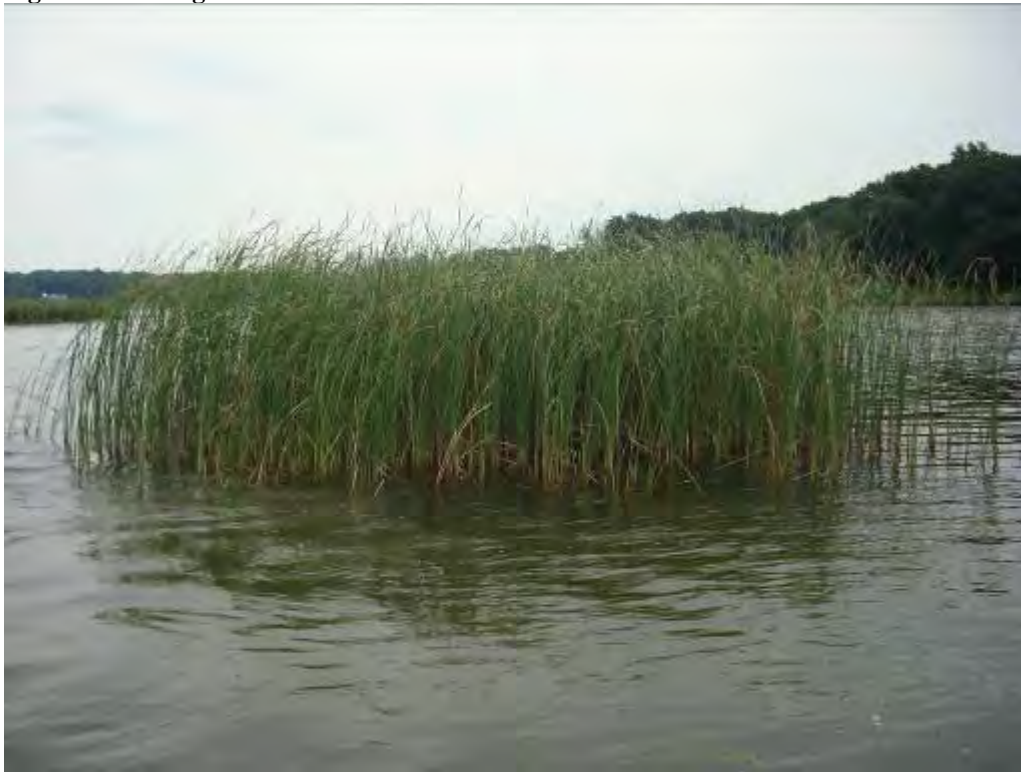
Figure 30: Emergent Bed 19

Description: Bed 19 is another offshore stand of only cattails. It is also located inside the buoyed off ecozone area.

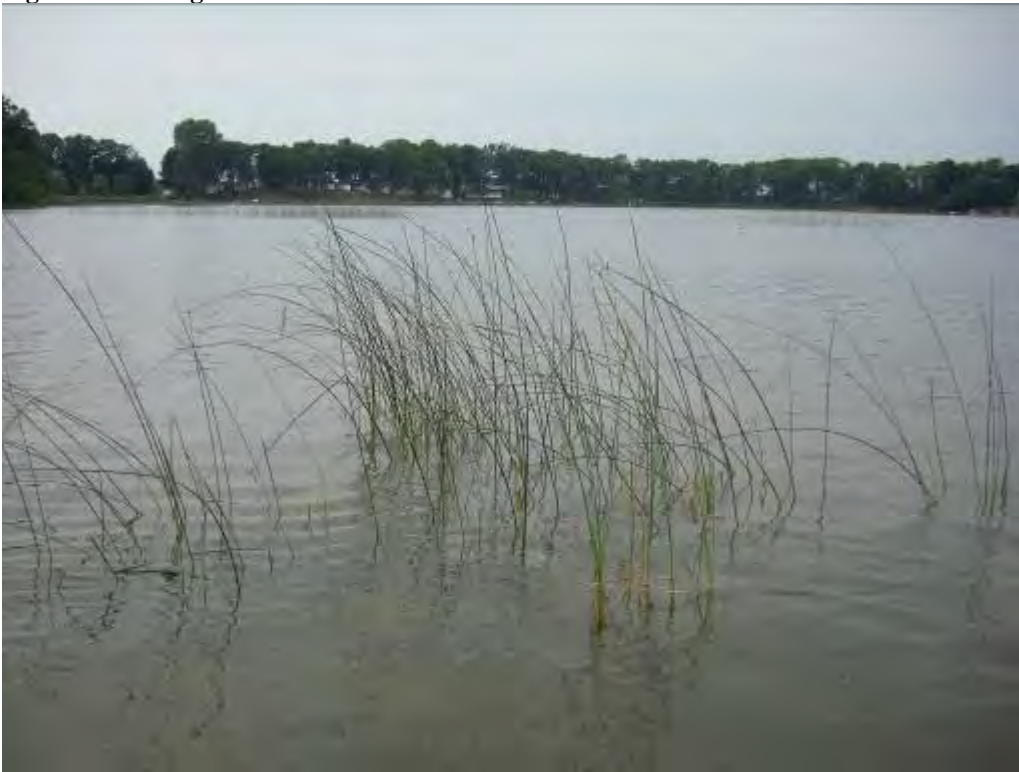
Figure 31: Emergent Bed 20

Description: Bed 20 contains a combination of both bulrushes and cattails, with bulrushes being dominant. This is also an offshore bed in the ecozone.

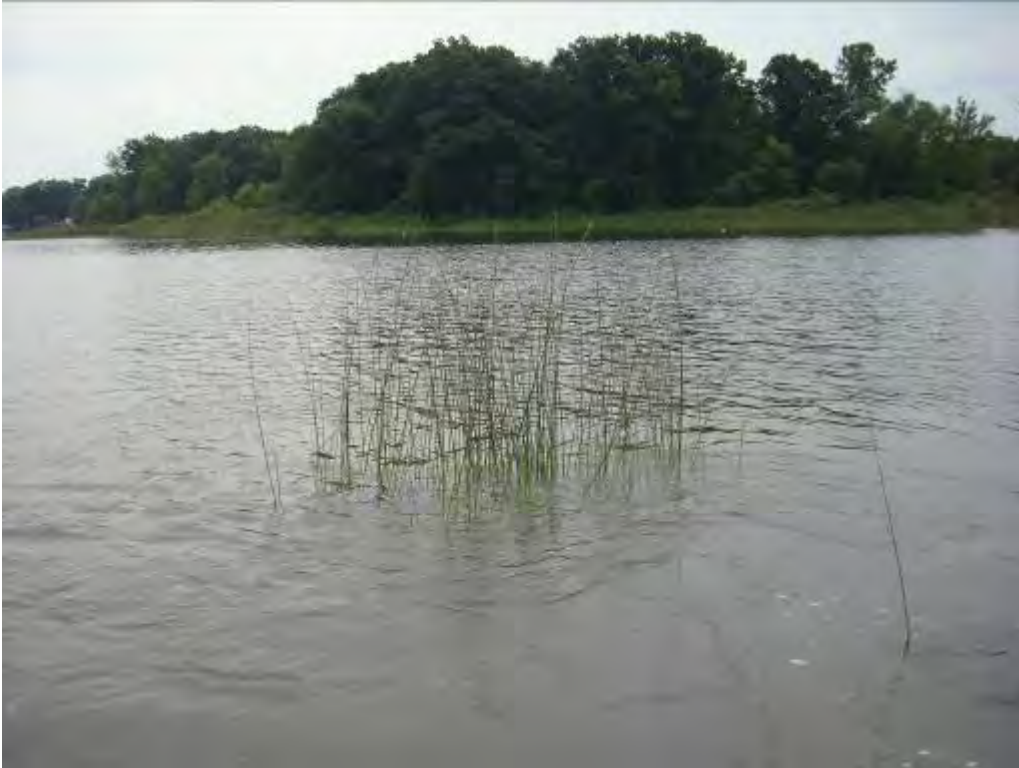
Figure 32: Emergent Bed 21

Description: Bed 21 is another small offshore clump of bulrushes in the ecozone.

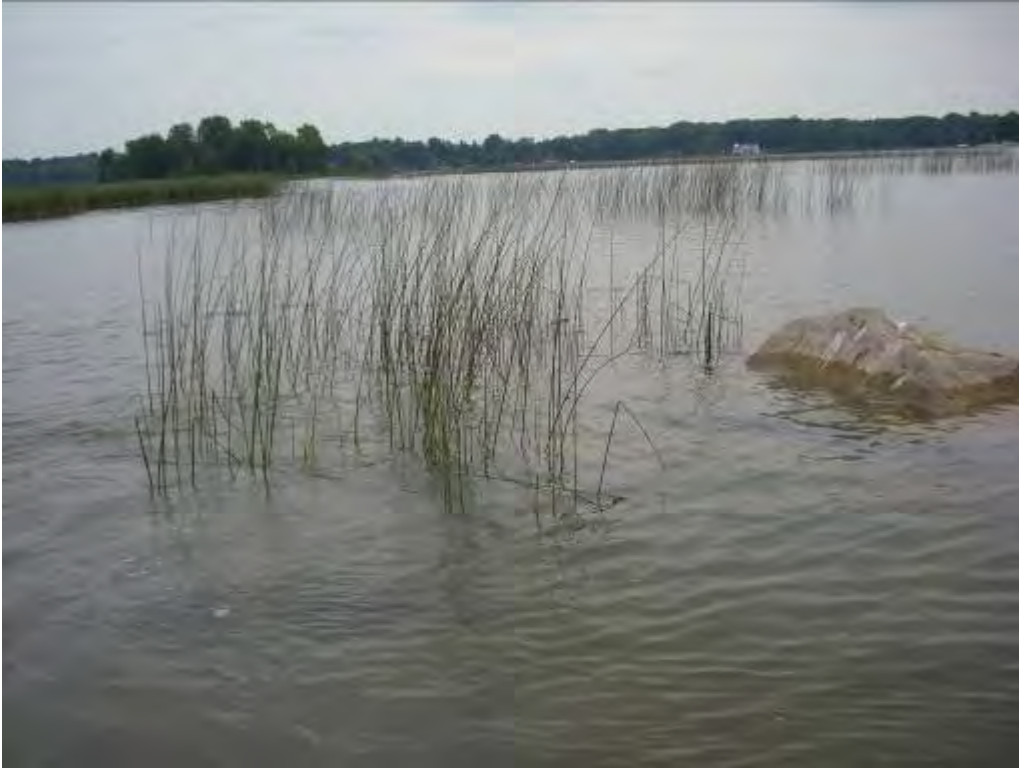
Figure 33: Emergent Bed 22

Description: Bed 22 is another small offshore bed of bulrushes.

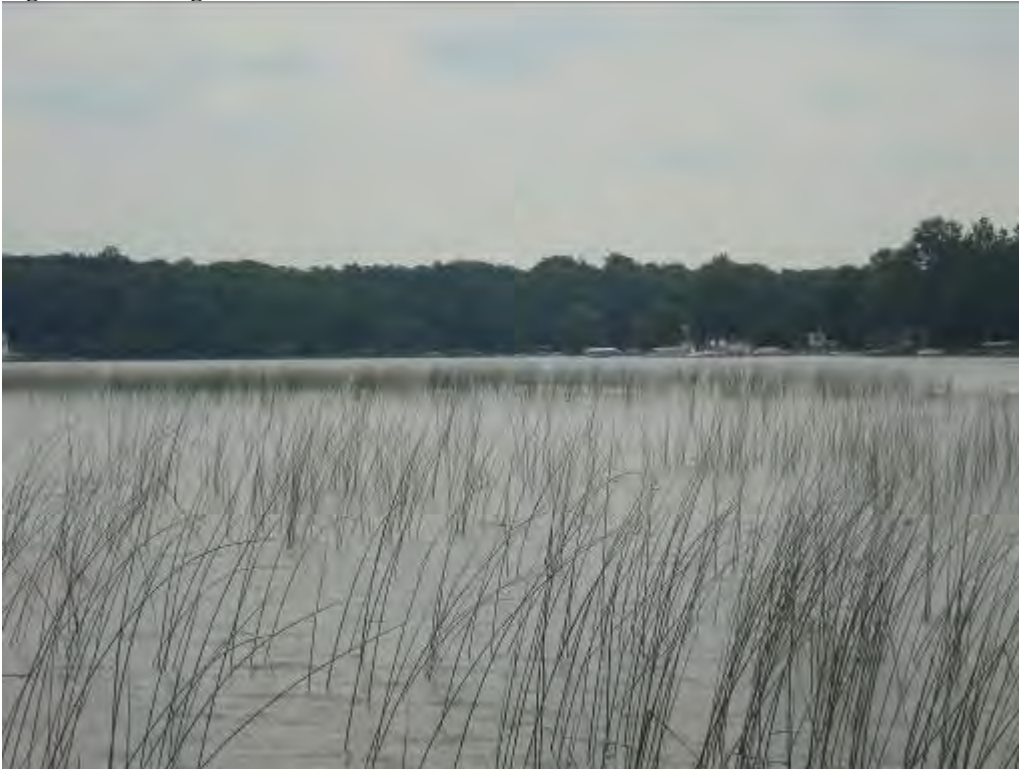
Figure 34: Emergent Bed 23

Description: Bed 23 is by far the largest offshore bulrush bed in the Dewart Lake Ecozone. Even though distribution is sparse, no other emergent plants are found growing throughout the bulrushes in this bed.

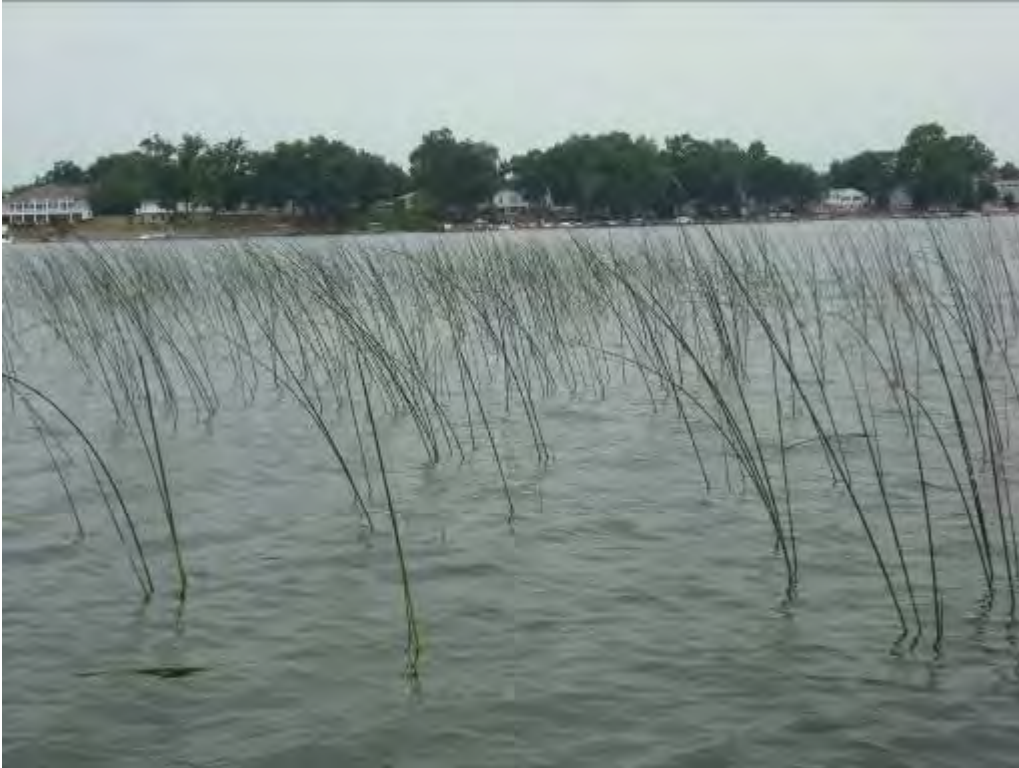
Figure 35: Emergent Bed 24

Description: Bed 24 is another offshore bed of bulrushes in the Dewart Lake Ecozone

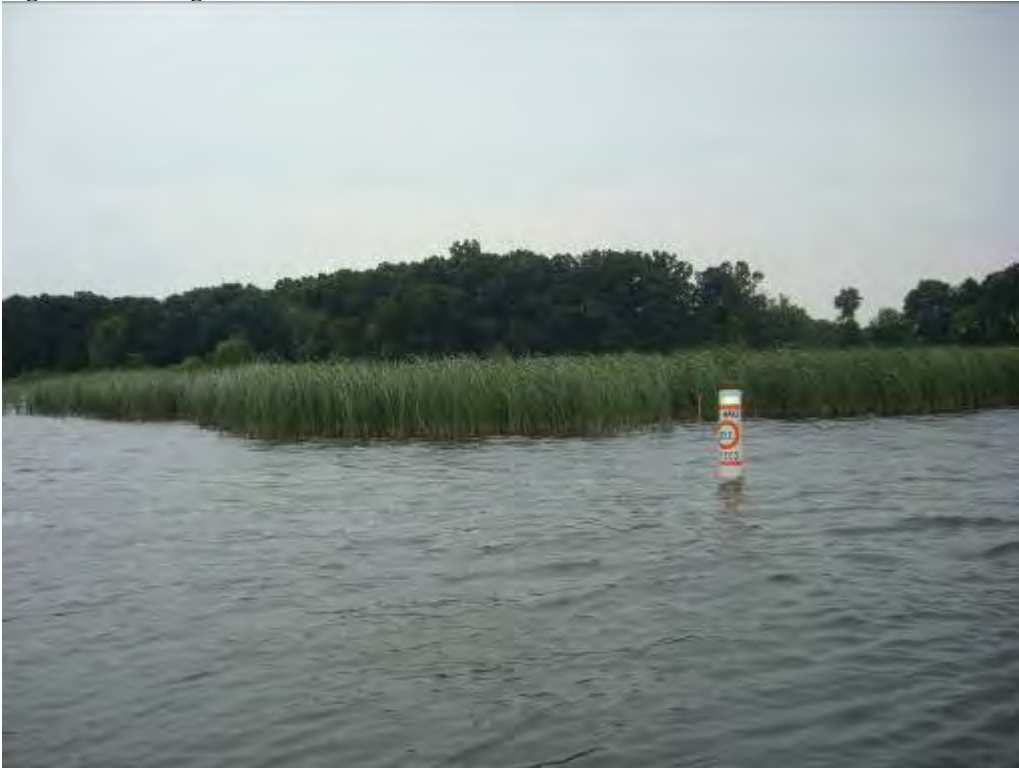
Figure 36: Emergent Bed 25

Description: Bed 25 is the largest offshore stand of cattails in the ecozone area. It is near the north edge of the ecozone. American pondweed is also present around the outer edges of this plant bed. This is a very dense stand, with no bulrushes found within the cattails.

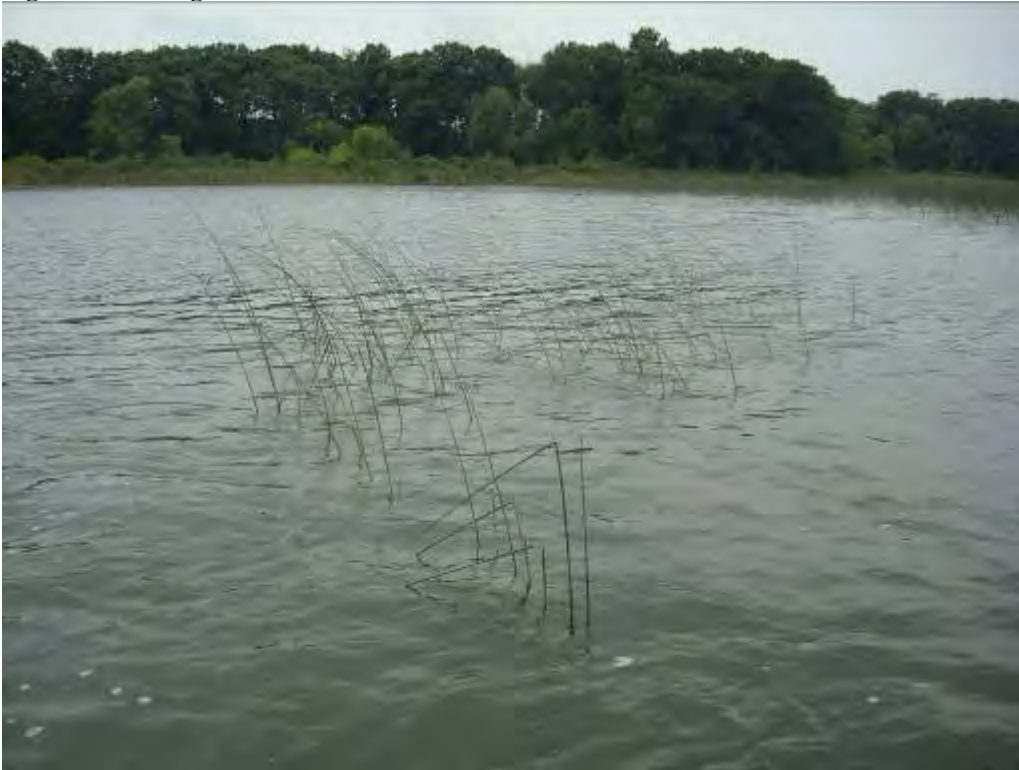
Figure 37: Emergent Bed 26

Description: This is another small offshore stand of bulrushes in the ecozone area. It is approximately 10 feet by 10 feet.

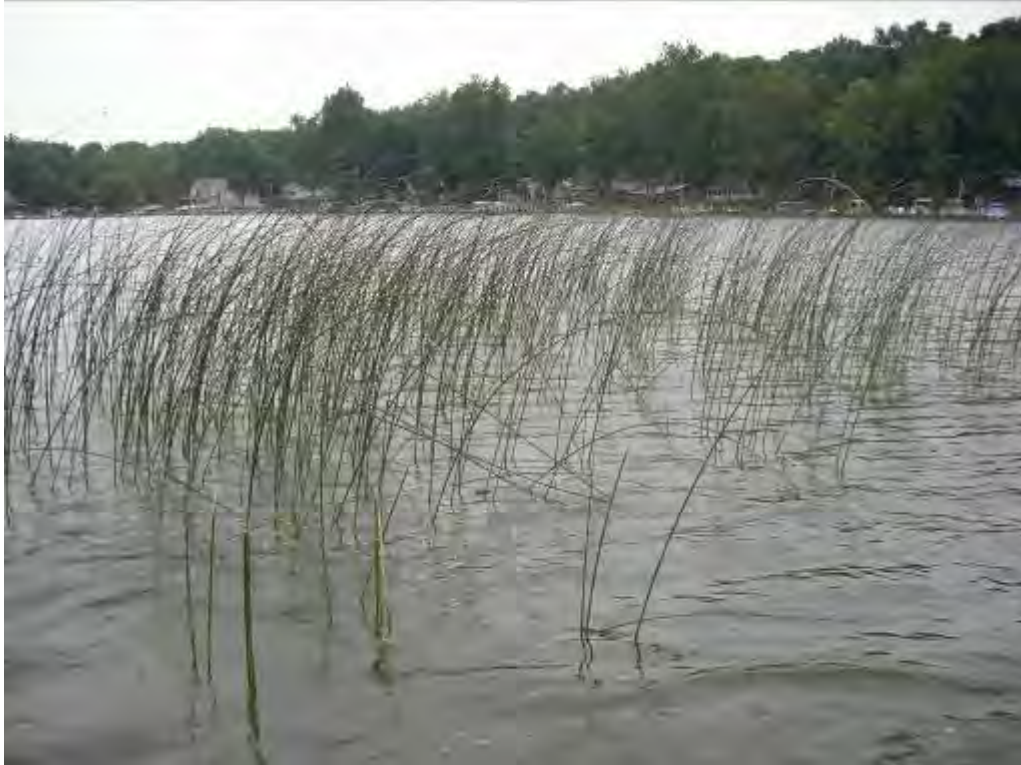
Figure 38: Emergent Bed 27

Description: Bed 27 is not located in the ecozone at the south end of the lake. It does not appear in Figure 10. It is one of two small bulrush stands in the northwest quarter of the lake. This small bed is approximately 186 yards from shore at the closest point.

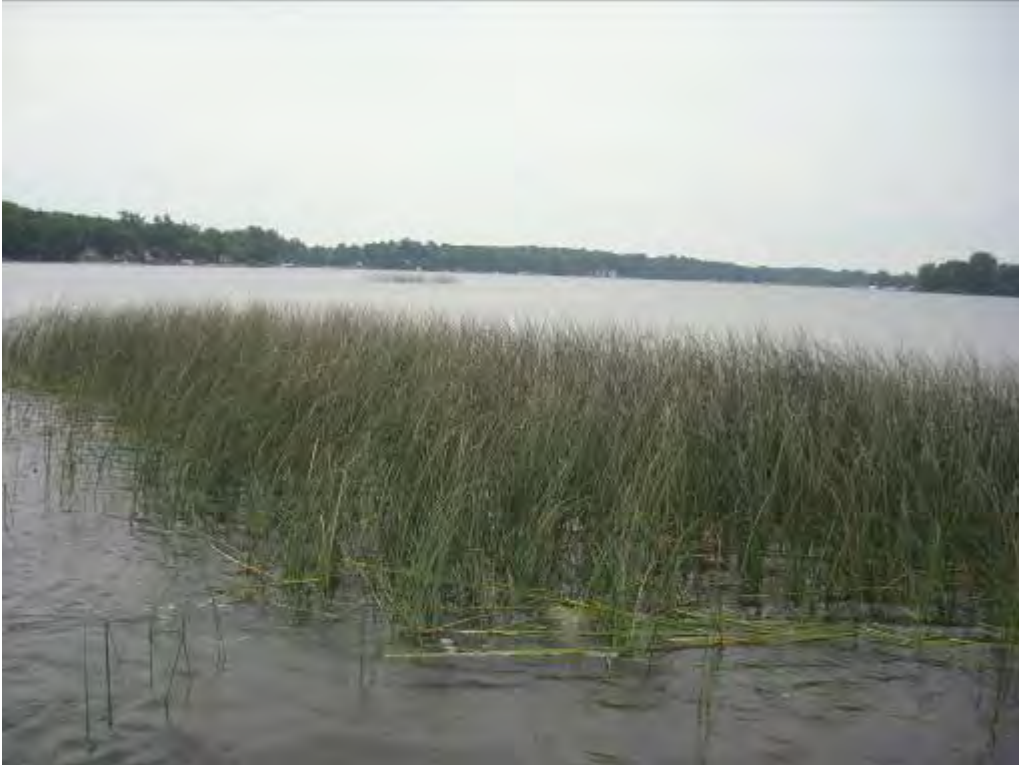
Figure 39: Emergent Bed 28

Description: Bed 28 is also located in the northwest quarter of Dewart Lake. This small stand of bulrushes is approximately 215 yards from shore at the closest point. Even though this bed is not big, it is one of the most dense bulrush beds in Dewart Lake.
