National Register of Historic Places Registration Form

historic name Chenoweth-Coulter Farm

**Chenoweth-Coulter Farm
Huntington County, Indiana**

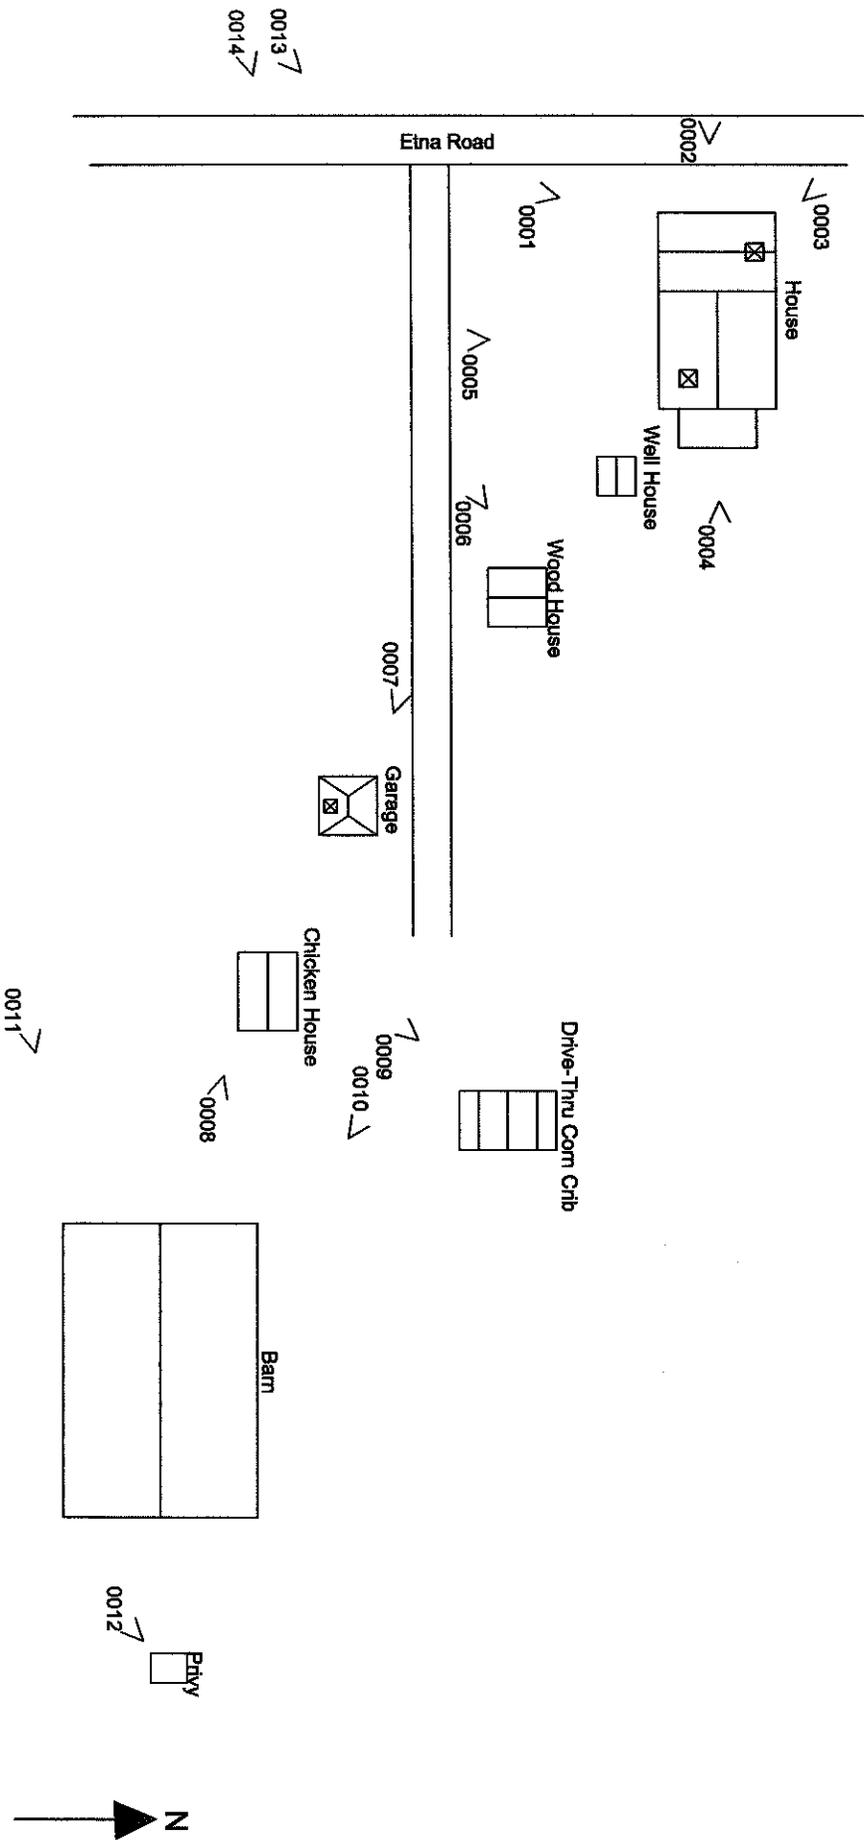
Site & Photo Map

Not to Scale

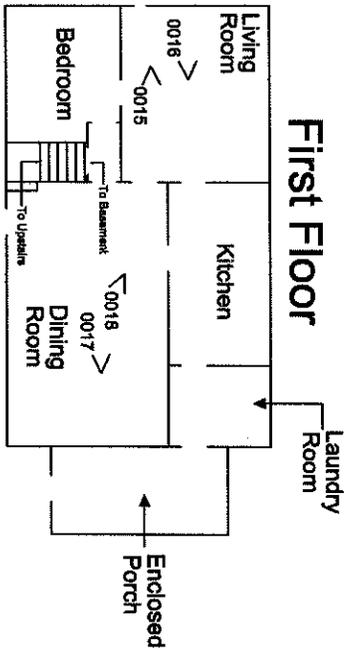
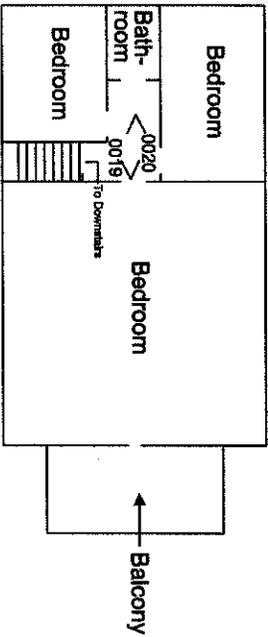
Interior Layout & Photo Map

Second Floor

Please note that this layout is intended only to show the room layout of the Chenoweth-Coulter Farm house. It is not to scale, and does not contain details such as window placement, closet placement, fireplaces, or other built-in features.
