Sherlock Holmes & the Watershed

Or, How We
Discovered Our
Own Backyard

**The Case:
Find out what's
up in the
Orchard Creek
watershed.**

Orchard Creek, Morgan County, IN

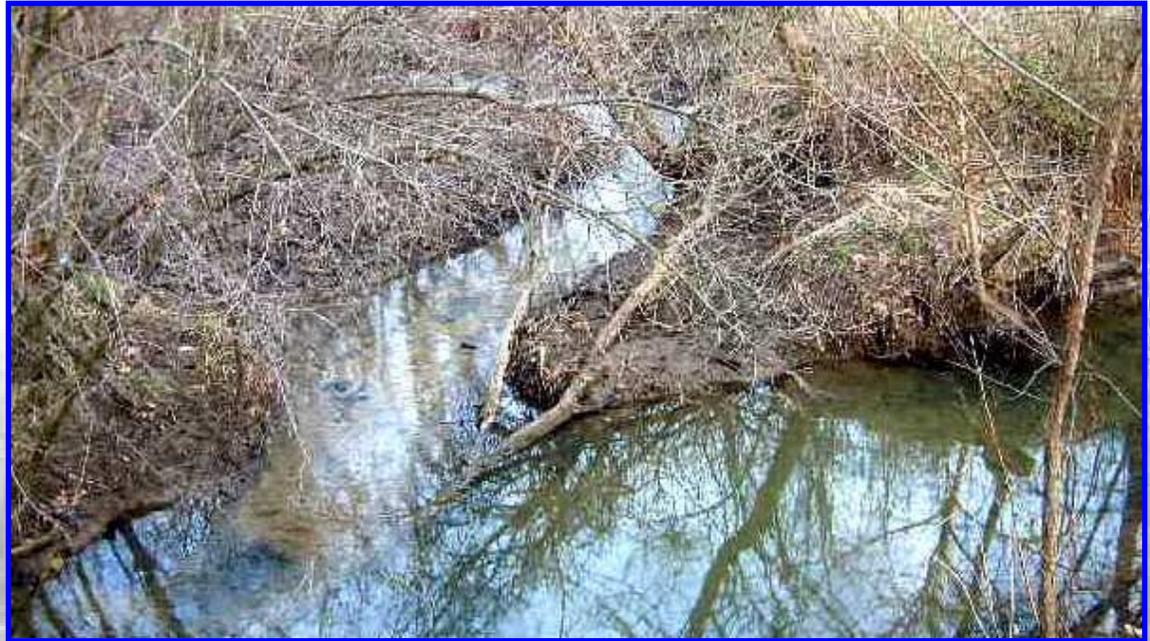
05120201-150-170

8548 Acres

13.36 square miles

3.25% of the total county area

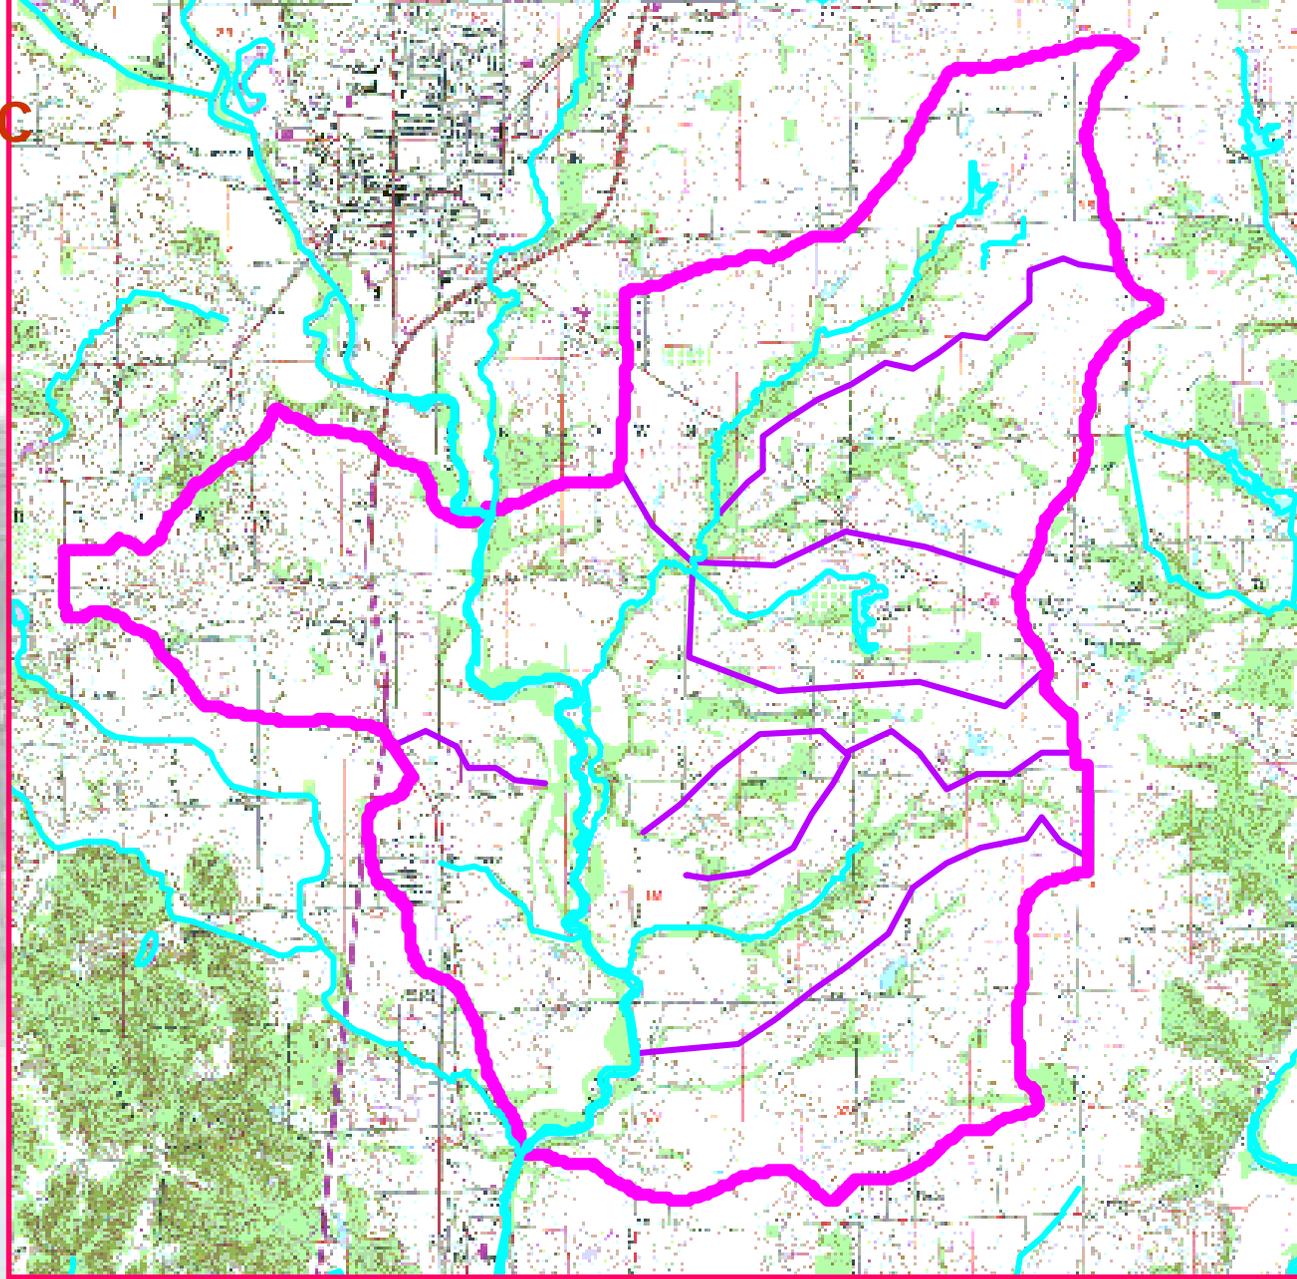
Major streams and
all 51 ponds.

White Lick Creek
[in red] is listed
as impaired for
Hg, PCBs [FCA].
Turbid appearance
and large sand and
silt deposits
indicate nutrient
and sediment
problems as well.

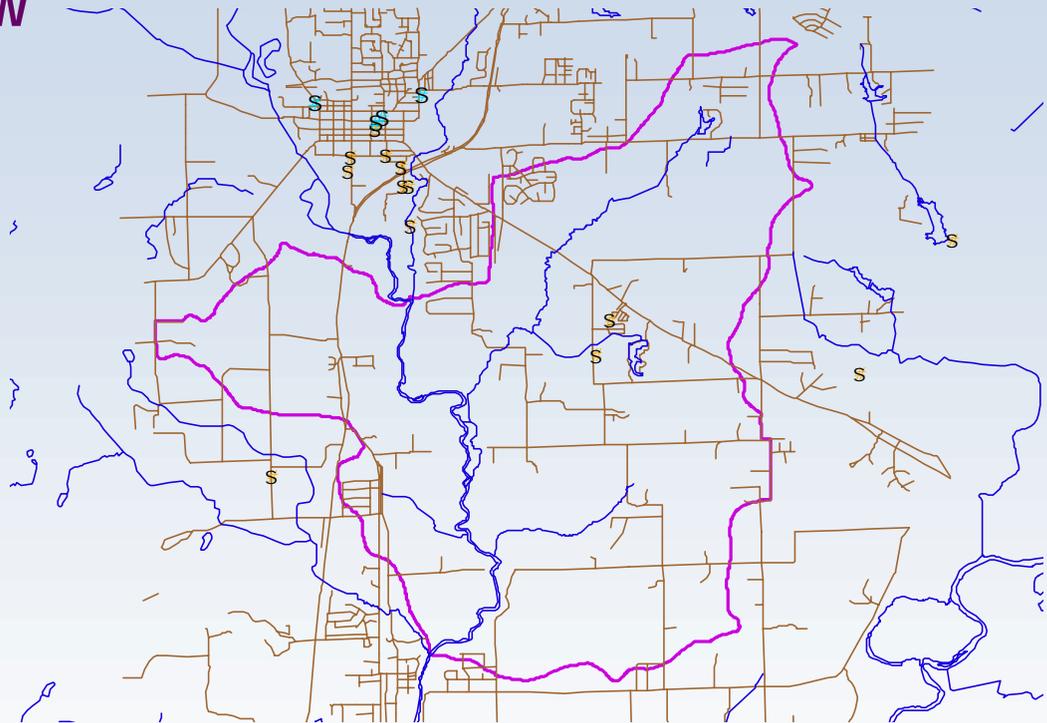
Point Sources

There are only a few NPDES sites in the WS.

However, upstream sites could affect White Lick Creek.

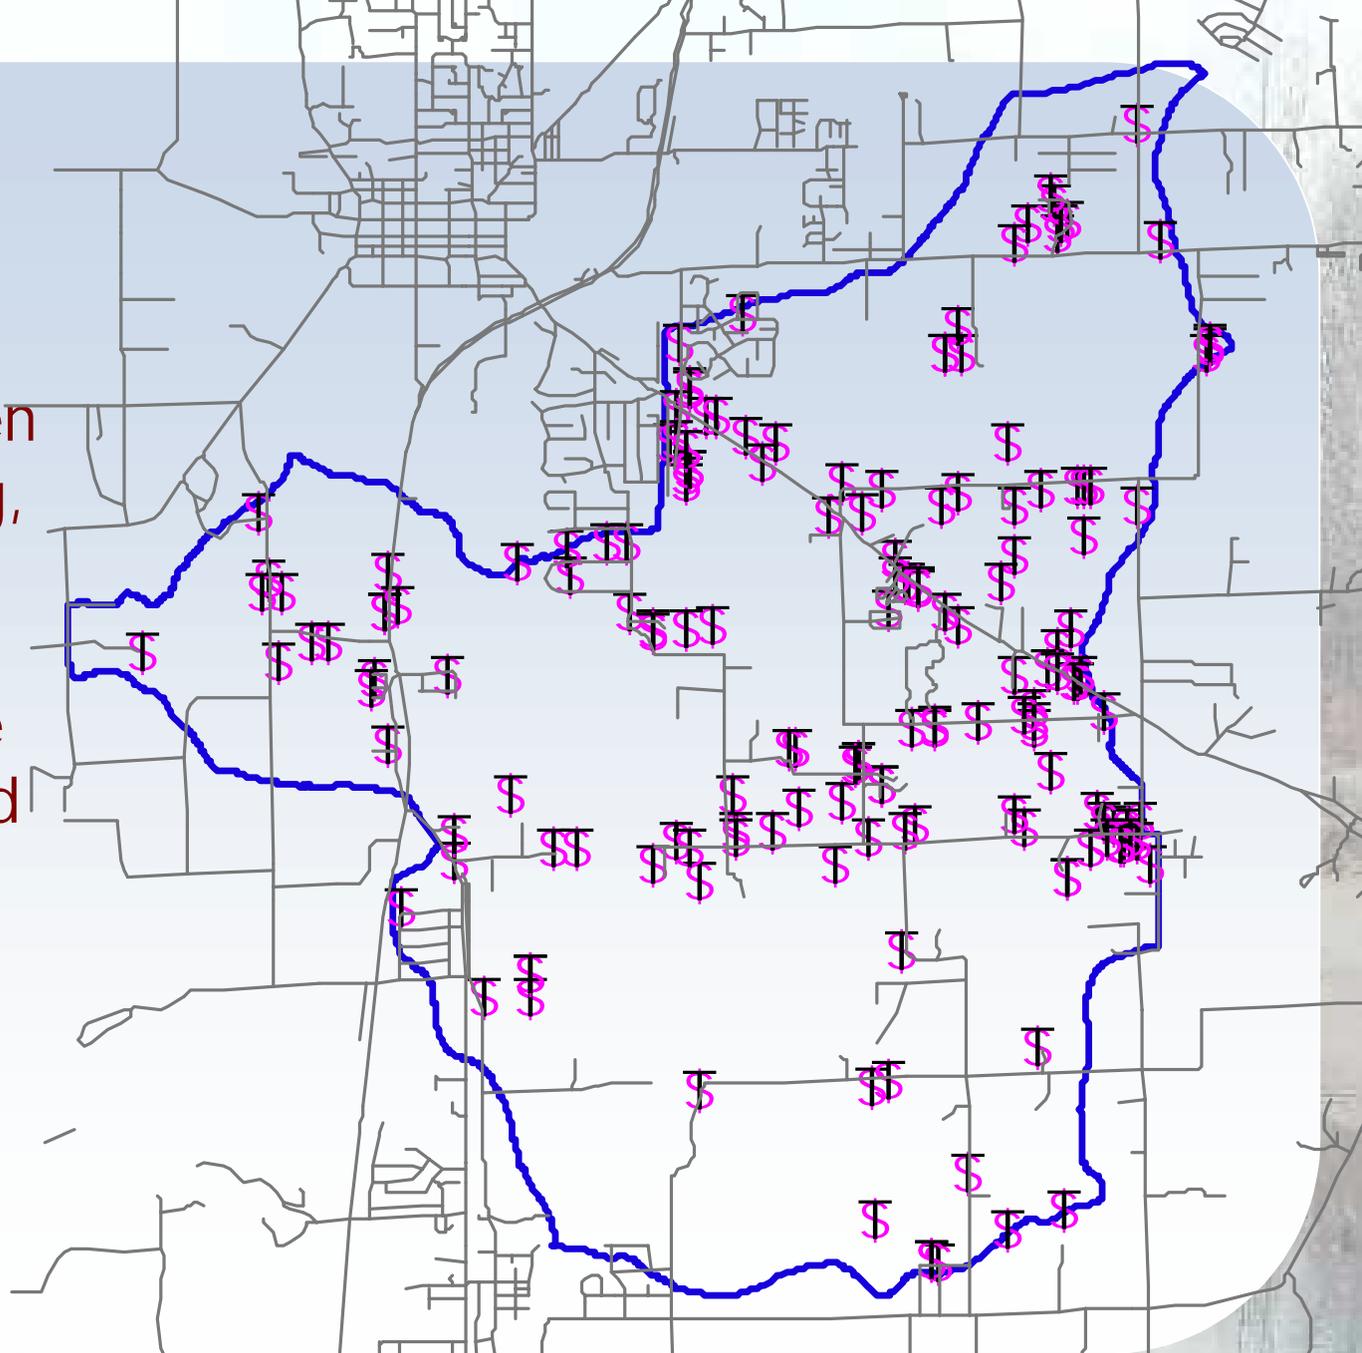
Stream observation sites..... Just about every place the road crossed a stream. These would NOT all be suitable water quality sampling sites. Note: the main stem was pretty inaccessible.

Visual Observation - Streams								
Site ID #	Stream	Location	Date	Weather	Stream Depth	Stream Width	Riparian Condition [E = eroded banks. L = livestock access. W = wooded riparian zone.]	Site Comments
ST1	Hub's Cr	Watson, just after Horse & Hub come together, nr WL	7/20	Hot, overcast, no recent rain	Almost empty, but would normally be 10-12"	Normally 6-8 feet	Shrubs & trees. Riparian buffer more than 50 feet on both sides.. Banks show a little undercutting but no slumping. Banks not more than 2 feet high. W E	bottom silty, some gravel, looks like a lot of stuff gets washed down. Bridge is scoured on one side & they have put rip-rap & gabions in previously in a vain attempt to stop the erosion. Woods both sides.
ST2	Hub's Cr	Pennington, flow from new pond into Crouse Lk	7/13	Hot, sunny, recent rain	Just a few inches in a culvert pipe.	Pipe is about 24"	In this case "riparian" means a culvert, since the stream just runs under the road. There is erosion around the upstream pipe, and sediment deposition bars around the outlet pipe into the lower pond. E L	Water just runs from one side of road, from pond outlet, into other pond on other side of road. Residential. Hub turns his cows in here during July & August.

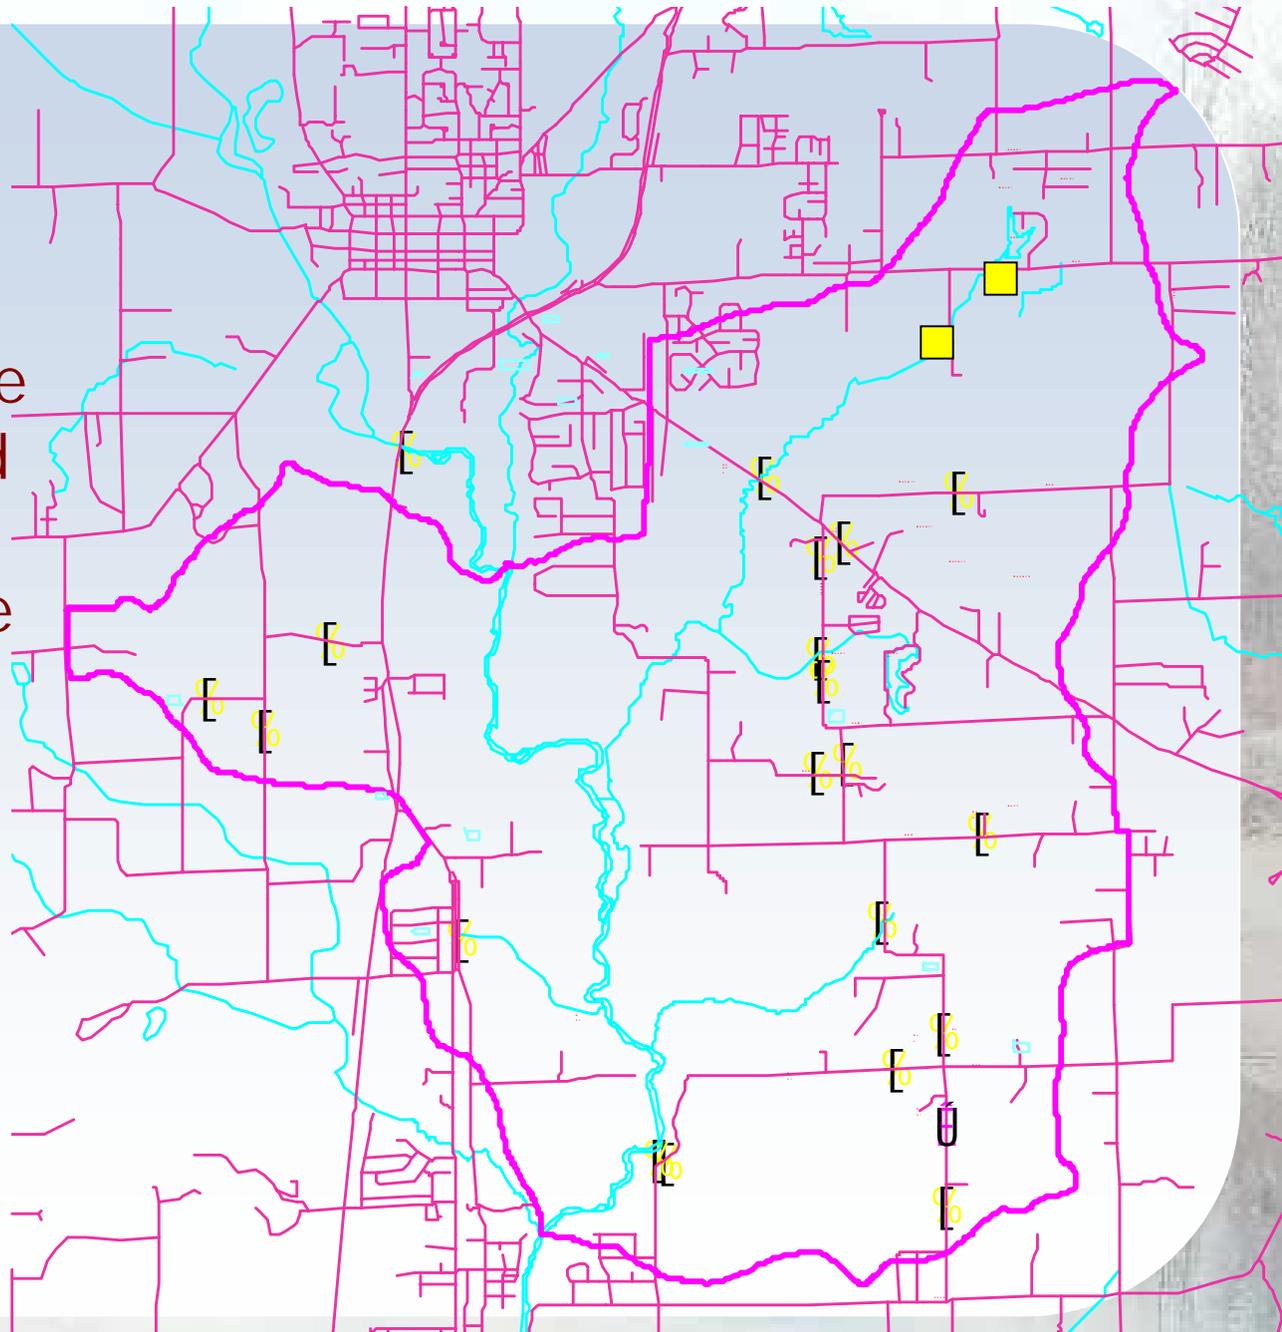
Most subdivisions in the WS have no storm water control. Control has not been required until very recently, and enforcement is uncertain. Impervious area = about 8% at present.

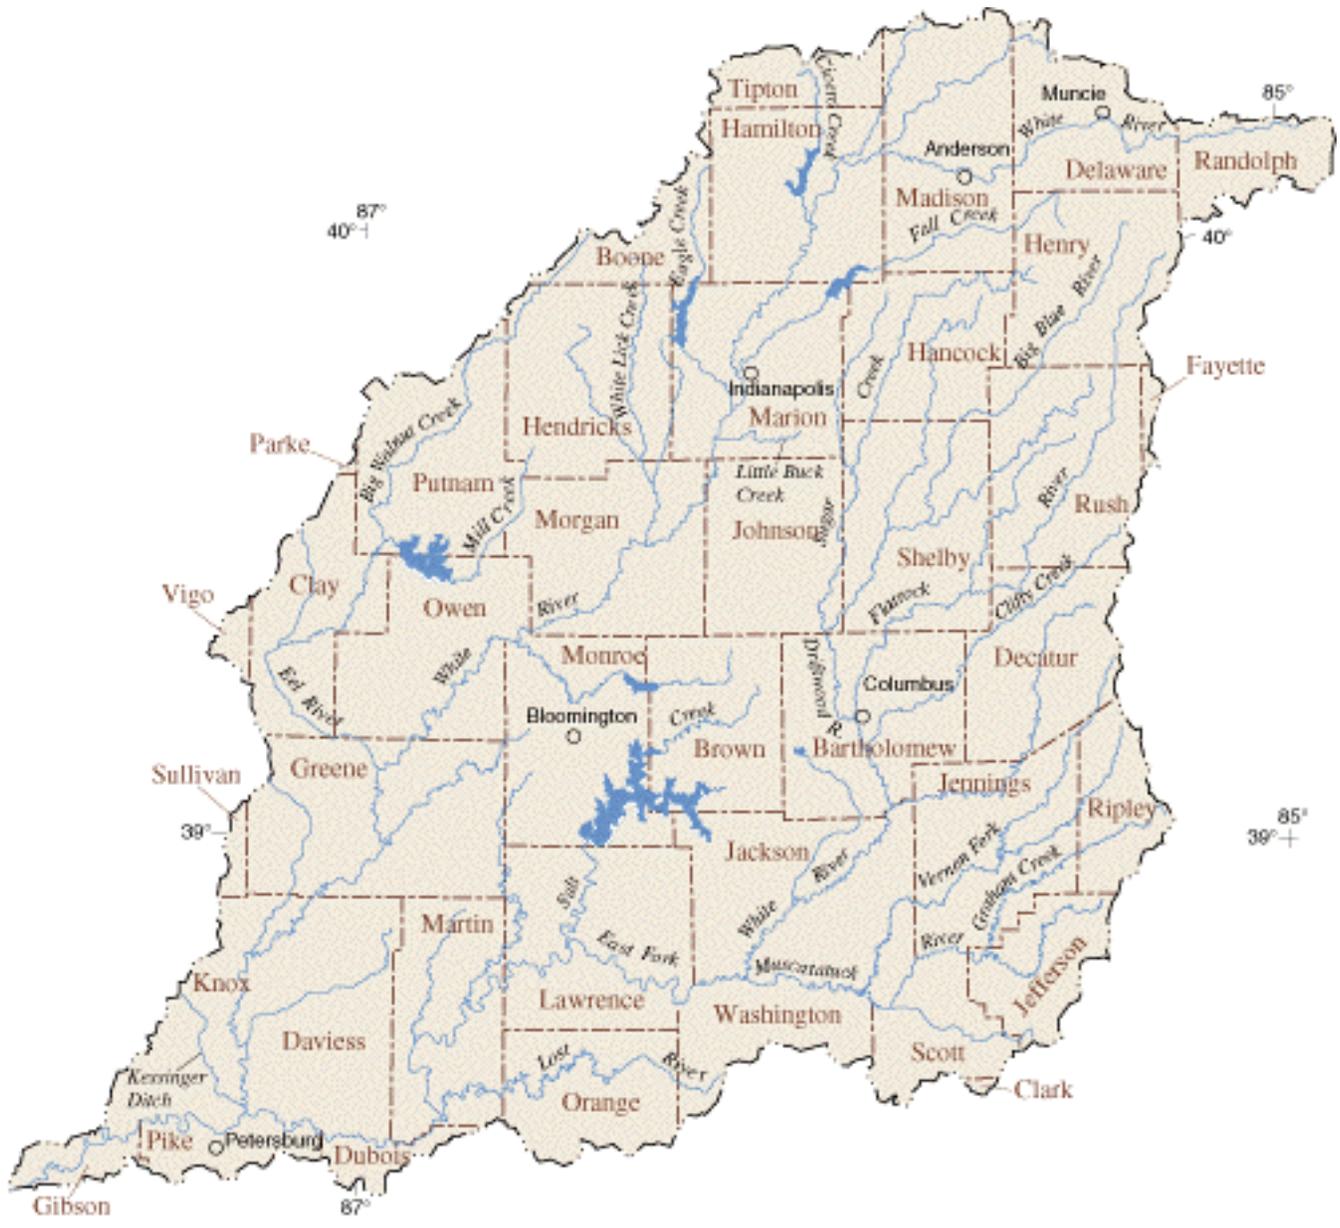
Base from U.S. Geological Survey digital data, 1:100,000, 1983
 Albers Equal-Area projection
 Standard parallels 29°30' and 45°30', central meridian -86°

----- White River Basin boundary

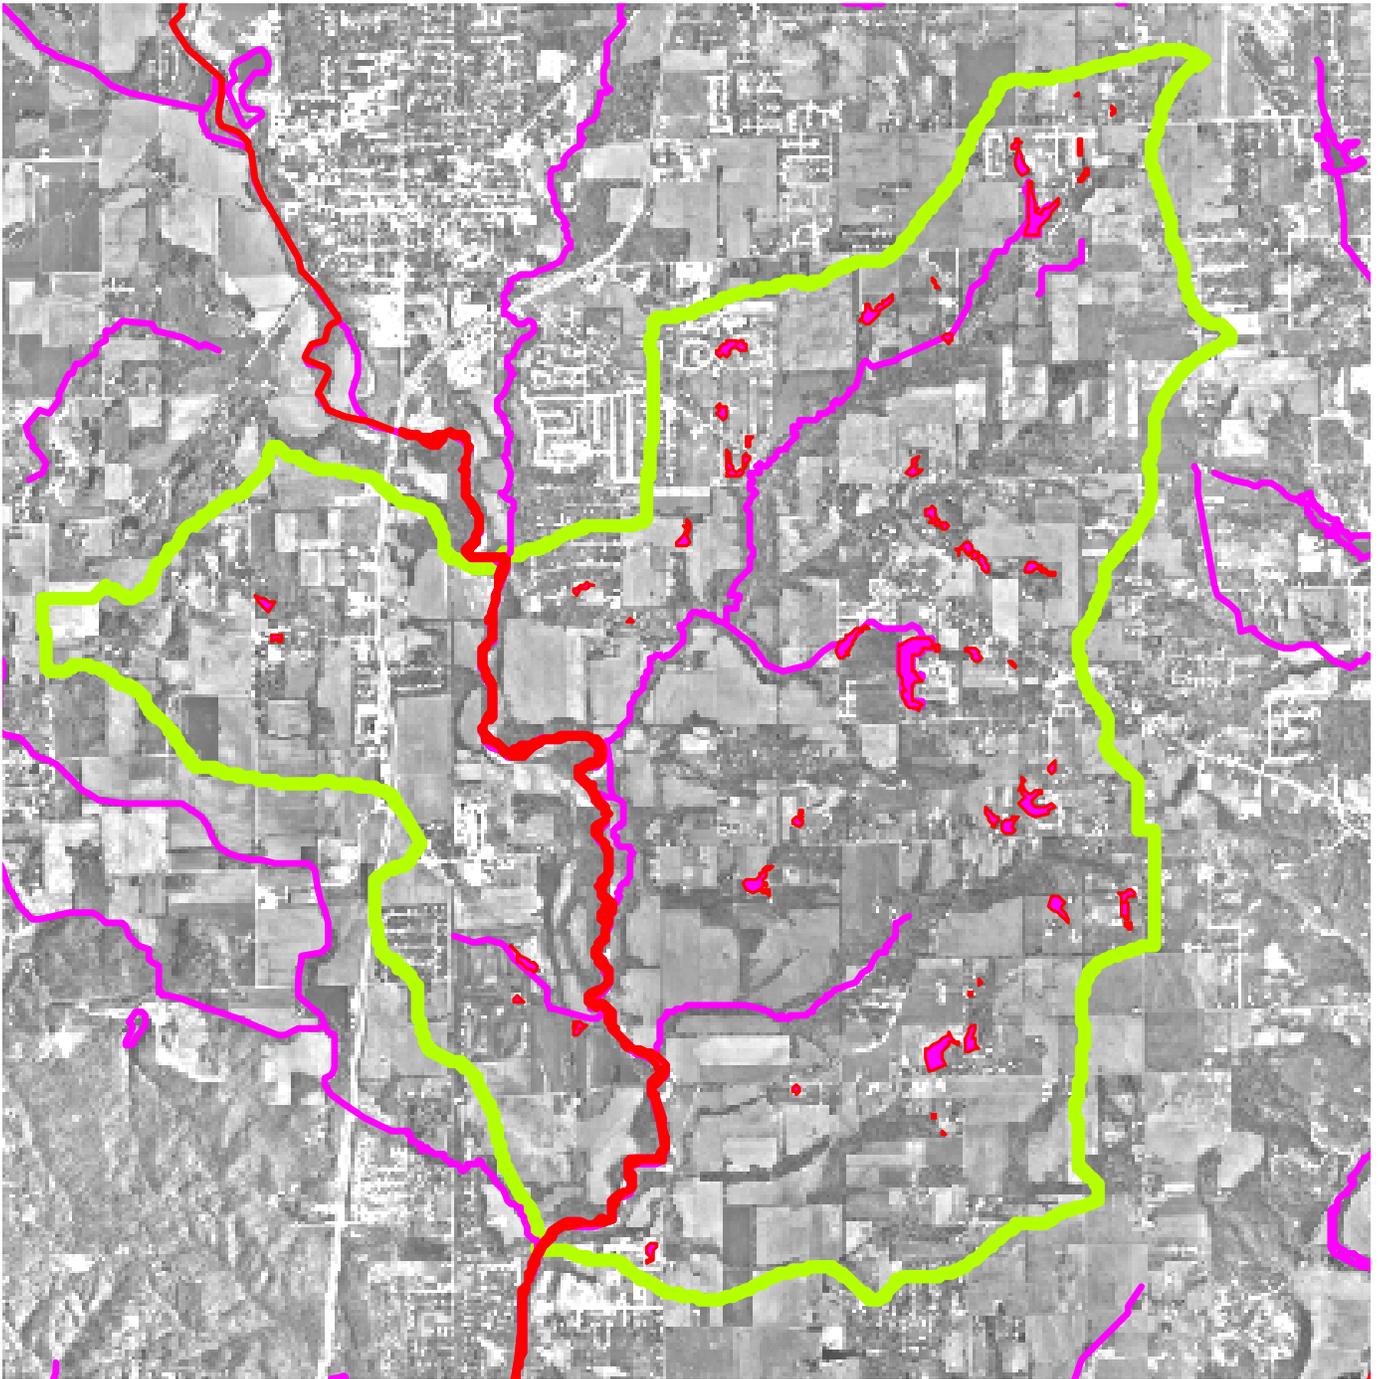
Streams & Lakes

1998 ortho photo showing streams and ponds. The 303d-listed White Lick Creek is shown in red.

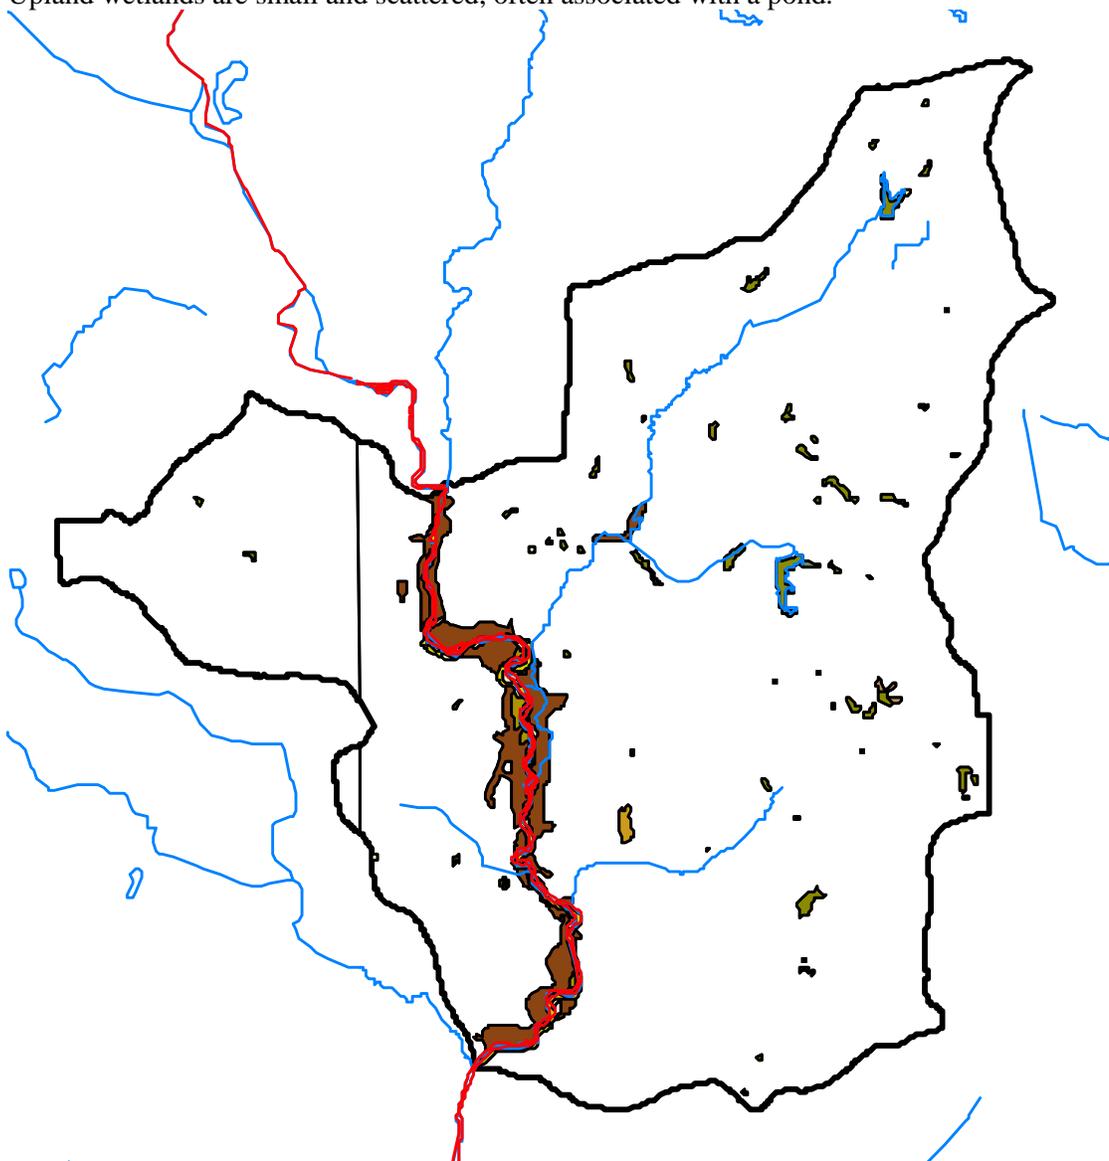
NWI wetlands

The USF&WS National Wetland Inventory digital maps identified 117 wetlands, including 52 ponds.

The palustrine types are what we normally think of as wetlands; all told there were 35 of those sites encompassing 341 acres, or 4.2% of the watershed. Except for one 8-acre tract, all the palustrine forested wetlands are along the White Lick in the floodplain. Hopefully they couldn't be developed because of being in the floodway.

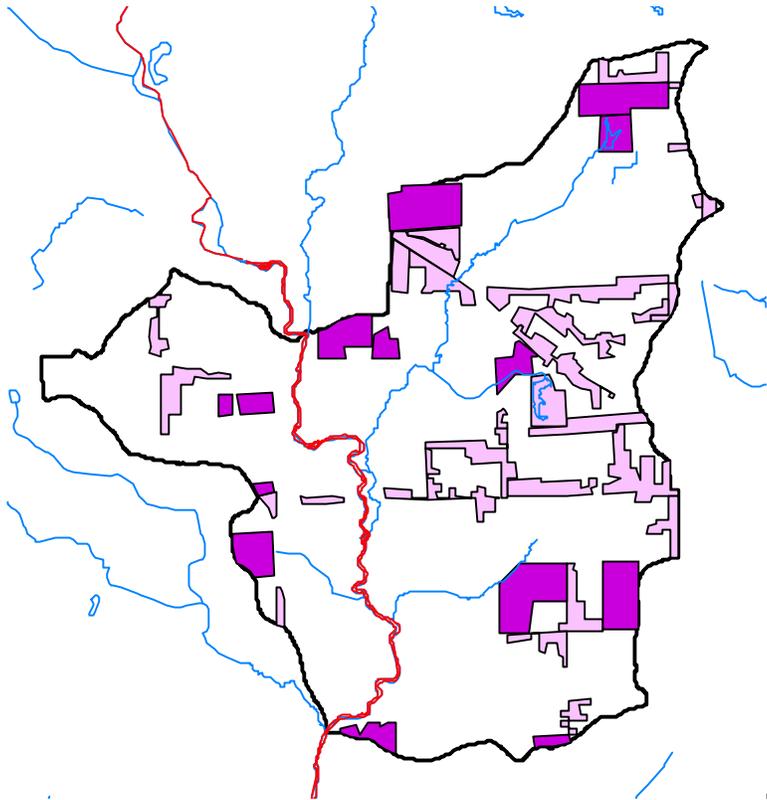
(lavendar) from the 1998 aerial photos.

Subdivisions (purple) and residential strips and clusters

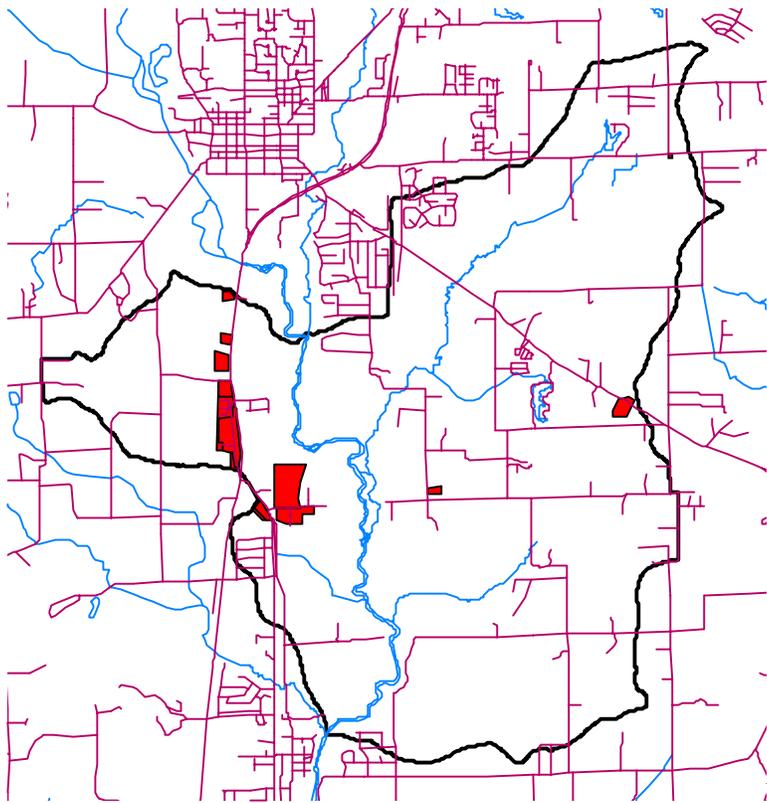
photos.

Industrial/commercial sites in red. From the 1998 aerial

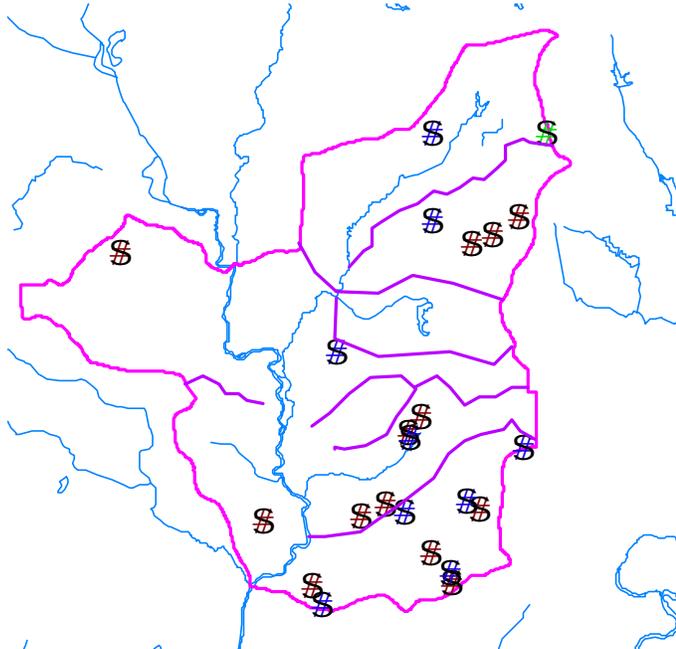
Three farms in the watershed went out of business within the last year and the land is being converted to housing. The map shows where livestock operations are located:

Green – dairy;
Brown – Beef;
Blue – horses or other stock

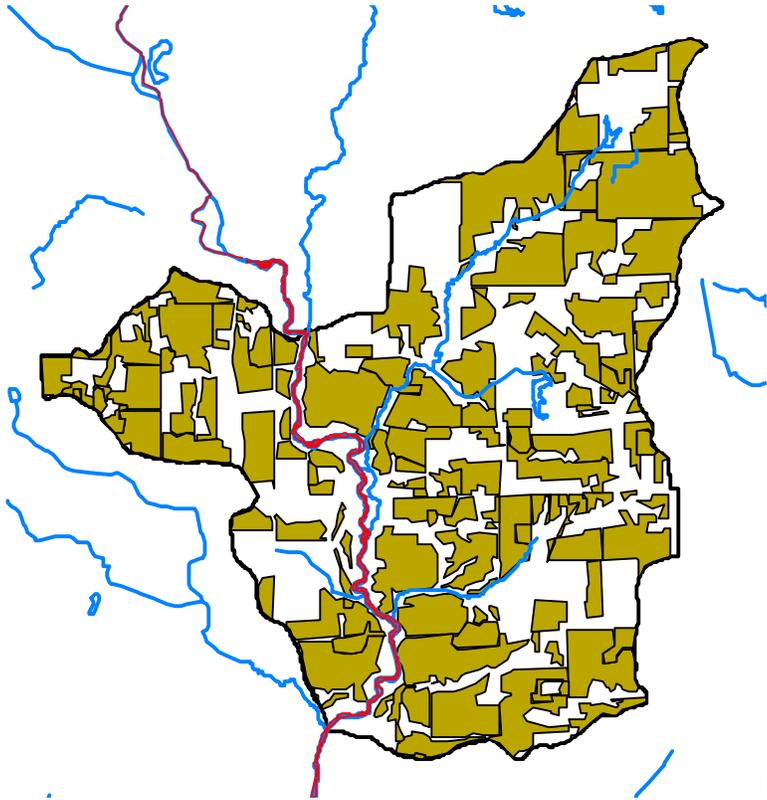
Location of crop or pasture fields.
