3.0 Watershed Inventory

3.1 Water Quality Data

3.2 Water Quality Sampling Efforts

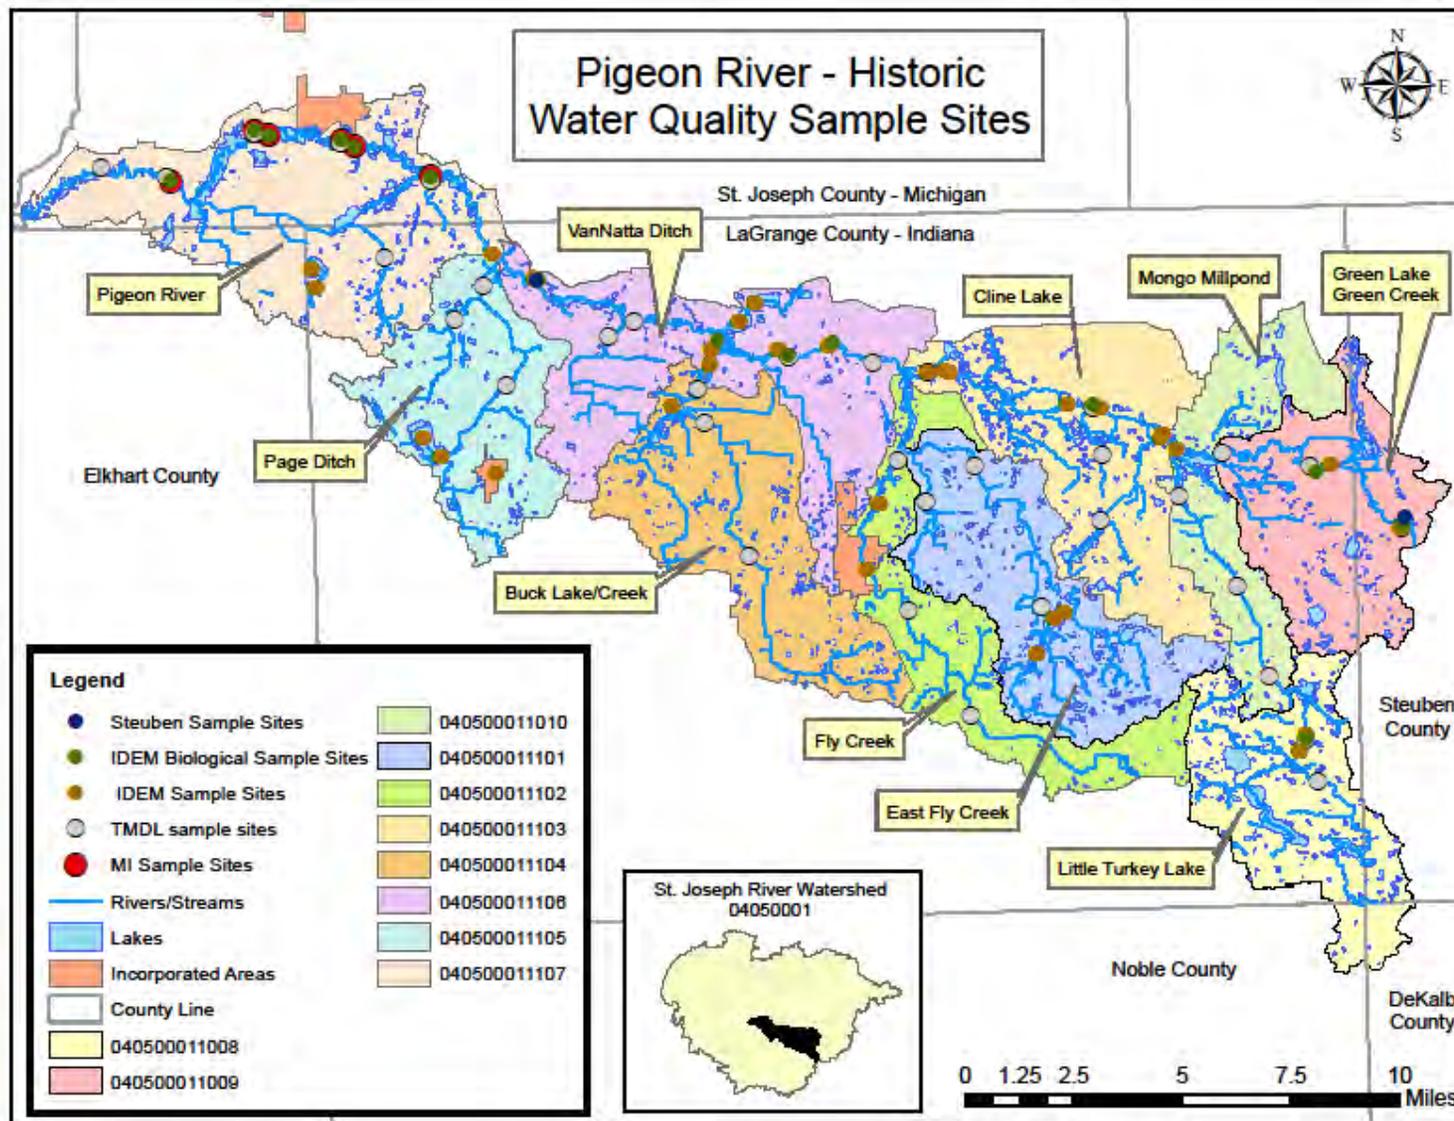
Figure 14: Pigeon River-Pigeon Creek Historic Sampling Locations

A variety of water quality assessment projects have been completed within the Pigeon River/Pigeon Creek and its tributaries. These include the Indiana and Michigan Integrated Reports, the Indiana TMDL Report, the Michigan Department of Environmental Quality’s Surface Water Protection Report, the Steuben County SWCD’s water quality monitoring program, and LaGrange County SWCD’s water quality monitoring program as part of this project. A summary of each study’s methodology and general results are discussed below. Subsequent sections detail specific study information as it relates to each subwatershed. Figure 14 displays all the historic sampling locations in the project area.

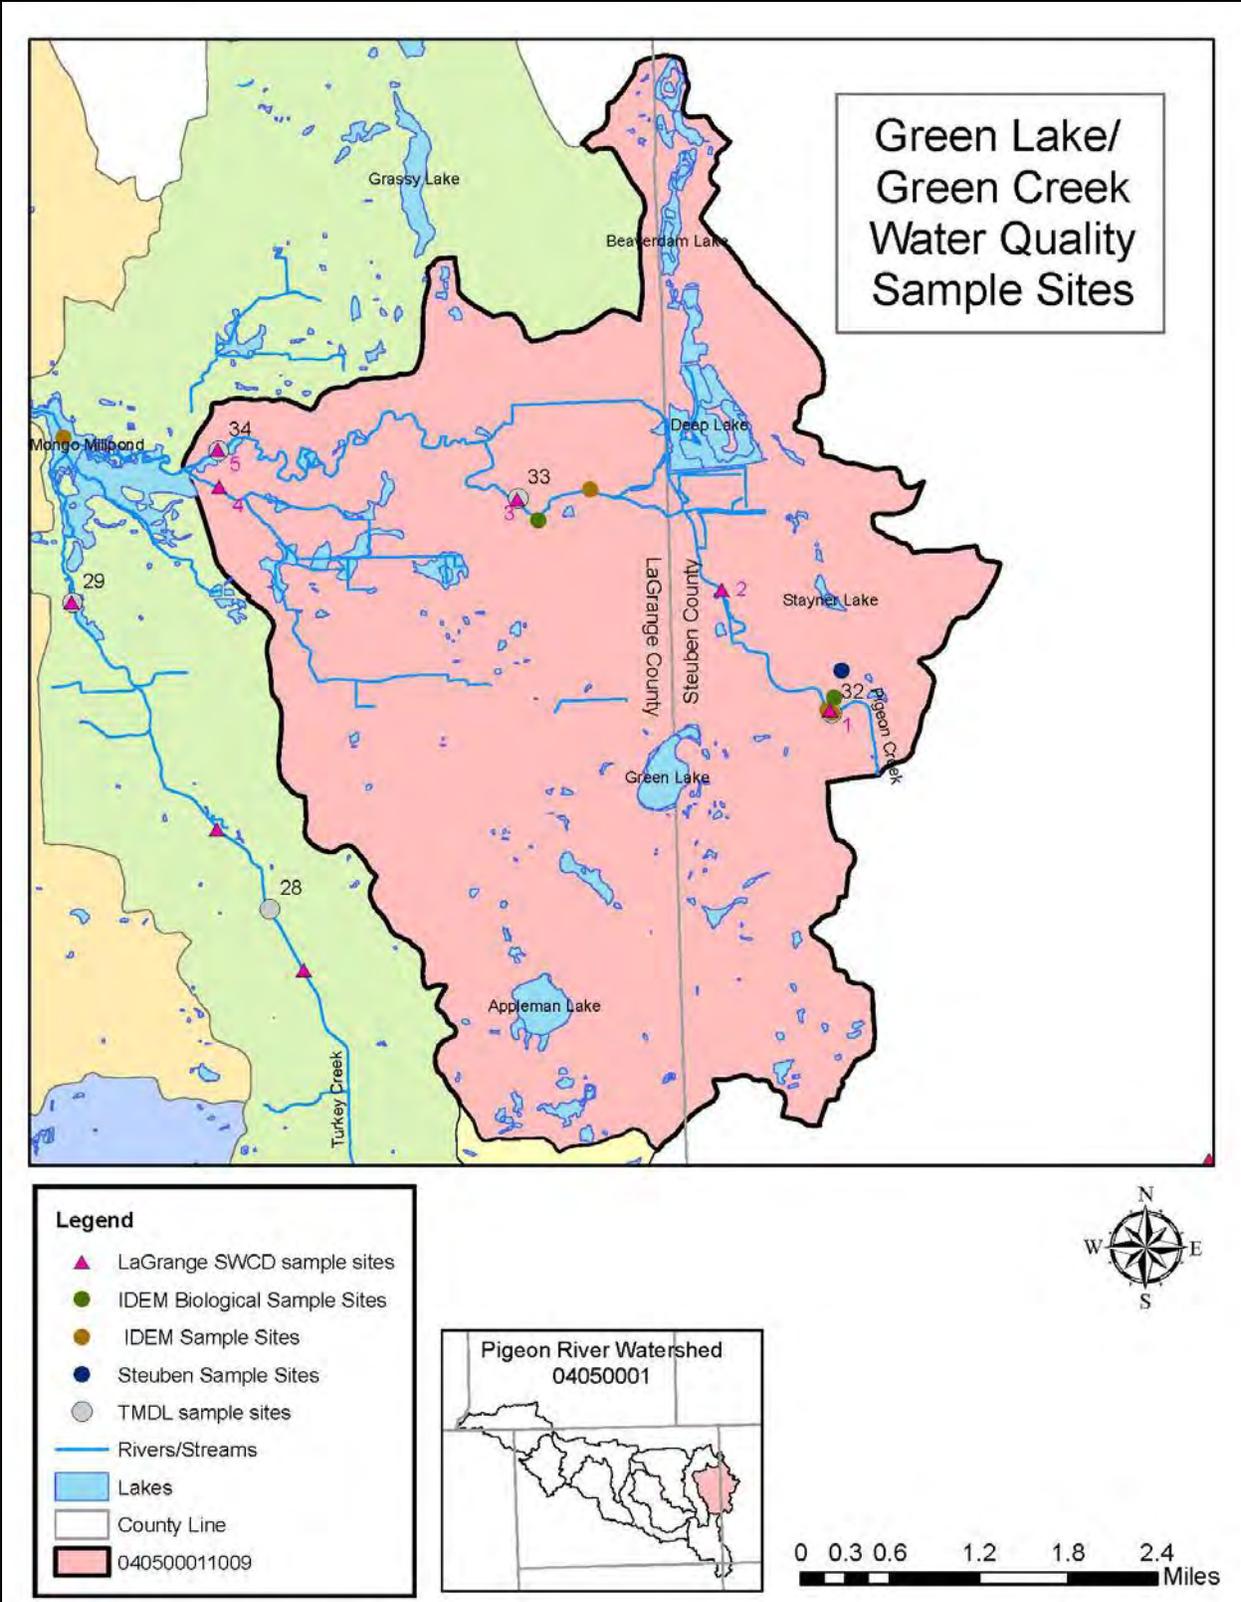
Figure 15: Green Lake/Green Creek Water Quality Sample Sites

There are fifteen total water quality sampling sites located within the Green Lake/Green Creek subwatershed, as can be seen in Figure 15. Three sites were used by IDEM for the 303(d) list; three sites were used by IDEM for the TMDL report; two sites were used by IDEM to collect biological data; one site was used by Steuben County SWCD for their water quality monitoring program, and five sample sites were used by LaGrange County SWCD to collect water quality data for the purposes of this WMP project.

Three sample sites were selected and analyzed by IDEM for the Pigeon Creek and Pigeon River TMDL. Each site was sampled in June, July and September, 2010. As can be seen in Table 22, nitrate-nitrite exceeded the target level of 1.5 mg/L in 11% of the samples, and dissolved oxygen exceeded the Indiana state standard in 11% of the samples. It should also be noted that IBI and QHEI was determined for this subwatershed, and the resulting scores indicate a healthy aquatic ecosystem.

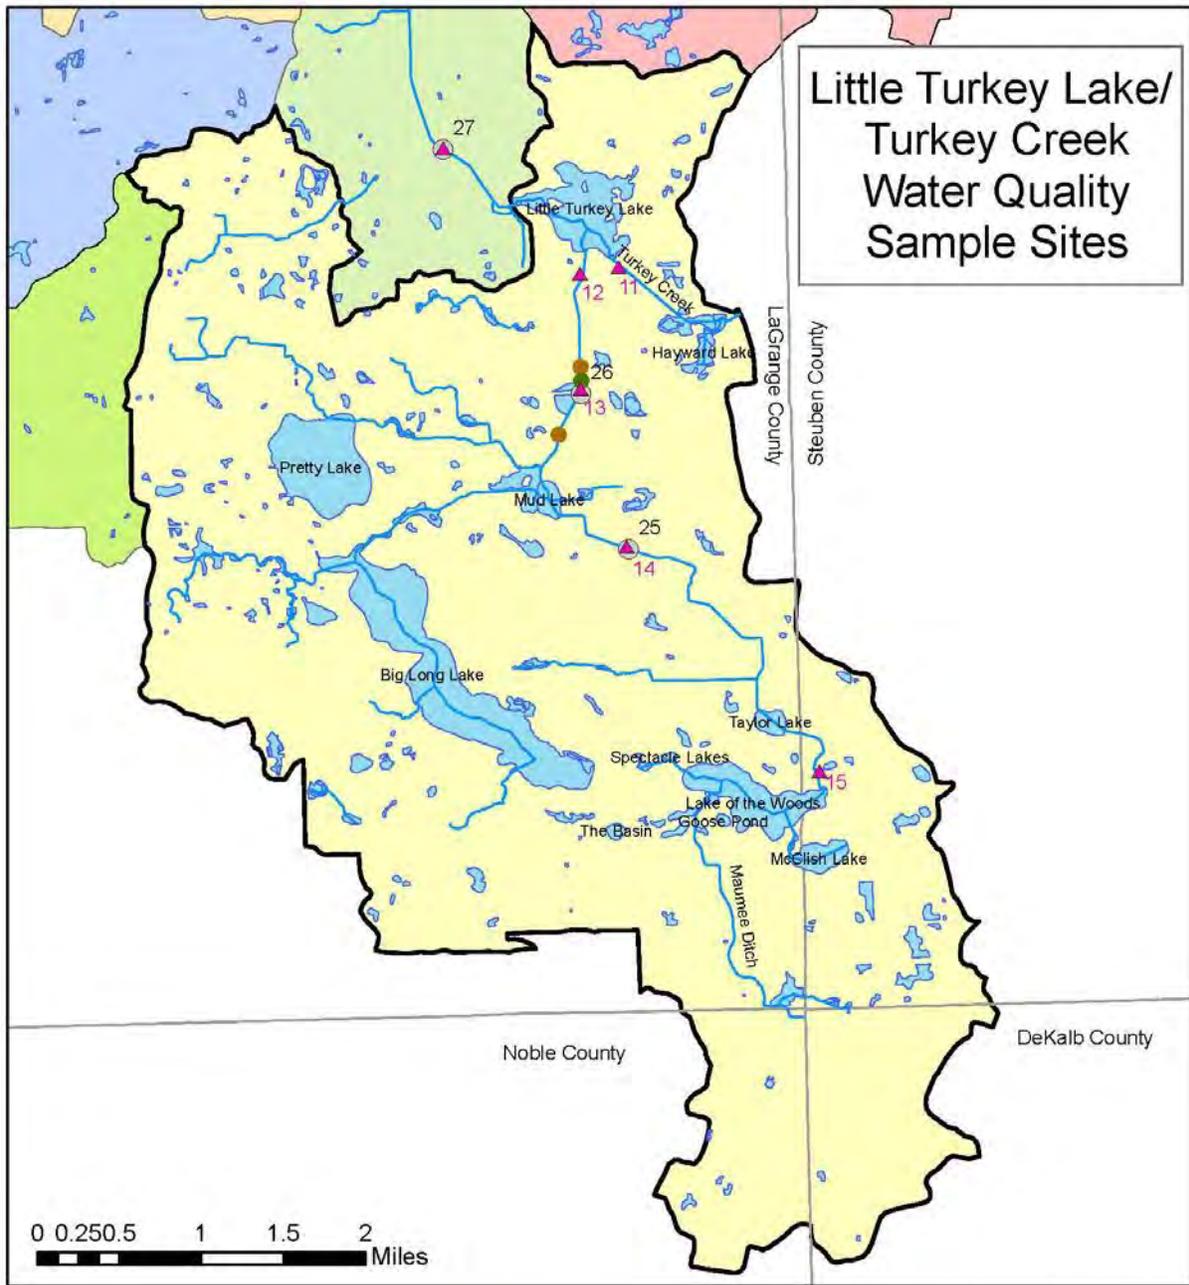
Figure 16: Little Turkey Lake/Turkey Creek Water Quality Sample Sites

There are ten total water quality sampling sites located within the Little Turkey Lake/Turkey Creek subwatershed, as can be seen in Figure 16. Two sites were used by IDEM for the 303(d) list; two sites were used by IDEM for the TMDL report; one site was used by IDEM to collect biological data, and five sample sites were used by LaGrange County SWCD to collect water quality data for the purposes of this WMP project.

Two sample sites within Little Turkey Lake/Turkey Creek subwatershed were selected and analyzed by IDEM for the Pigeon Creek and Pigeon River TMDL. Each site was sampled in June, July and September, 2010. As can be seen in Table 26, TKN exceeded the target level of 0.076 mg/L in 50% of the samples, nitrate-nitrite exceeded the target level of 1.5 mg/L in 33% of the samples, TSS exceeded the target level of 25 mg/L in one sample, and dissolved oxygen exceeded the Indiana state standard in 50% of the samples. It should be noted that the high level of D.O. in the water column may be directly related to the high level of nitrogen found in the water column. IBI and QHEI were determined for Little Turkey Lake/Turkey Creek and the scores indicate a very poor aquatic ecosystem.

LaGrange County SWCD sampled water quality monthly at five sites within Little Turkey Lake/Turkey Creek subwatershed from November 2010 through August 2011. As can be seen in Table 27, all parameters exceeded the target levels at some point during the sampling cycle. However, it should be noted that pH and D.O. exceeded the target levels in at least 60% of the samples, nitrate exceeded the target level 43% of the time, and *E. coli* and total phosphorus exceeded the target levels in at least 20% of the samples. The SWCD also sampled the macroinvertebrate community located at each of the five sample sites located in Little Turkey Lake/Turkey Creek. Sites 11, 12, 13, and 15 all scored high enough to indicate an excellent aquatic ecosystem. Site 14 also scored high indicating a good aquatic ecosystem.

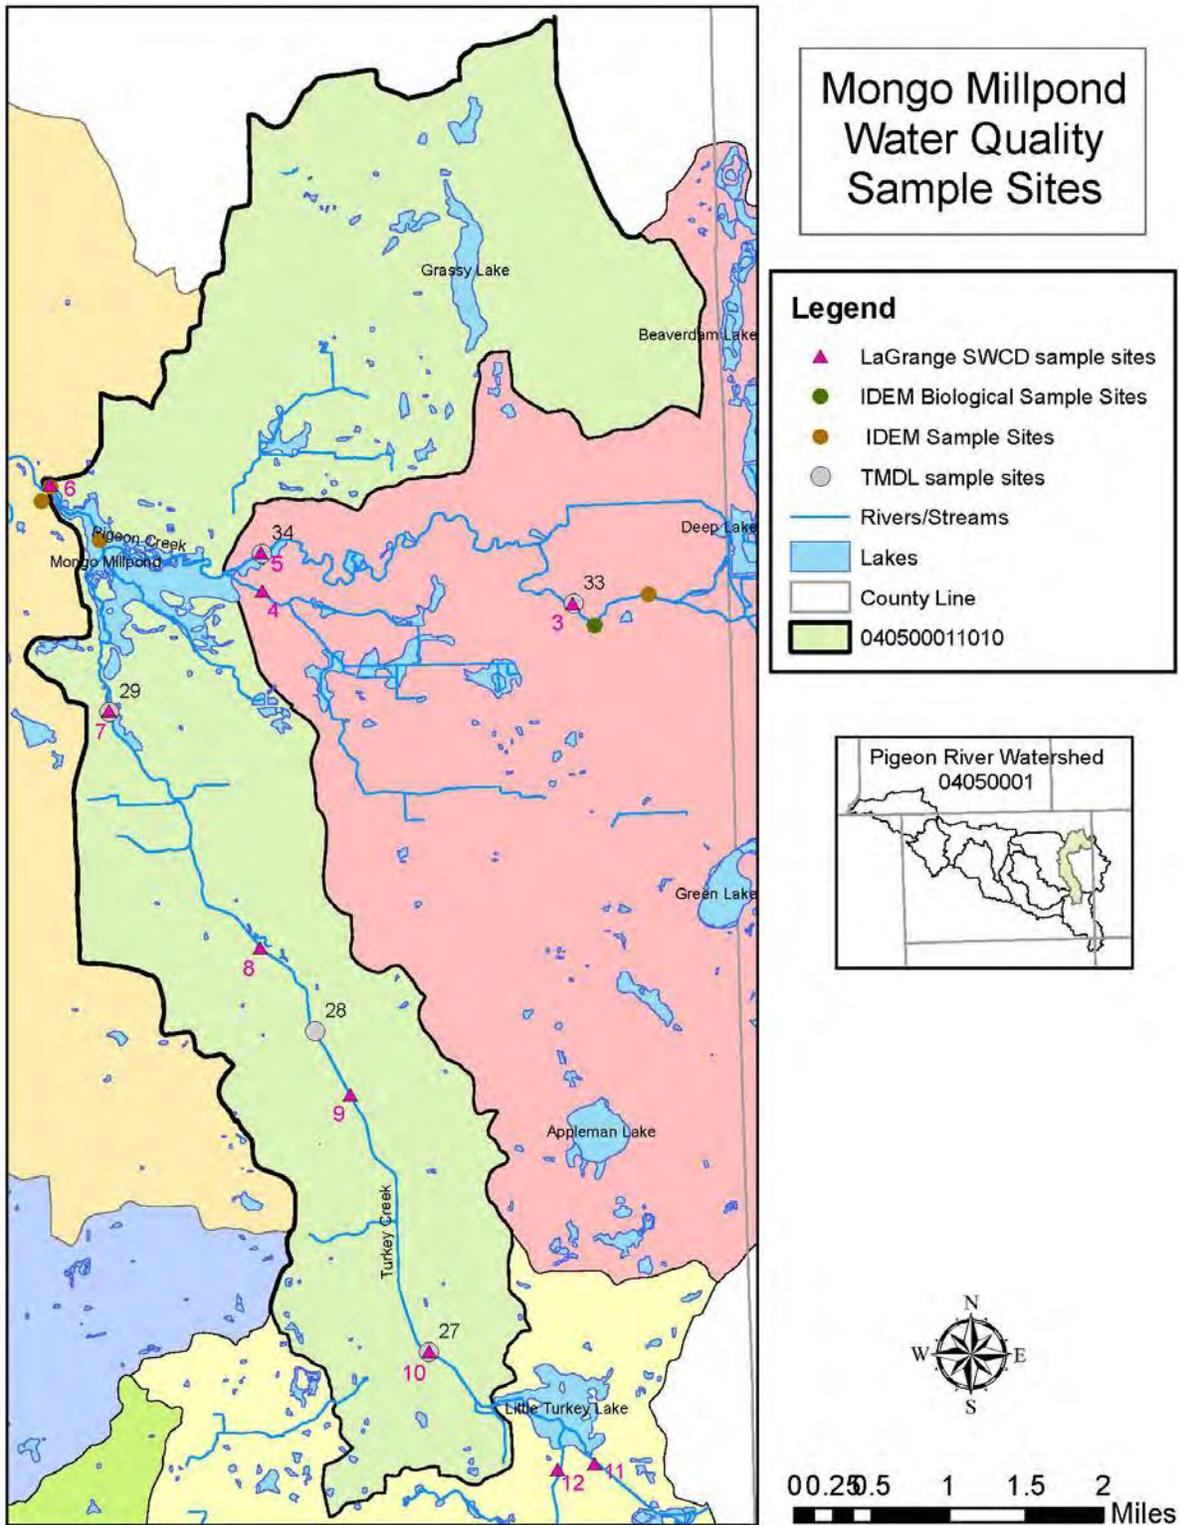
Figure 17: Mongo Millpond Water Quality Sample Sites

There are ten total water quality sampling sites located within the Mongo Millpond subwatershed, as can be seen in Figure 17. Two sites were used by IDEM for the 303(d) list; two sites were used by IDEM to collect biological data; three sites were used by IDEM for the TMDL report, and five sample sites were used by LaGrange County SWCD to collect water quality data for the purposes of this WMP project.

Three sample sites within Mongo Millpond subwatershed were selected and analyzed by IDEM for the Pigeon Creek and Pigeon River TMDL. Each site was sampled in June, July and September, 2010. As can be seen in Table 30, nitrate-nitrite and D.O. were the only two parameters that exceeded the target level. Nitrate-nitrite and D.O. exceeded the target levels each twice. Therefore, it is reasonable to suspect that the spikes in D.O. may be due to the spikes in nitrogen levels which can increase algae production and increase dissolved oxygen in the water column. It should also be noted that biological data was collected at two sites in Mongo Millpond. The IBI and QHEI scores indicate a healthy aquatic ecosystem in the Mongo Millpond subwatershed.

LaGrange County SWCD sampled water quality monthly at five sites within Mongo Millpond subwatershed from November 2010 through August 2011. As can be seen in Table 31, all parameters exceeded the target levels at some point during the sampling cycle except for pH which never exceeded the target level. However, it should be noted temperature and nitrate exceeded the target levels set by this project in 50% and 56%, respectively, of the samples. D.O. exceeded target levels in 62% of the samples, and total phosphorus and *E. coli* exceeded the targets levels in at least 10% of the samples. The SWCD also sampled the macroinvertebrate community located at each of the five sample sites located in the Mongo Millpond subwatershed. All five sites scored high enough to indicate an excellent aquatic ecosystem.

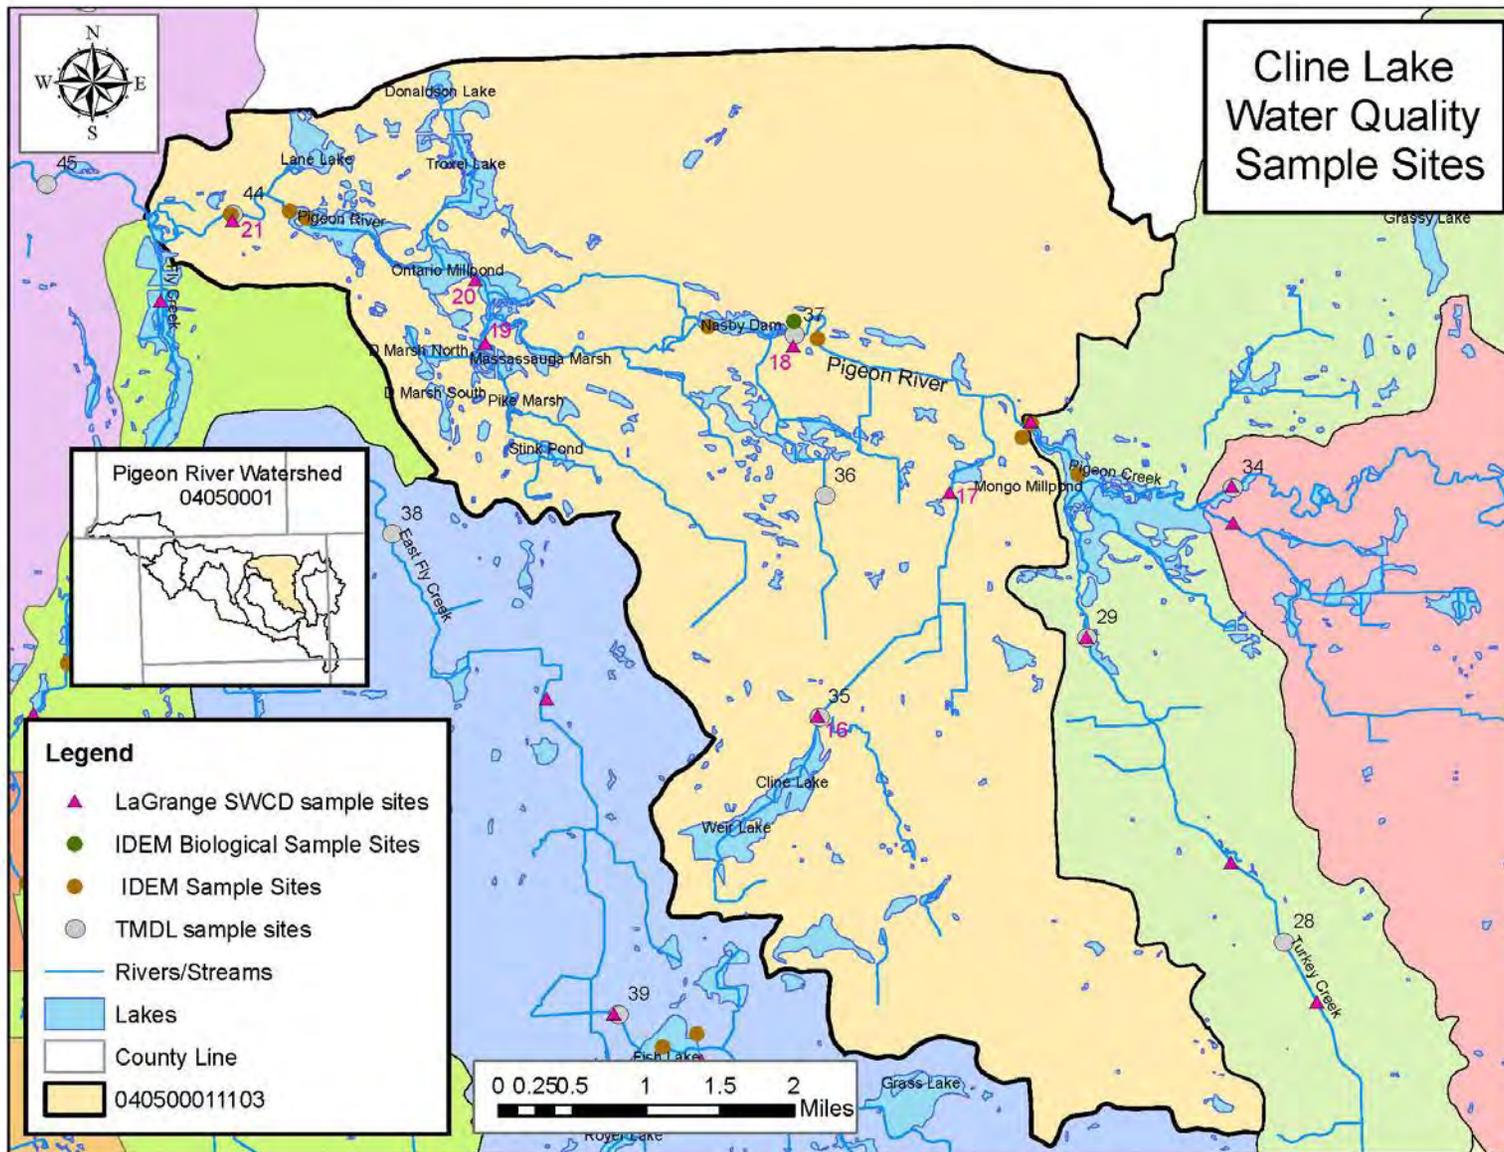
Figure 18: Cline Lake Subwatershed Water Quality Sample Sites

There are sixteen total water quality sampling sites located within the Cline Lake subwatershed, as can be seen in Figure 18. Six sites were used by IDEM for the 303(d) list; four sites were used by IDEM for the TMDL report, of which three were used to collect biological data, and six sample sites were used by LaGrange County SWCD to collect water quality data for the purposes of this WMP project.

Four sample sites within Cline Lake subwatershed were selected and analyzed by IDEM for the Pigeon Creek and Pigeon River TMDL. Each site was sampled in June, July and September, 2010. As can be seen in Table 34, nitrate-nitrite and D.O. were the only two parameters that exceeded the target level. Nitrate-nitrite and D.O. exceeded the target levels each once. TKN exceeded the target level of 0.076 mg/L in 82% of the samples and TSS exceeded the target level of 25 mg/L in 27% of the samples. It should also be noted that biological data was collected at three sites in Cline Lake. The IBI and QHEI for site 35, a headwater stream, indicate a healthy aquatic ecosystem. However, downstream at sites 37 and 44, both located on the main stem of the Pigeon River, the IBI and QHEI scores indicate a very poor aquatic ecosystem.

LaGrange County SWCD sampled water quality monthly at six sites within Cline Lake subwatershed from November 2010 through August 2011. As can be seen in Table 35, all parameters did not meet the target levels at some point during the sampling cycle except for TSS which never exceeded the target level. D.O. did not meet target levels 64% of the time, with 7% of those that did not meet the target level falling below 4 mg/L and all other samples measuring above 9 mg/L. It should also be noted that E. coli exceeded the state standard of 235 cfu/100 ml in 20% of the samples and nitrates exceeded the target level of 1.5 mg/L in 46% of the samples. The SWCD also sampled the macroinvertebrate community located at each of the six sample sites located in the Cline Lake subwatershed. All six sites scored high enough to indicate an excellent aquatic ecosystem.

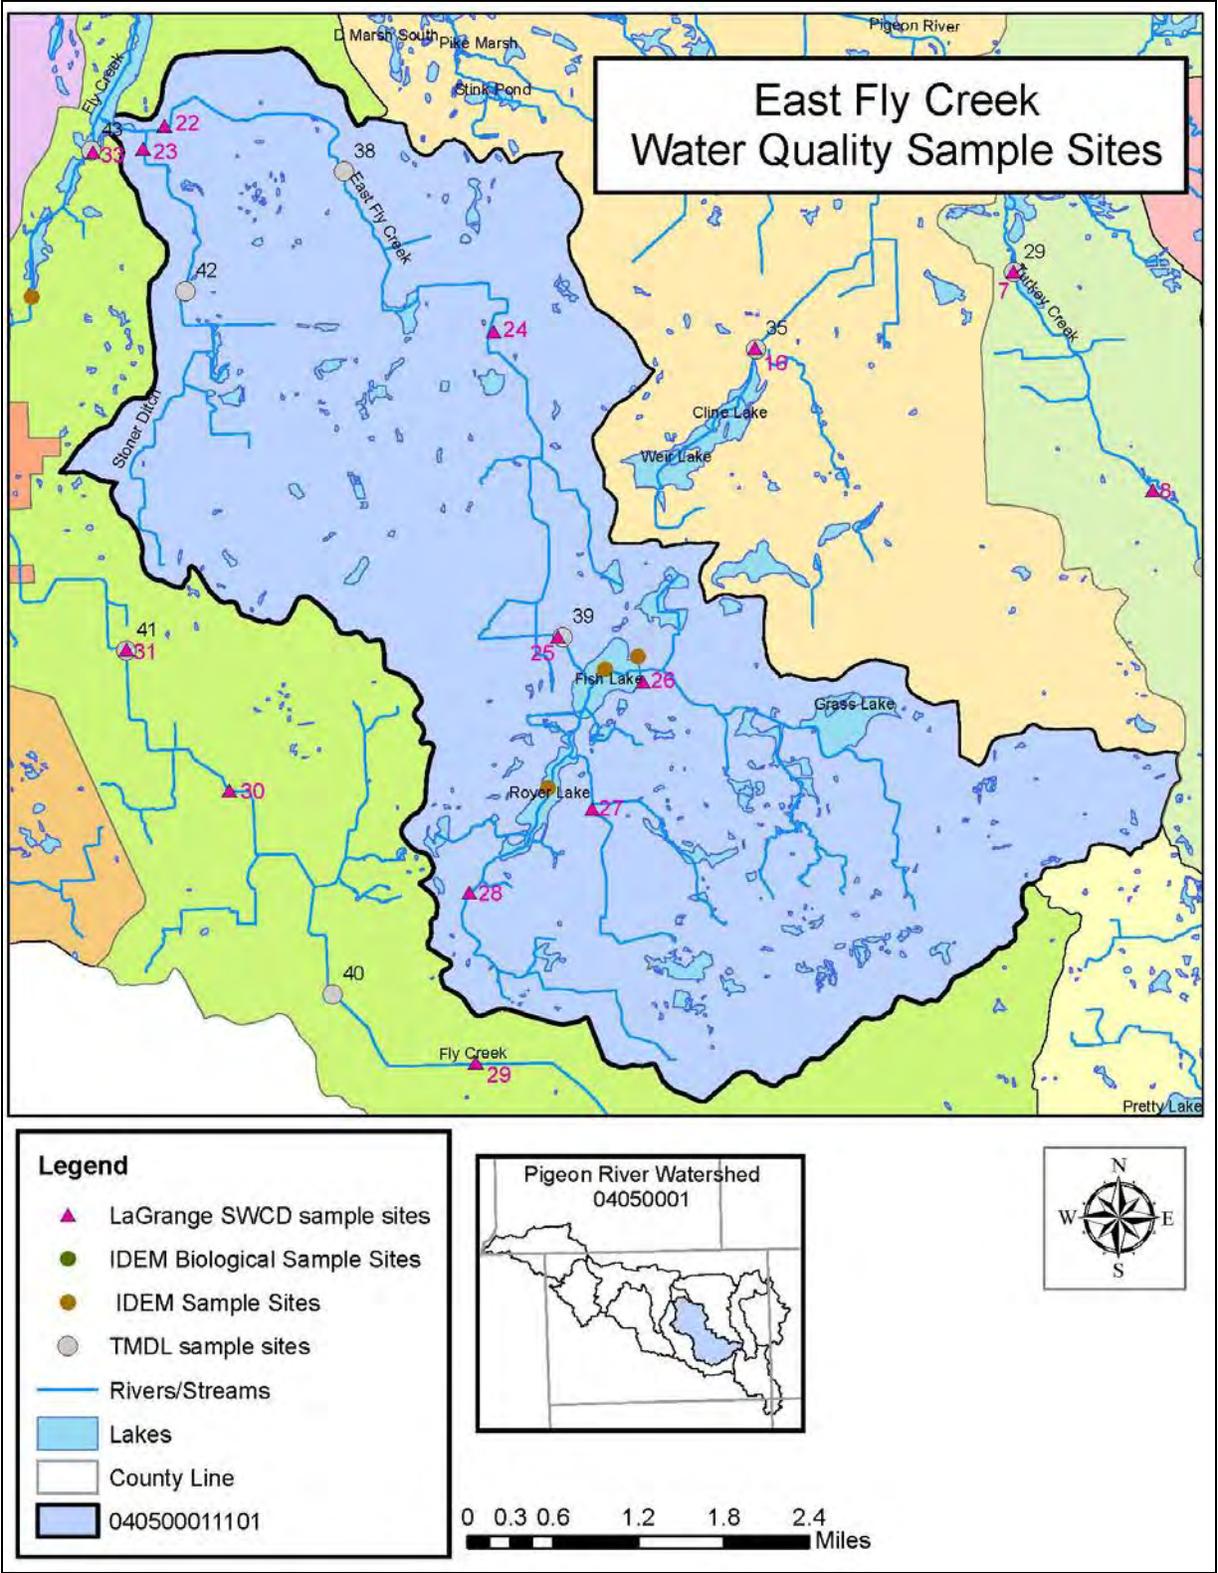
Figure 19: East Fly Creek Water Quality Sample Sites

There are thirteen total water quality sampling sites located within the East Fly Creek subwatershed, as can be seen in Figure 19. Three sites were used by IDEM for the 303(d) list; three sites were used by IDEM for the TMDL report, of which two were used to collect biological data, and seven sample sites were used by LaGrange County SWCD to collect water quality data for the purposes of this WMP project.

LaGrange County SWCD sampled water quality monthly at seven sites within East Fly Creek subwatershed from November 2010 through August 2011. As can be seen in Table 39, all parameters did not meet the target levels at some point during the sampling cycle except for TDS which never exceeded the target level. D.O. did not meet target levels 72% of the time, with 5% of those that did not meet the target level falling below 4 mg/L and all other samples measuring above 9 mg/L. It should also be noted that E. coli exceeded the state standard of

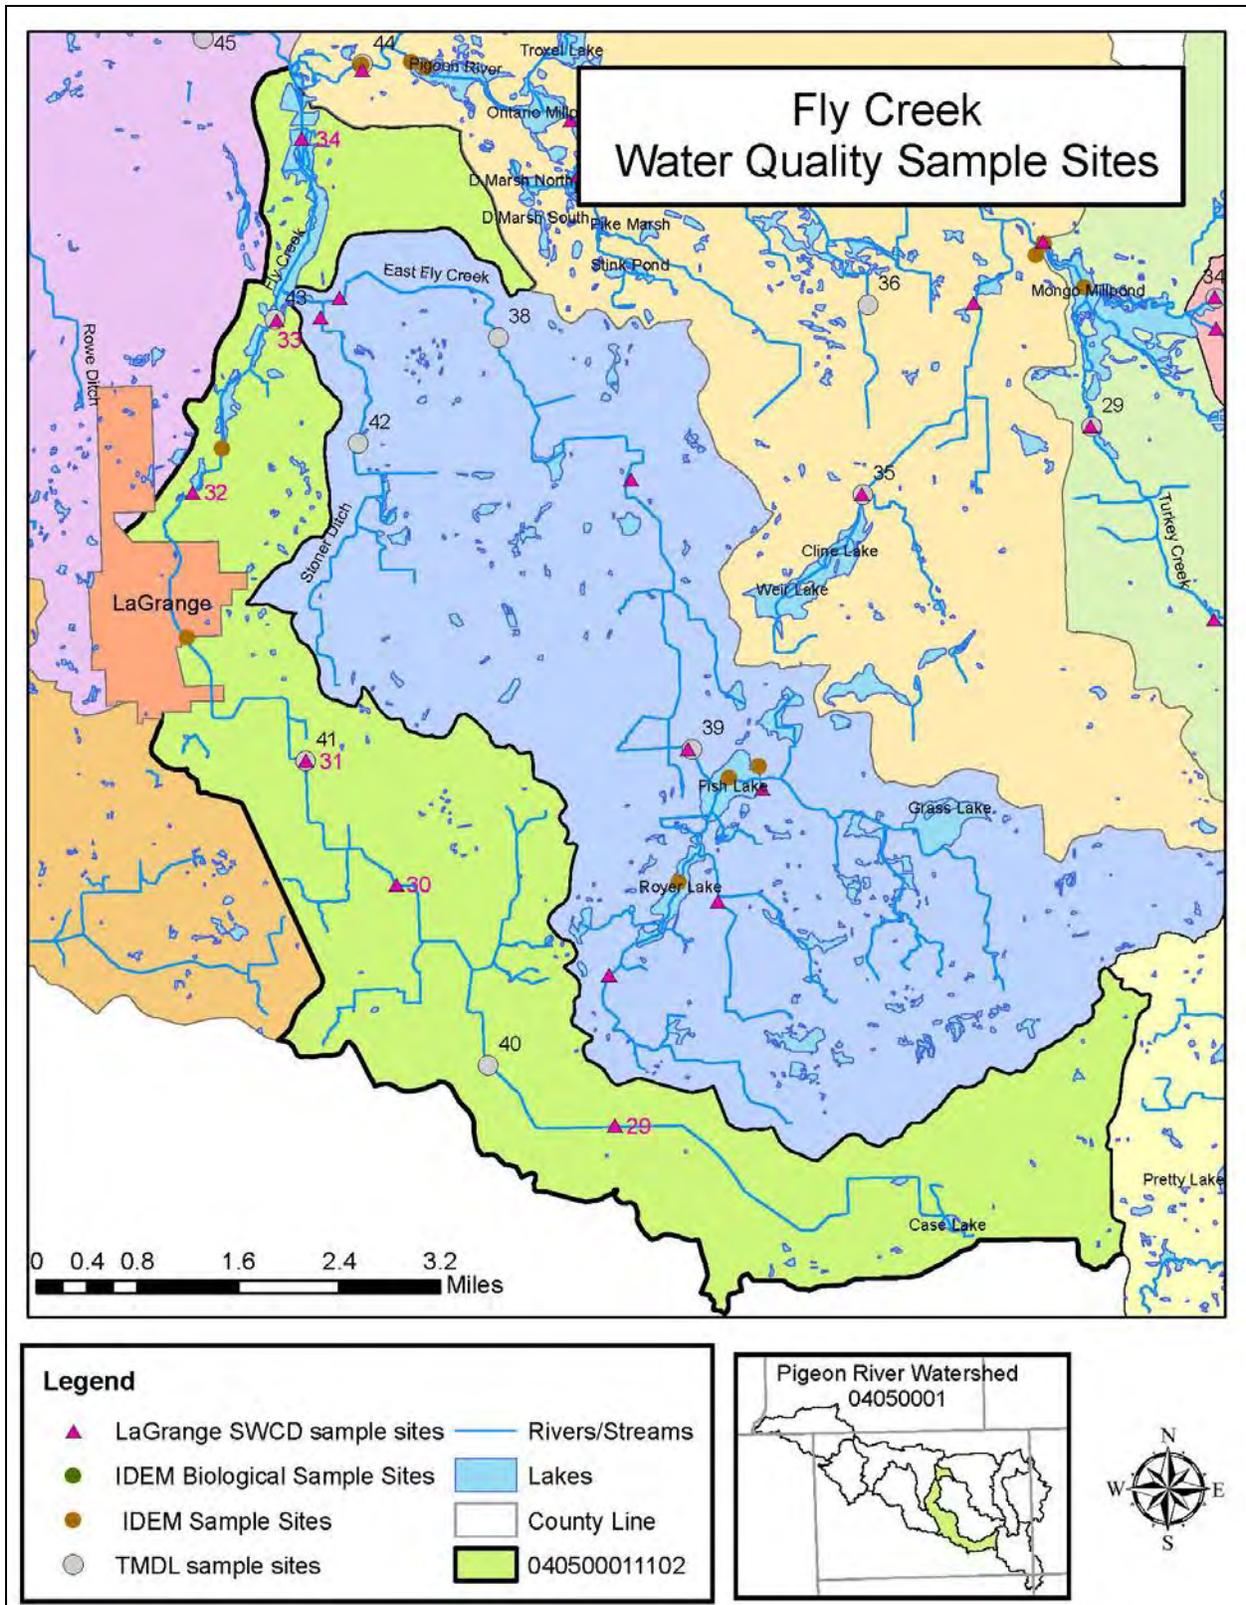
Figure 20: Fly Creek Water Quality Sample Sites

There are eleven total water quality sampling sites located within the Fly Creek subwatershed, as can be seen in Figure 20. Two sites were used by IDEM for the 303(d) list; three sites were used by IDEM for the TMDL report, of which two were used to collect biological data, and six sample sites were used by LaGrange County SWCD to collect water quality data for the purposes of this WMP project.

Three sample sites within Fly Creek subwatershed were selected and analyzed by IDEM for the Pigeon Creek and Pigeon River TMDL. The sites were sampled in June, July and September, 2010. As can be seen in Table 41, nitrate-nitrite, TKN, and D.O. were the only parameters that exceeded the target levels. TKN exceeded the target level of 0.076 mg/L in 11% of the samples, nitrate-nitrite exceeded the target level of 1.5 mg/L in 100% of the samples, and D.O. exceeded the target level of < 9mg/L in one sample. It should also be noted that biological data was collected at one site in Fly Creek subwatershed. The IBI and QHEI scores for site 43, located on the main channel of Fly Creek, indicate a poor to very poor aquatic ecosystem.

LaGrange County SWCD sampled water quality monthly at six sites within Fly Creek subwatershed from November 2010 through August 2011. As can be seen in Table 42, all parameters did not meet the target levels at some point during the sampling cycle except for TDS which never exceeded the target level. D.O. did not meet target levels 73% of the time, with 1% of those that did not meet the target level falling below 4 mg/L and all other samples measuring above 9 mg/L. It should also be noted that *E. coli* exceeded the state standard of 235 cfu/100 ml in 58% of the samples, total phosphorus exceeded the target level of 0.3 mg/L in 17% of the samples, and nitrates exceeded the target level of 1.5 mg/L in 100% of the samples. The high nitrates are due to direct animal access, lack of filter strips or streambank buffering, barnyards with direct runoff into ditches, and to a lesser extent field tiling and faulty or improperly installed septic systems. It would not be unreasonable to assume the high levels of D.O. are associated with the high levels of nutrients found in the water column as high levels of nutrients can contribute to excessive algae growth which will produce a lot of dissolved oxygen. The SWCD also sampled the macroinvertebrate community located at each of the six sample sites located in the Fly Creek subwatershed. All six of the sites scored high enough to indicate an excellent aquatic ecosystem.

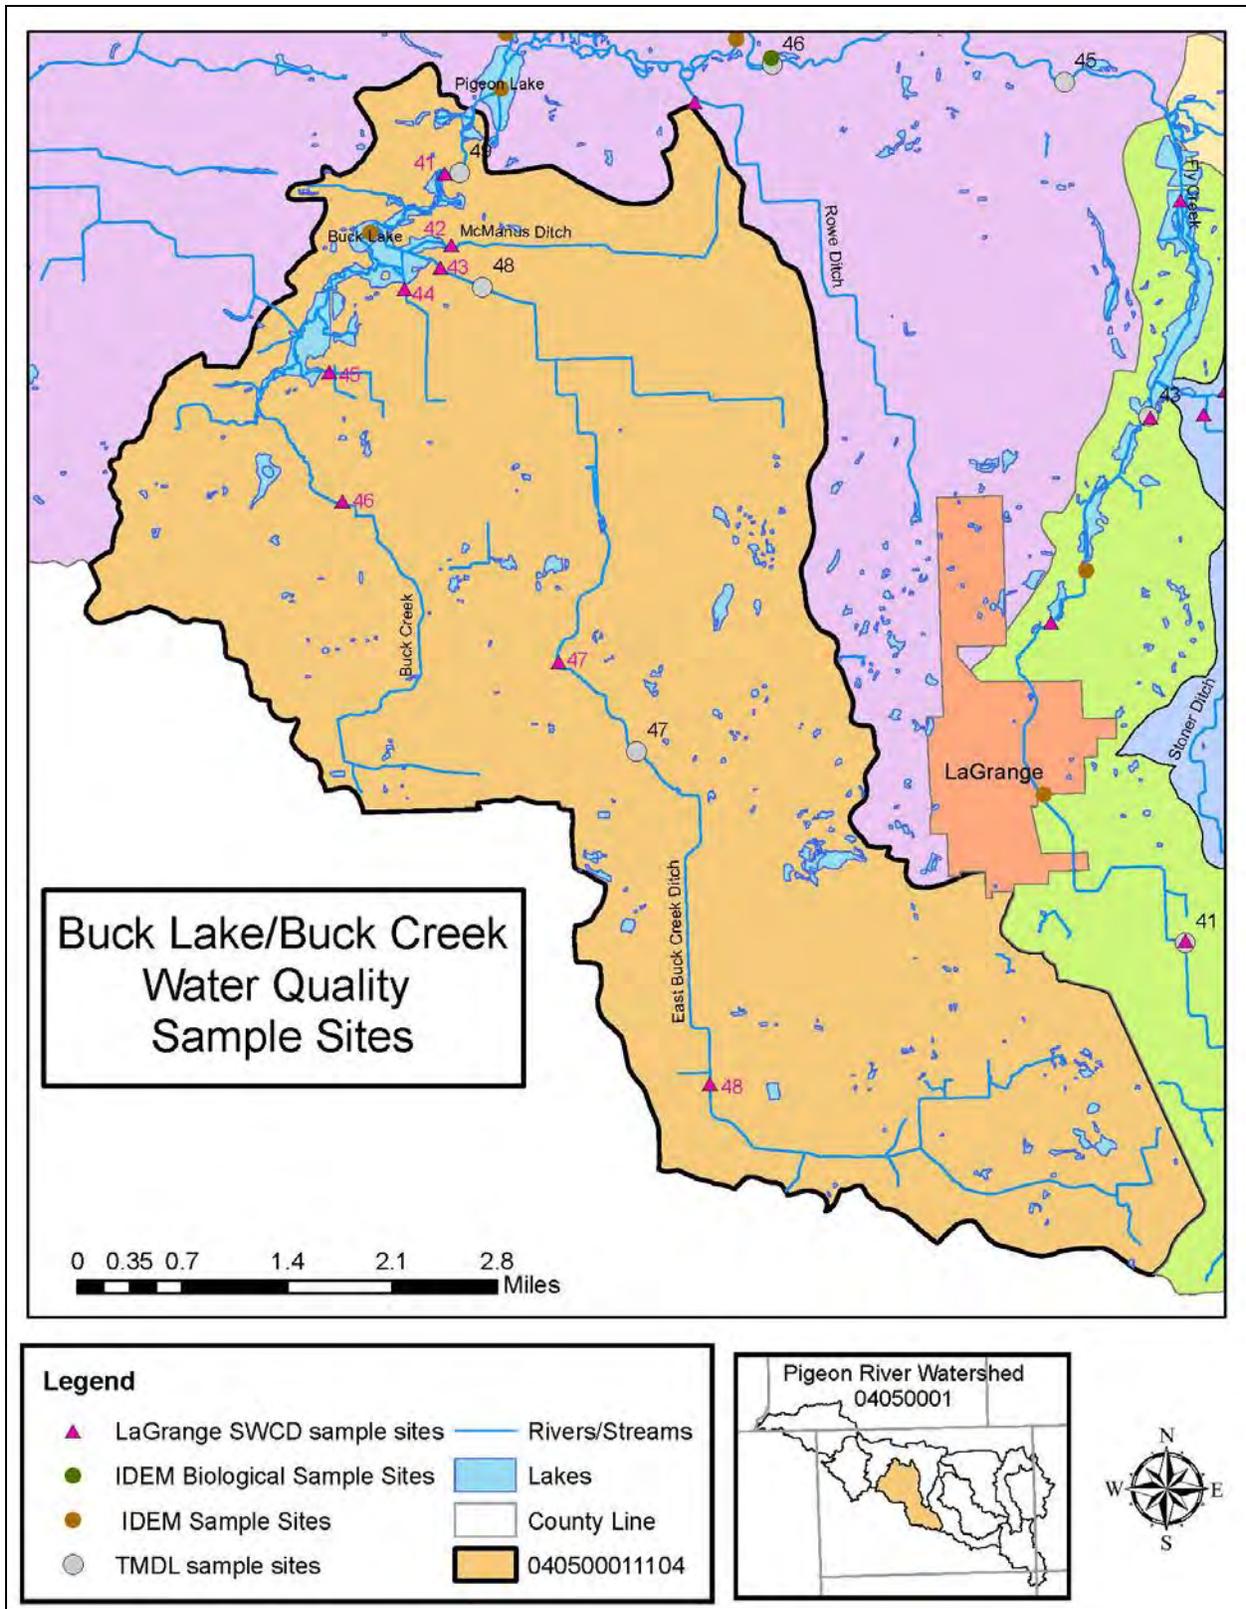
Figure 21: Buck Lake/Buck Creek Water Quality Sample Sites

There are twelve total water quality sampling sites located within the Buck Lake/Buck Creek subwatershed, as can be seen in Figure 21. One site was used by IDEM for the 303(d) list; three sites were used by IDEM for the TMDL report, of which one was used to collect biological data, and eight sample sites were used by LaGrange County SWCD to collect water quality data for the purposes of this WMP project.

Three sample sites within Buck Lake/Buck Creek subwatershed were selected and analyzed by IDEM for the Pigeon Creek and Pigeon River TMDL. The sites were sampled in June, July and September, 2010. As can be seen in Table 44, nitrate-nitrite, TKN, and D.O. were the only parameters that exceeded the target levels. TKN exceeded the target level of 0.076 mg/L in 100% of the samples, nitrate-nitrite exceeded the target level of 1.5 mg/L in 67% of the samples, and D.O. exceeded the target level of < 9mg/L in 33% of the samples. It should also be noted that biological data was collected at one site in Buck Lake/Buck Creek subwatershed. The IBI and QHEI scores for this site located on the main channel of Buck Creek indicate an excellent aquatic ecosystem.

LaGrange County SWCD sampled water quality monthly at eight sites within Buck Lake/Buck Creek subwatershed from November 2010 through August 2011. As can be seen in Table 45, all parameters did not meet the target levels at some point during the sampling cycle. D.O. did not meet target levels 76% of the time, with all of those that did not meet the target level exceeding 9 mg/L. It should also be noted that *E. coli* exceeded the state standard of 235 cfu/100 ml in 64% of the samples, total phosphorus exceeded the target level of 0.3 mg/L in 40% of the samples, and nitrates exceeded the target level of 1.5 mg/L in 67% of the samples. It would not be unreasonable to assume the high levels of D.O. are associated with the high levels of nutrients found in the water column as high levels of nutrients can contribute to excessive algae growth which will produce a lot of dissolved oxygen initially, but can cause D.O. depletion as excessive algae die and decompose. The SWCD also sampled the macroinvertebrate community located at each of the eight sample sites located in the Buck Lake/Buck Creek subwatershed. Six sites scored high enough to indicate an excellent aquatic ecosystem, while site 44, a small headwater stream leading into Buck Lake scored only to be in poor aquatic health, and site 46, another headwater stream on the western edge of the subwatershed leading into Buck Lake scored to be in fair aquatic health.

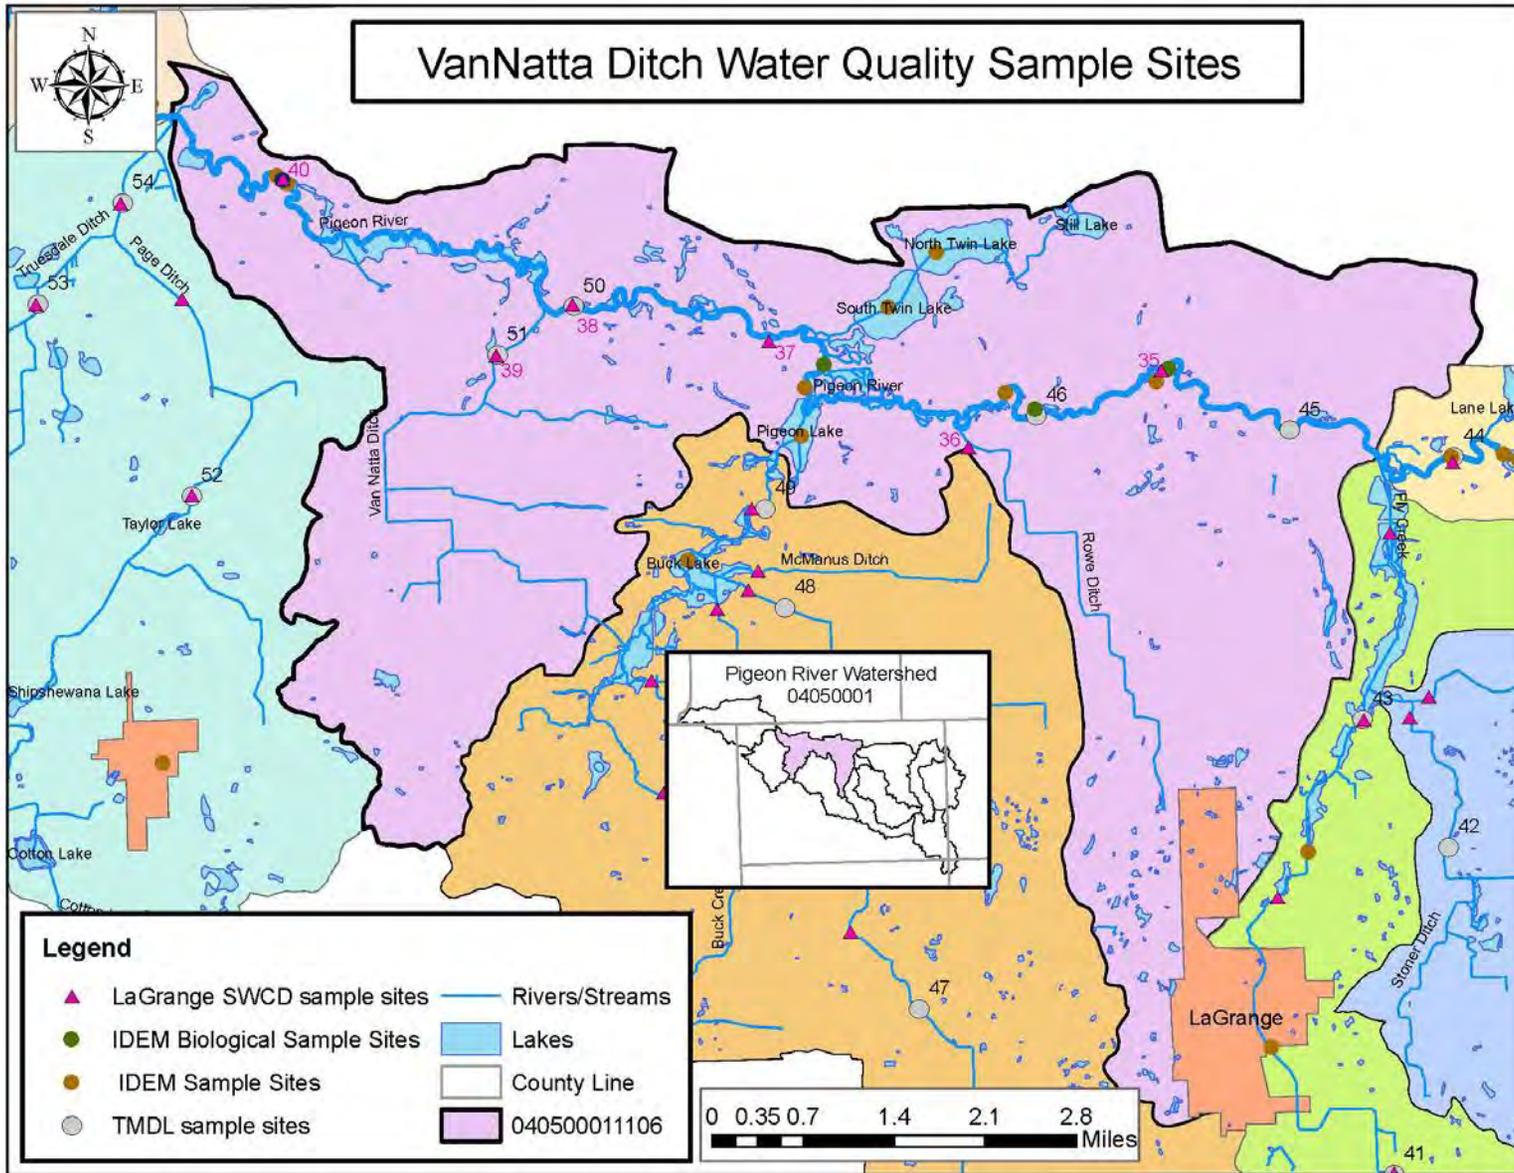
Figure 22: VanNatta Ditch Water Quality Sample Sites

There are twenty-two total water quality sampling sites located within the VanNatta Ditch subwatershed, as can be seen in Figure 22. Eight sites were used by IDEM for the 303(d) list; four sites were used by IDEM for the TMDL report, IDEM also collected biological data at four sites for use in developing the TMDL report, and six sample sites were used by LaGrange County SWCD to collect water quality data for the purposes of this WMP project.

Four sample sites within VanNatta Ditch subwatershed were selected and analyzed by IDEM for the Pigeon Creek and Pigeon River TMDL. The sites were sampled in June, July and September, 2010. As can be seen in Table 47, TKN is the only parameter that did not meet the target level. TKN exceeded the target level of 0.076 mg/L in 75% of the samples. It should also be noted that biological data was collected at four sites in VanNatta Ditch subwatershed. The IBI scores indicated a fair to good representation of fish in the ecosystem. The QHEI scores for this subwatershed indicate a fair to poor aquatic habitat.

LaGrange County SWCD sampled water quality monthly at six sites within VanNatta Ditch subwatershed from November 2010 through August 2011. As can be seen in Table 48, only TDS and TSS did not exceed target levels during the sampling cycle. Nitrate exceeded the target level of 1.5 mg/L in 48% of the samples, and total phosphorus exceeded the target level of 0.3 mg/L in 10% of the samples. D.O. did not meet target levels 55% of the time, with all of those that did not meet the target level exceeding 9 mg/L. It should also be noted that *E. coli* exceeded the state standard of 235 cfu/100 ml in 64% of the samples. It would not be unreasonable to assume the high levels of D.O. are associated to the high levels of nutrients found in the water table as high levels of nutrients can contribute to excessive algae growth which will produce a lot of dissolved oxygen initially, but can cause D.O. depletion as excessive algae die and decompose. The SWCD also sampled the macroinvertebrate community located at each of the six sample sites located in the VanNatta Ditch subwatershed. All six sites mIBI scores were high enough to indicate an excellent aquatic ecosystem.
