3.0 Watershed Inventory

3.1 Water Quality Data

3.2 Water Quality Sampling Efforts

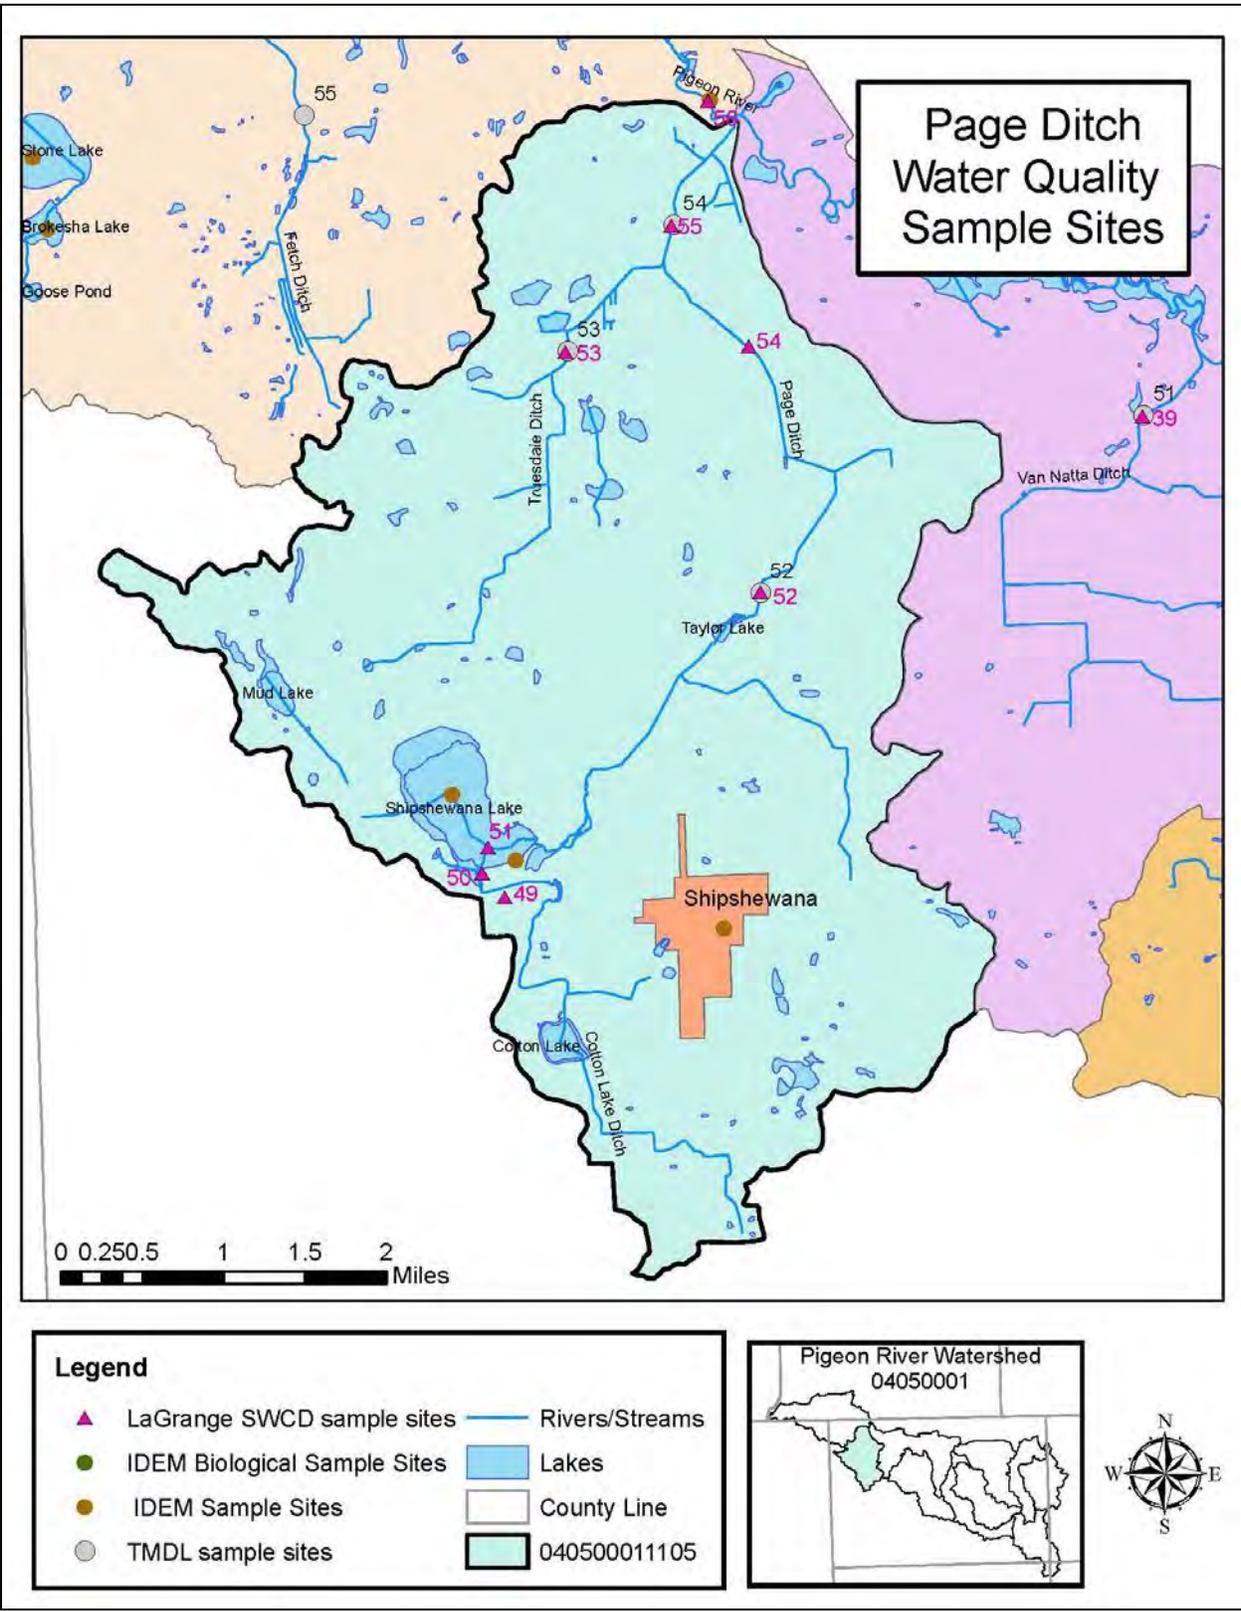
Figure 23: Page Ditch Water Quality Sample Sites

There are thirteen total water quality sampling sites located within the Page Ditch subwatershed, as can be seen in Figure 23. Three sites were used by IDEM for the 303(d) list; three sites were used by IDEM for the TMDL report, IDEM also collected biological data at two sites for use in developing the TMDL report, and seven sample sites were used by LaGrange County SWCD to collect water quality data for the purposes of this WMP project.

Three sample sites within Page Ditch subwatershed were selected and analyzed by IDEM for the Pigeon Creek and Pigeon River TMDL. The sites were sampled in June, July and September, 2010. As can be seen in Table 50, TKN, nitrate-nitrite, TSS, and total phosphorus all exceeded target levels. TKN exceeded target levels in 100% of the samples, nitrate-nitrite exceeded the target level of 1.5 mg/L in 78% of the samples, TSS exceeded the target level of 25 mg/L in 44% of the samples, and total phosphorus exceeded the target level of 0.3 mg/L in 33% of the samples. It should also be noted that biological data was collected at two sites in Page Ditch subwatershed. Site 53, a headwater stream had an IBI score indicative of an excellent macroinvertebrate community while site 54 scored much lower indicating a poor macroinvertebrate community. The same pattern was seen with the QHEI scores where site 53 scored high enough to be considered an excellent aquatic habitat, and site 54 scored much lower indicating a poor aquatic ecosystem. Several differences help explain such a wide gap in scores between sites. Site 53 has many wetland areas adjacent to the ditch system and fewer livestock influences while site 54 has fewer wetland buffers allowing greater livestock influences. In addition site 54 is directly influenced by the town of Shipshewana and a much higher rural population.

LaGrange County SWCD sampled water quality monthly at seven sites within Page Ditch subwatershed from November 2010 through August 2011. As can be seen in Table 51, all parameters did not meet target levels at least once during the sample cycle. It should be noted that nitrate exceeded the target level of 1.5 mg/L in 78% of the samples, and total phosphorus exceeded the target level of 0.3 mg/L in 70% of the samples. This may account for D.O. not meeting target levels in 61% of the samples with only 1% of those falling below 4 mg/L. *E. coli* exceeded the state standard of 235 cfu/ml in 51% of the samples. Turbidity exceeded the target level of 10.4 NTU in 29% of the samples and TSS exceeded the target level of 25 mg/L in 17% of the samples which indicates there may be some erosion issues, raw sewage entering the water column, livestock access or barnyard runoff in the Page Ditch subwatershed. The SWCD also sampled the macroinvertebrate community at each of the seven sample sites located in the Page Ditch subwatershed. All seven sites mIBI scores were high enough to indicate a good to excellent aquatic ecosystem.

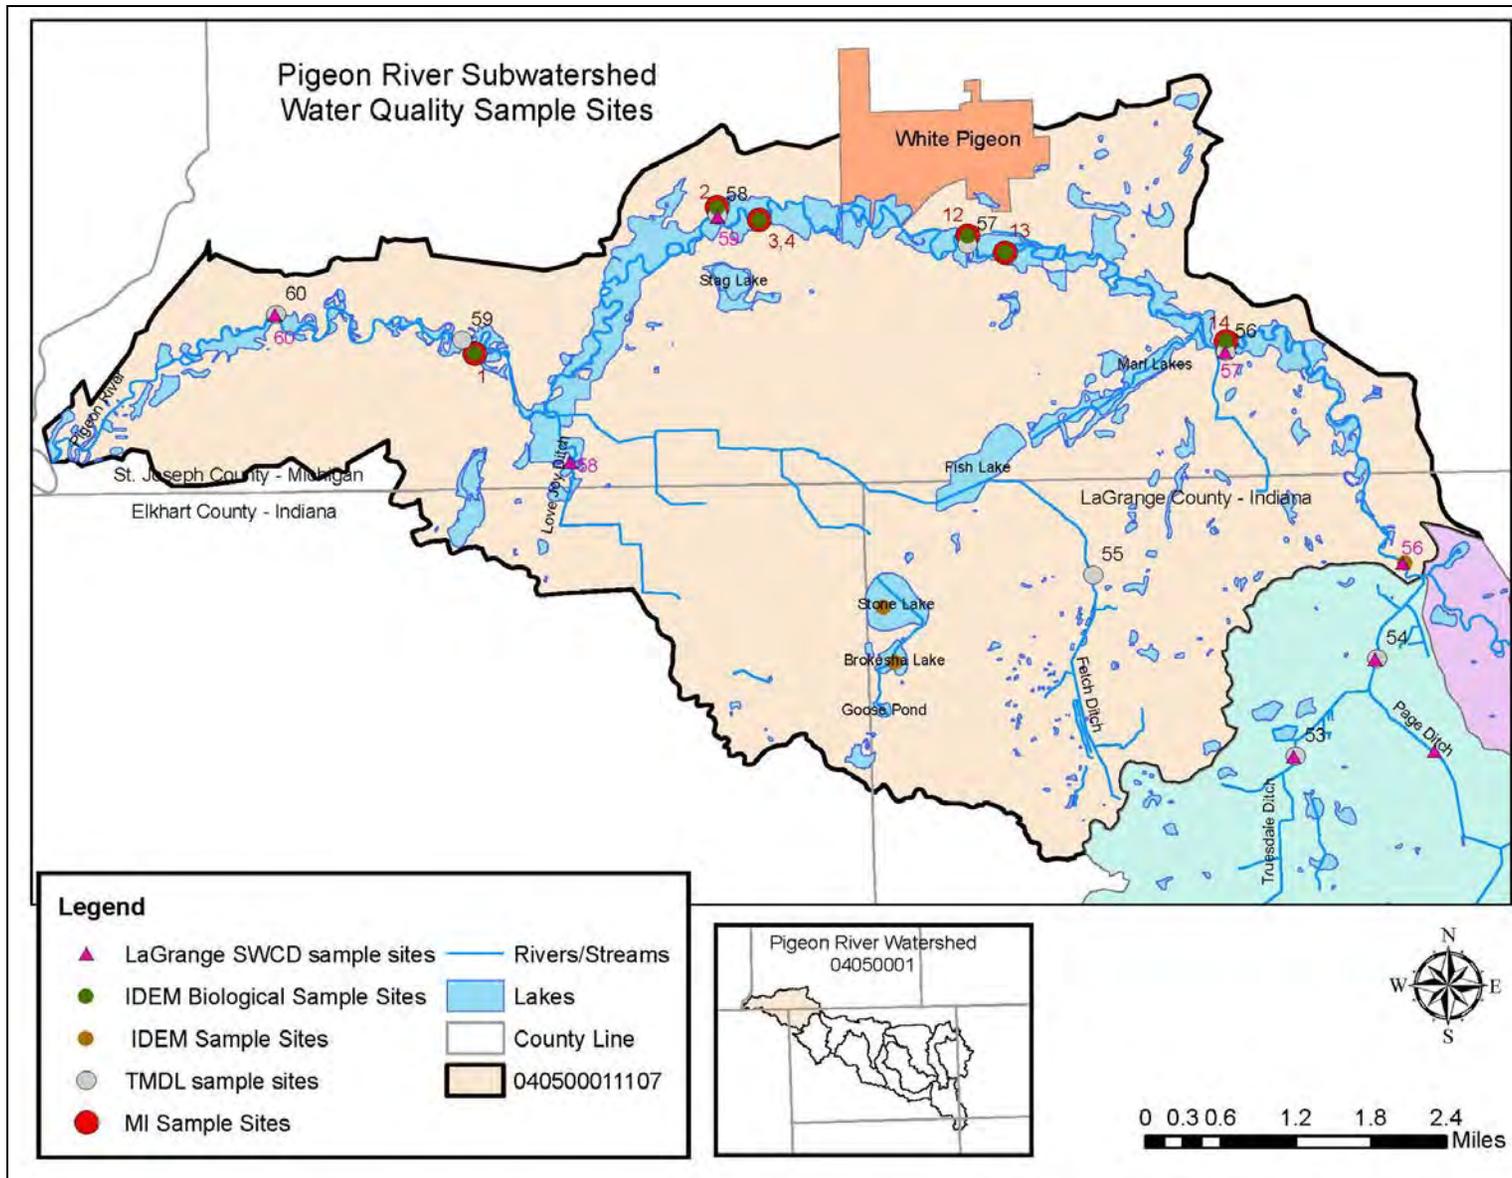
Figure 24: Pigeon River Subwatershed Water Quality Sample Sites

Six sample sites within Pigeon River subwatershed were selected and analyzed by IDEM for the Pigeon Creek and Pigeon River TMDL. The sites were sampled in June, July and September, 2010. As can be seen in Table 54, TKN, TSS, and D.O. all exceeded target levels. TKN exceeded target levels in 94% of the samples which can be attributed to traditional farming practices and the ditch system containing many tile outflows. TSS exceeded the target level of 25 mg/L in one of the samples, and D.O. exceeded the target level in 34% of the samples. It should also be noted that biological data was collected at four sites in Pigeon River subwatershed. All four sites are located on the Pigeon River main stem with sites 56 and 57 upstream of White Pigeon and sites 58 and 59 downstream of White Pigeon. The IBI score for site 56 ranked the fish community to be in fair health, and the QHEI score for site 56 ranked the aquatic habitat to be in poor to fair health. The IBI score for sites 57 and 58 were both 22 which indicates a poor fish community and the QHEI score for both sites indicate a very poor aquatic habitat. The IBI score for site 59 was very high indicating an excellent fish community and the QHEI score was also very high indicating an excellent aquatic ecosystem.

LaGrange County SWCD sampled water quality monthly at five sites within Pigeon River subwatershed from November 2010 through August 2011. As can be seen in Table 56, all parameters did not meet target levels at least once during the sample cycle except for TDS which never exceeded the target level. It should be noted that nitrate exceeded the target level of 1.5 mg/L in 52% of the samples, and D.O. exceeded 9mg/l in 44% of the samples. It should also be noted that temperature exceeded the maximum target level in 26% of the samples analyzed. However, when compared to recent water quality analysis in other subwatersheds, Pigeon River subwatershed ranks higher in overall water quality. The SWCD also sampled the macroinvertebrate community located at each of the five sample sites located in the Pigeon River subwatershed. All five sites mIBI scores were high enough to indicate an excellent aquatic ecosystem.

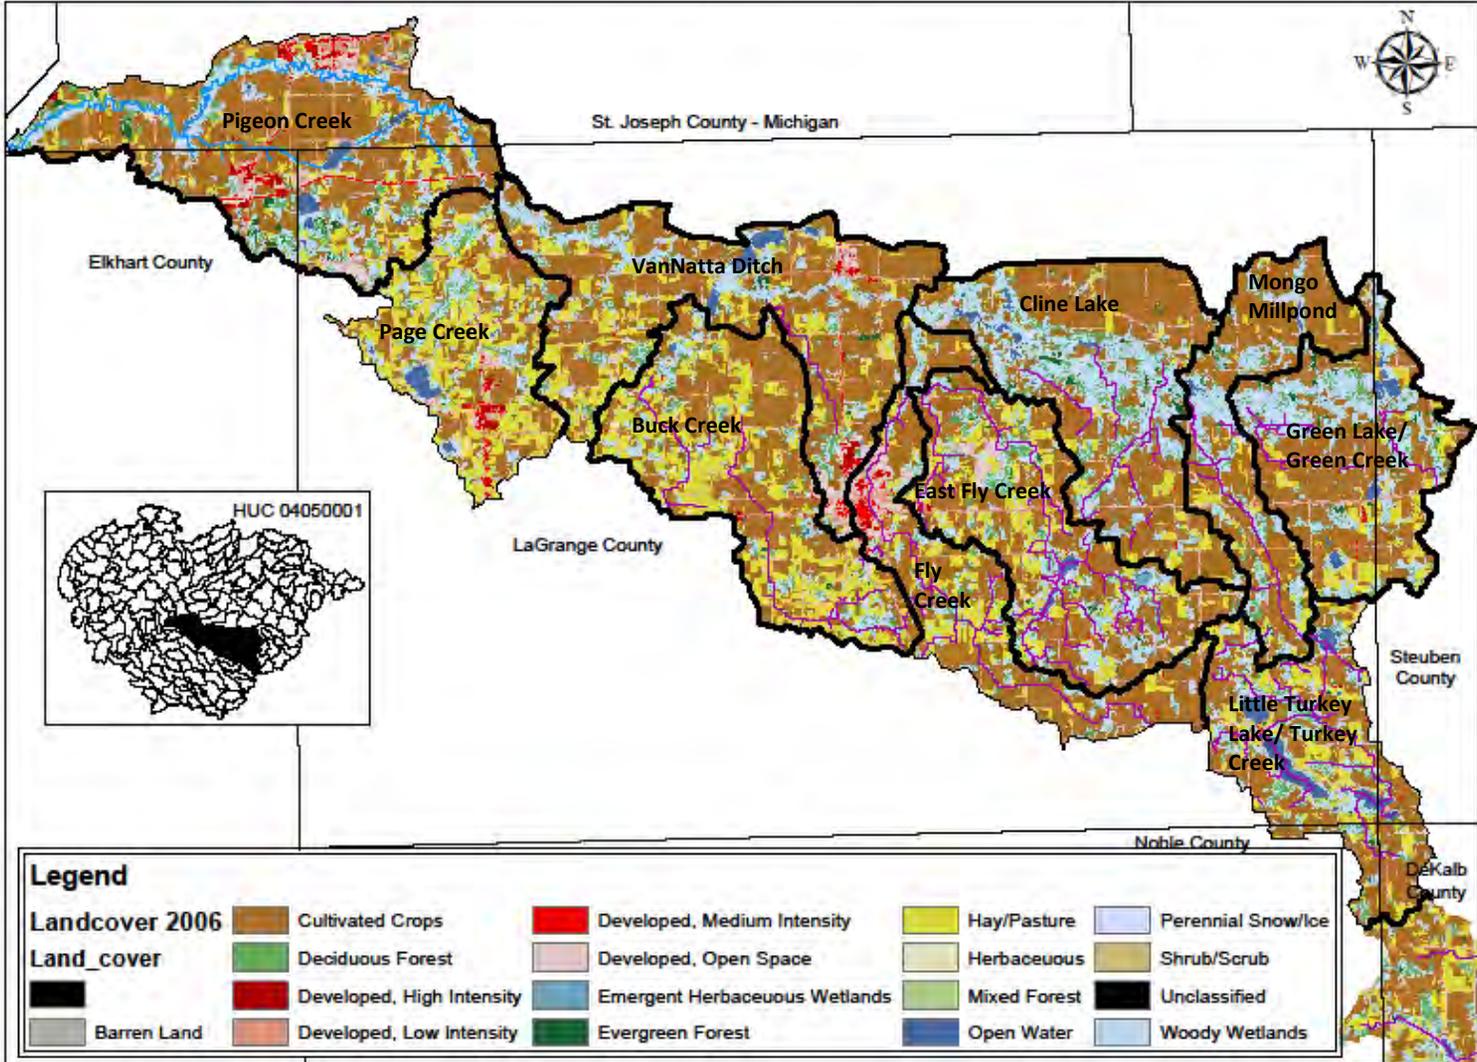
Figure 25: Land Use in the Pigeon River Project Area

Although there are few urban areas in the project area, it has been found that urban and lake resident stakeholders do have influence on the water system in the project area. Educational outreach is ongoing with groups such as the Steuben and Lagrange County Lake Associations, and working with the growing community of Shipshewana is planned for the future. Working with the built-up communities in the project area will play a major role in reducing NPS from urban and lake resident sources. However, the quickest and most dramatic results in reducing nonpoint source pollutants lie in utilizing BMP installation within the agricultural community. Below is a breakdown of land use gathered in the project area including NPDES permitted facilities, potential pollution sources, and areas of concern which were identified through an extensive watershed survey. Looking at the land use practices and issues at a subwatershed level will help to identify where efforts should be focused to reduce NPS in surface water.

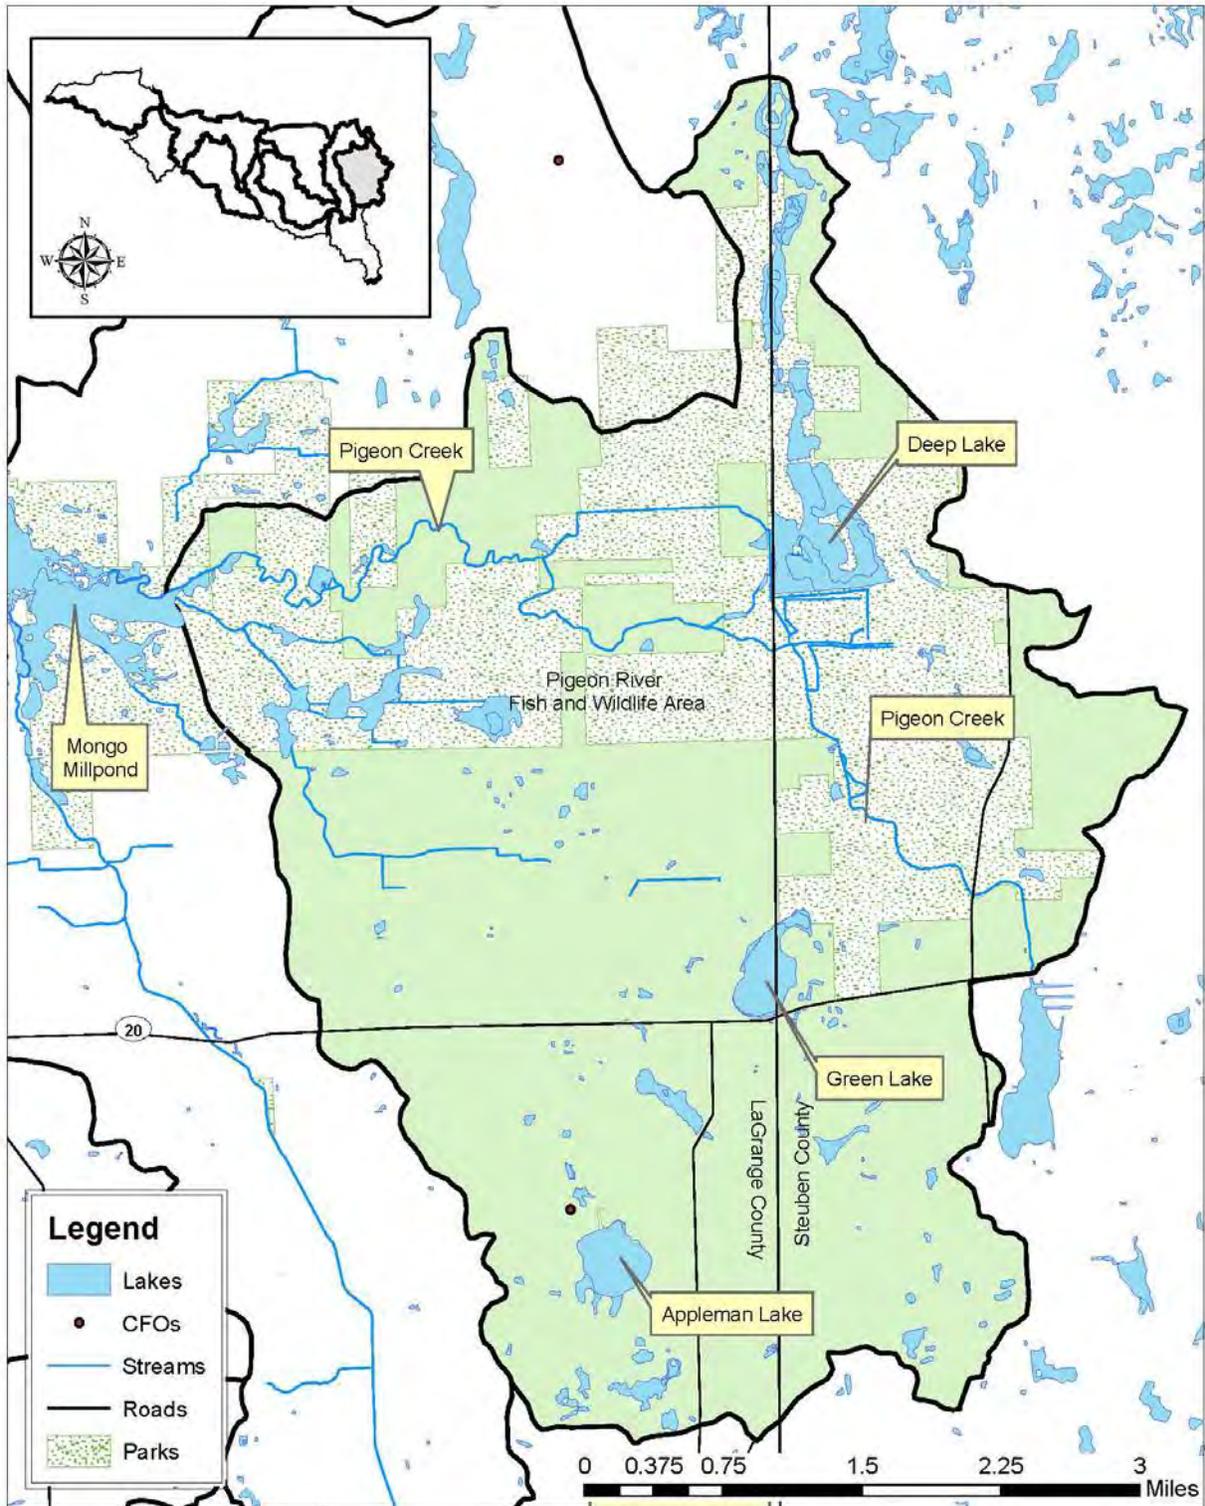
Figure 26: Green Lake-Green Creek Sub-Watershed

The Green Lake-Green Creek subwatershed is located on the east edge of the project area in Steuben and LaGrange counties (Figure 26). The watershed is 13,562 acres (5488.35 hectares) in size and contains Green Lake, Deep Lake, and Appleman Lake. The major influence on water quality in Green Lake – Green Creek subwatershed is agriculture as cultivated crops and grass and/or pasture take up approximately 60% of the land (Table 60).

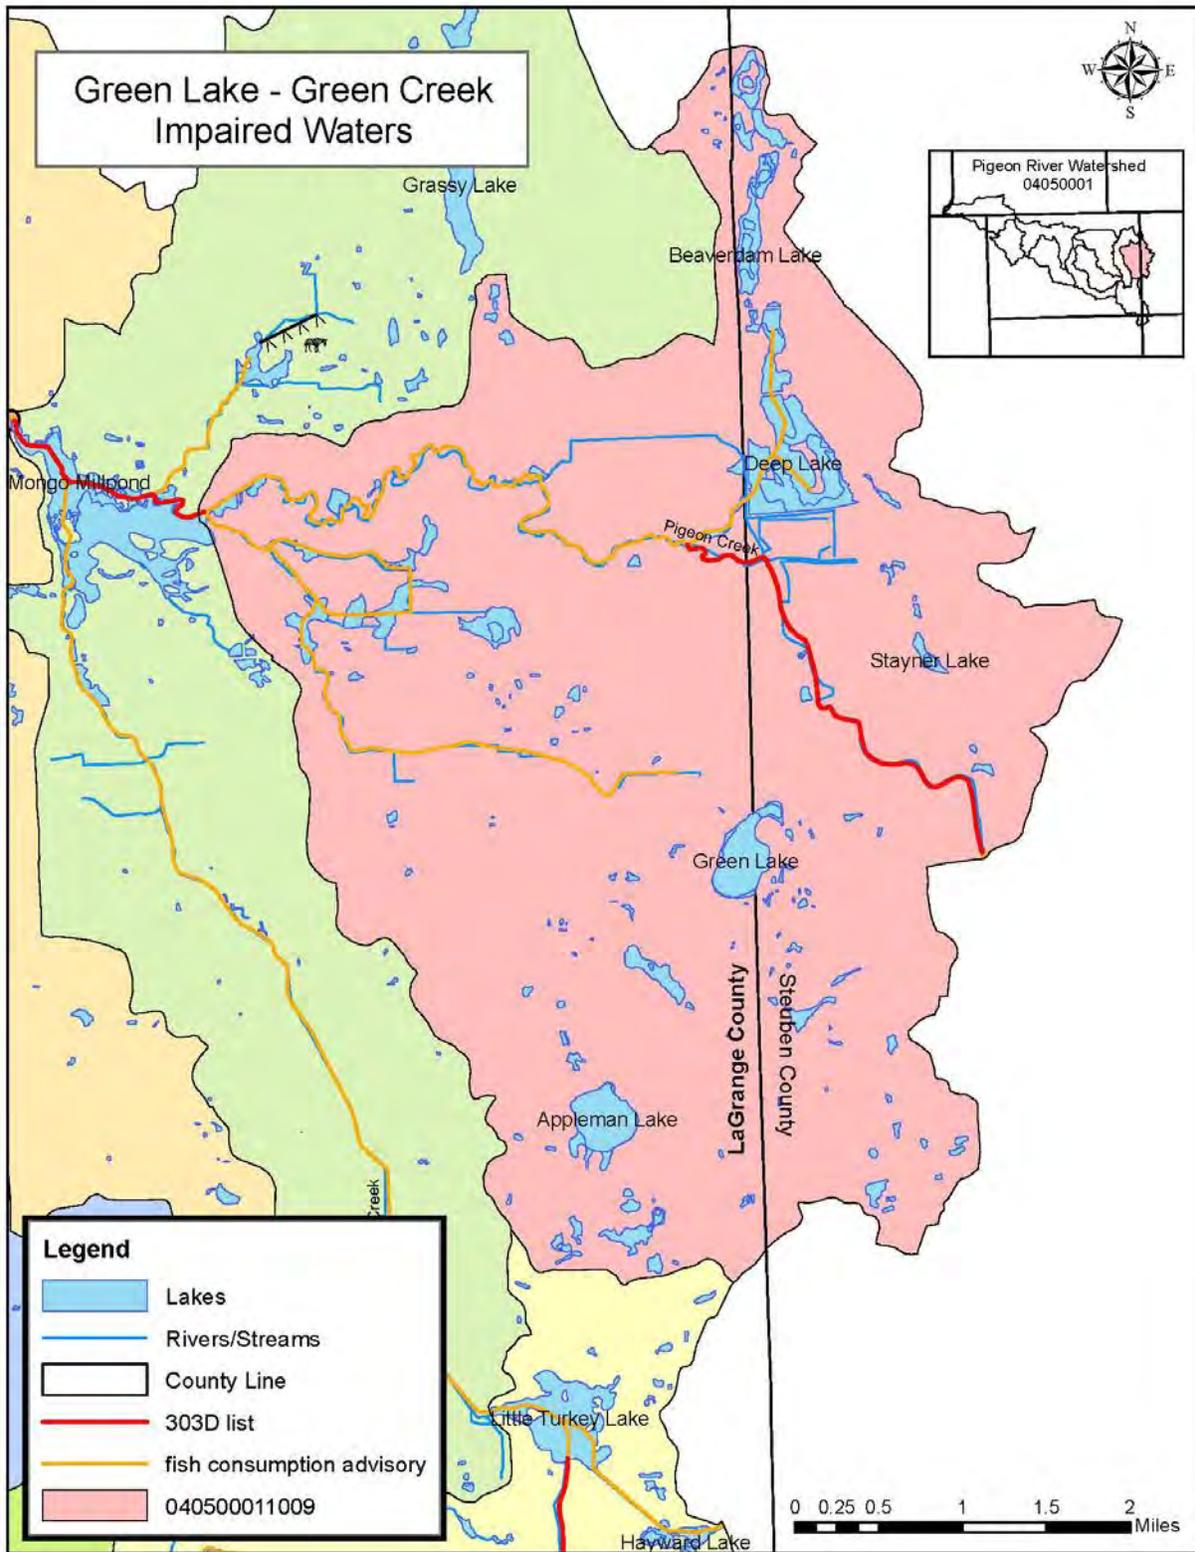
Figure 27: Green Lake – Green Creek Impaired Waters

Pigeon Creek, located within Green Lake-Green Creek subwatershed, is listed on the 2008 303(d) list of impaired waters for *E. coli* and Impaired Biotic Communities. Pigeon Creek is also listed in the Indiana Fish Consumption Advisory. Figure 27 displays those waterways that are listed as impaired by the state of Indiana.

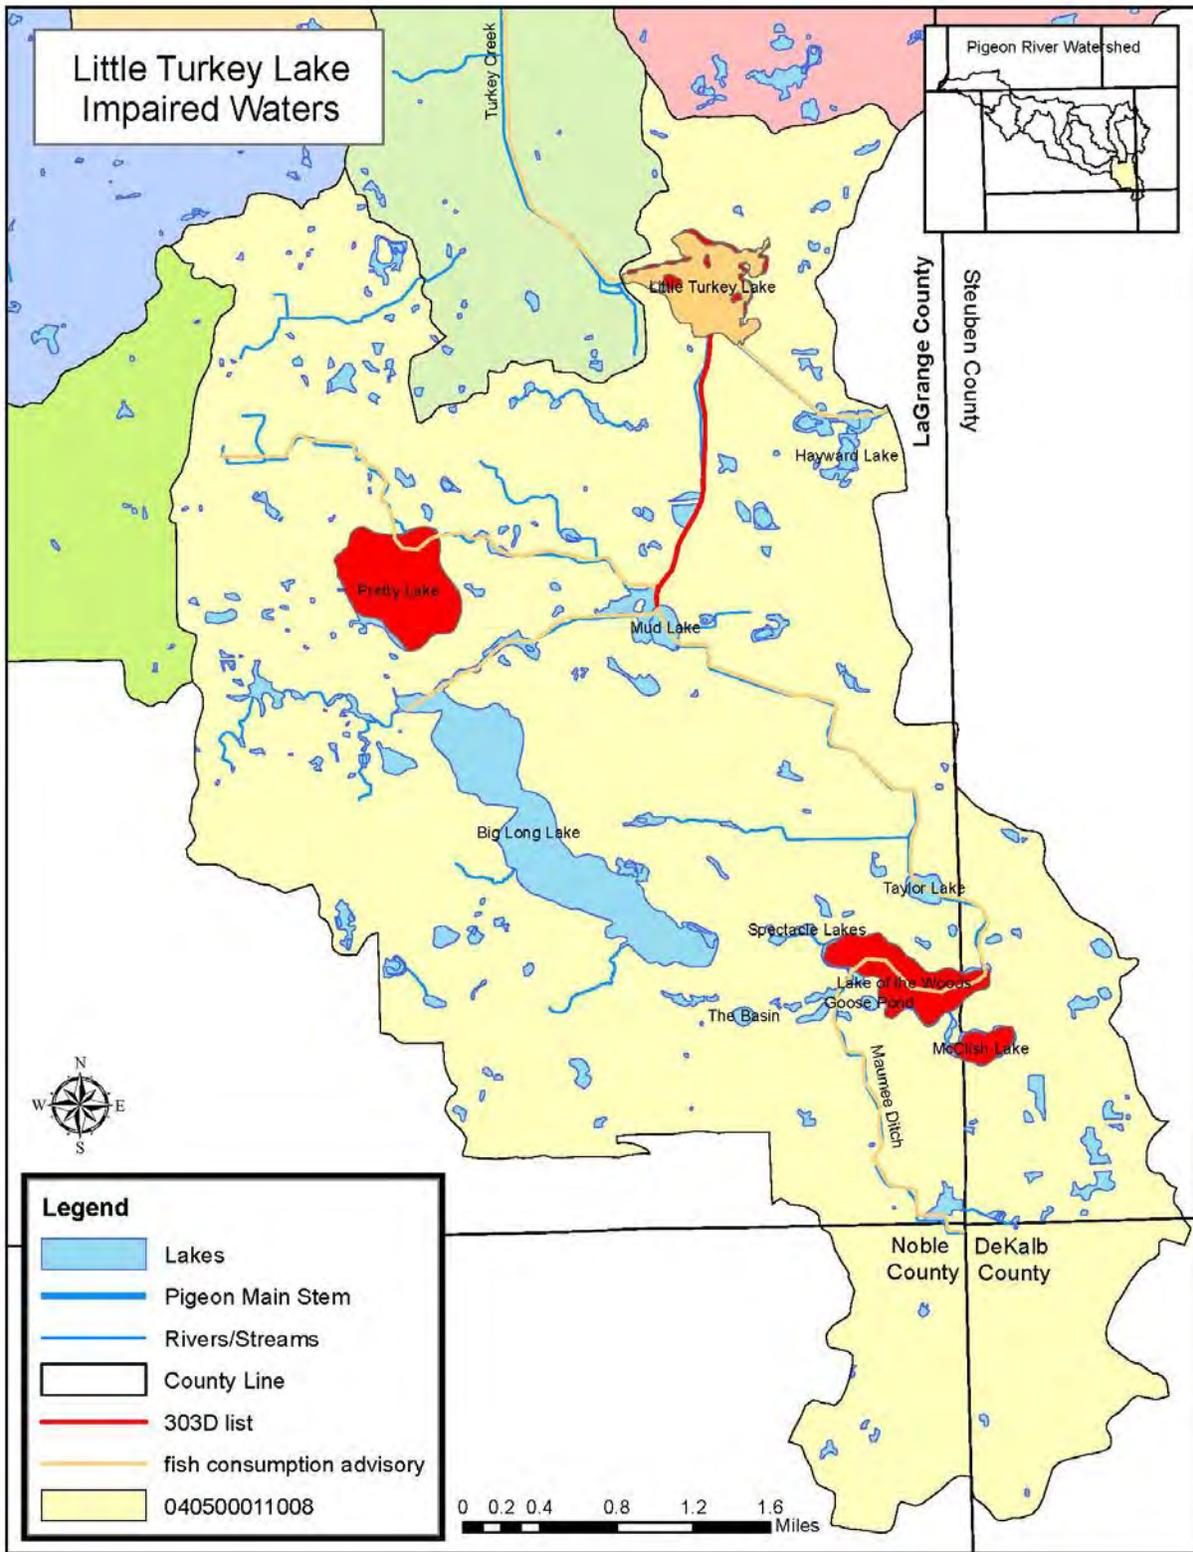
Figure 31: Little Turkey Lake Impaired Waters

An unnamed tributary to Turkey Creek is listed on Indiana’s 2008, 303(d) list of impaired waters for dissolved oxygen and *E. coli*. Lake of the Woods and McClish Lake are listed for an impaired biotic community (IBC), Lake of the Woods and Pretty Lake are listed for mercury in fish tissue, and Little Turkey Lake is listed for phosphorus. Turkey Creek, Maumee Ditch and three unnamed tributaries are on the Indiana Fish Consumption advisory for black Crappie and Bluegill, both ranked as a Group 1 advisory. These impairments can be seen on Figure 31.

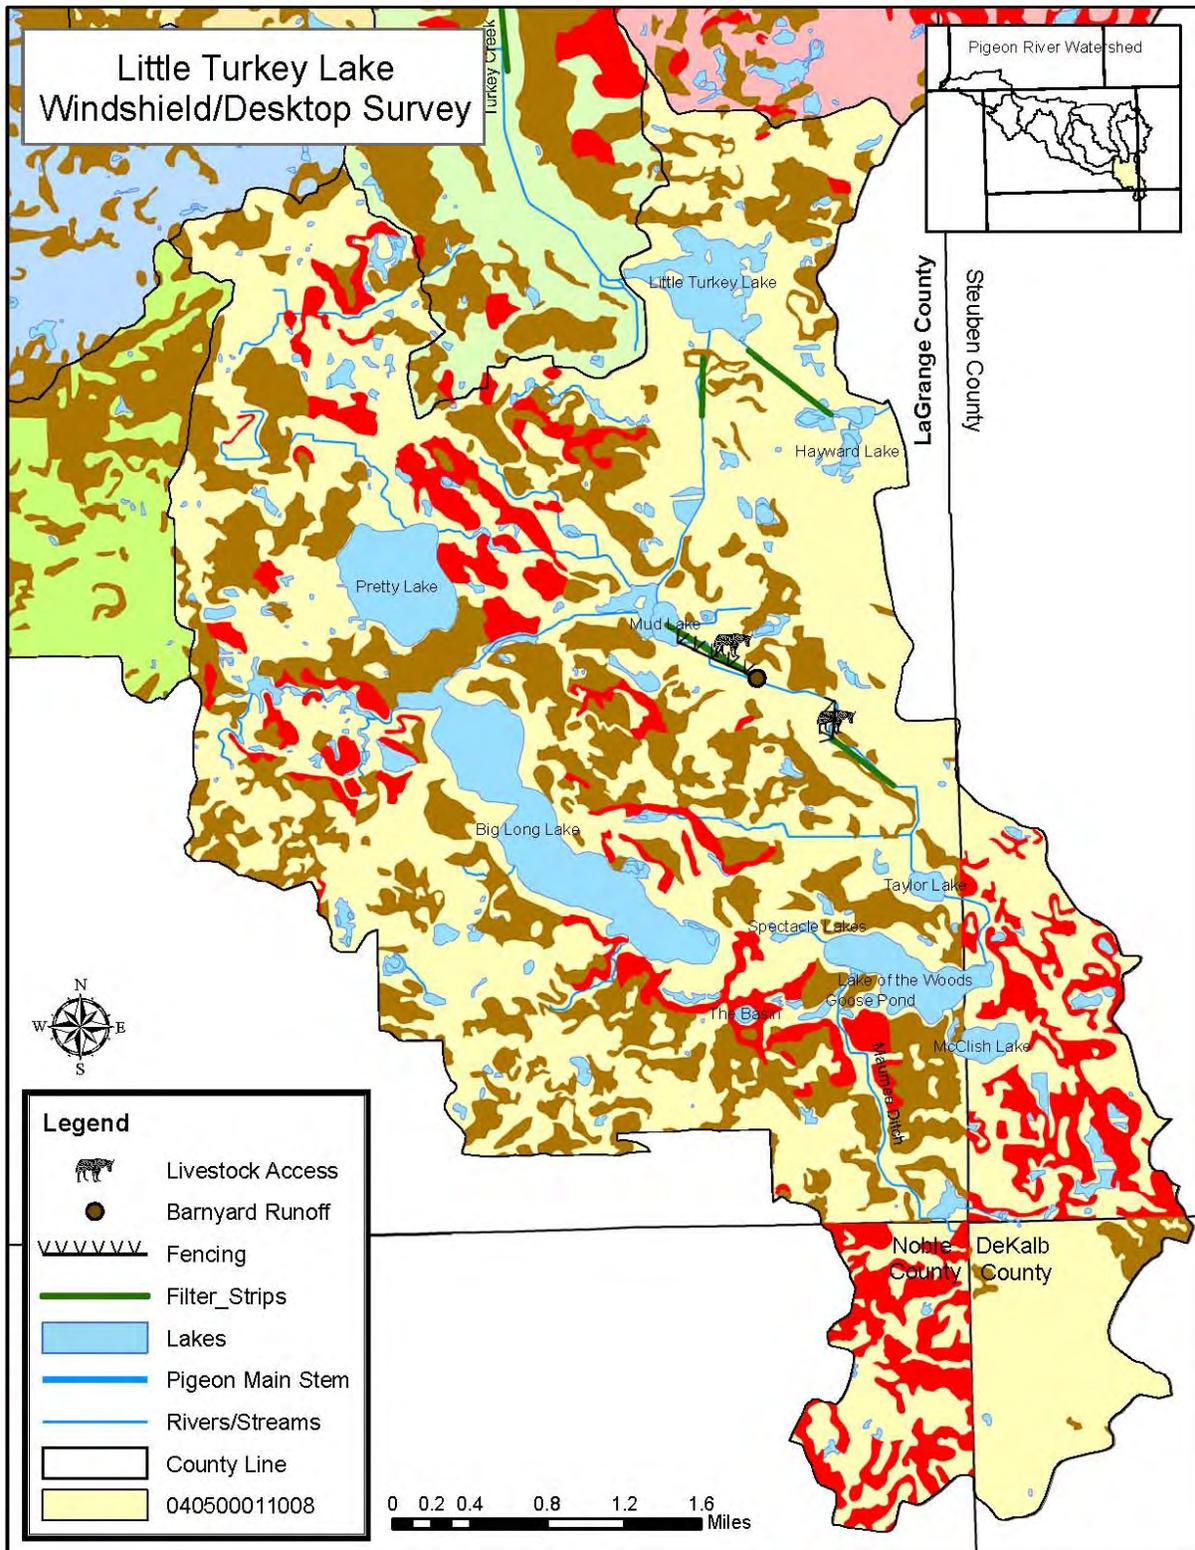
Figure 33: Little Turkey Lake – Turkey Creek Windshield/Desktop Survey

Windshield and desktop surveys revealed that Little Turkey Lake is primarily influenced by agriculture, including many animal feeding operations. Several sites were noted while performing the windshield survey which can be seen in Table 65 and Figure 33. The surveys also revealed the large amount of soil located within Little Turkey Lake subwatershed that is ranked as either HEL or PHEL. Special care will need to be taken by landowners who are farming this land.

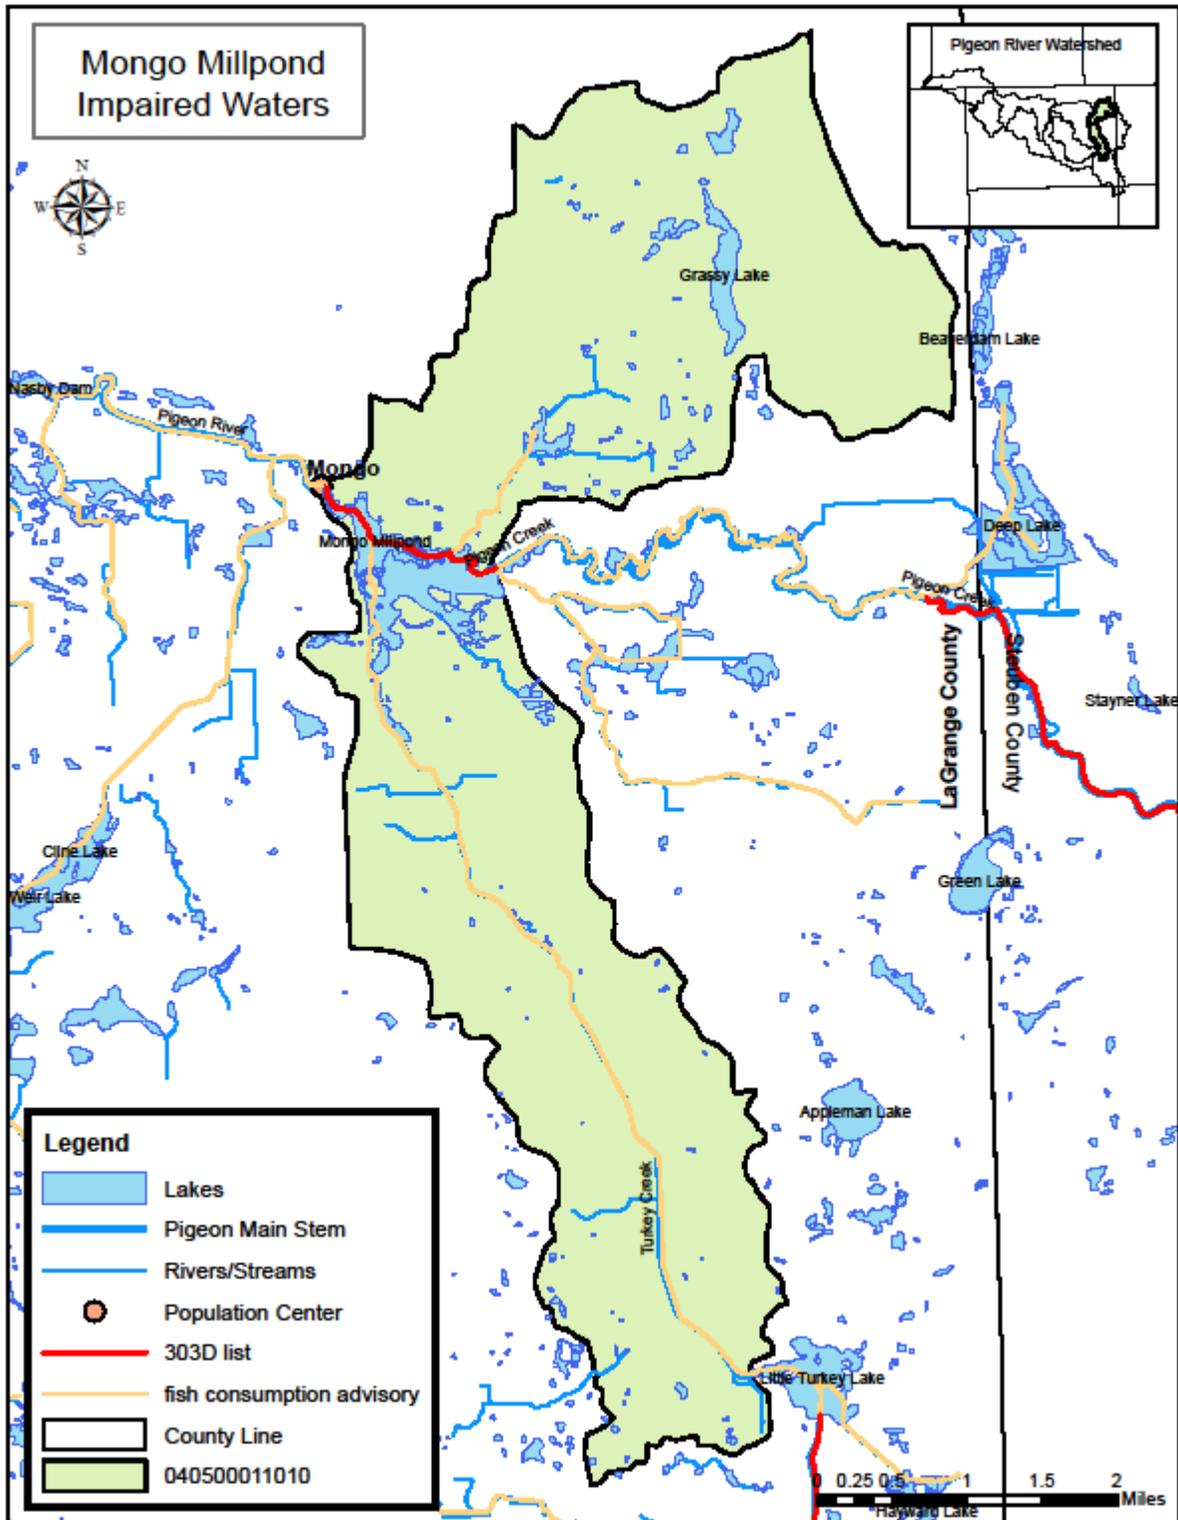
Figure 35: Mongo Millpond Impaired Waters

Pigeon Creek, located east of the Mongo Millpond, is listed on the Indiana 2008, 303(d) list of impaired waters for *E. coli*. Turkey Creek and an unnamed tributary to Mongo Millpond are listed on the Indiana fish consumption advisory (Figure 35).

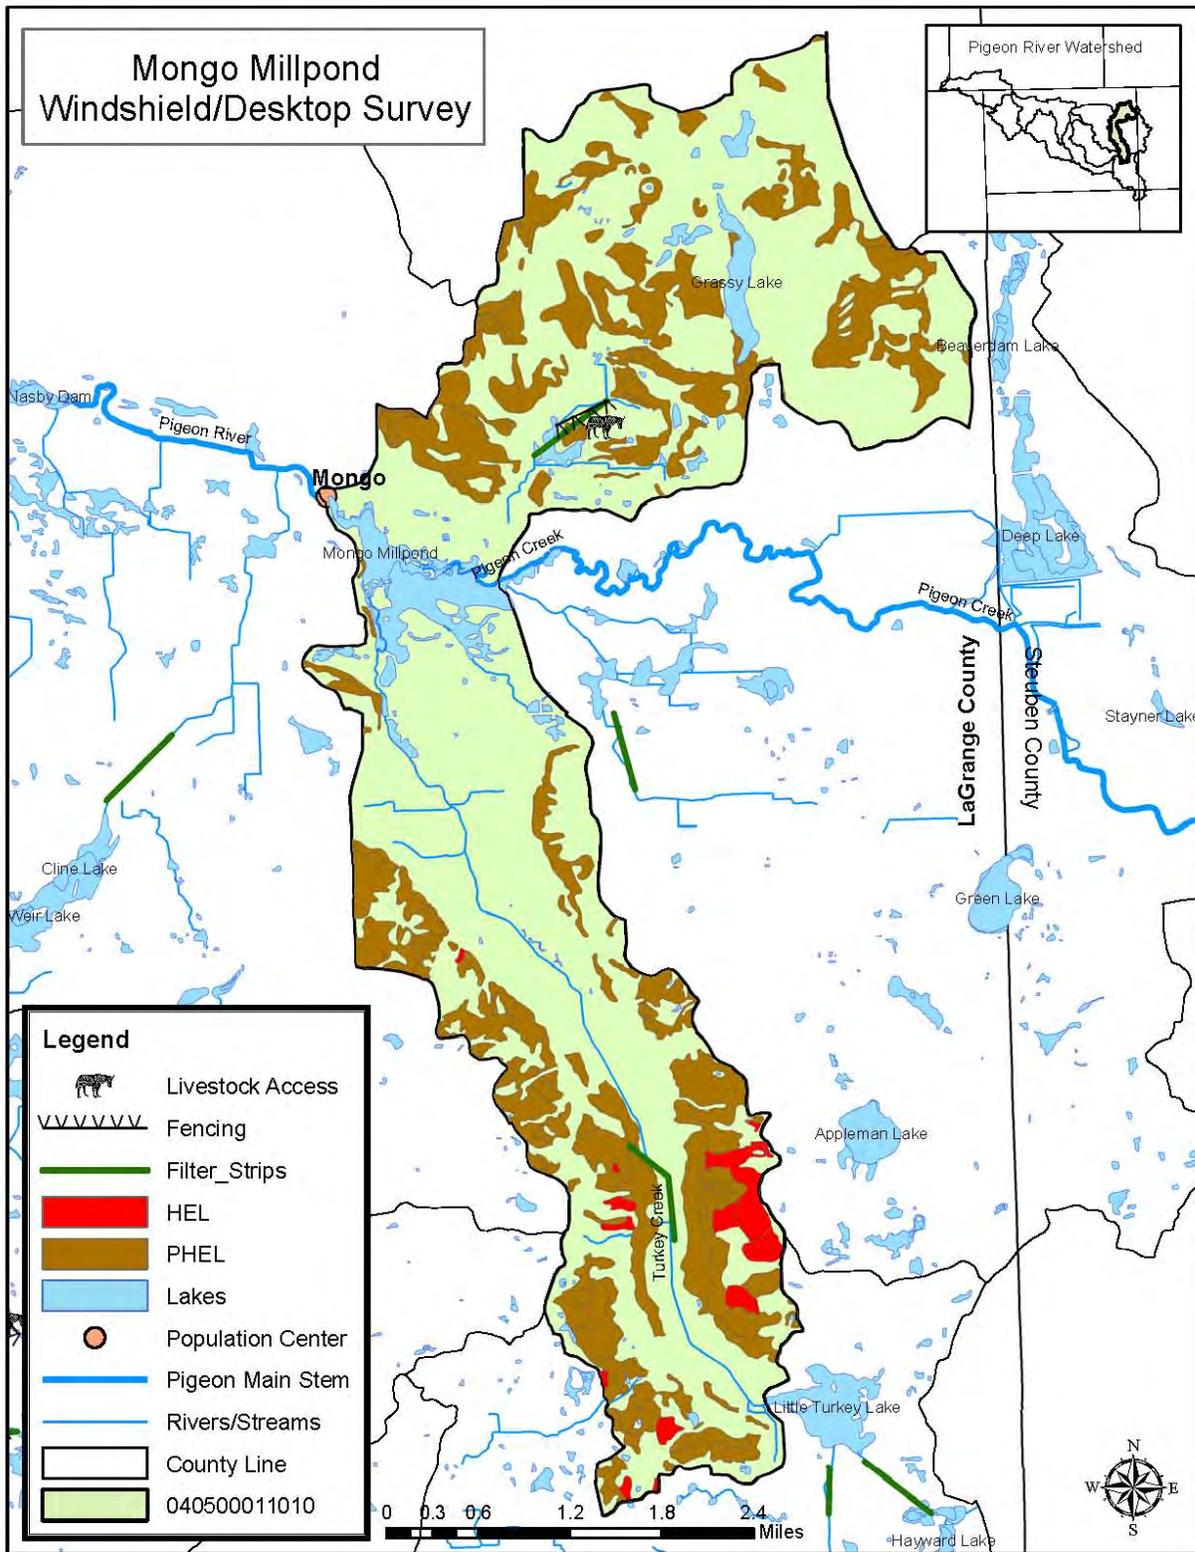
Figure 37: Mongo Millpond Windshield/Desktop Survey Results

The windshield and desktop survey revealed that the Mongo Millpond is primarily influenced by agricultural fields along Pigeon Creek south of the main channel which flows through Pigeon River Fish and Wildlife Area. The north lateral ditch is filtered through a series of wetlands. While the majority of the town of Mongo is located in the Cline Lake subwatershed, it is important to this project as the town of Mongo surrounds the tail-waters and is not on a centralized sewer system. Improperly maintained or faulty septic systems may have some influence on pollutants entering the main river channel. As was mentioned in section 2.6, the LaGrange County Health Department estimates that nearly 75% of installed septic systems are currently failing. However, visual observations of Mongo Millpond revealed one area in particular where livestock have direct access to open water as a drinking water source which can lead to significant sedimentation and high nutrient and *E. coli* levels in the water column. Where the livestock have access to the stream, the bank has become completely denuded of vegetation and is in need of a riparian buffer. The survey also revealed the large amount of soil rated as PHEL. Table 68 and Figure 37 show the results of the windshield and desktop surveys for the Mongo Millpond subwatershed.
