**PHASE I**  
**ENVIRONMENTAL SITE ASSESSMENT**

Six Excess Parcels for Disposal  
Adjacent to Lloyd Expressway, (SR 62)  
Evansville, IN

South of US 62 (Lloyd Expressway)  
LA Code 4913, Parcels 1, 2, 4 & 6  
LA Code 4914, Parcel 1

**Revised date 7/9/2012**

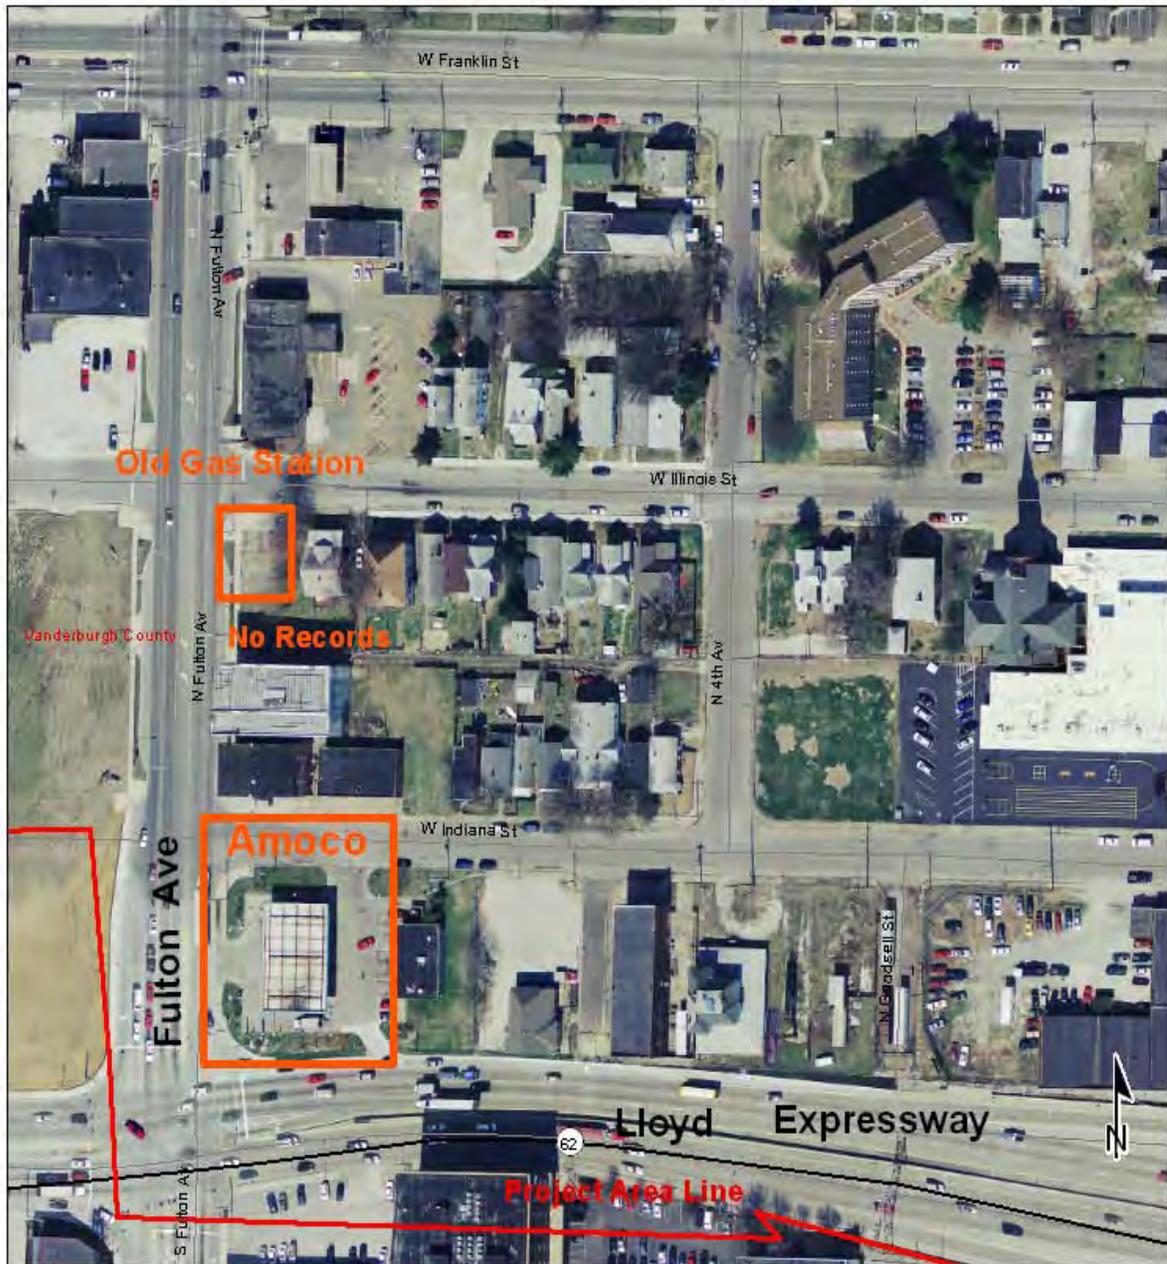
Figure 3 - Aerial Detail NE Quad  
 Lloyd Expressway & Fulton Ave  
 LA Code 4603, Parcel # 1 , Excess Parcel Disposal  
 Vanderburgh County, Indiana

Northeast Quadrant is only Quadrant with no INDOT Excess parcels

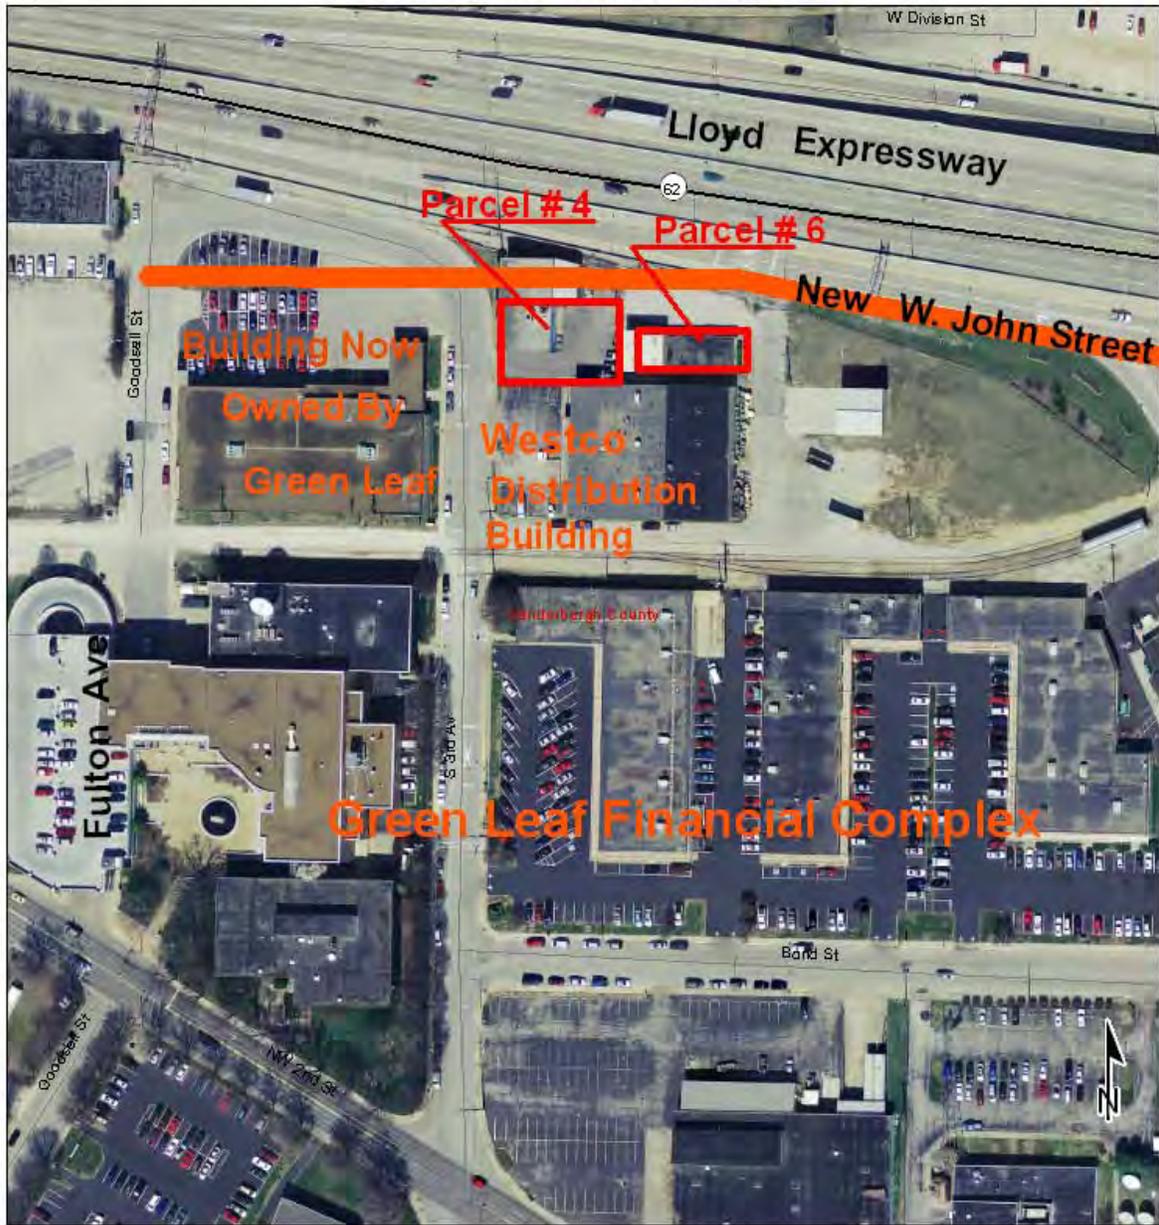
Figure 5 - Aerial Detail SE Quad  
 Lloyd Expressway & Fulton Ave  
 LA Code 4913, Parcels # 4 & #6 Excess Parcels  
 Vanderburgh County, Indiana

Southwest Quadrangle, Parcels #4 & #6  
 ——— Boundary INDOT Excess Property  
 ——— Location of New Street (St. John)

Parcels #4 and #6 are very small parcels that are east of the Shelby O’Neal Steel building. These lay immediately south of the Lloyd Expressway, and part of these parcels was taken and used for the construction of John Street and for the entrance/exit ramps for Lloyd Expressway. No environmental records for either parcel could be found. The area is now used for parking, and a 2005 aerial photograph indicates the presence of a small storage shed on parcel # 4.

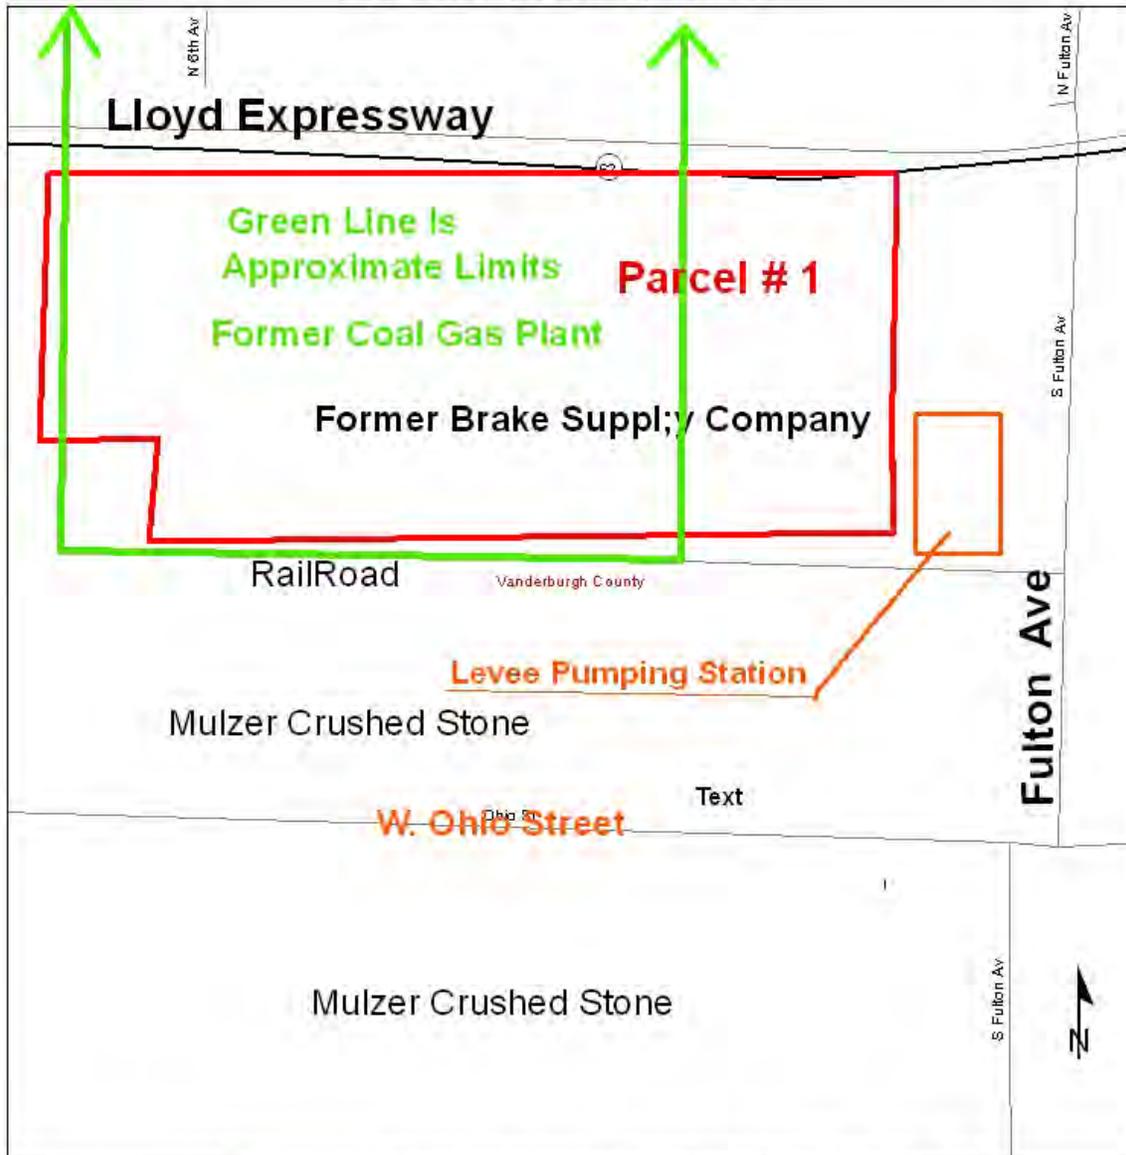
Figure 6 - Aerial Detail SW Quad  
 Loyd Expressway & Fulton Ave  
 LA Code 4914, Parcels # 1  
 Vanderburgh County, Indiana

- Approximate Boundary Coal Gas Plant
- Parcel # 4 Boundary
- Levee Pump House Boundary

The first concern is on INDOT parcel LA Code 4914 parcel 1. This parcel is the site of the former Brake Supply Company. Previous to Brake Supply Company, this parcel was used by the former manufactured gas plant. This area was the southern parcel of the manufactured gas plant where the manufacturing actually occurred. This parcel was investigated and found to have residual Contaminants of Concern (COCs) in the subsurface. These include coal tar and related compounds. In 10 of the 114 subsurface soil samples that were collected, PAHs were above the Tier II residential closure levels. These included benzo (a) anthracene, benzo (a) pyrene, benzo (b) flouranthene, and naphthalene. According to sampling results, these COCs are found in a limited portion of the property, near the former “tar wells”.

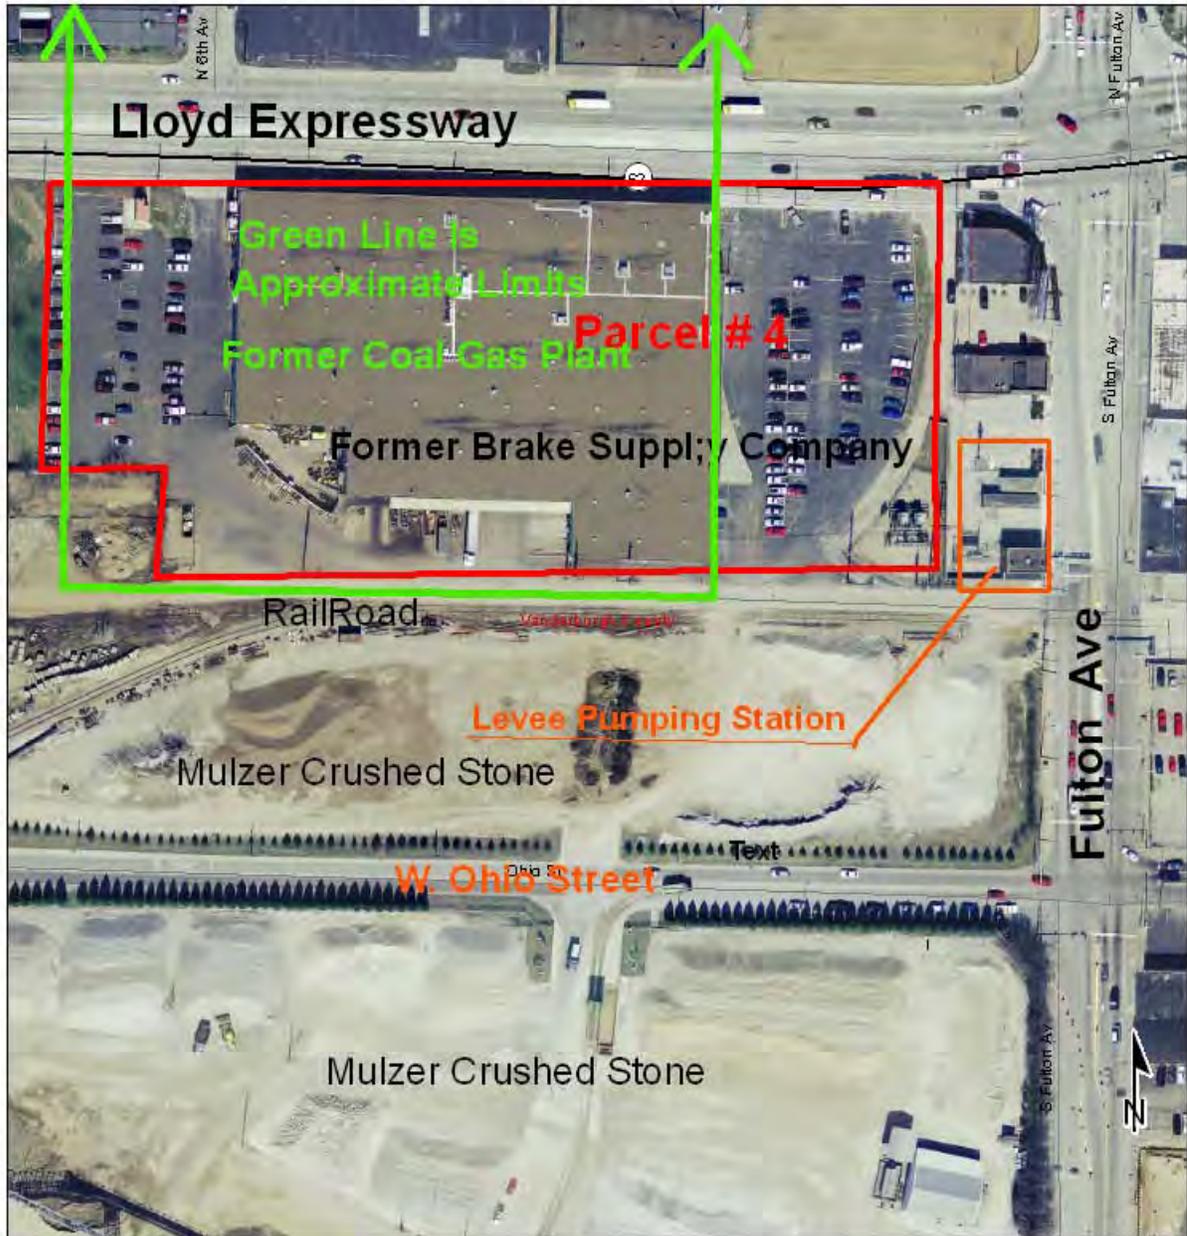
Figure 6 - Aerial Detail SW Quad  
 Lloyd Expressway & Fulton Ave  
 LA Code 4914, Parcels # 4  
 Vanderburgh County, Indiana

- Approximate Boundary Coal Gas Plant
- Parcel # 4 Boundary
- Levee Pump House Boundary

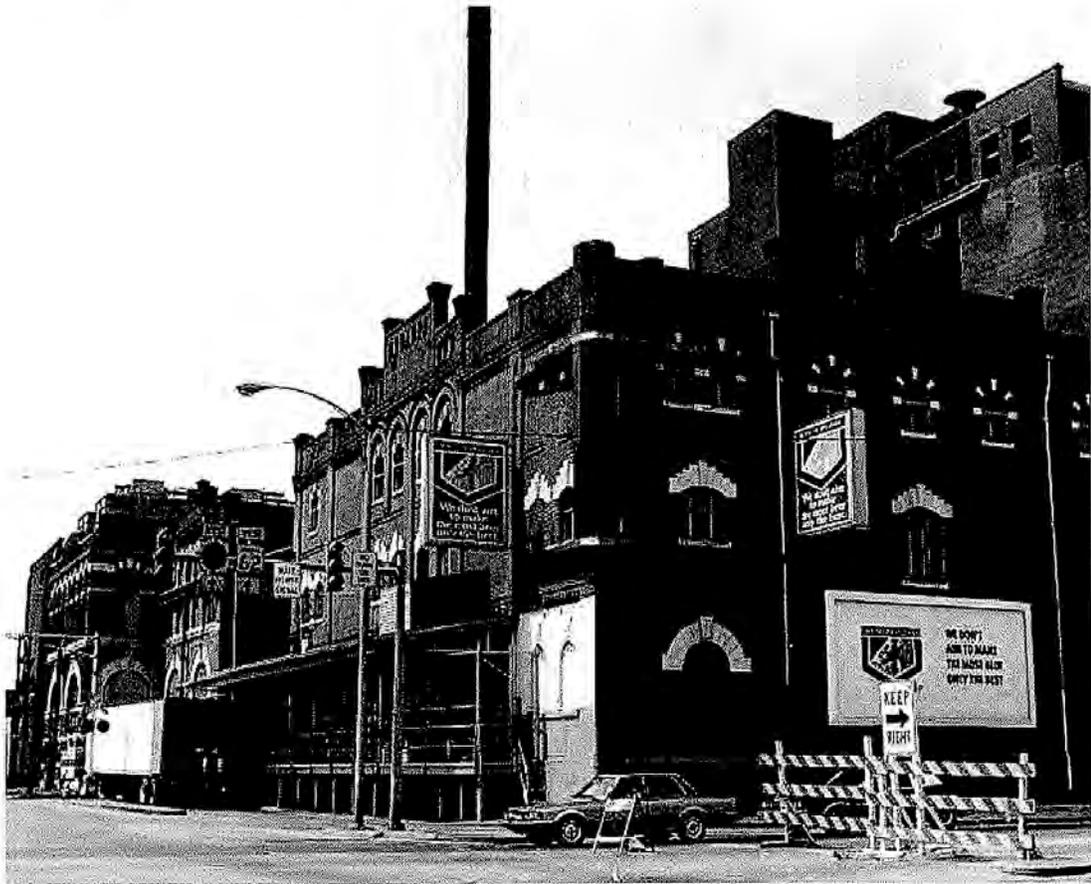
## Sterling Brewers Inc

Photograph of the now demolished Sterling Brewers building. This building was on the corner of Fulton and Pennsylvania (now Lloyds Expressway). This is in the northwest quadrant of the Lloyds Expressway and Fulton Avenue overpass.

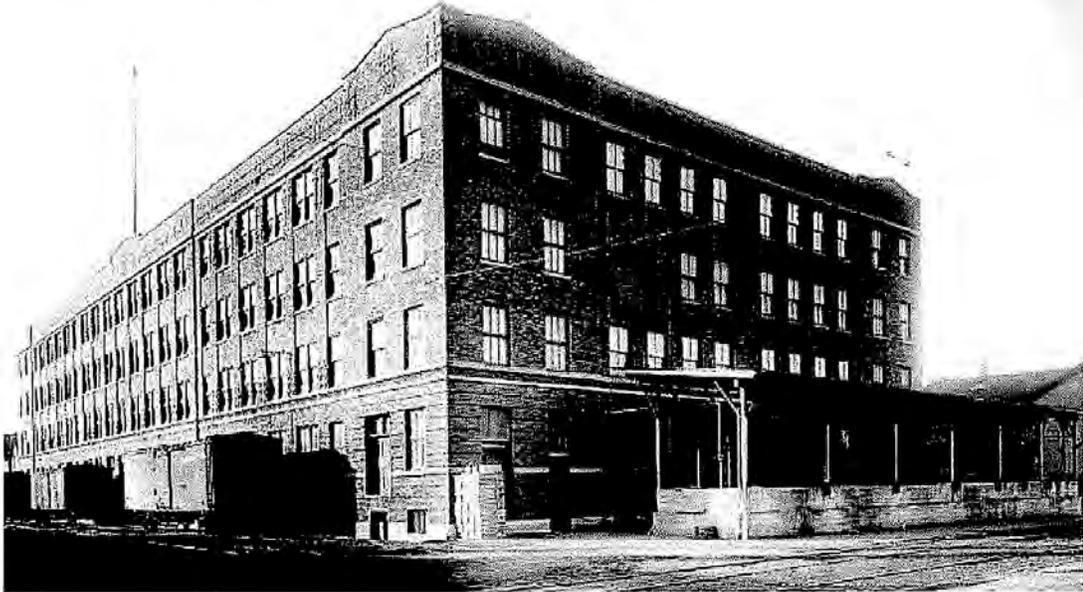
## Evansville Brewing Association Bottling Dept

Photo graph of the former Evansville Brewing Association Bottling building. This building now has several satellite dishes on the roof and many fiber optic trunk lines entering and exiting this building. It is currently owned by Sigecom. This building is immediately north and west of the INDOT LA Code 4603 parcel 1 location.

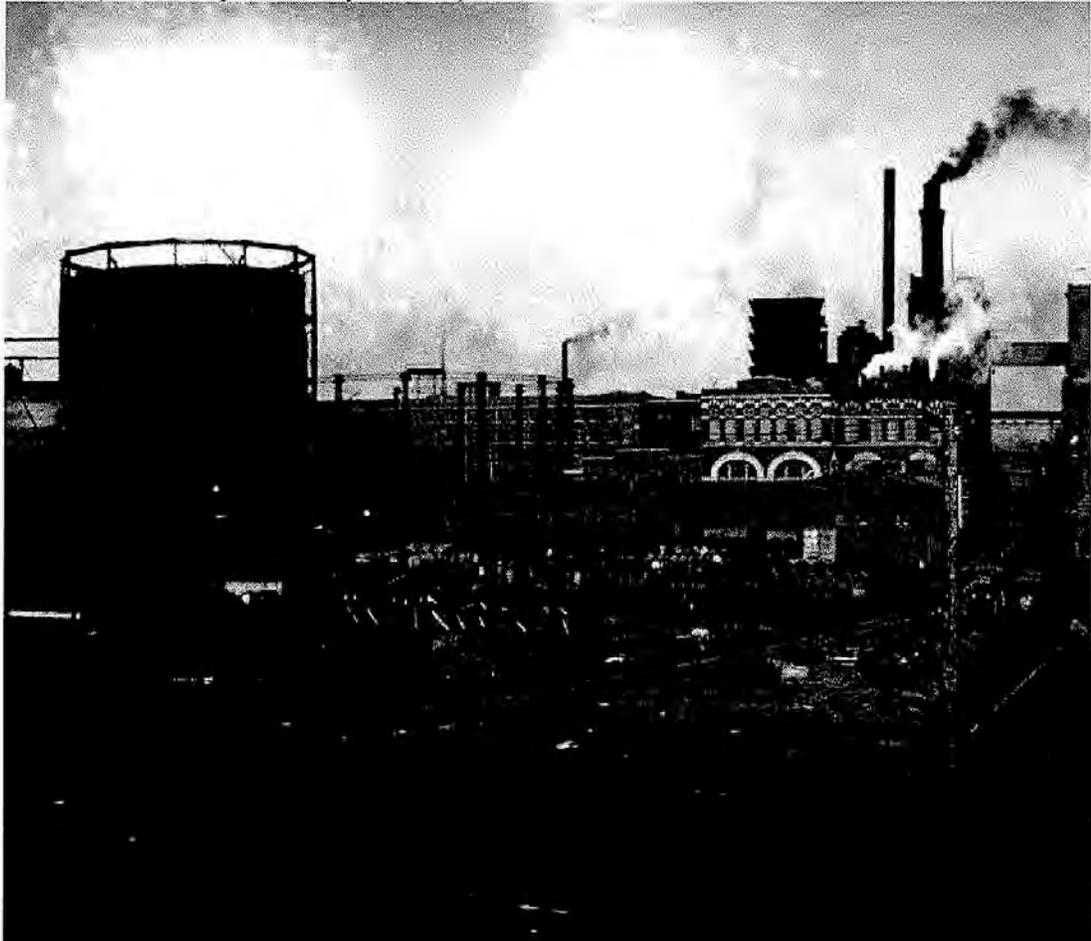
## View of Gas & Electric Light Co

With Sterling Brewery in the distance. View is looking northwest from roof of 400 Fulton (corner of present-day John St)

This photograph is of the Evansville Gas and Electric Company. The view looks mostly to the north. The Evansville Brewery Association building is visible in the back of this photography.

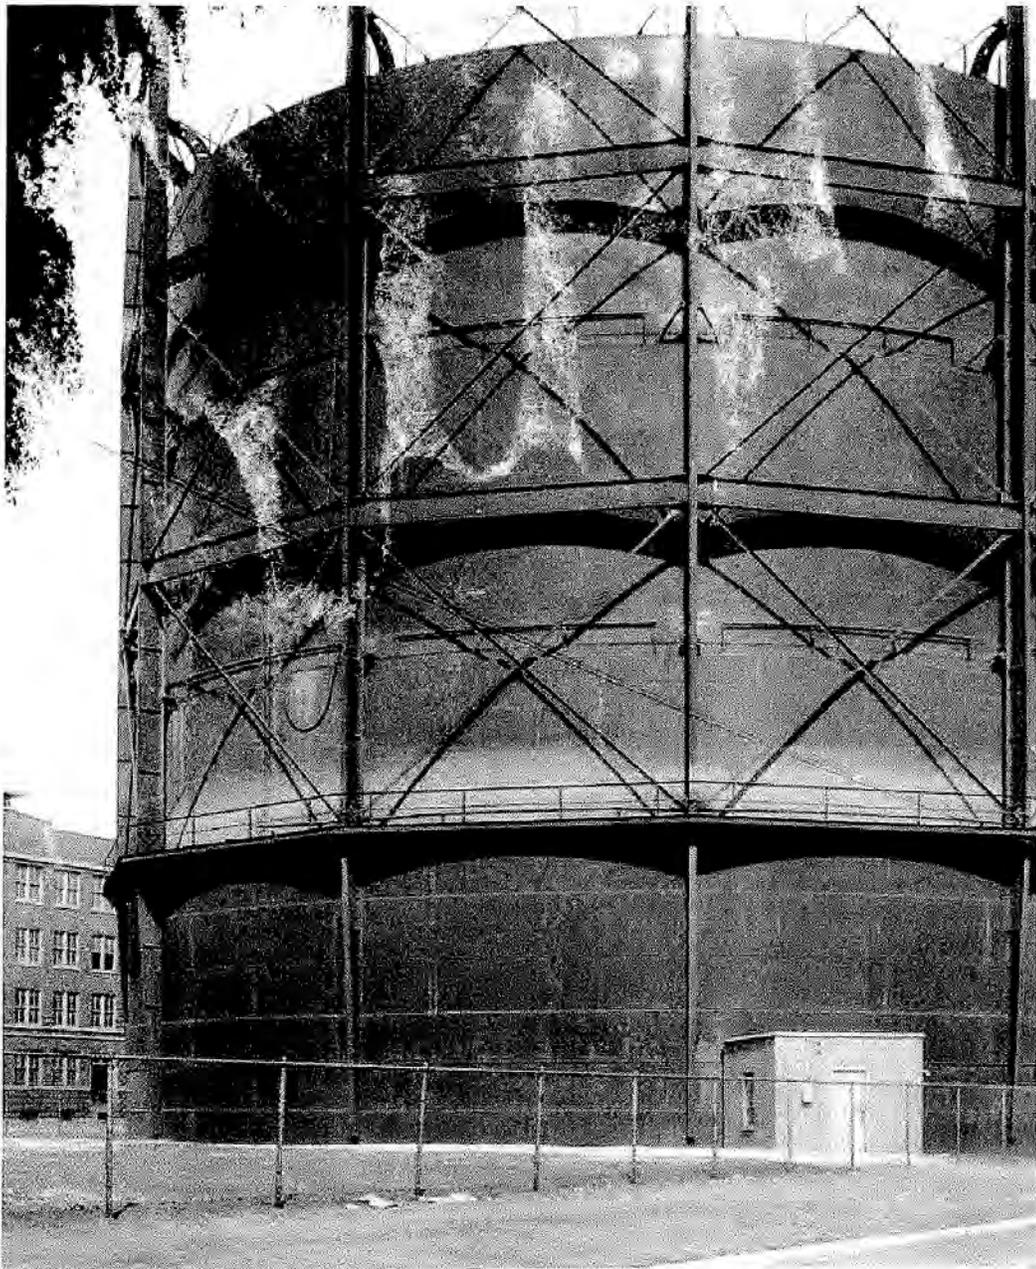
Photograph of the Gas and Electric Company gasometer. This was on the north side of the current Lloyd Expressway and immediately west of the INDOT LA Code 4603 parcel 1 location. The single story Sigecom building is now on this location.

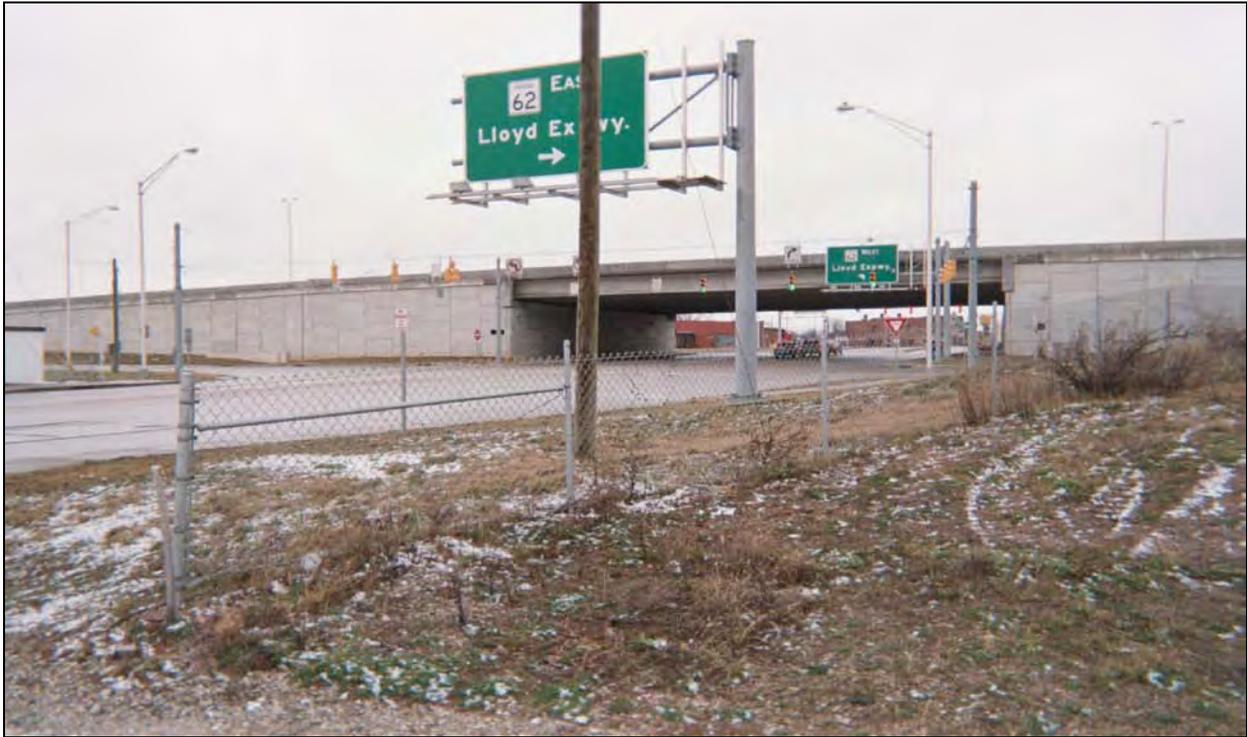
Lloyd Expressway overpass over Fulton Avenue. The construction of this overpass and its entrance and exit ramps necessitated the purchase of many parcels and the demolition of many buildings. View is to northwest, from the now vacant lot of the former Creative Press (LA Code 4913, parcel 1).

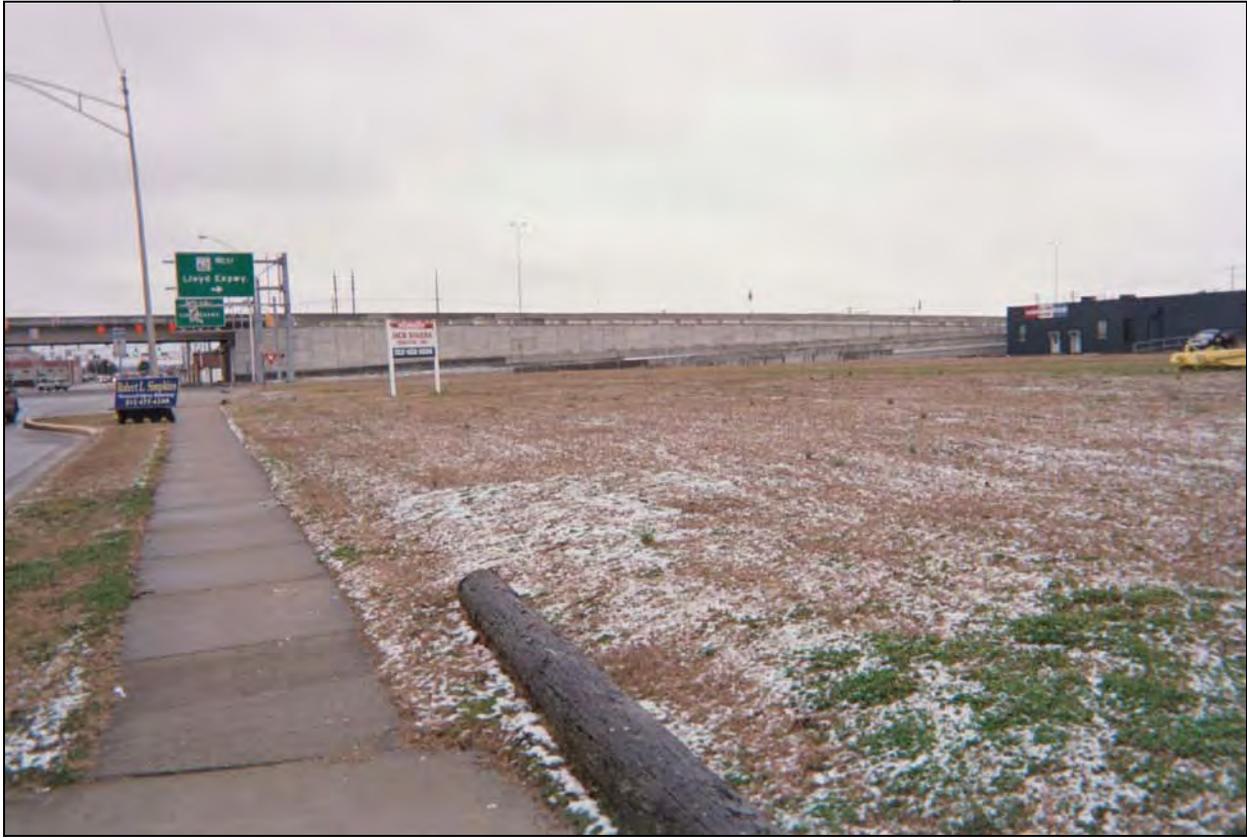
LA Code 4603 Parcel 1 (only excess parcel that is north of Lloyd Expressway. Now vacant, was site of Evansville Brewing Association mixing vat building.

- LA Code 4603 parcel 1, northwest quadrant. This property once housed the Sterling Brewery, but is now a vacant lot. During a site visit to this area, an abandoned gas station was found to the northeast of this parcel. IDEM had no records of this former gas station, possibly because the station may have been abandoned before the regulation of Underground Storage Tanks. Given the location of the station and the groundwater flow direction, it is possible that leaking petroleum product may be migrating from this former gas station towards or beneath INDOT LA Code 4603 Parcel 1. The historical records do not indicate that the brewery used solvents or chemicals. There is no indication that there were environmental issues stemming from the brewery; any environmental issues are likely to have originated from the upgradient former gas station.

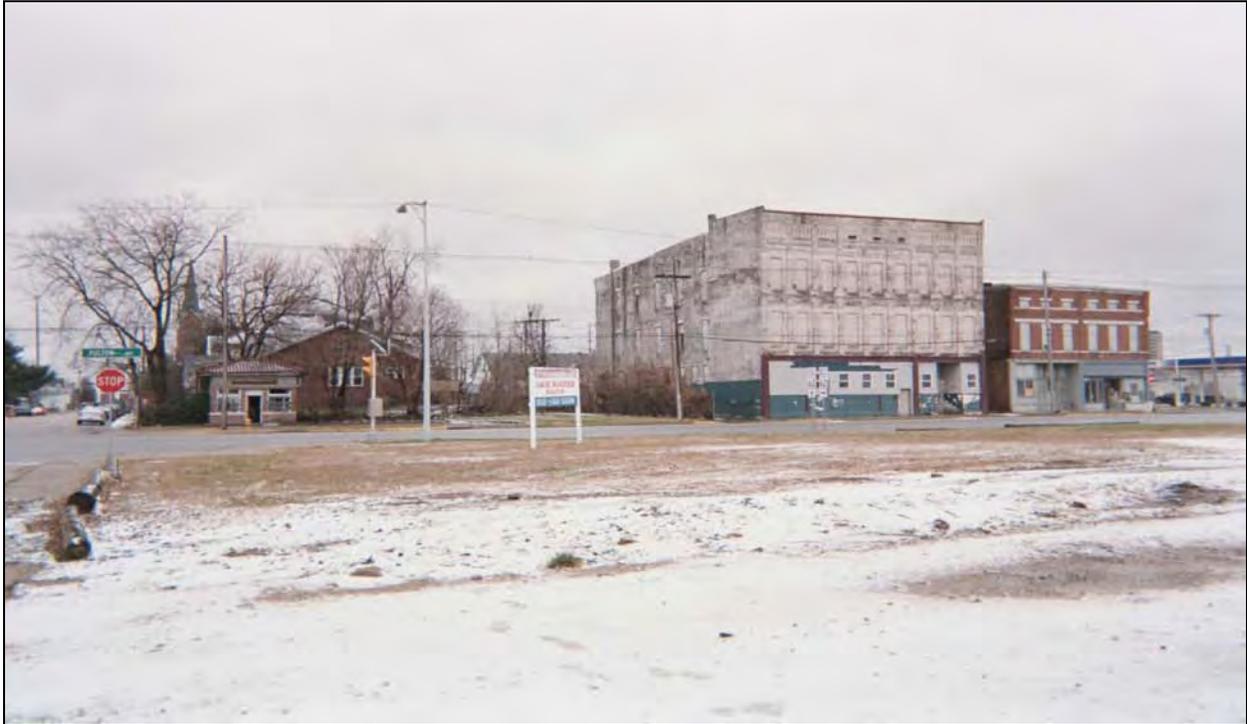
View to east, Fulton Avenue in background. At extreme right is part of Amoco Station UST site (7 N. Fulton Ave, FID # 19654) At the extreme left, just right of the red stop sign is the abandoned gas station that has no IDEM records. This gas station is discussed in the Recommendations Section.

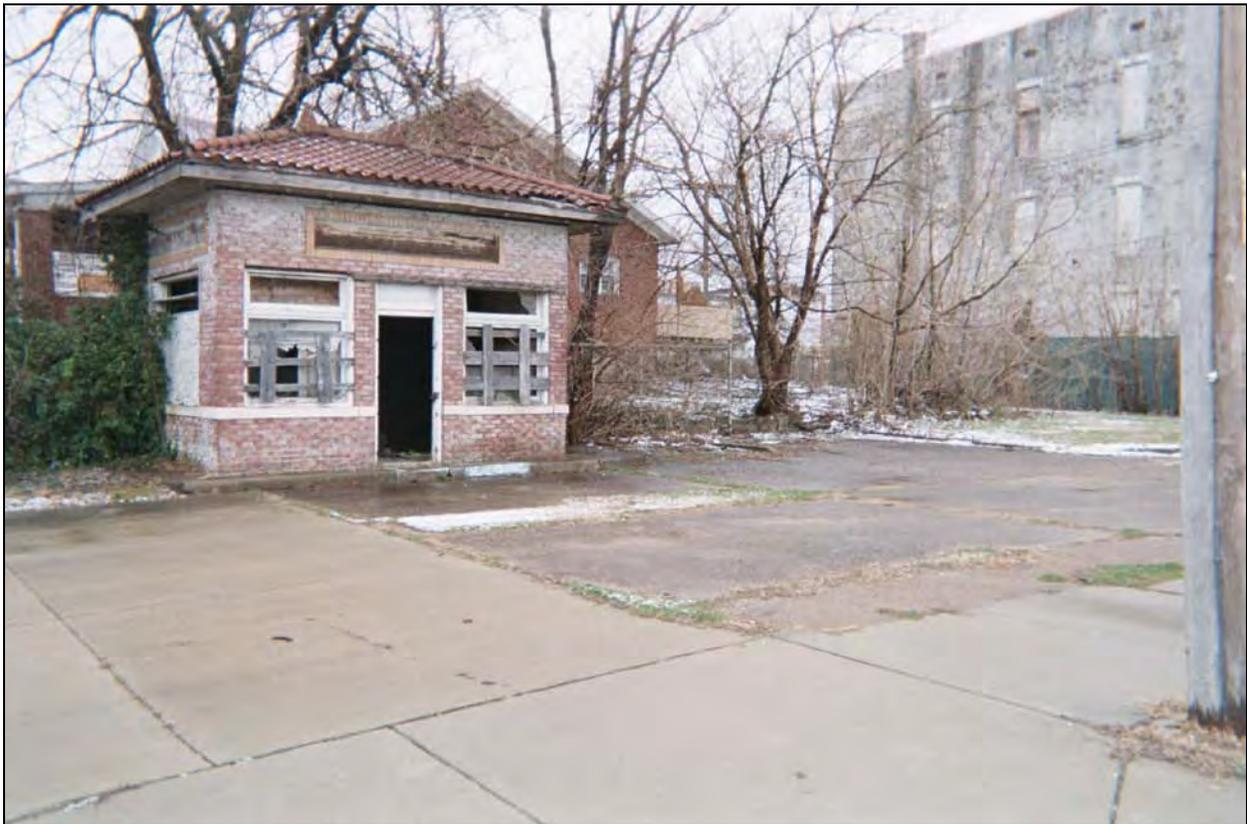
View to east, abandoned gas station with no IDEM records.

During the site reconnaissance, adjacent properties, businesses, and buildings were observed for any obvious environmental issues. The results of these observations, including the discovery of an old abandoned gas station with no IDEM records, are included in the appropriate sections of this report.

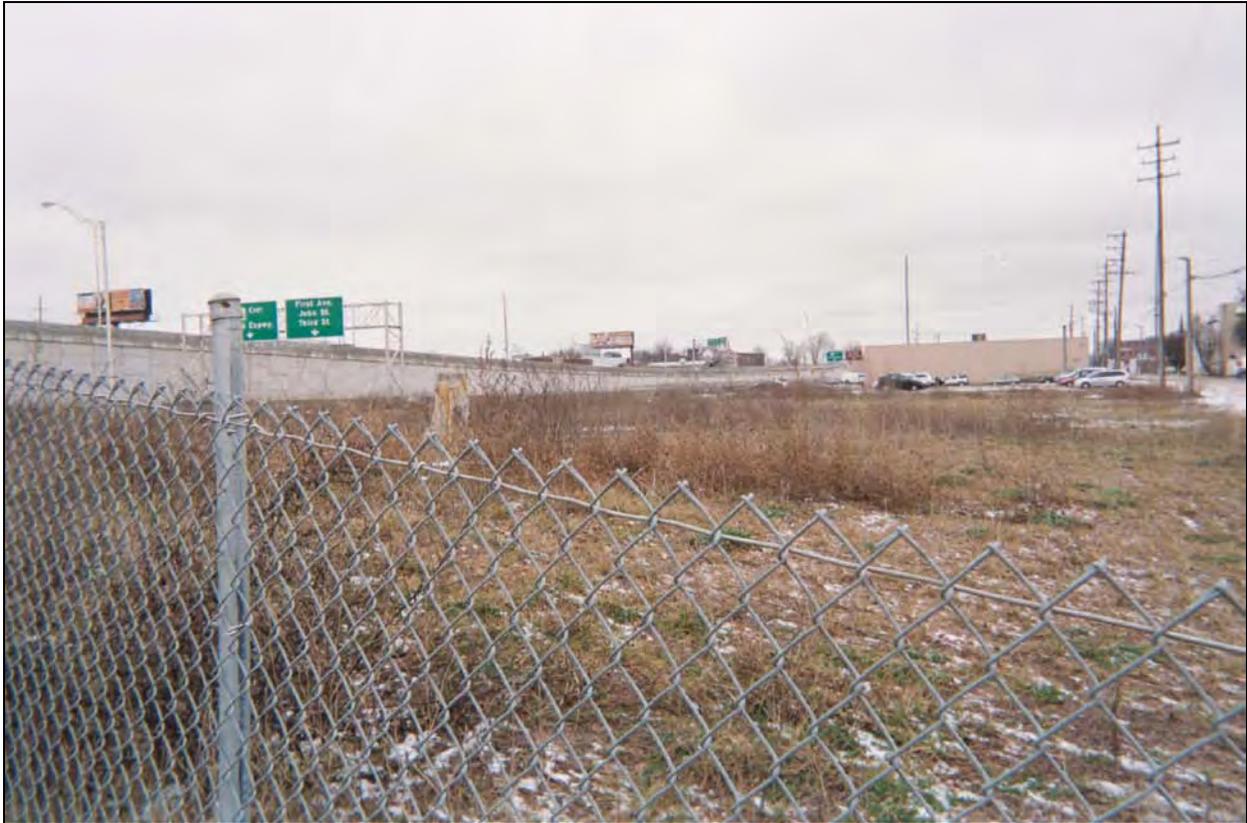
View to east. Vacant lot that was Creative Press. LA Code 4913, Parcels 1 and 2 are behind Teh chain link fence. Parcels 4 & 6 are still further east, behind the tan building in the background of this photograph. Lloyd Expressway on left (north), is elevated some 20 feet above the INDOT parcels.

Parcel #1 is the westernmost of the four parcels. This is now a vacant lot, but was the site of the former Creative Press. The Indiana Department of Environmental Management files list twelve records for this site. Eleven of these are for annual air permits. The last file is also the most recent. In 2008, IDEM inspectors visited the site and found it closed and no longer in business. The record states “no waste left around, No Further Action needed”.

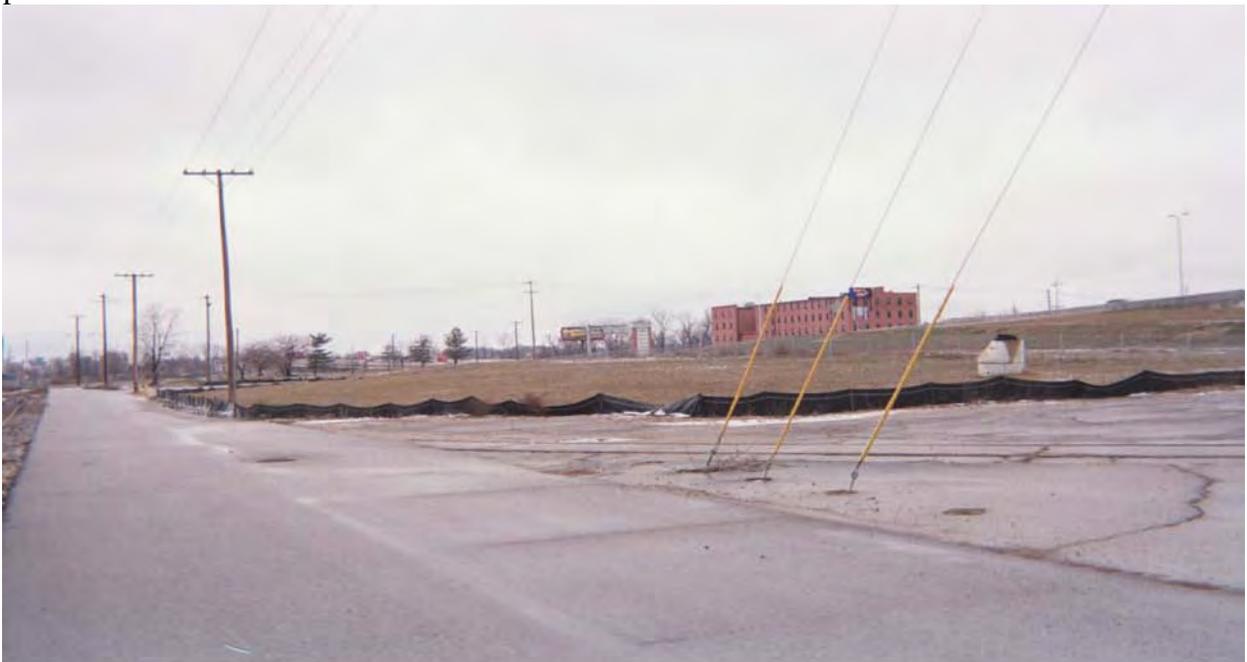
View to west, in the southwest quadrant. Shows now vacant lot that was manufactured gas plant, and later was Brake Supply building.
