**PHASE I**  
**ENVIRONMENTAL SITE ASSESSMENT**

Six Excess Parcels for Disposal  
Adjacent to Lloyd Expressway, (SR 62)  
Evansville, IN

South of US 62 (Lloyd Expressway)  
LA Code 4913, Parcels 1, 2, 4 & 6  
LA Code 4914, Parcel 4

**Hazardous Materials Unit  
Office of Environmental Services  
Indiana Department of Transportation**

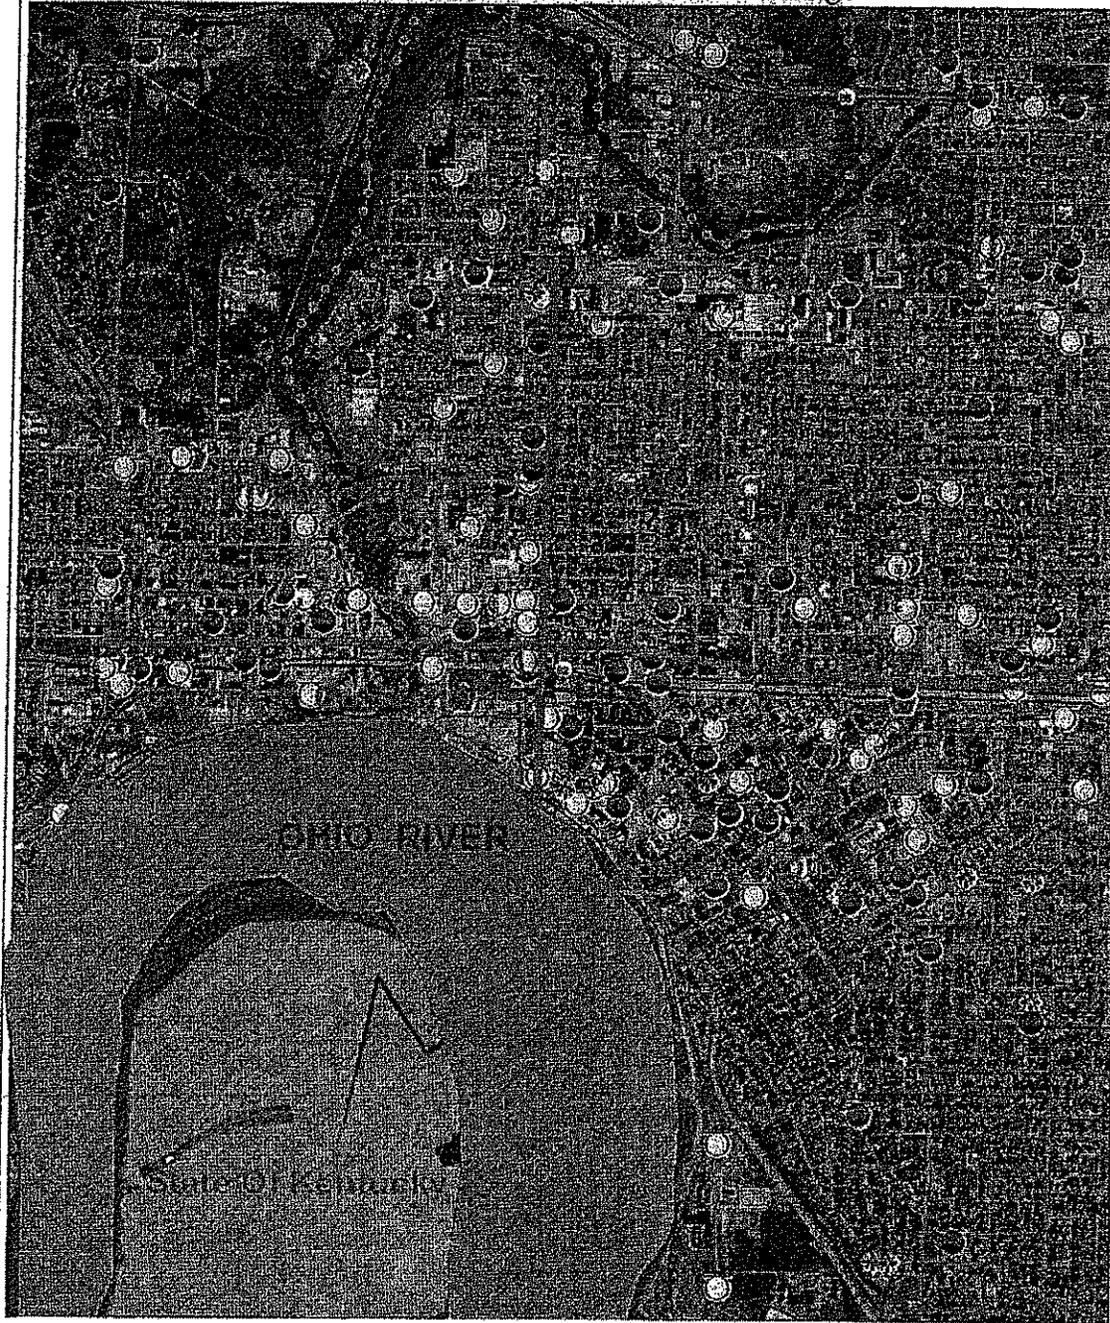
Figure 2  
 One Half Mile Buffer Light Green  
 Project Area Red Boundary  
 Quadrant Divisions Indicated in Orange

The first set of quadrant maps depicts the subject parcels and the immediate vicinity of the six parcels. The second set of quadrant maps extends out to the one half mile buffer radius from the Lloyd Expressway and Fulton Avenue overpass. In addition, a third map showing the one mile buffer area from the excess parcel area is included. The ASTM criteria for a Phase I Environmental Assessment required that a one mile search be conducted for superfund sites. However, no ASTM criteria sites, i.e. E.P.A. Superfund sites were found within the one mile search buffer.

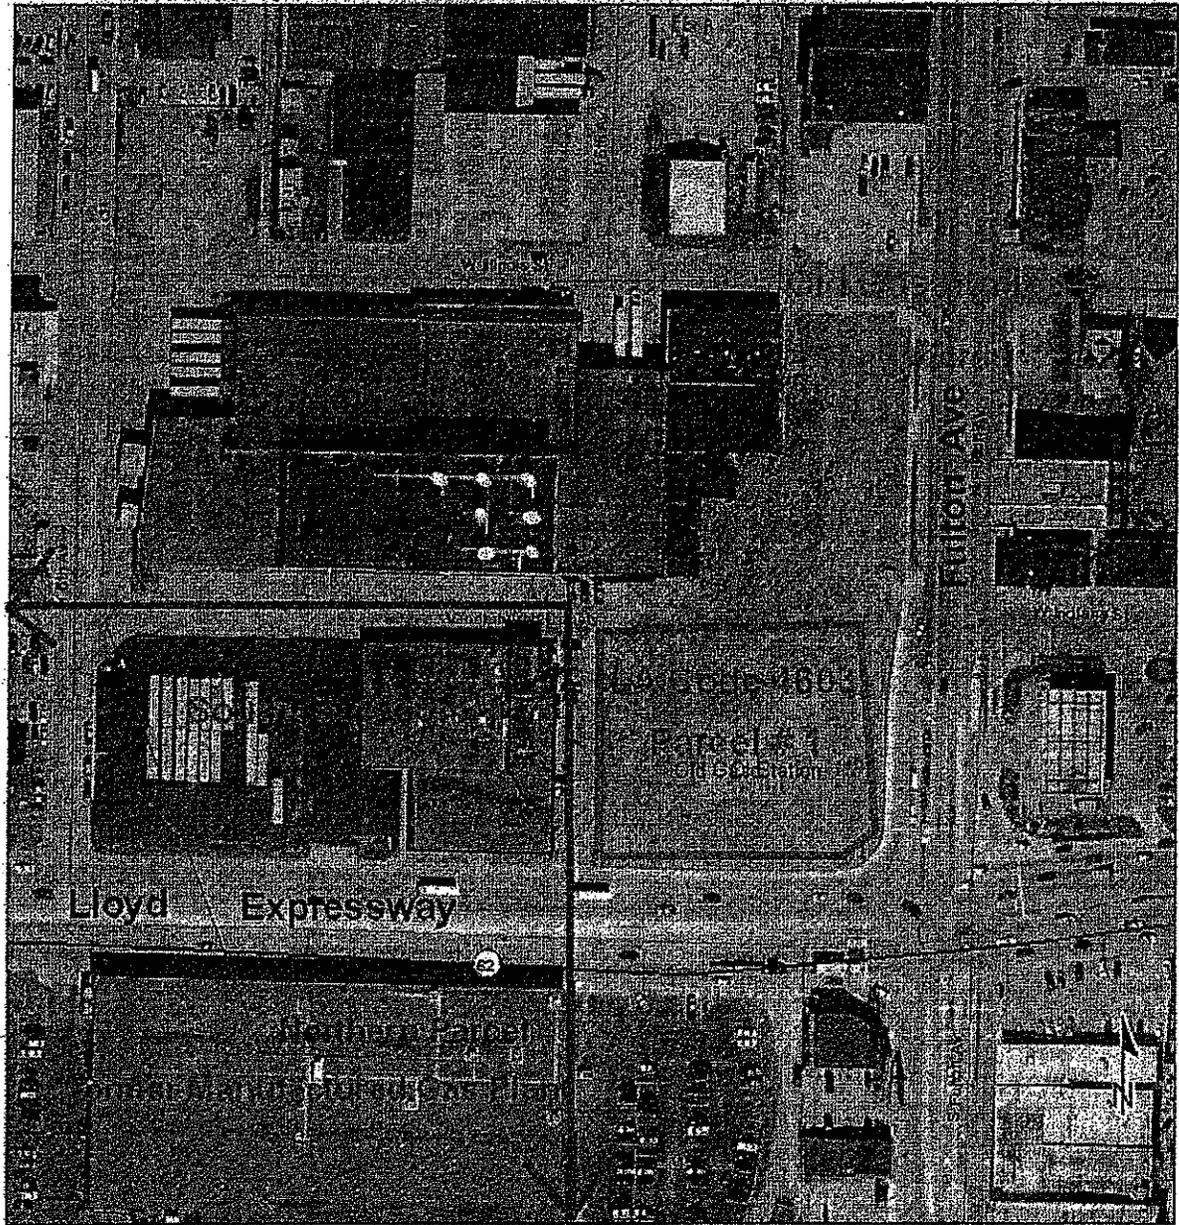
Figure # 7 - Aerial Detail NW Quad  
 Lloyd Expressway & Fulton Ave  
 LA Code 4603, Parcel # 1, Excess Parcel Disposal  
 Vanderburgh County, Indiana

During the site reconnaissance, adjacent properties, businesses, and buildings were observed for any obvious environmental issues. The results of these observations, including the discovery of an old abandoned gas station with no IDEM records, are included in the appropriate sections of this report.

| | Boundary Old Gas Station |
