SUPPORT DOCUMENTATION

Braun Entervan (low floor)

The documents in this section are being submitted as required in the RFP document for the Low Floor Mini Van. Each is listed below and is referenced by location in the RFP where they can be found and are in the same order as the RFP.

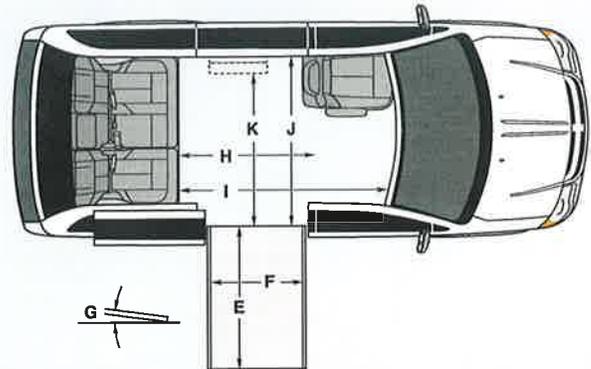
Door Opening Usable Width (Slide Door)	A	31-1/2"
Door Opening Usable Height (Slide Door)	B	56-1/4"
Interior Height at Center of Van*	C	61"
Interior Height at Driver and Passenger Position*	D	60"
Ramp Length	E	52"
Ramp Width (Usable Clear Opening)	F	30"
Ramp Angle (Unloaded)	G	12.5°
Interior Floor Length (Behind Front Seats)	H	57"
Overall Interior Floor Length (Flat Area)	I	87-1/2"
Interior Width at B-Pillars	J	62"
Width - Ramp to Optional 2-Pass. Seat (Folded)	K	49-3/4"
¹ Ground Clearance (Unloaded) - ² Loaded @ 1200 lbs	L	¹ 6-1/4" - ² 5"
Overall Vehicle Height (Unloaded)	M	74"

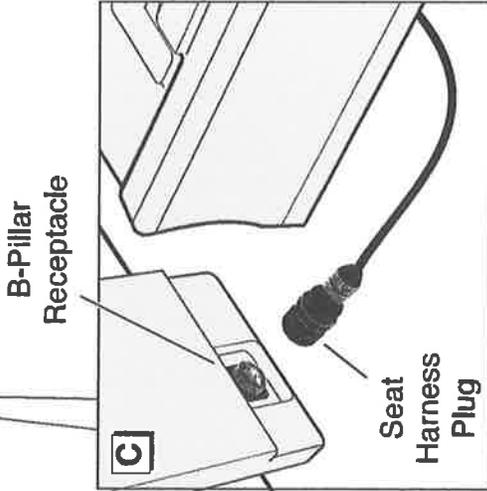
An electrical harness receptacle is located to the rear of each seat base in the wall (at "B" pillar). See Figures A and C. The seat wiring harness plug connects to the receptacle socket (screw-on connector details on pages 34 and 35).

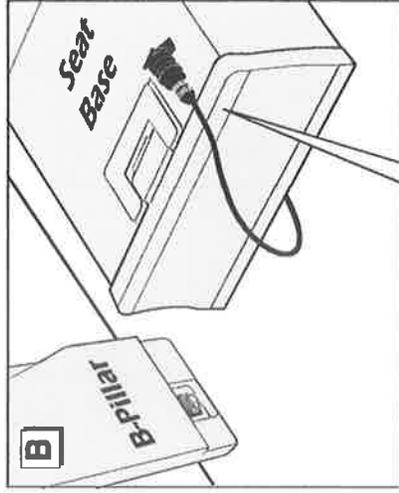
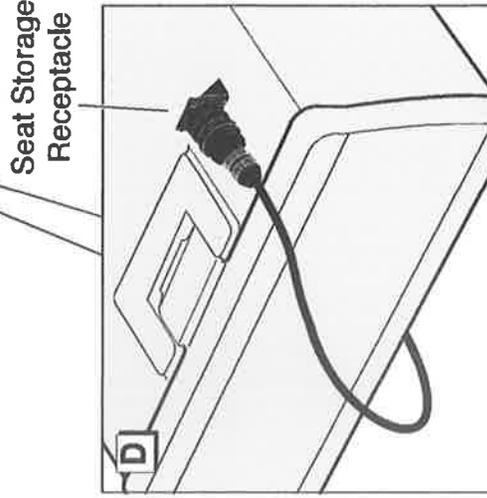
When seats are removed, the seat electrical harness plug must be connected to the receptacle provided in the seat base. See Figures B and D.

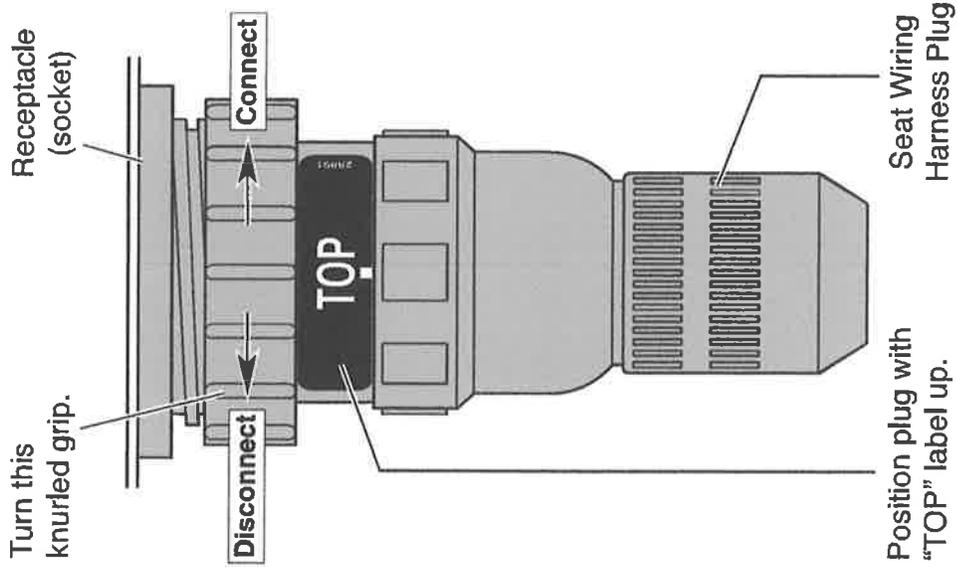
Screw-on Connectors

To Connect: Align the seat harness connector by positioning the plug with the "TOP" label facing up. Align the seat harness connector alignment keys (guides) with the receptacle socket alignment slots (will only connect one way).

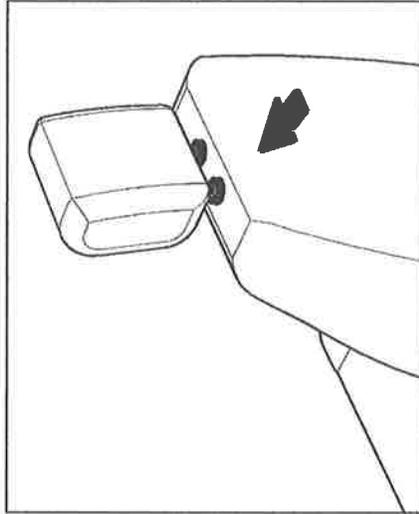
“Step & roll” quick-release seat base attachments engage recessed floor strikers (supports). A foot-activated release pedal is located at the rear of the seat base. Stepping on the pedal disengages the attachments and deploys the seat base rear wheels.

Note: For ease of disengagement, move the seat to the full forward and upright position before removing seat(s). Push the seat back forward and upward while stepping on foot pedal (ensures full deployment of rear wheels).

Push seat back forward and upward while stepping on foot pedal.

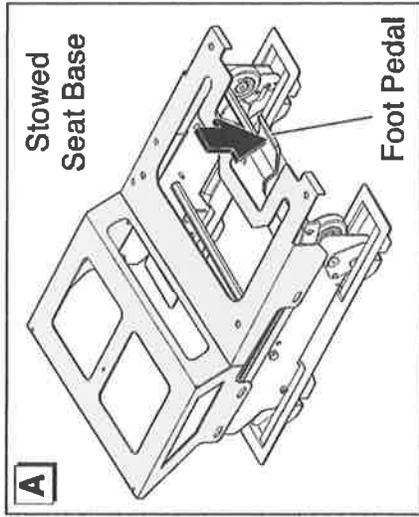
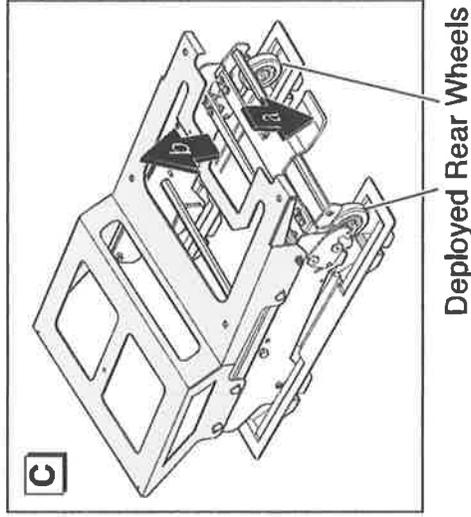
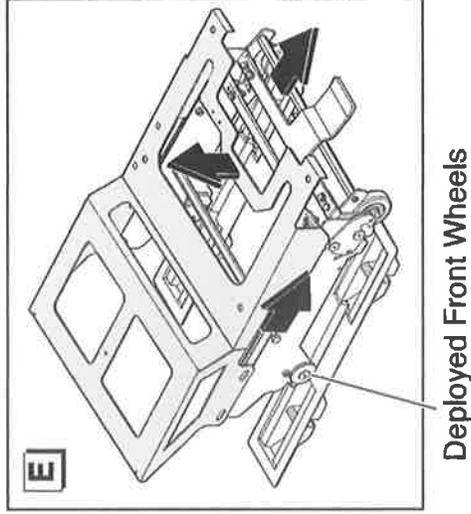
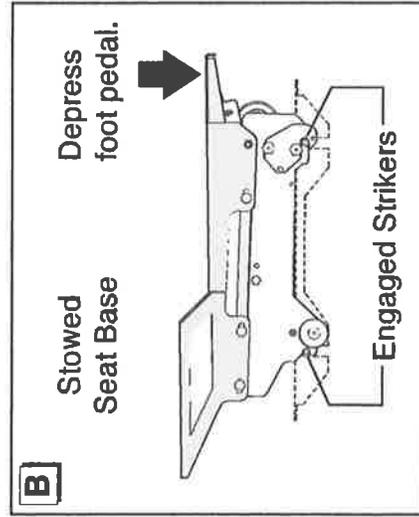
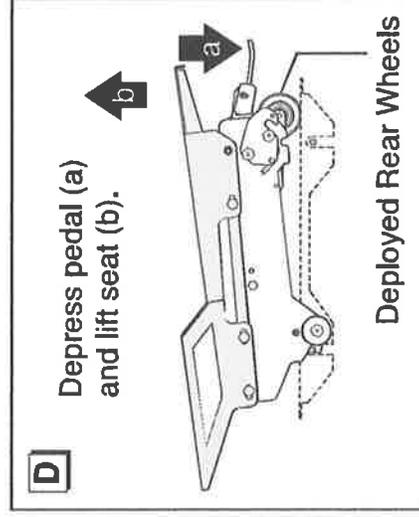
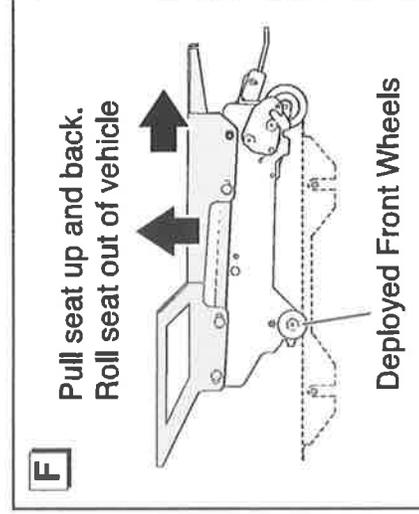
Front Seat Removal Instructions

1. Move seat to full forward and upright position.
2. **Caution!** Disconnect seat wiring harness before removing a front seat base. Connect harness to seat base socket. See page 33-35 for wiring harness details.
3. Depress foot pedal (push down). **Note:** Push seat back forward and upward while stepping on foot pedal (shown at left). See Figures A-D.
4. Pull up and back on the rear of seat (deploy front wheels). See Figures E and F.
5. Roll seat base out of vehicle as shown.

Illustrations depict seat base only.

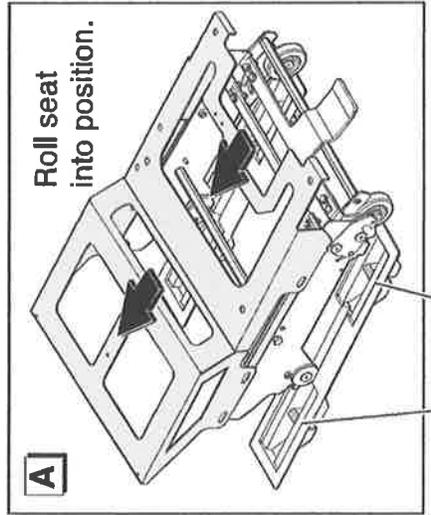
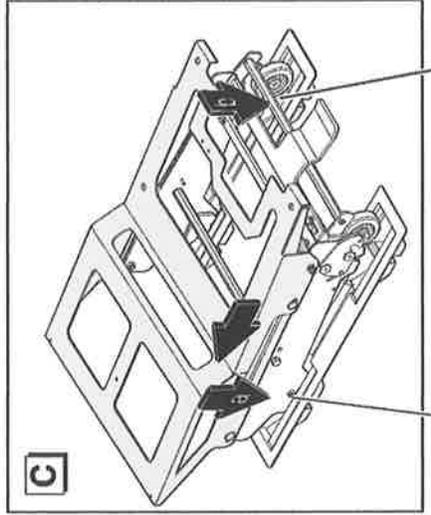
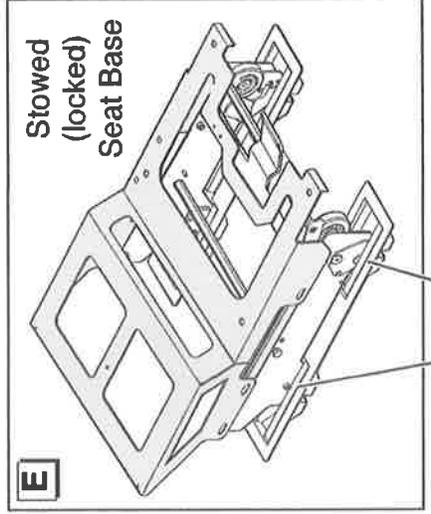
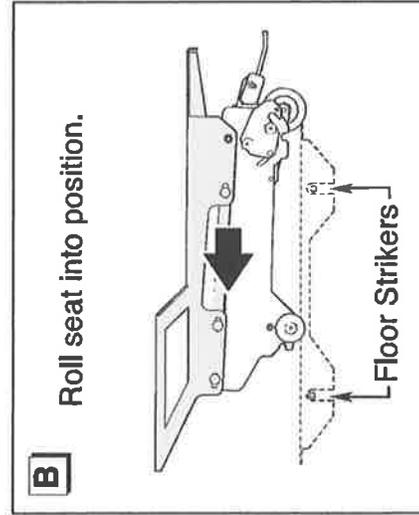
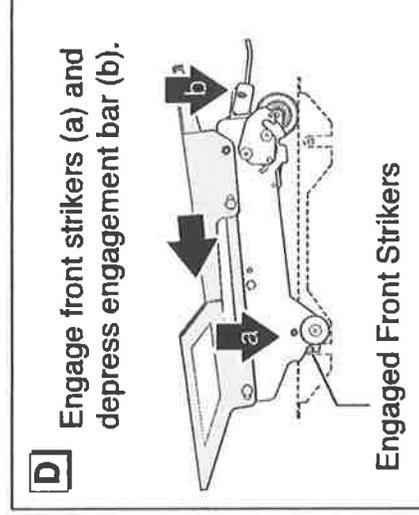
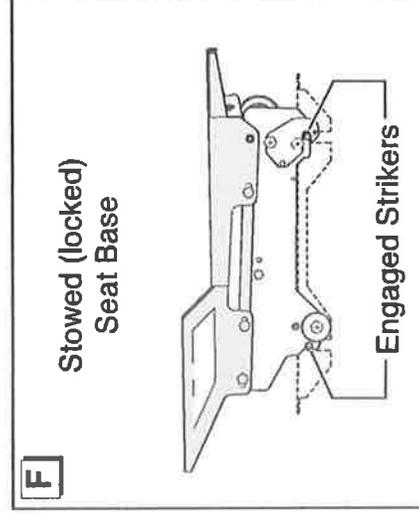
“Step & roll” quick-release seat base attachments engage recessed floor strikers (supports). A foot-activated release pedal is located at the rear of the seat base. A cross bar is positioned directly under the pedal. Stepping on the bar engages the rear seat base attachments to lock the seat base.

2. Depress rear cross bar (push down) to stow rear wheels and engage rear seat attachments with floor strikers. See Figures C-F. Lift seat to ensure floor strikers are locked in seat attachments.
3. Connect (plug) seat electrical harness to B-pillar receptacle. See page 33.

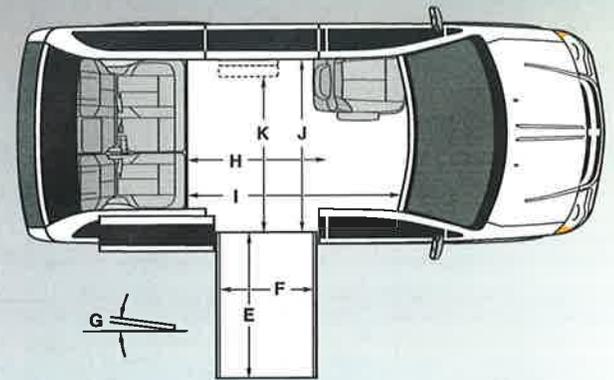
2008+

A	Door Opening Usable Width (Slide Door)	31-1/2
B	Door Opening Usable Height (Slide Door)	56-1/4
C	Interior Height at Center of Van*	61
D	Interior Height at Driver and Passenger Position*	60
E	Ramp Length	52
F	Ramp Width (Usable Clear Opening)	30
G	Ramp Angle (Unloaded)	12.5°
H	Interior Floor Length (Behind Front Seats)	57
I	Overall Interior Floor Length (Flat Area)	87-1/2
J	Interior Width at B-Pillars	62
K	Width - Ramp to Optional 2-Pass. Seat (Folded)	49-3/4
L	¹ Ground Clearance (Unloaded) - ² Loaded @ 1200 lbs	¹ 6-1/4 ² 5
M	Overall Vehicle Height (Unloaded)	74

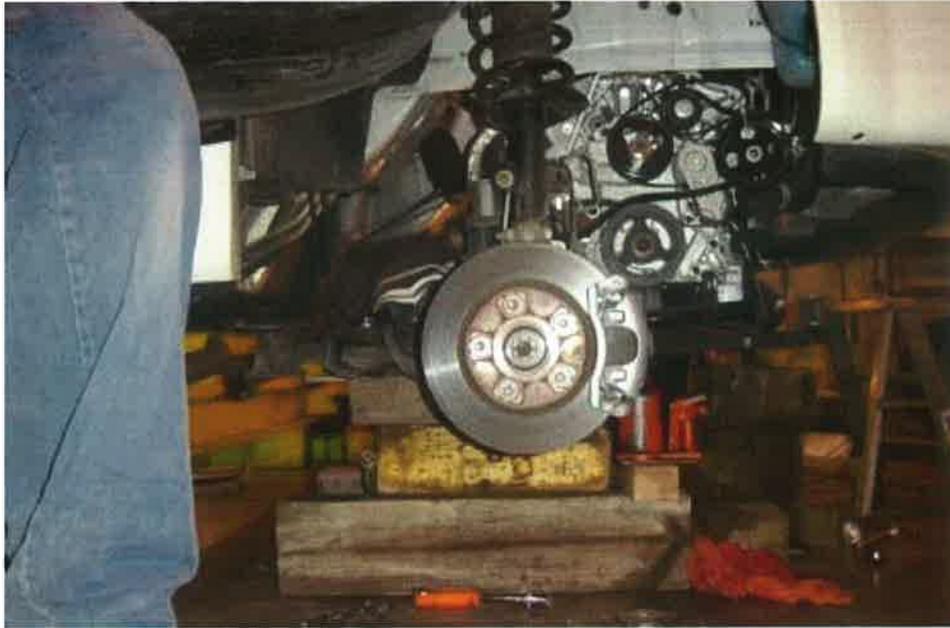
TRANSAXLE REMOVAL AND REPLACEMENT (8.0 MAN HOURS)

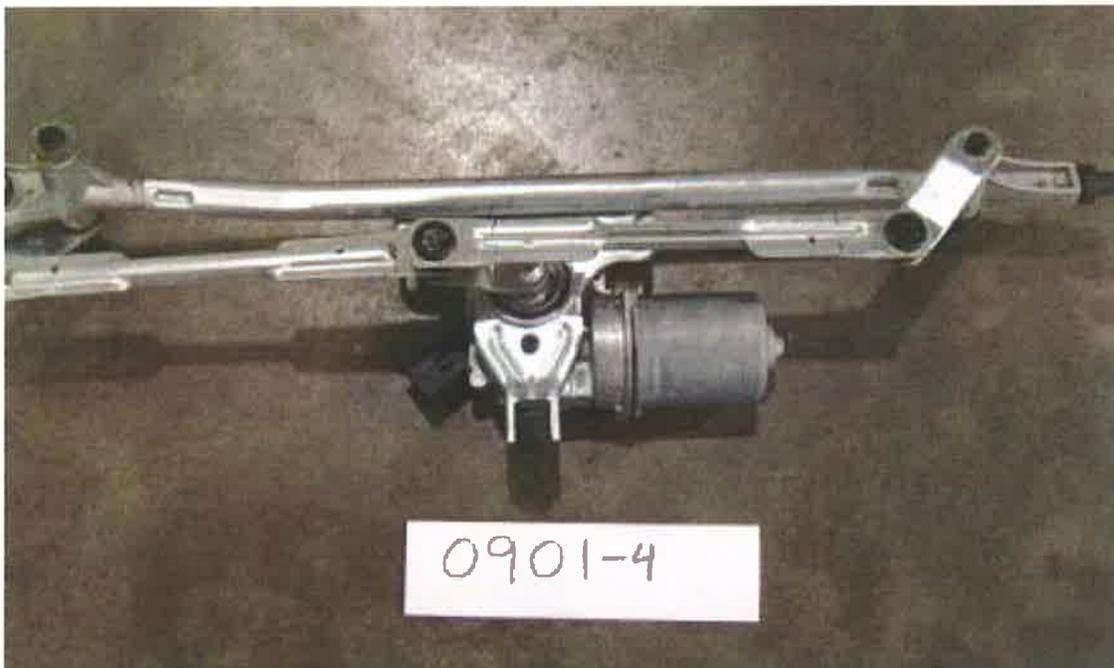
WIPER MOTOR REMOVAL AND REPLACEMENT (0.5 MAN HOURS)

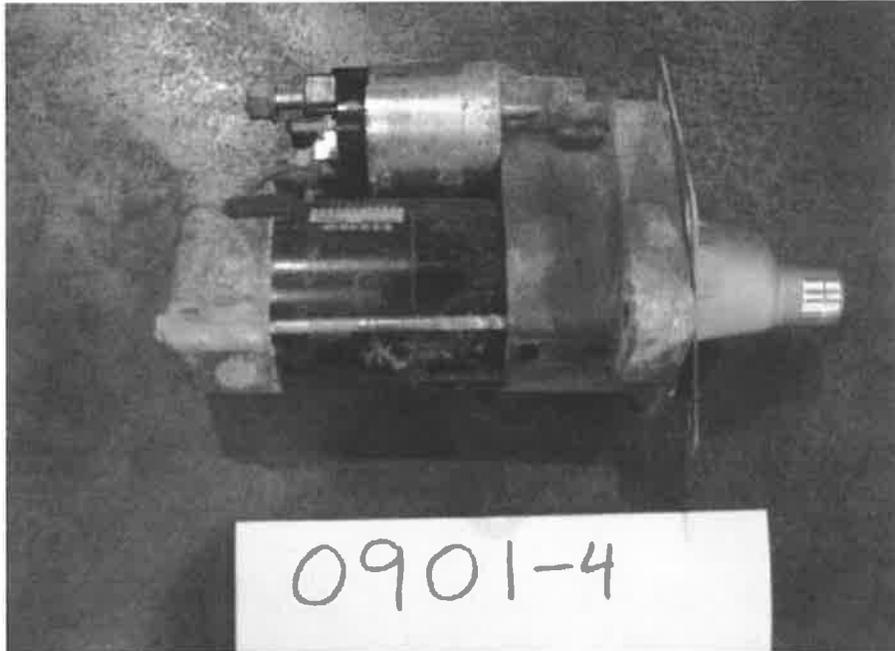
**STARTER REMOVAL AND REPLACEMENT
(0.5 MAN HOURS)**

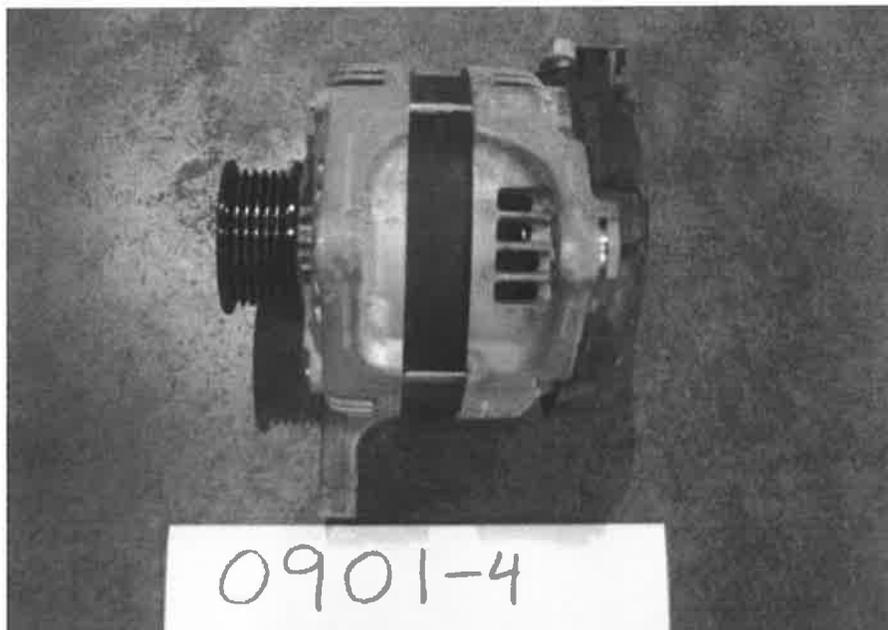
**ALTERNATOR REMOVAL AND REPLACEMENT
(0.5 MAN HOURS)**

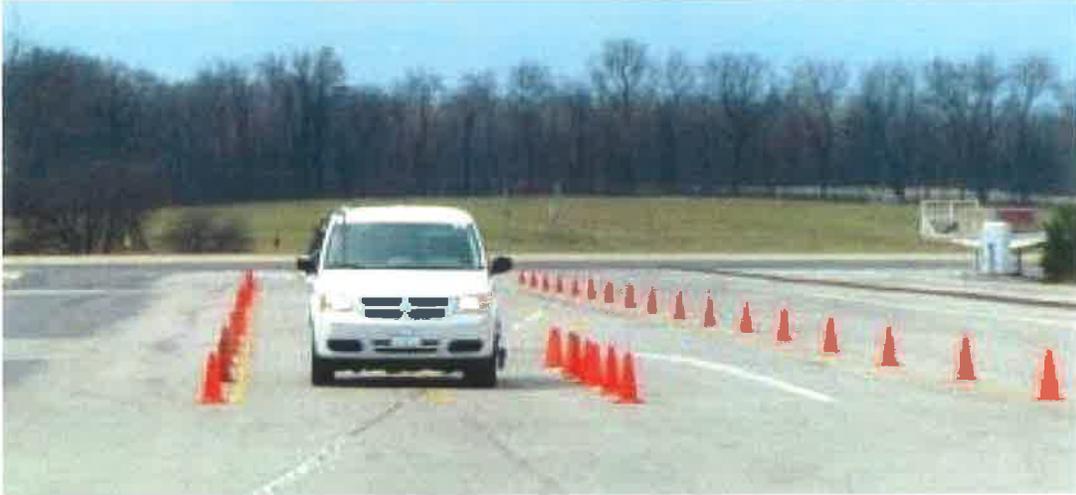
RIGHT - HAND APPROACH

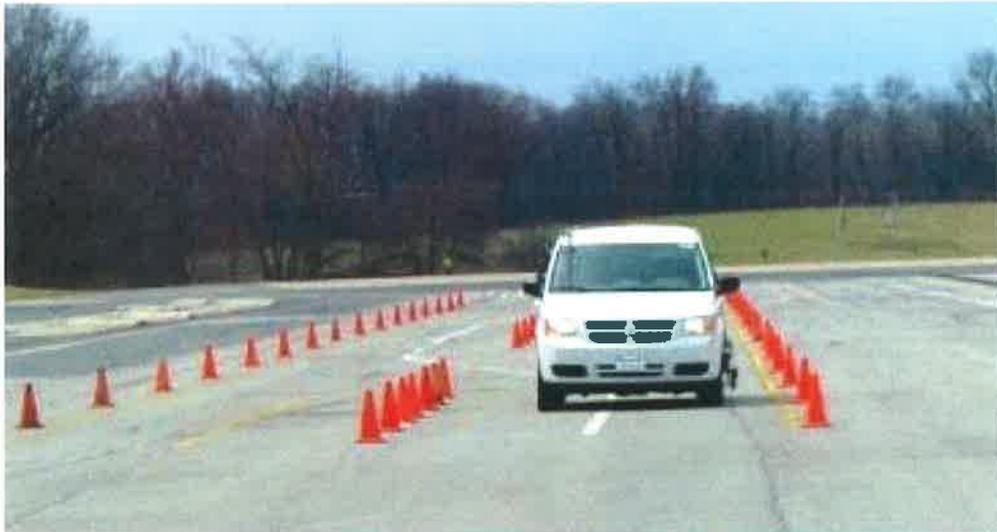
LEFT - HAND APPROACH

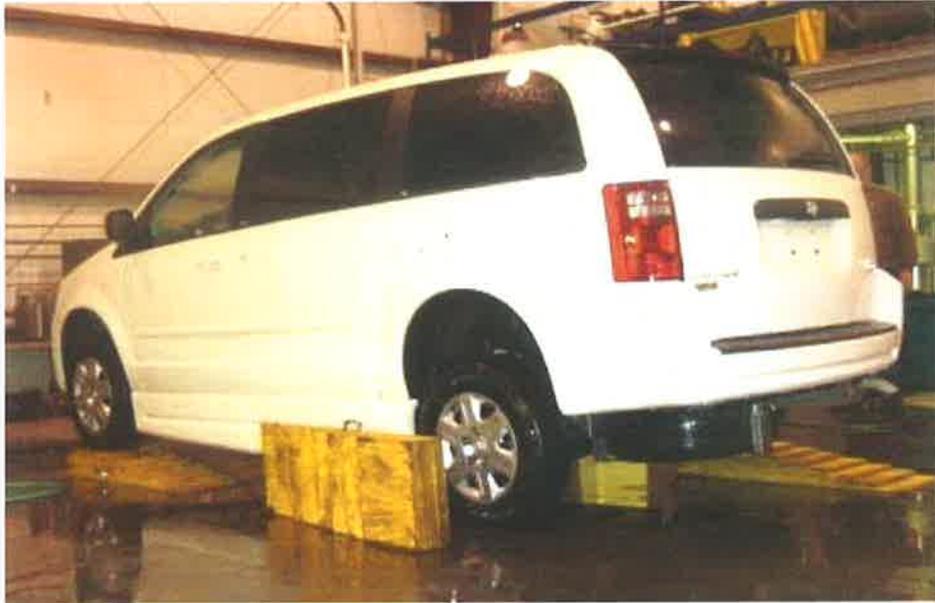
RIGHT REAR WHEEL SIX INCHES LOWER

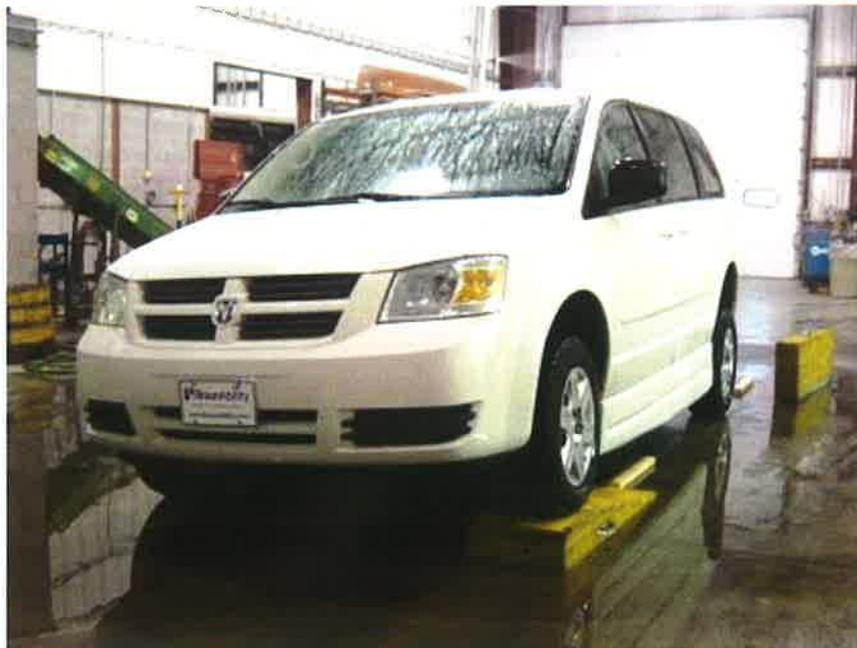
LEFT FRONT WHEEL SIX INCHES HIGHER

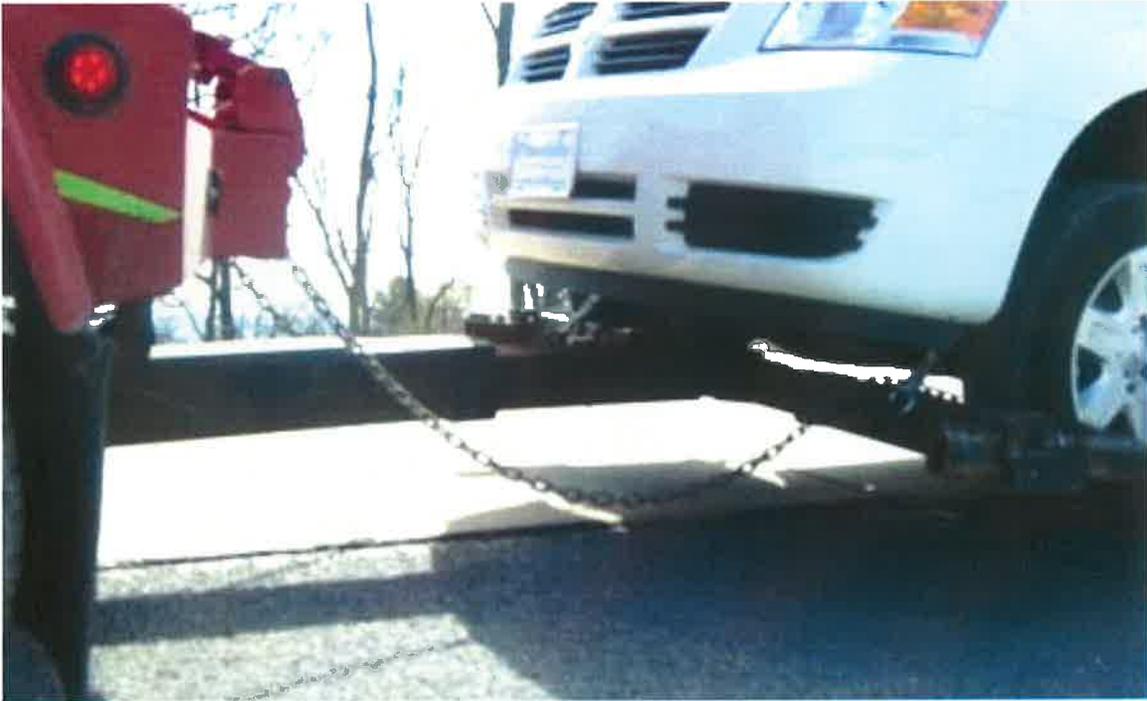
TOWING INTERFACE

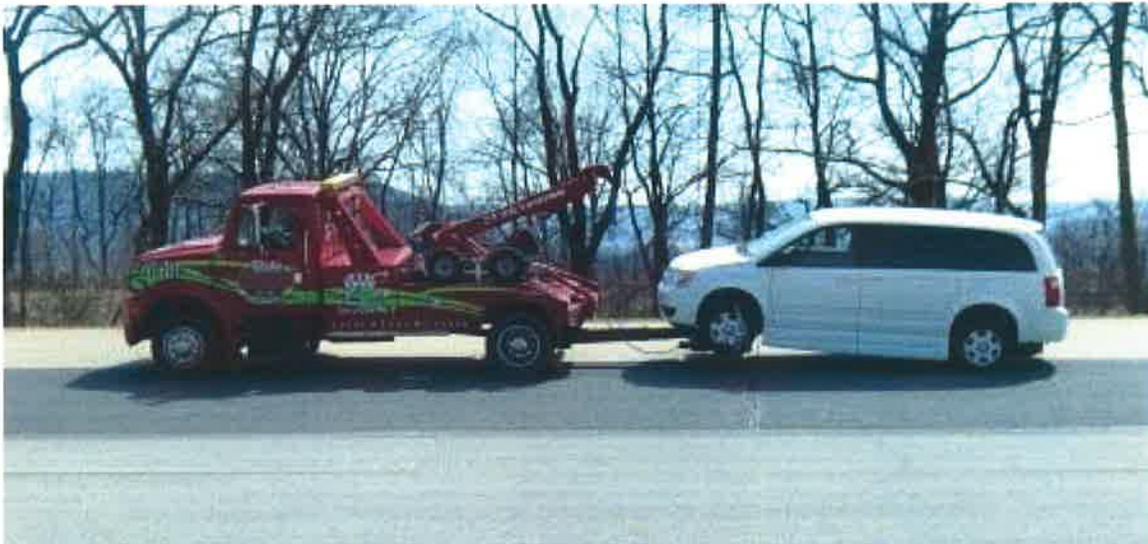
TEST BUS IN TOW

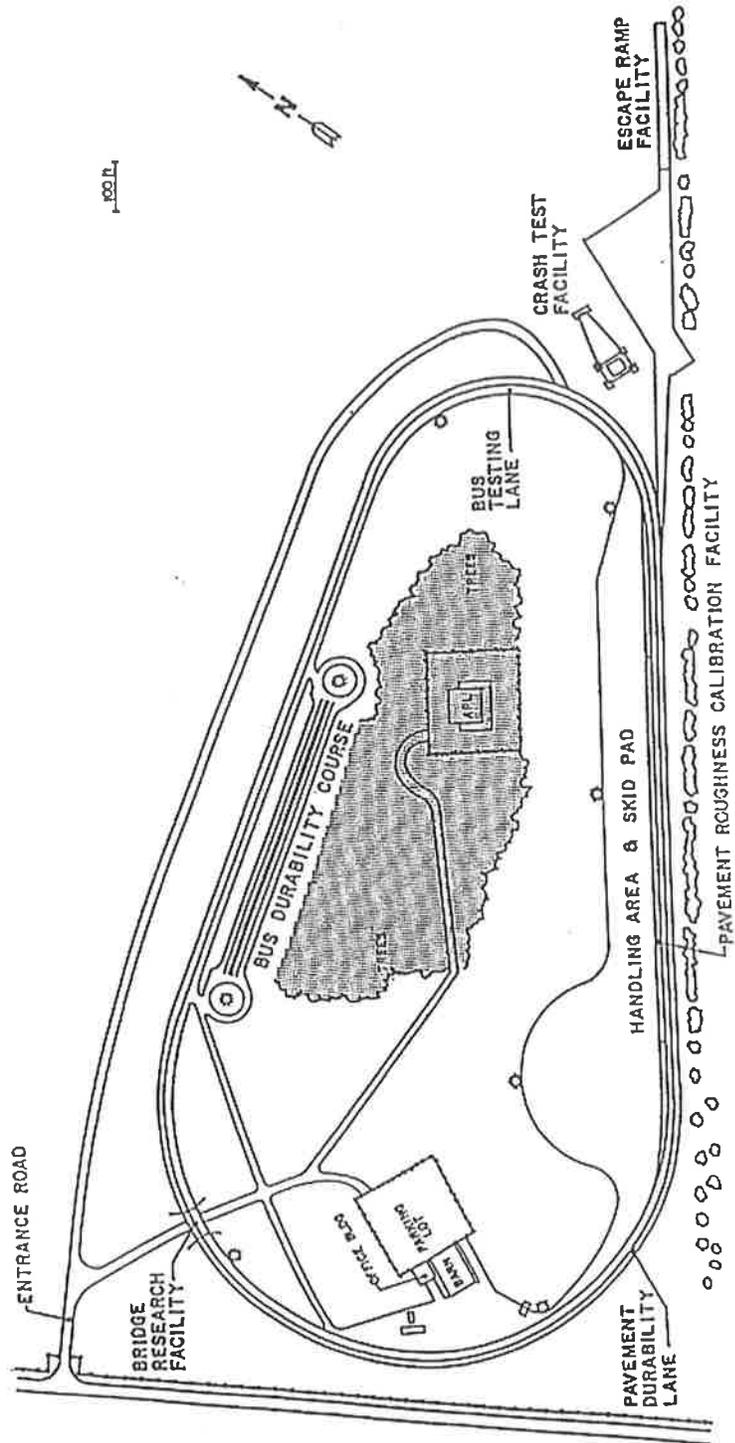
“PLAN VIEW OF PENN STATE BUS TESTING AND RESEARCH FACILITY”

**BUS TESTING AND RESEARCH TEST TRACK
UNIVERSITY PARK, PA**

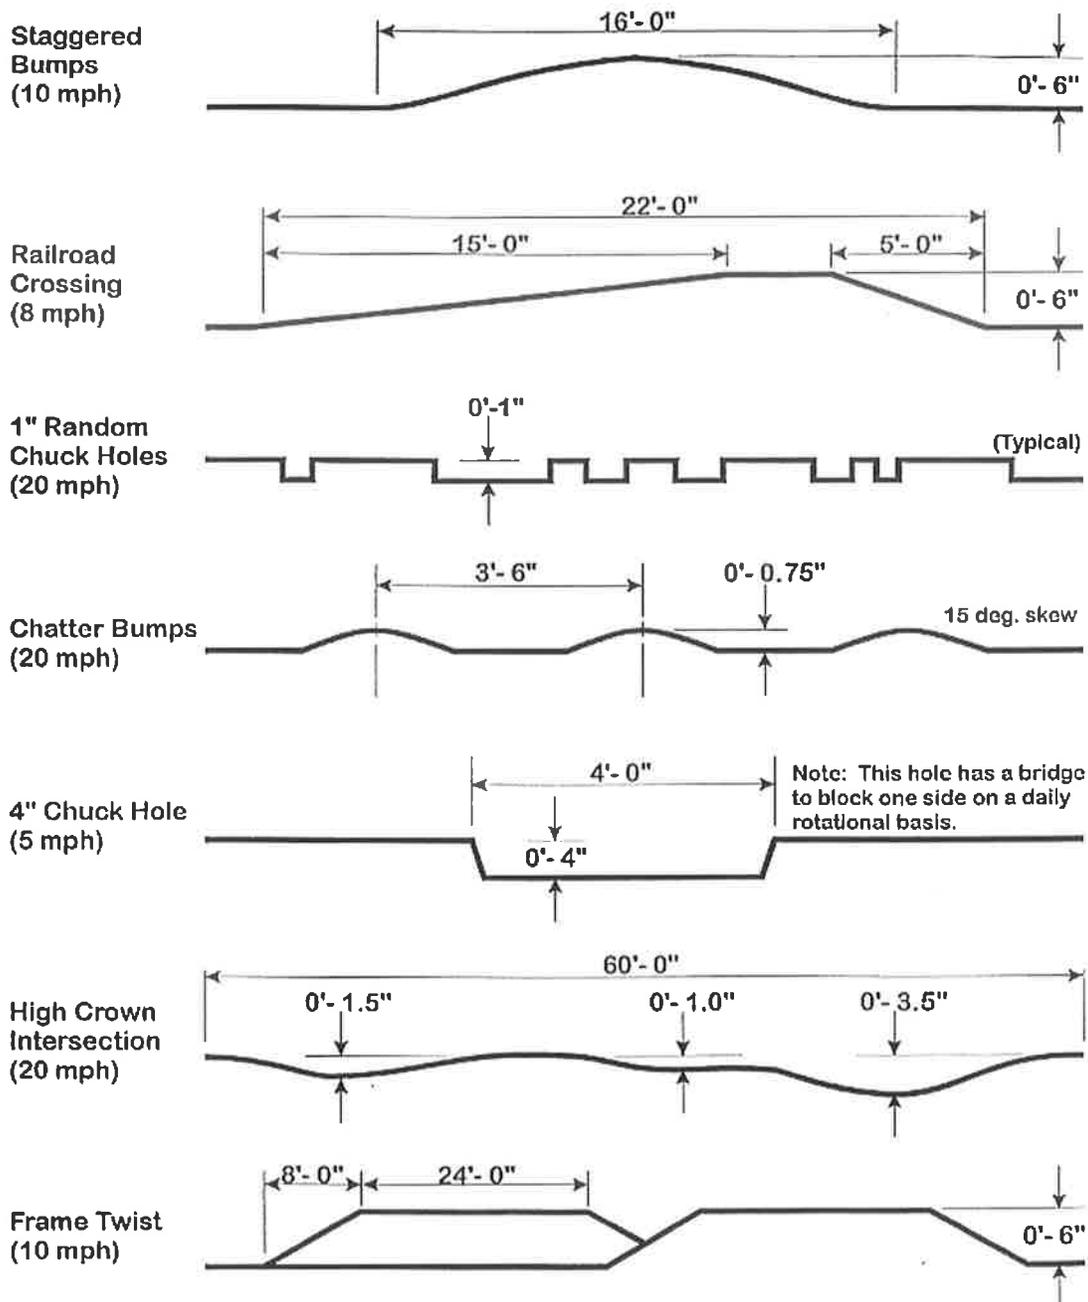
Durability Element Profiles

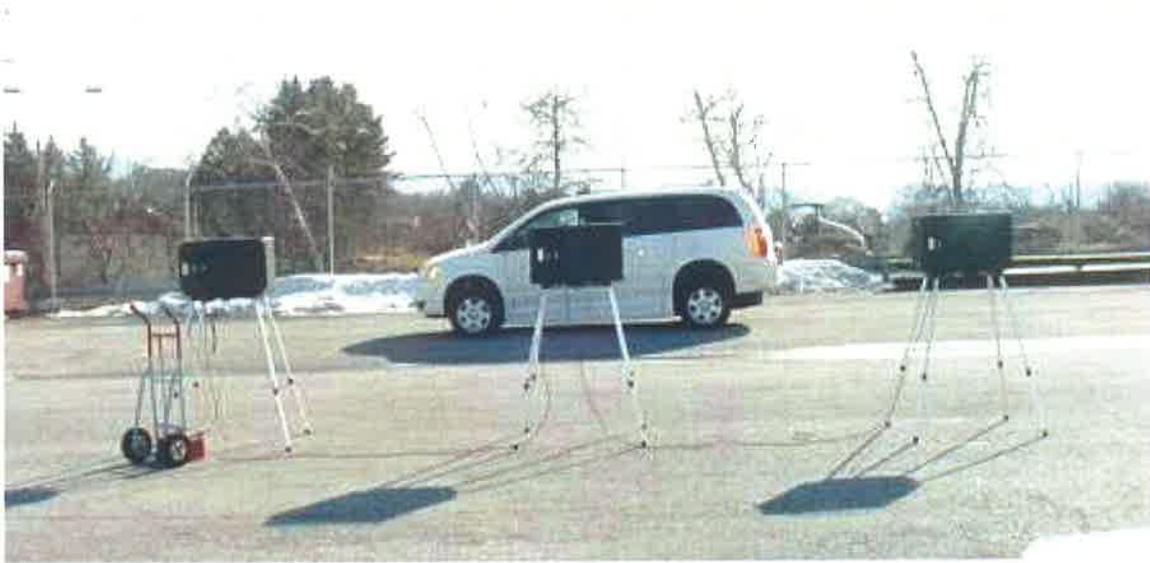
**TEST BUS SET-UP FOR 80 dB(A)
INTERIOR NOISE TEST**

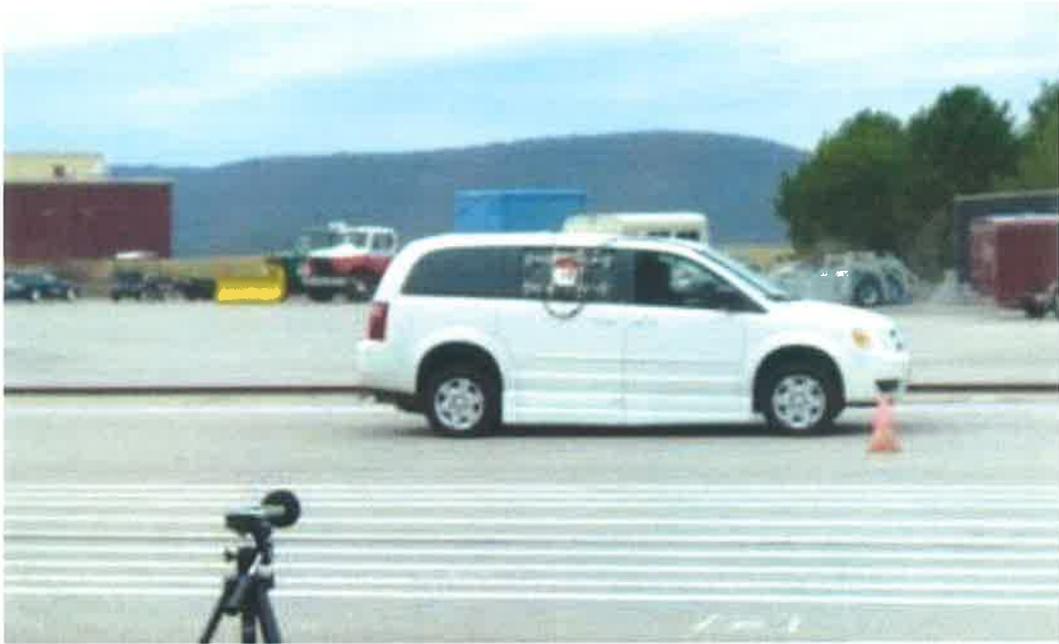
**TEST VEHICLE UNDERGOING
EXTERIOR NOISE TEST**

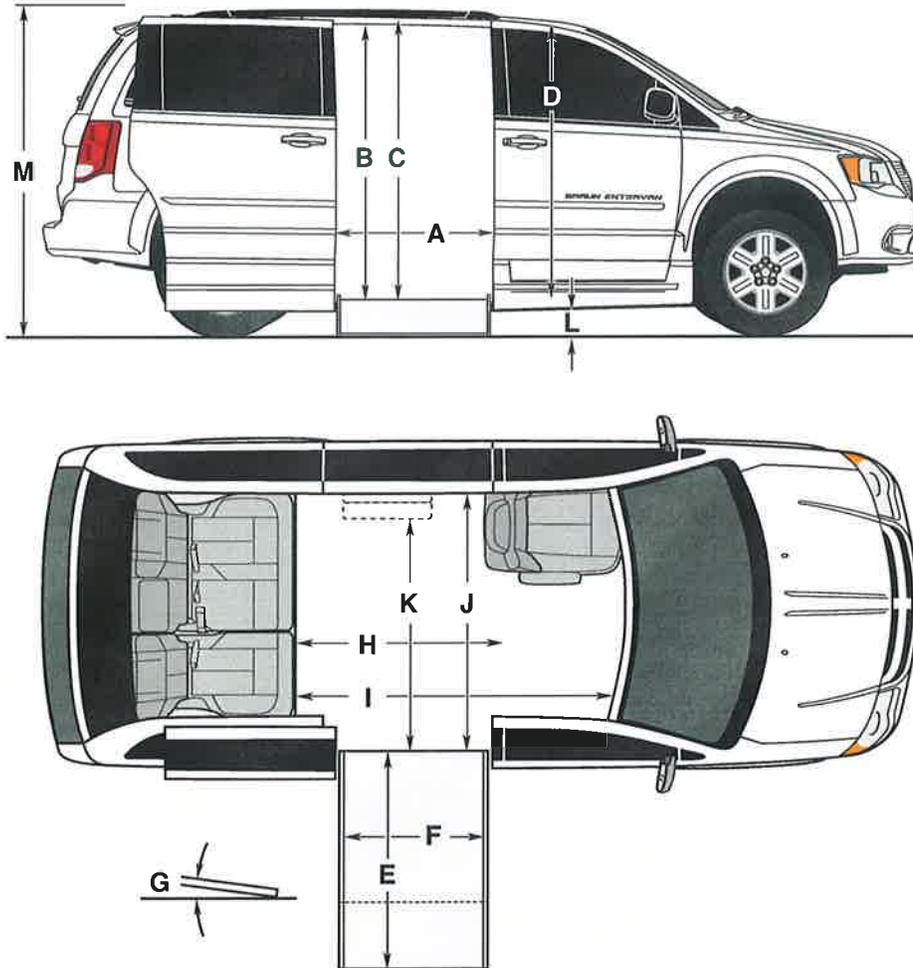
Dimensions - Dodge Conversion - Public Use

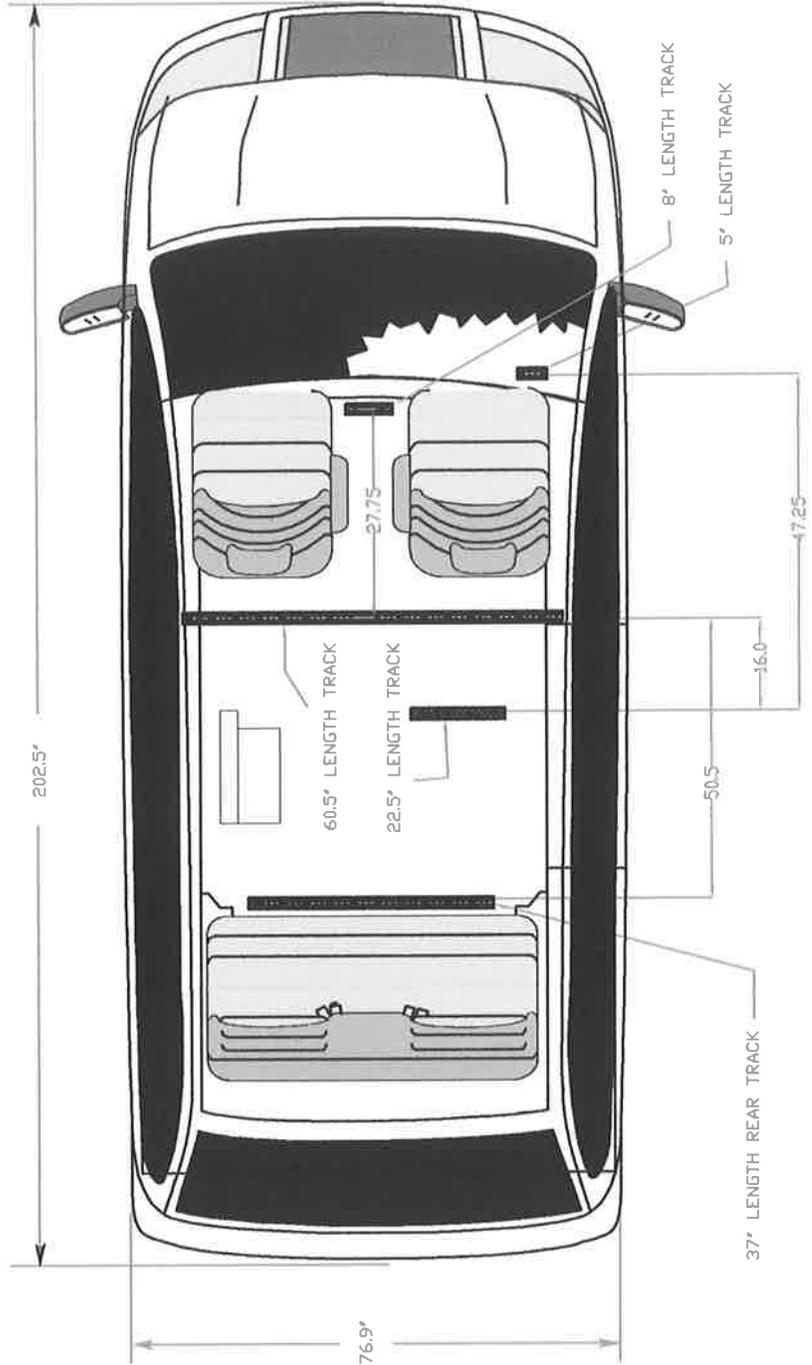
**MOBILITY AID TRACK MOUNTING DIMENSIONS
SHOWING LOCATION OF TRACKING**

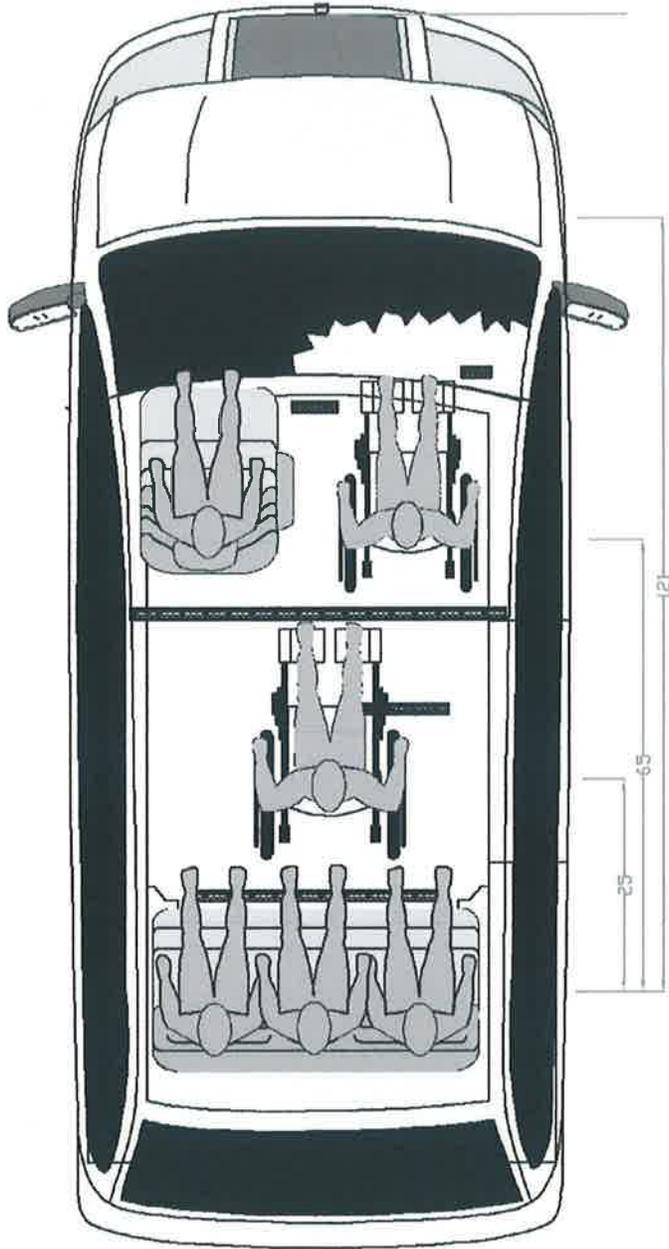
FLOOR PLAN WITH TWO WHEELCHAIRS
 (BASE MODEL NO CENTER FOLD A WAY SEAT)

SEATING OPTION: (3) AMBULATORY PASSENGERS, (1) MOBILITY AID PASSENGER, AND THE DRIVER

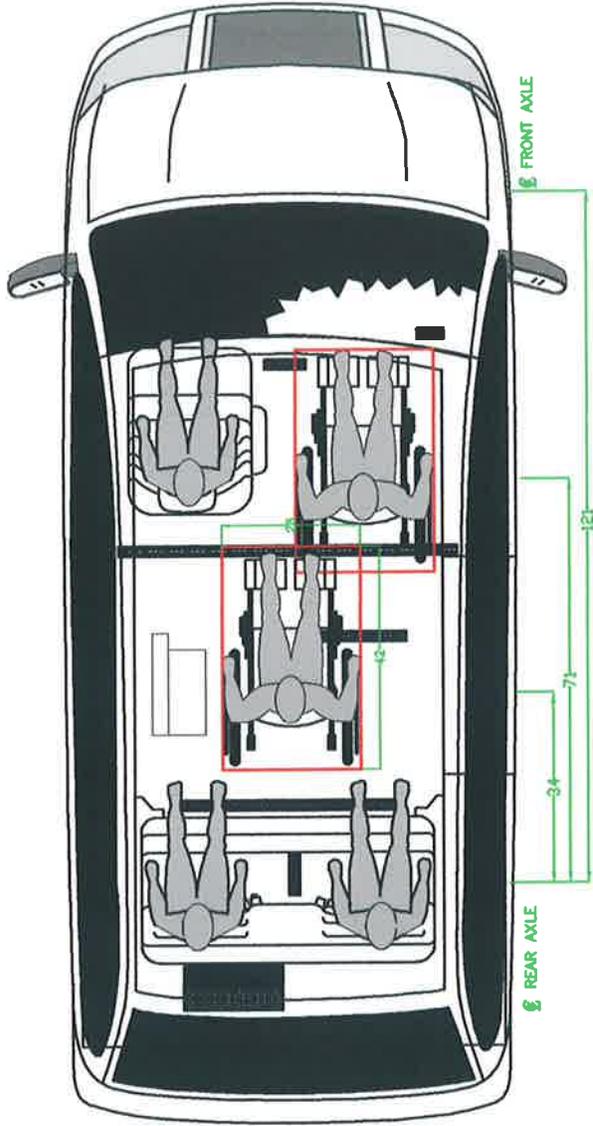
FLOOR PLAN WITH OPTIONAL CENTER FOLD A WAY SEAT AND TWO WHEELCHAIRS

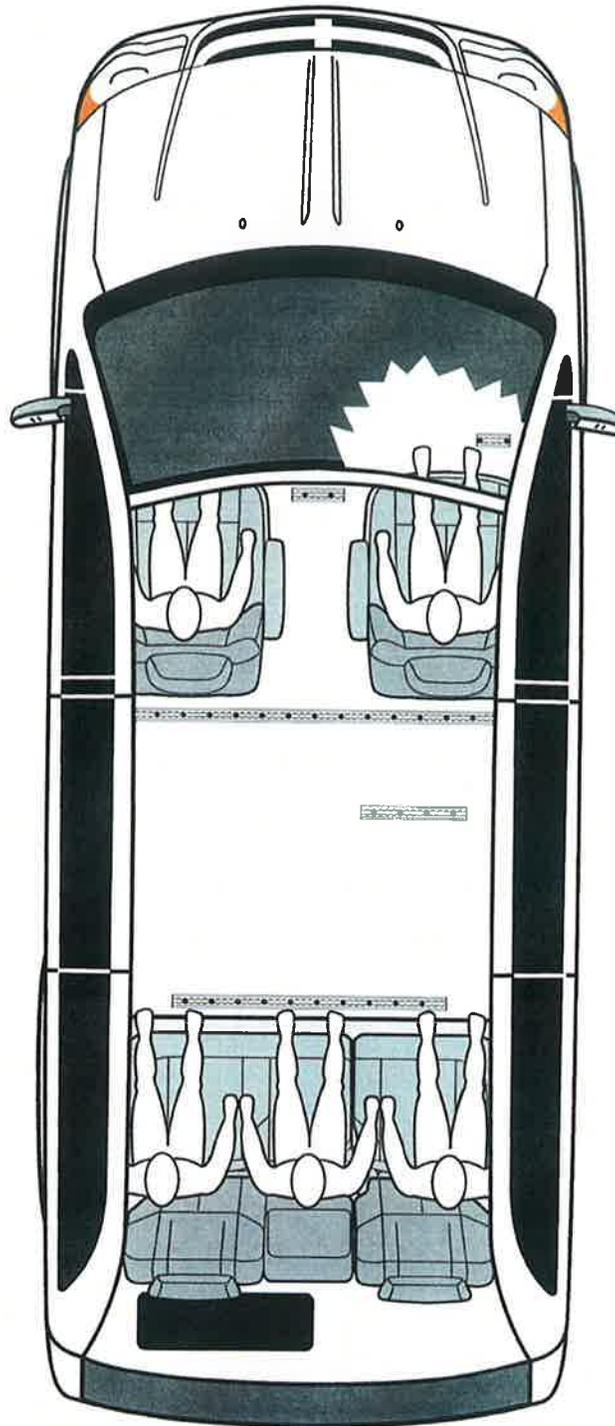
FLOOR PLAN NO WHEELCHAIRS AND NO CENTER SEAT

2015 Dodge/Chrysler WAV - (5) Passenger, (No) Wheelchair Position

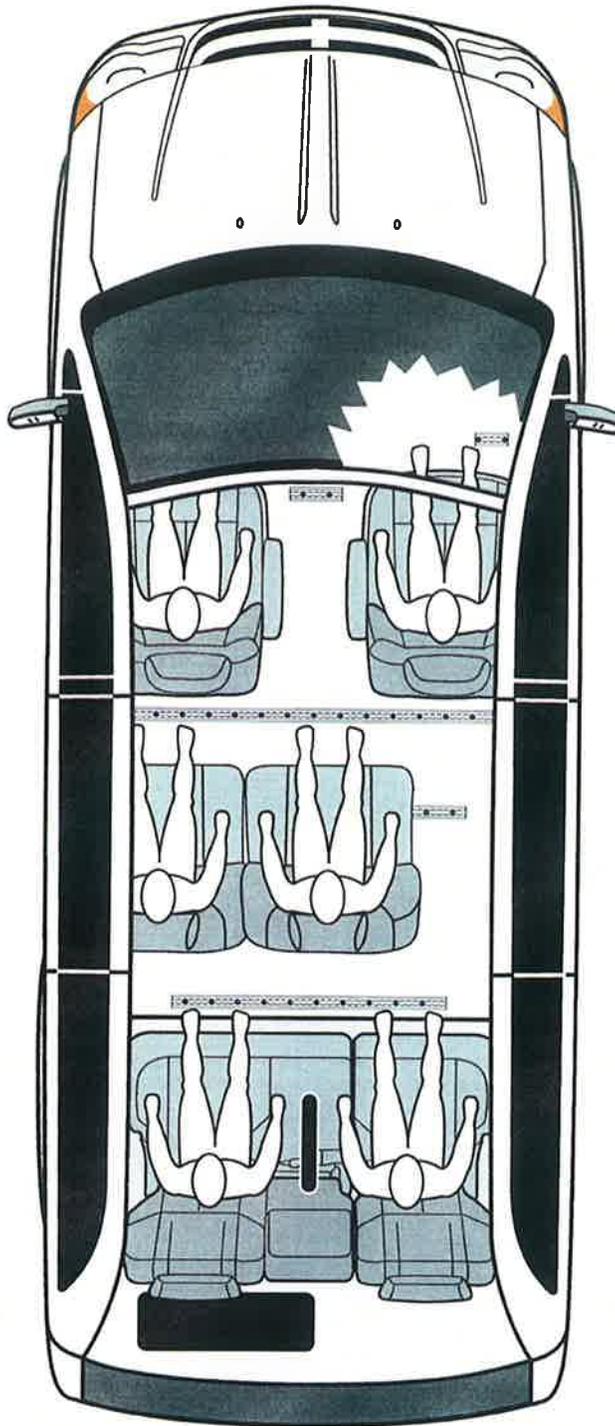
FLOOR PLAN NO WHEELCHAIRS WITH CENTER SEAT

2015 Dodge/Chrysler WAV - (6) Passenger, (No) Wheelchair Position

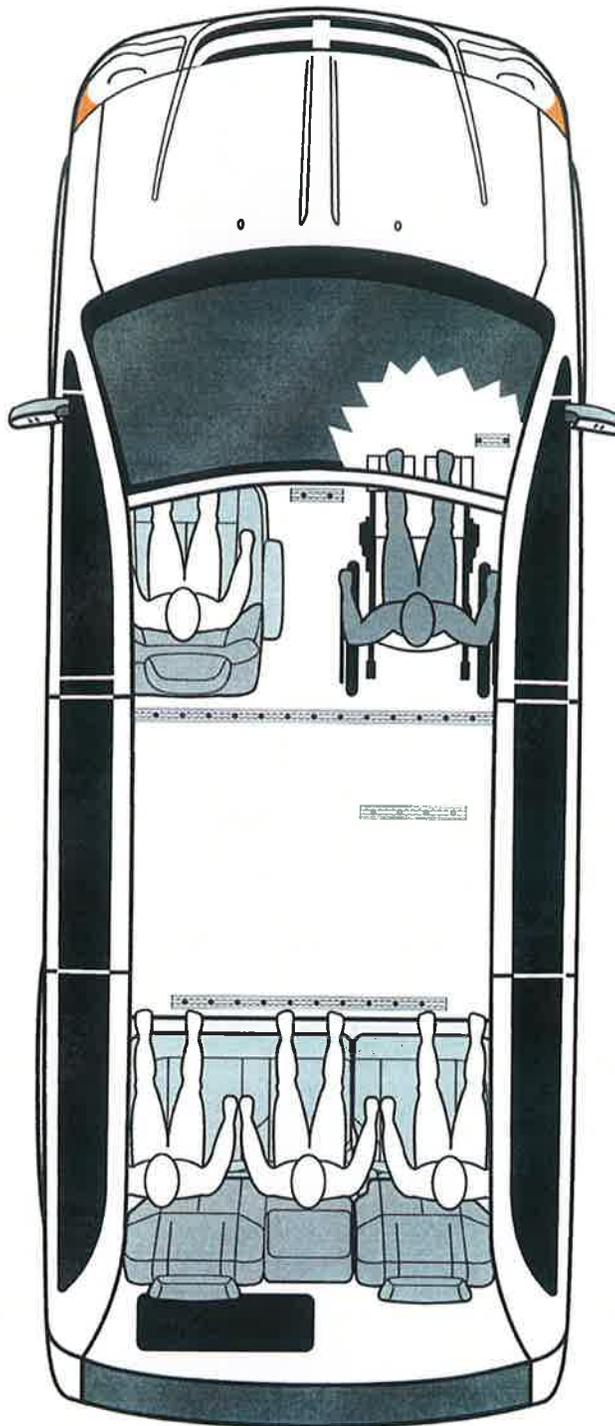
FLOOR PLAN WITH FRONT WHEELCHAIR AND NO CENTR SEAT

2015 Dodge/Chrysler WAV - (4) Passenger, Front Passenger Wheelchair Position
