SUPPORT DOCUMENTATION

Braun Entervan (low floor)

The documents in this section are being submitted as required in the RFP document for the Low Floor Mini Van. Each is listed below and is referenced by location in the RFP where they can be found and are in the same order as the RFP.

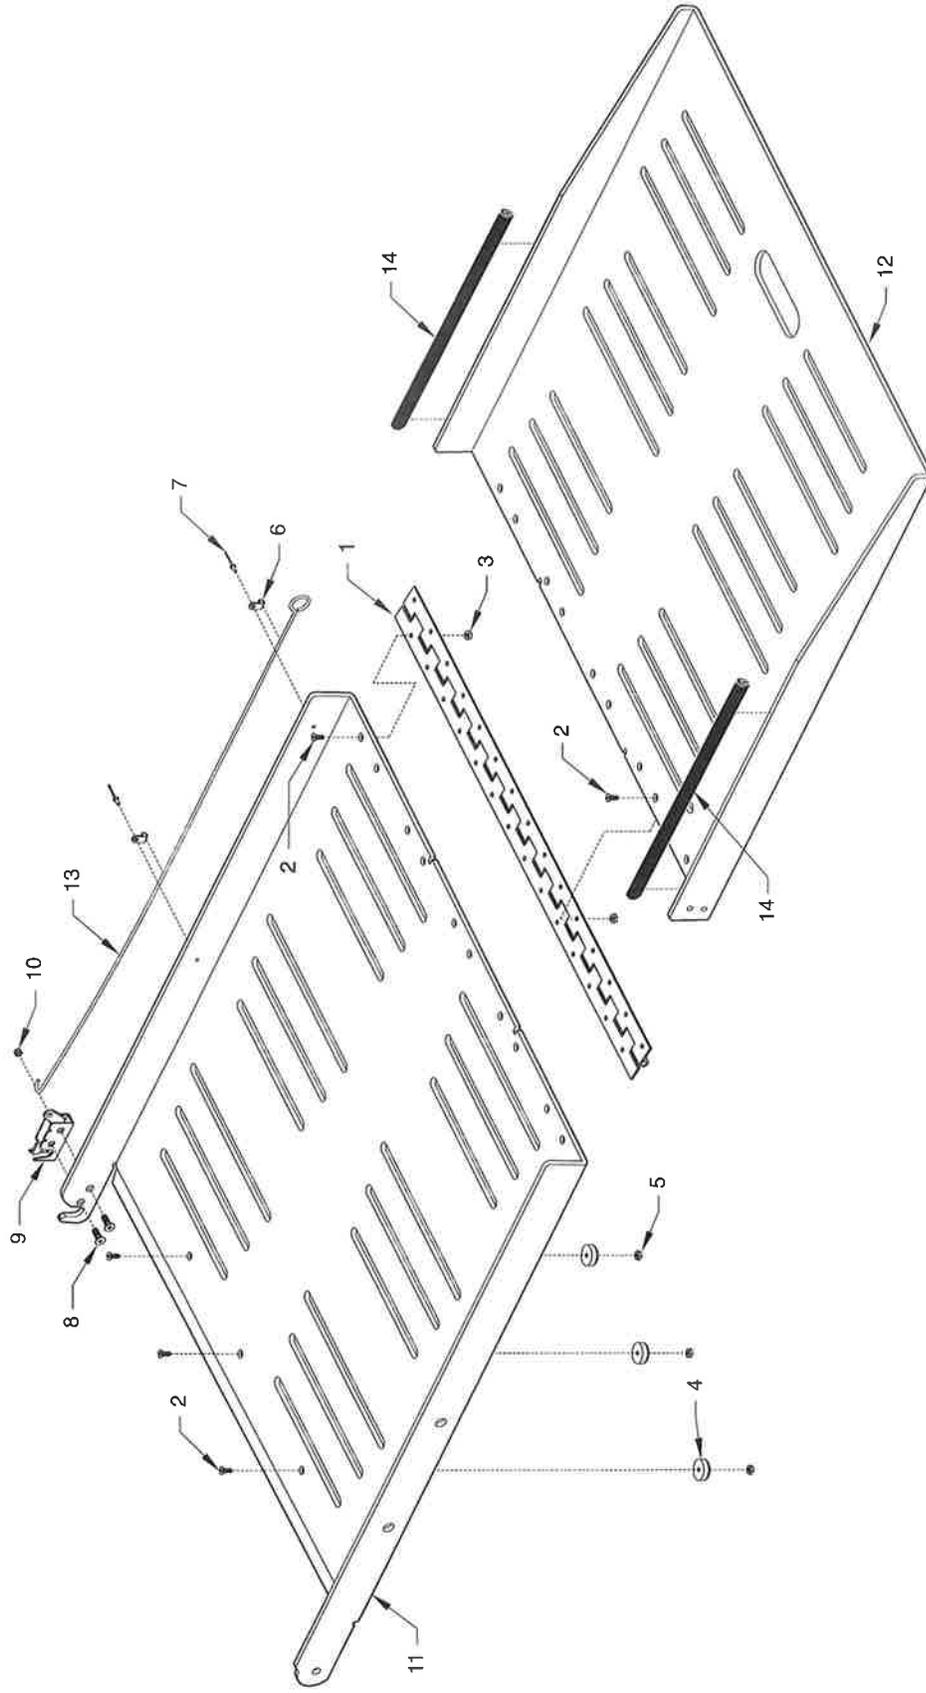
Parts List - 50/50 Manual Swing Out Ramp - Platform Assembly

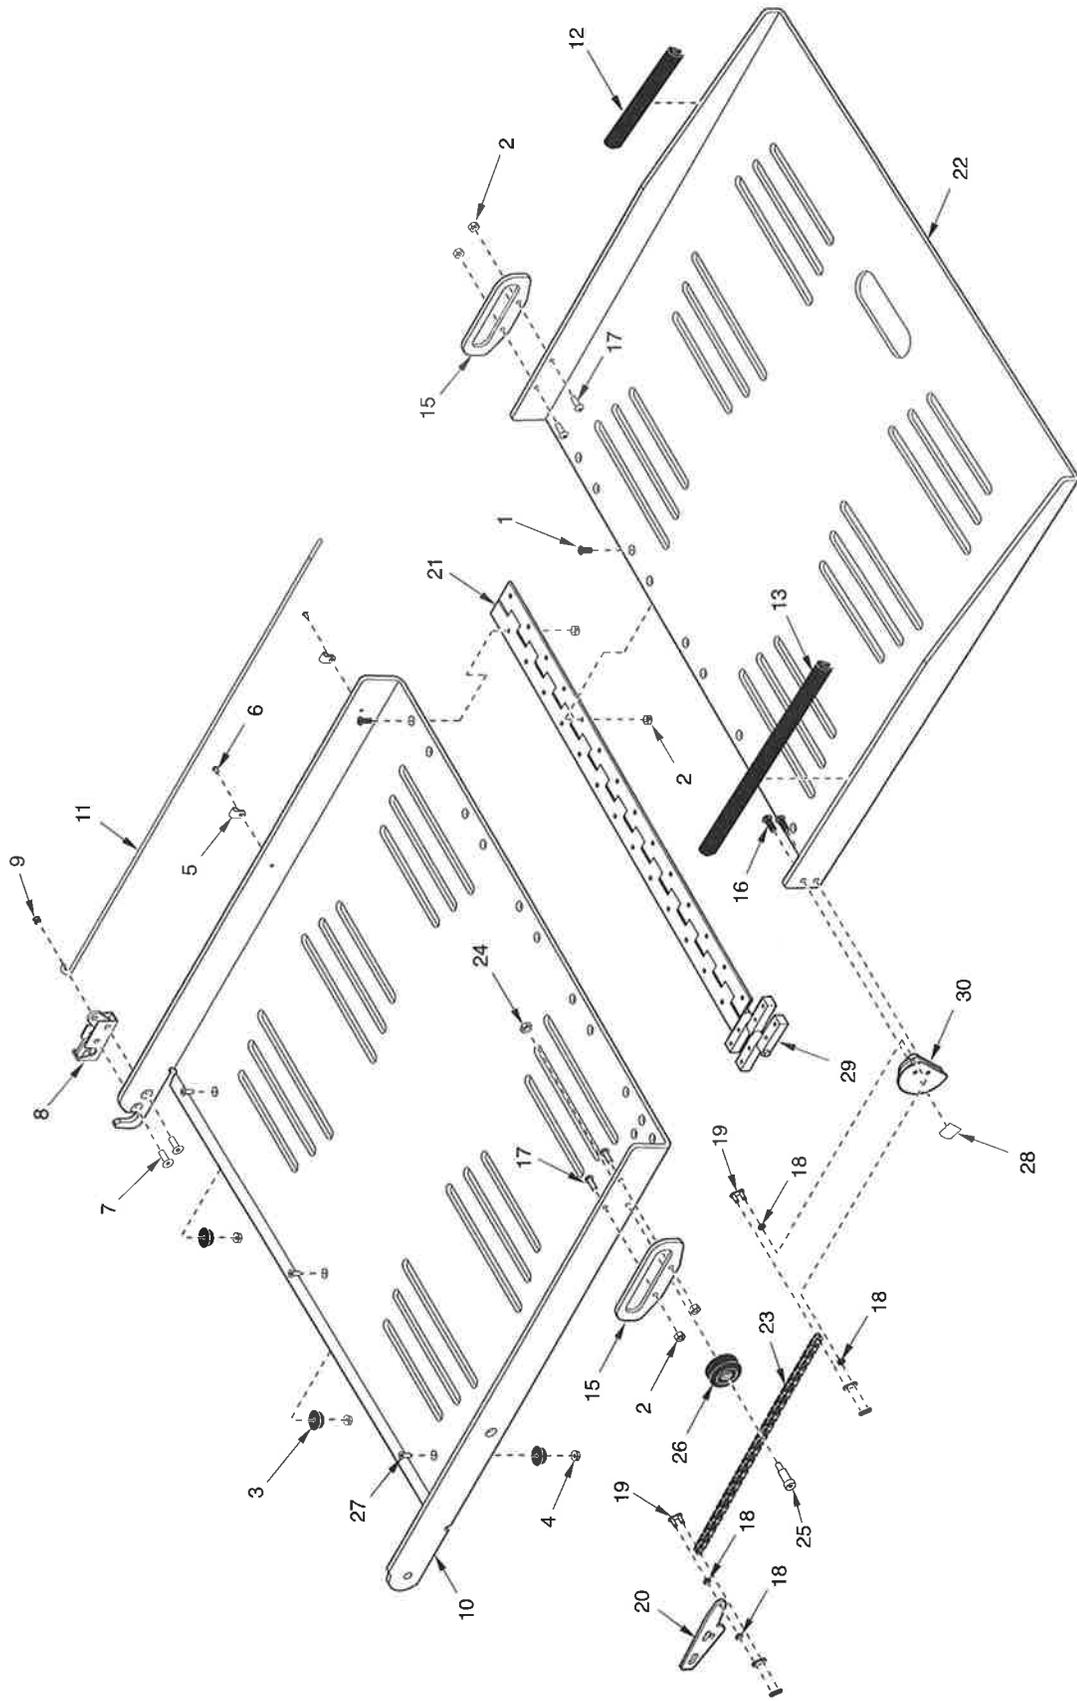
Exploded View - 50/50 Manual Swing Out Ramp - Gas Spring Assist - Ramp Platform / Extension Assembly

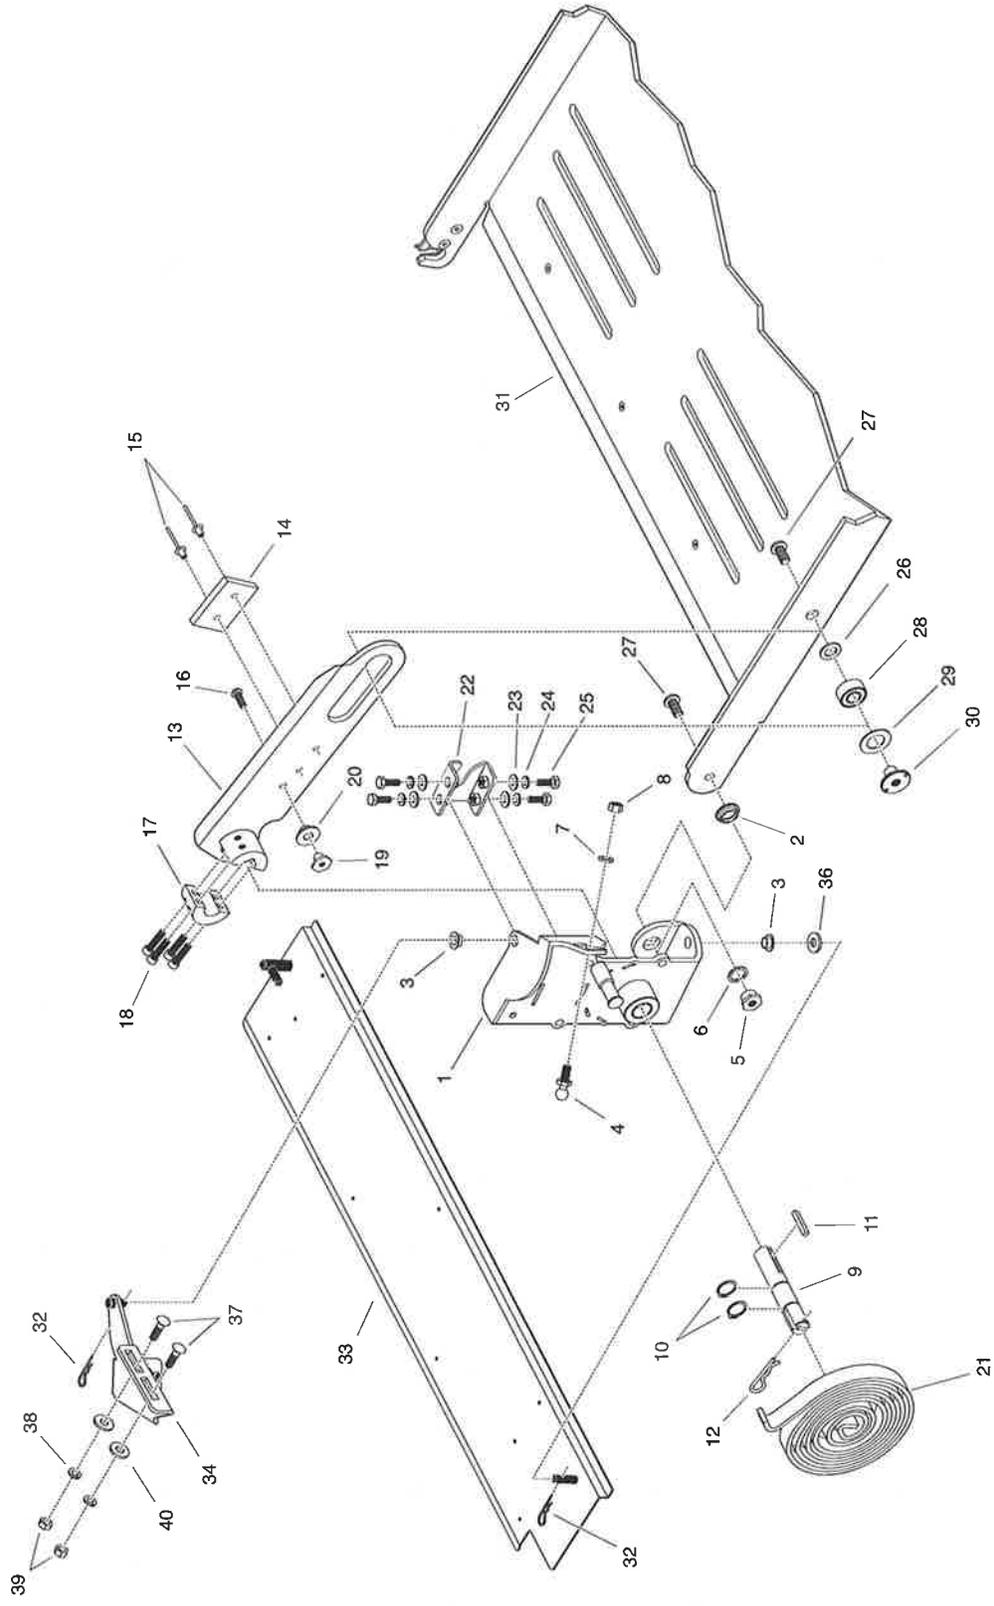
Exploded View - 50/50 Manual Swing Out Ramp - Ramp Threshold, Arm & Spring Assembly

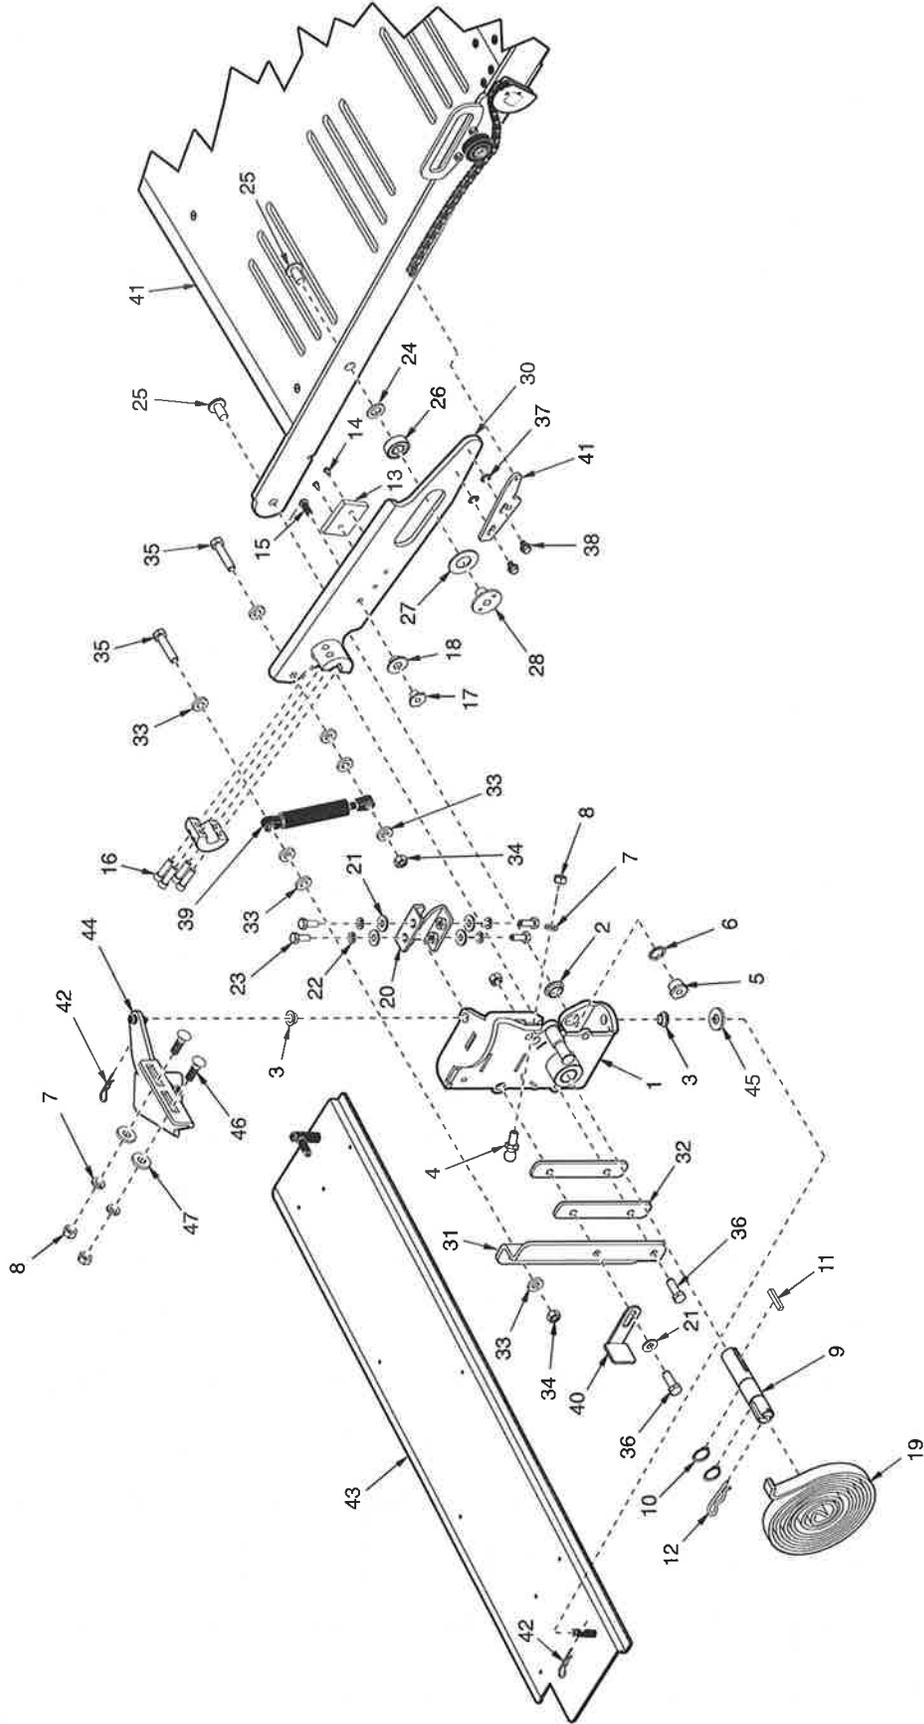
Exploded View - 50/50 Manual Swing Out Ramp - Gas Spring Assist - Ramp Threshold / Arm / Spring Assembly

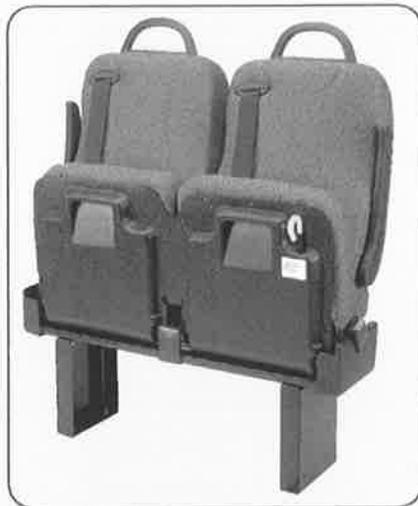
Stowed Position
Flip Seat

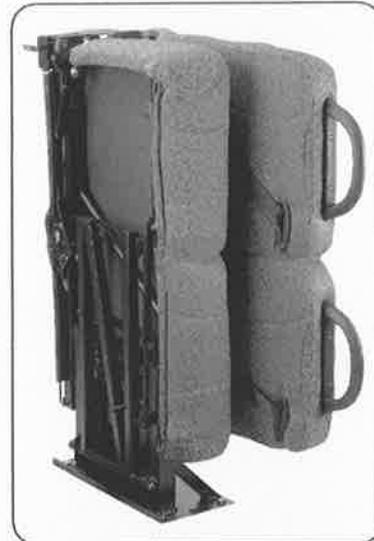
Stowed Position
Foldaway Seat

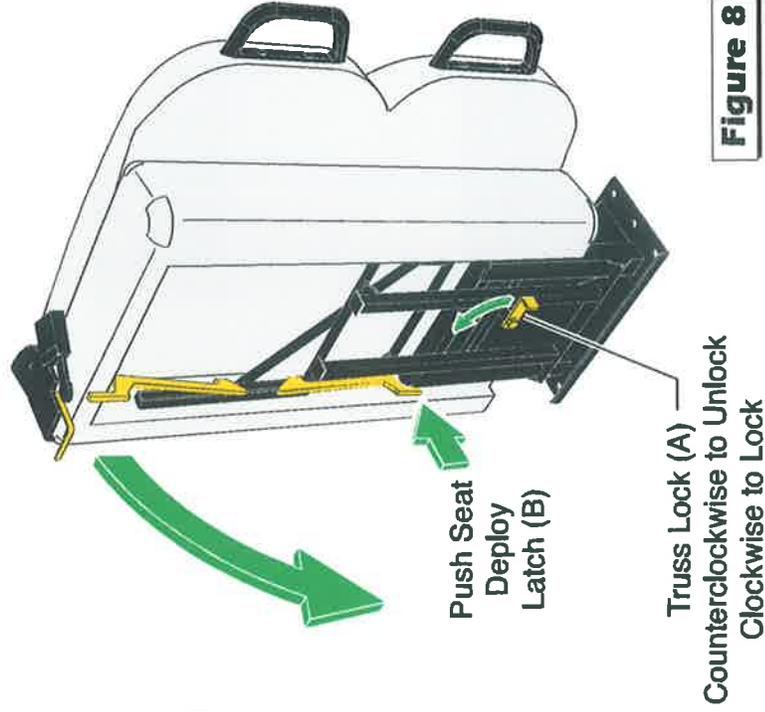
Figure 8

1. Rotate truss lock (A) counterclockwise to unlock seat.
2. Push seat deploy latch (B), pull top of seat and lower to full horizontal position (ensure locked).

1. Lift seat stow latch (D) and lift seat to full vertical position (ensure locked).
2. Rotate truss lock (A) clockwise to lock seat. See Figure 8.

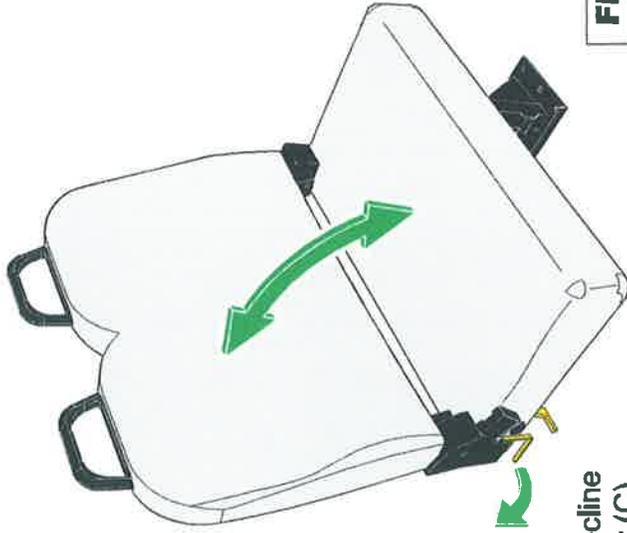
Figure 9

Lift recline lever (C) and lower seatback forward to horizontal position. Ensure latch engagement.

Lift Recline Lever (C)
