# Indiana Classified Forest & Wildlands Forestry Best Management Practices Monitoring Results

By: Jennifer Sobecki & Duane McCoy

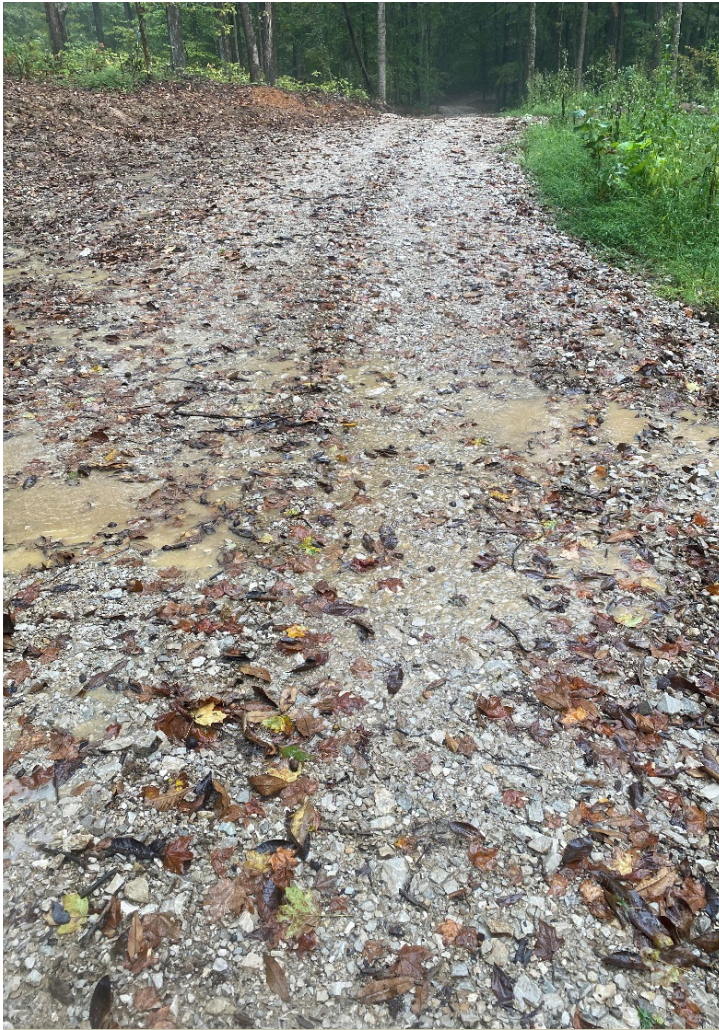
An outslope on this access road channels runoff to the forest floor. This prevents runoff from continuing down the access road, thus limiting erosion potential. Photo by Duane McCoy, DNR

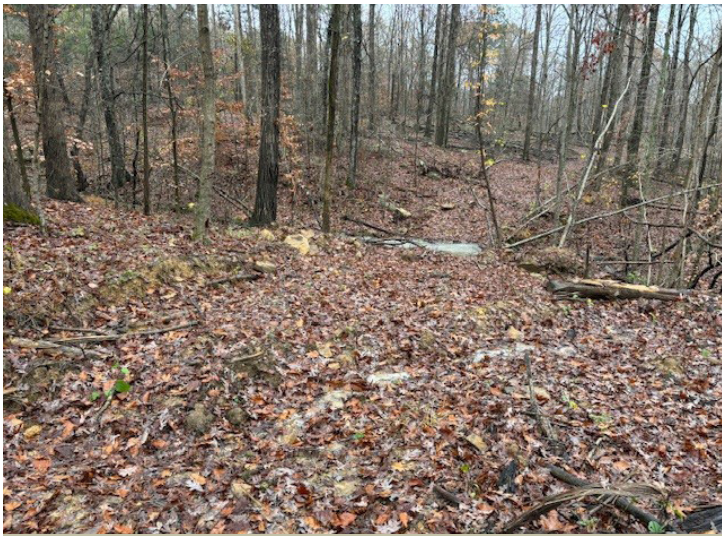
This diversion is moving runoff to the forest floor before an ephemeral crossing, reducing the amount of sediment-laden water that reaches the ephemeral stream. Photo by Jennifer Sobecki, DNR

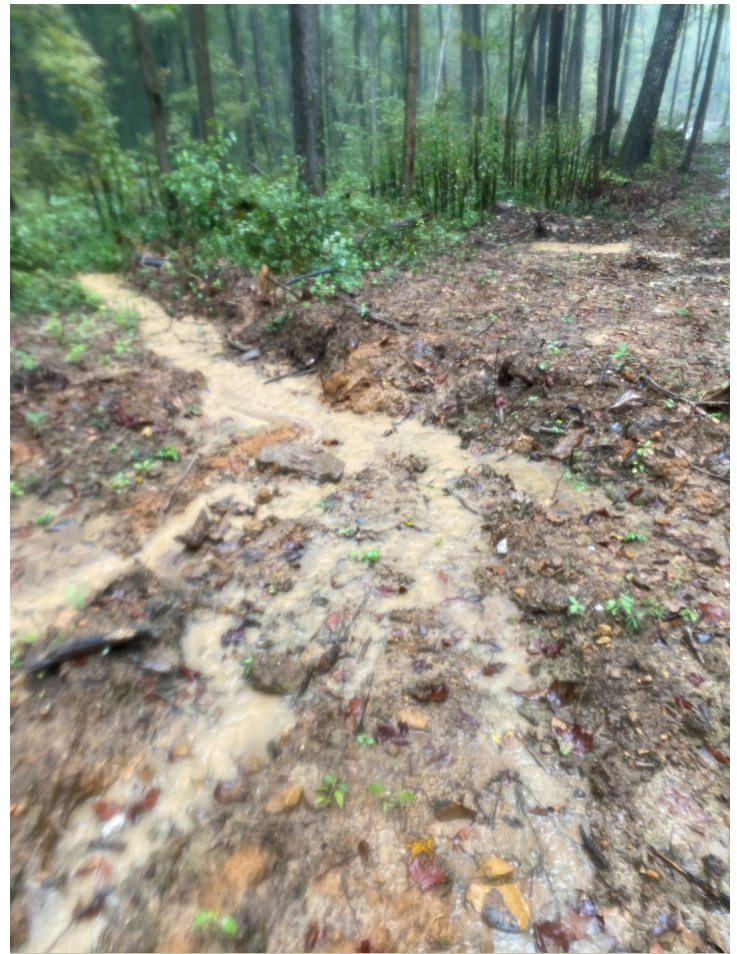
Waterbars doing their job during a rainstorm. Photo by Duane McCoy, DNR

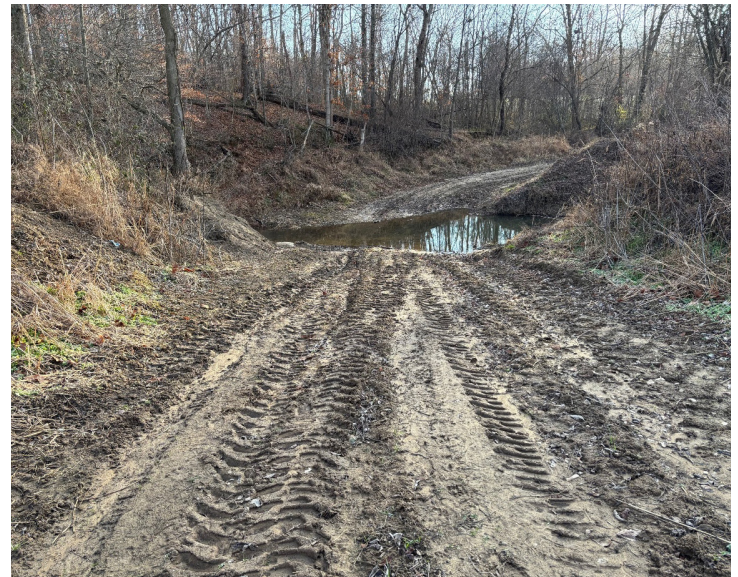
This permanent agricultural crossing was also used for a timber harvest. There is no hardening or diversions, and a lot of loose soil will go directly into a perennial stream. Photo by Jennifer Sobecki, DNR

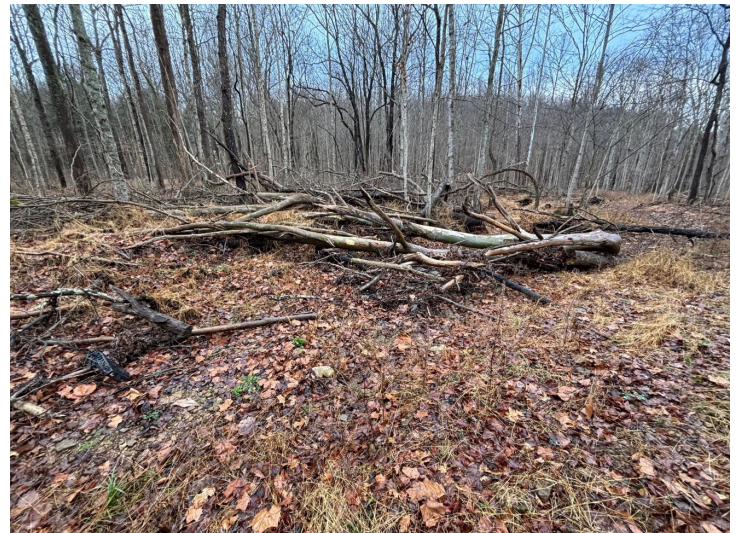
Tops felled into a stream, causing a large amount of debris to build up.  
Photo by Jennifer Sobecki, DNR

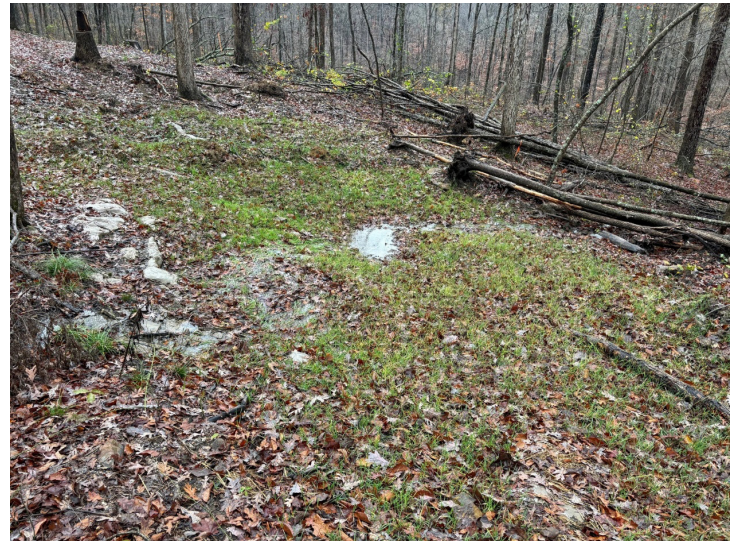
An ephemeral that was previously filled with soil and debris, cleaned out and stabilized. Photo by Jennifer Sobecki, DNR

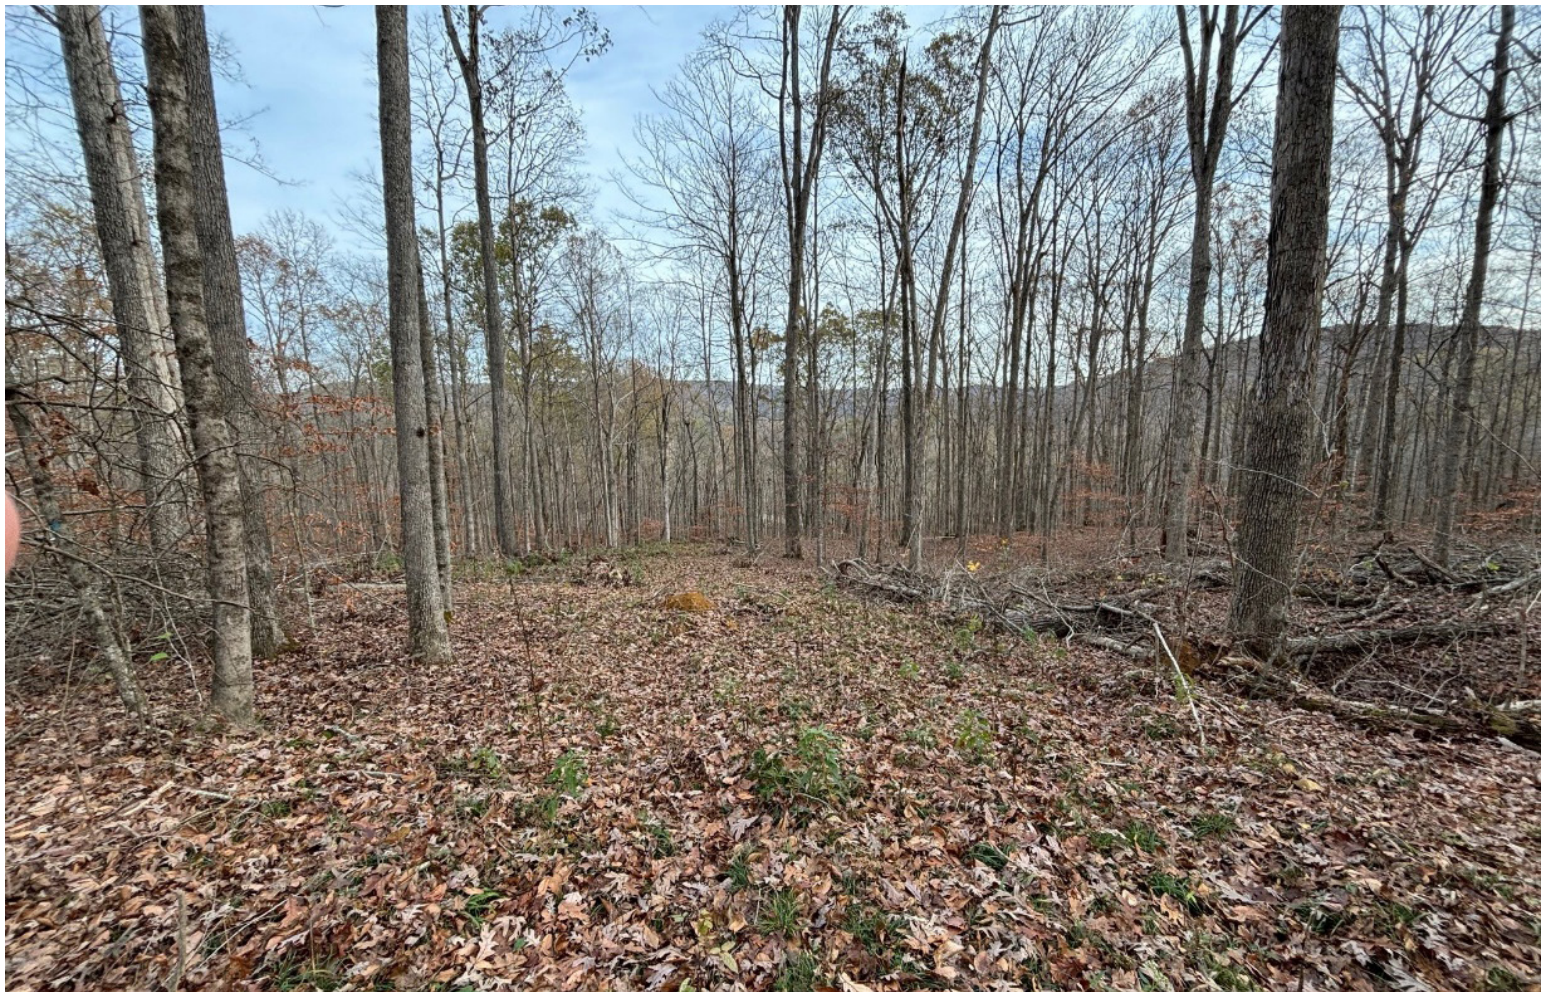
Trail revegetating well after harvest. Photo by Jennifer Sobecki, DNR
