**Des 1702735 CE-4**

**Red Flag Investigation**

Re: RED FLAG INVESTIGATION  
DES #1702735, Local Project  
Bridge Project  
CR 100 N over Rock Creek, 0.5 Mile West of CR 400 W  
Wells County, Indiana

## HISTORIC BRIDGE ALTERNATIVES ANALYSIS

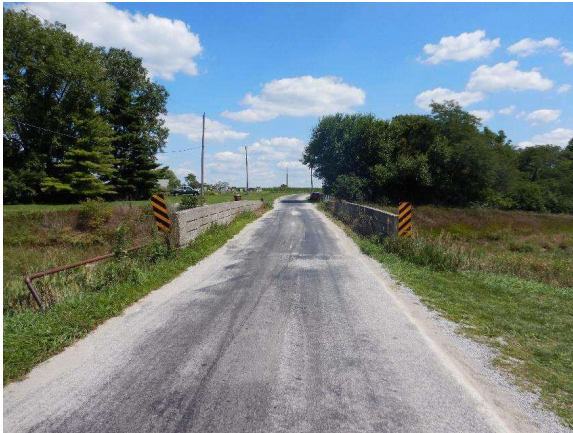
Photo 1: West side project bridge facing southeast

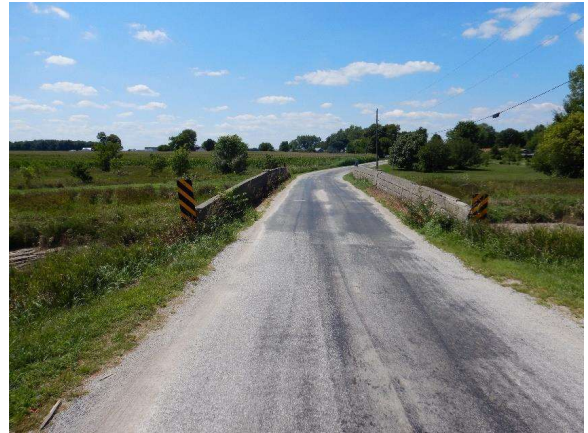
Photo 2: East side project bridge facing northwest

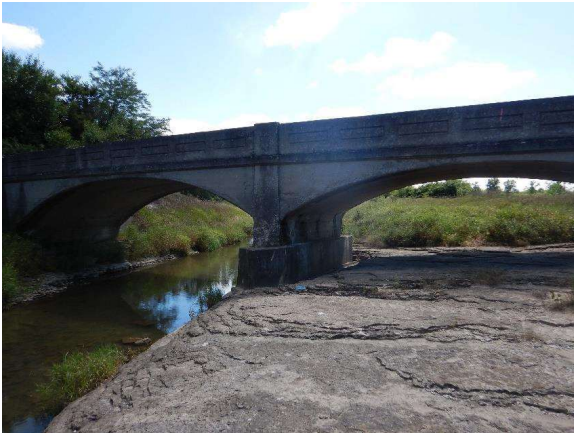
Photo 5: Project bridge and Rock Creek facing south

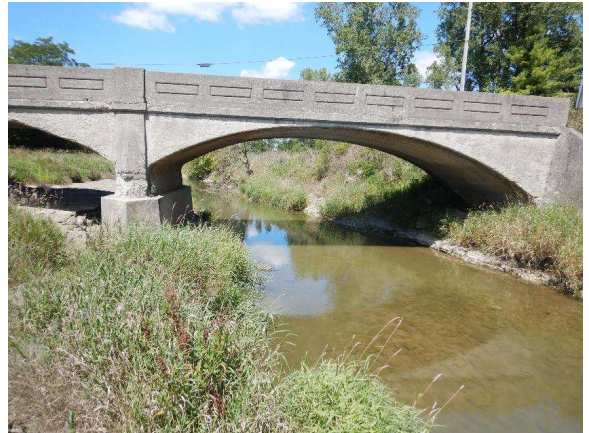
Photo 6: Project bridge and Rock Creek facing north

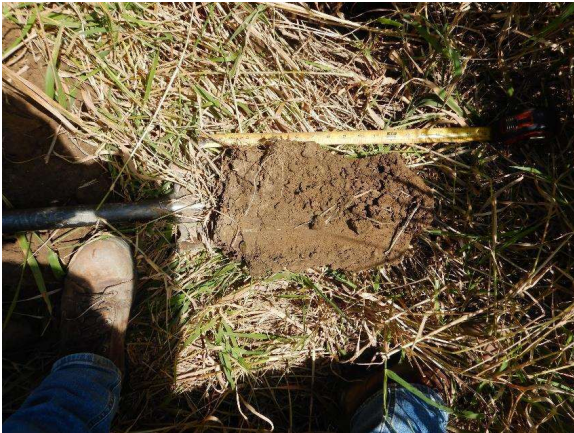
Photo 9: Sample Point 1 soil

Sample Point 1 (SP1) was an upland point in the northwest quadrant of the bridge on a floodplain terrace. Vegetation at this sample point was dominated by Reed Canary Grass (*Phalaris arundinacea*, FACW). This vegetation community passed the rapid test, dominance test, and prevalence index for hydrophytic vegetation. Hydrology indicators observed at SP1 include FAC-Neutral Test (D5). This does not meet wetland hydrology criteria. Soils at SP1 were 10 YR 4/3 (100%) with a texture of silt loam from 0-16 inches. This does not meet any hydric soil criteria. This sample point met the criteria for hydrophytic vegetation but did not meet the criteria for wetland hydrology or hydric soils; therefore, it was not within a wetland. Hydrophytic vegetation is present because Reed Canary Grass (*Phalaris arundinacea*) is an aggressive invasive species that often takes over floodplains and roadsides. Water draining into Rock Creek likely does not stay on the floodplain terrace long enough to develop hydric soils. The impervious rock substrate also allows water to quickly drain into Rock Creek throughout most of the investigated area.

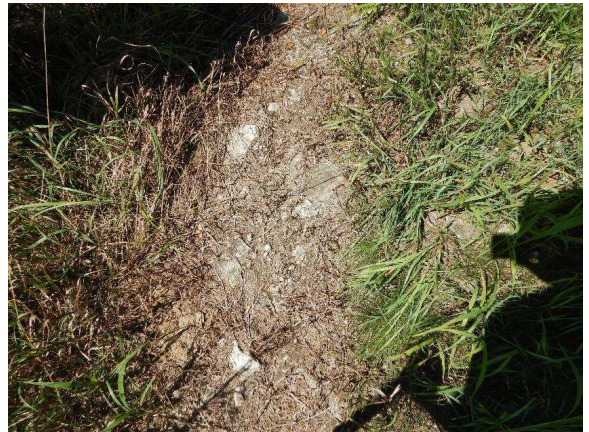
Photo 12: Sample Point 2 location soil

Sample Point 2 (SP2) was an upland point in the southeast quadrant of the bridge on a floodplain terrace. Vegetation at this sample point was dominated by Honey Locust (*Gleditsia triacanthos*, FACU), Field Brome (*Bromus arvensis*, FACU), and Reed Canary Grass (*Phalaris arundinacea*, FACW). This vegetation community did not pass the rapid test, dominance test, or prevalence index for hydrophytic vegetation. Hydrology indicators were not observed at SP2. Soils at SP2 were very shallow and had an impervious
