INDIANA DNR DIVISION OF FORESTRY
STATE FOREST PROPERTIES

**1996 through 2008
Forestry Best Management Practices
Monitoring Results**

By: Duane A. McCoy and Jennifer Sobecki

1996 through 2008 State Forest BMP Report

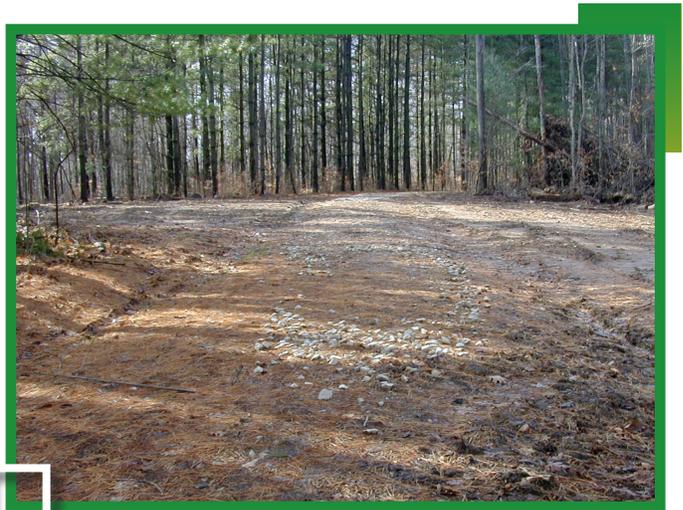
Table 1: Application and Effectiveness of BMP Specifications for Access Roads

Access Roads	% Application	% Effective
A1. Uses existing routes where appropriate	100.0	100.0
A2. Adequate buffer strip next to water courses and sensitive areas	95.1	98.0
A3. Avoids unstable gullies, seeps, very poorly drained areas	94.9	100.0
A4. Road grades are within standards	97.7	100.0
A5. Amount of roads minimized	100.0	100.0
A6. Stream crossings minimized	100.0	100.0
A7. Road excavation minimized	98.6	100.0
A8. Excavated and fill materials placed properly	98.6	99.1
A9. Roads constructed to drain well	87.5	98.6
A10. Appropriate road stabilization, drainage and diversions installed	81.3	96.2
A11. Water diversions functioning properly	89.5	96.7
A12. Runoff diverted onto stable forest floor areas	90.0	93.8
A13. Public road drainage system maintained	99.5	100.0
A14. Public road's drainage maintained	100.0	100.0
A15. Traffic barriers installed	98.1	100.0
Overall Access Road	96.4	98.8

The only specification needing greater attention in the application phase is installation of drainage diversions and road stabilization. Although that area had only an 81.3% application rate, there was a 96.2% effectiveness rate indicating virtually no visible impact to water quality due to those departures. Many of the access roads are permanent fire trails or other roads that are used and maintained to varying degrees, thus some are more structurally stable while others have had the diversions worn down by use over long periods.
