Indiana
Forestry Best
Management
Practices
Monitoring
Results for State
Forest Properties

1996-2024

By: Jennifer Sobecki & Duane McCoy

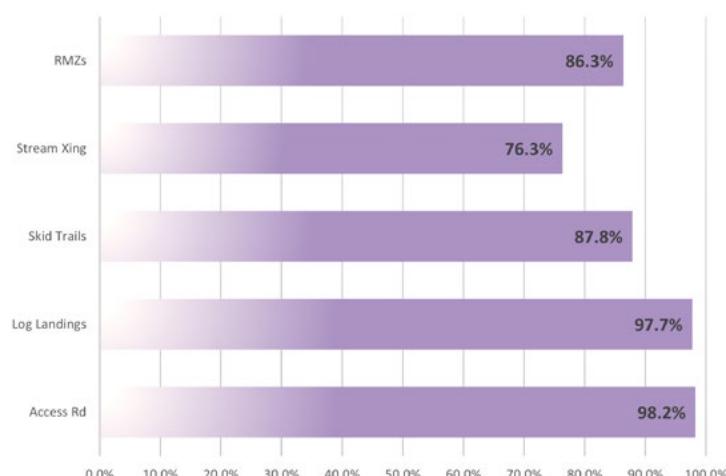
Figure 7. Overall BMP effectiveness for each of the five BMP categories.

The overall BMP application and effectiveness for the five categories was highest for access roads, which had a 94.9% application rate and 98.2% effectiveness rate. Second-highest was log-landing application, with an application rate of 90.4% and effectiveness, 97.7%. The third-highest category was RMZs, with 82.0% application and 86.3% effectiveness rates. While skid trails rated low in application at 75.2%, the effectiveness was still good at 87.8%. Stream crossings had the lowest application rate of all categories but was 74.9% application. Effectiveness on stream crossings is 76.3%. The BMP area with the most difficulty was stream crossings. Because of the direct impact crossings can have on water resources, BMP applications are most critical in this area. Small problems in stream crossings can lead to lower effectiveness with more direct impacts to them. Wet conditions can also lead to more departures in effectiveness of stream crossings.

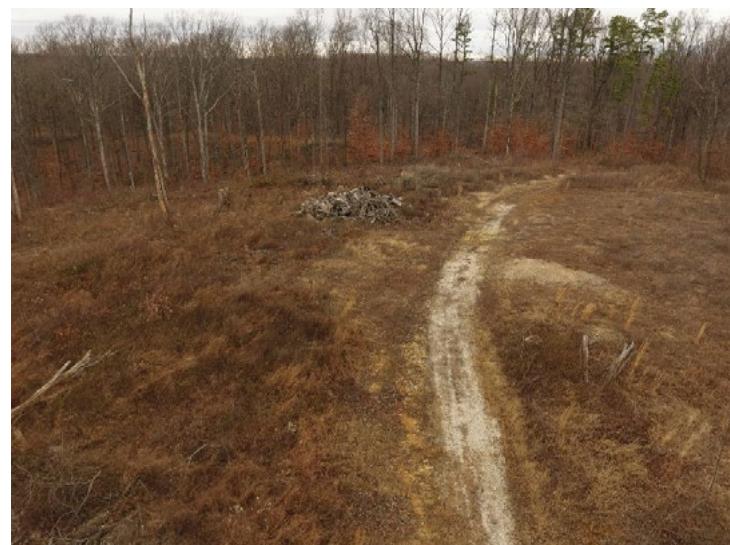
Access road is the lane that connects log landings to municipal roads. Here an access lane approaches a log landing. Drone photo taken on state forest property by Jamie Winner, DNR.

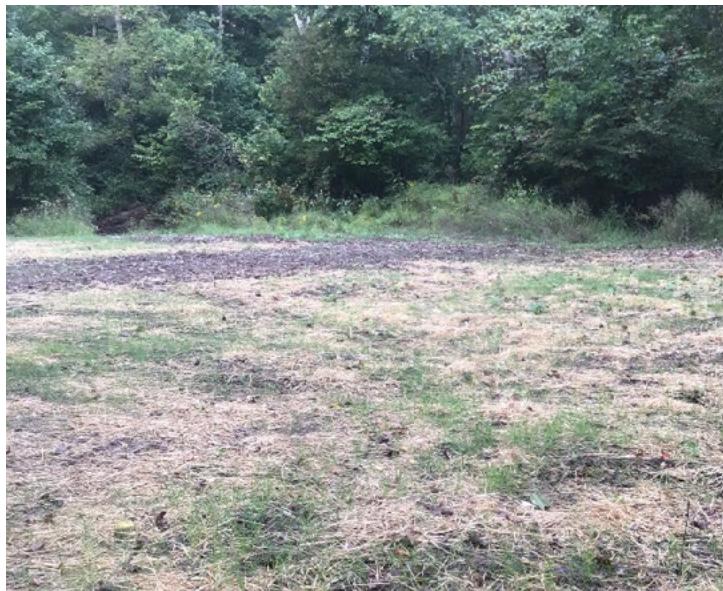
Seeding and strawing a landing after a harvest helps to quickly establish new plant growth while providing protection to the soil surface. This reduces erosion and increases water infiltration. Photo taken on state forest. Photo by: Jennifer Sobecki DNR

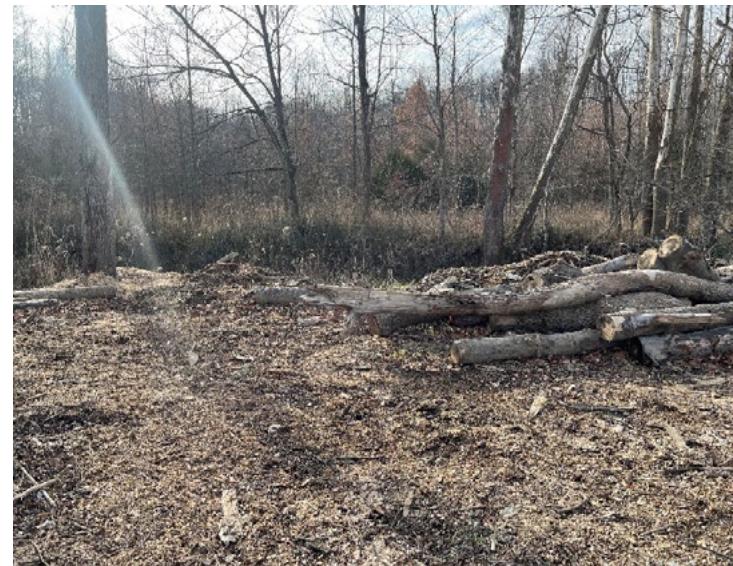
Log landings should generally be avoided near a stream. This landing used debris to filter water before it flowed into the stream, so while this site scored low on application, it was still effective at protecting the water resources on site. Photo taken on private property by Jennifer Sobecki DNR

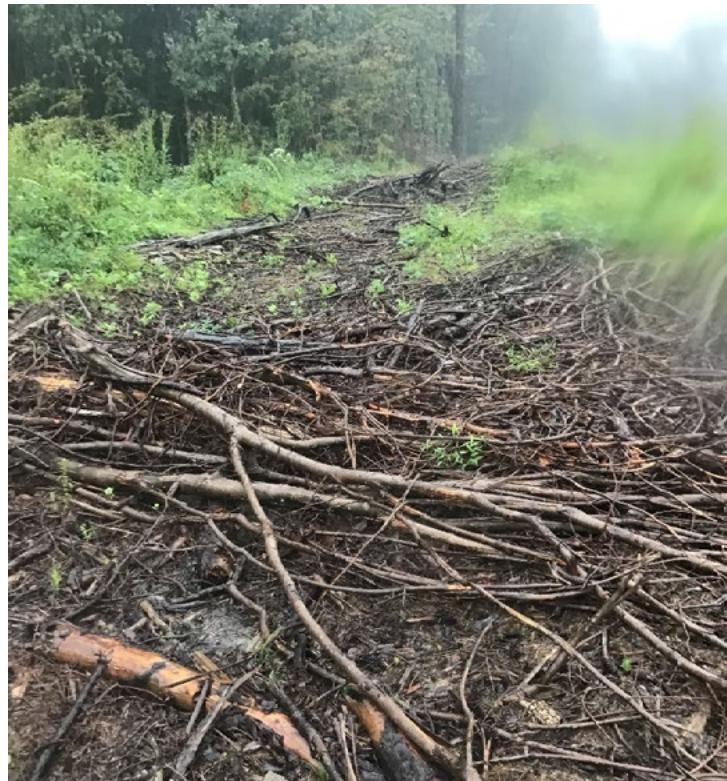
Debris armoring skid trails reduces compaction and subsequent runoff. This works particularly well if ground conditions deteriorate during a harvest. Photo by: Duane McCoy DNR

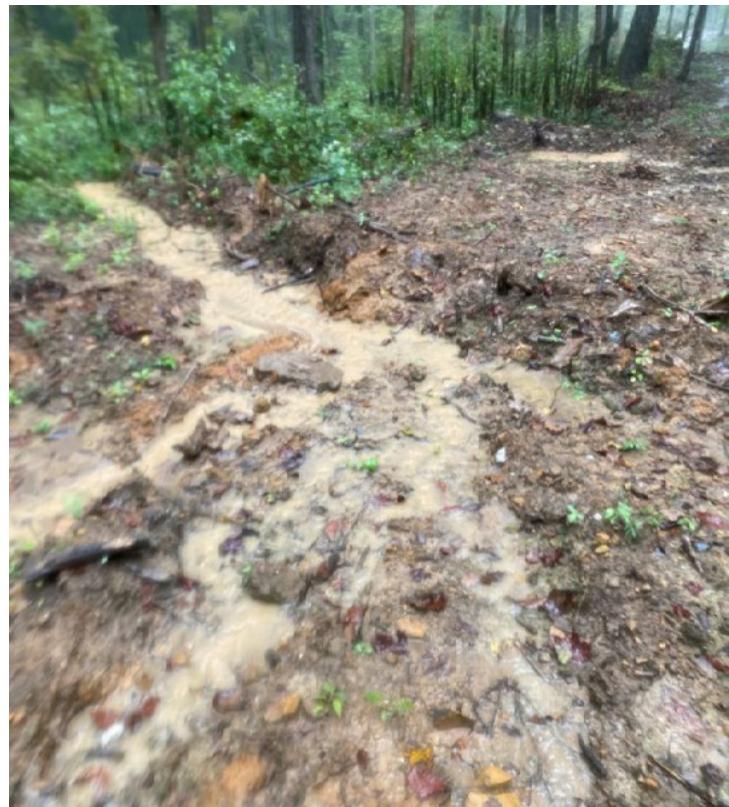
Waterbars actively moving stormwater off a skid trail during a rain event. Photo taken on state forest lands by Duane McCoy DNR.

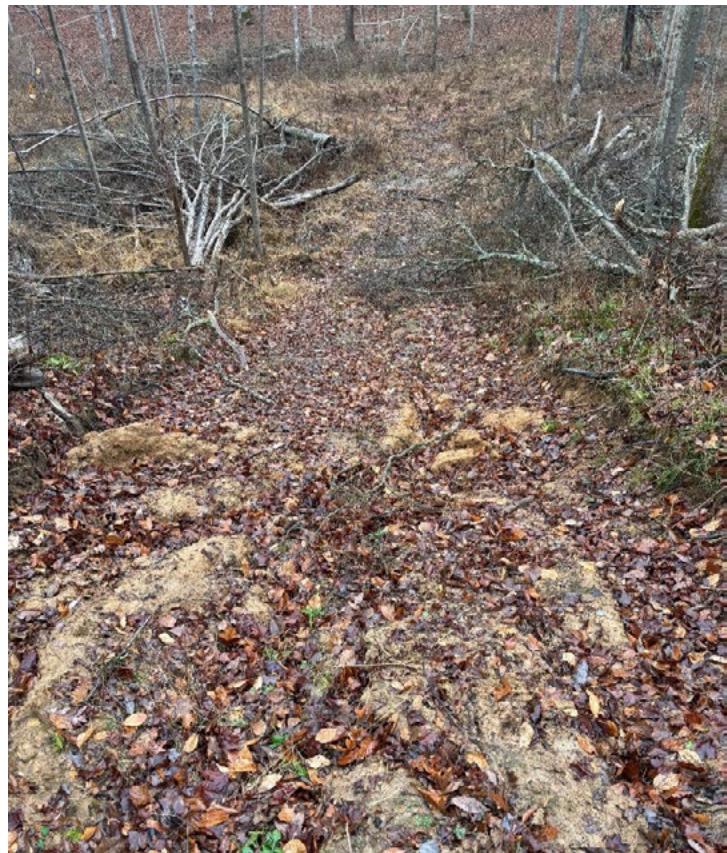
Blown waterbar above a stream crossing. Stream is filled with harvest debris. Photo taken on private land by Jennifer Sobecki, DNR.

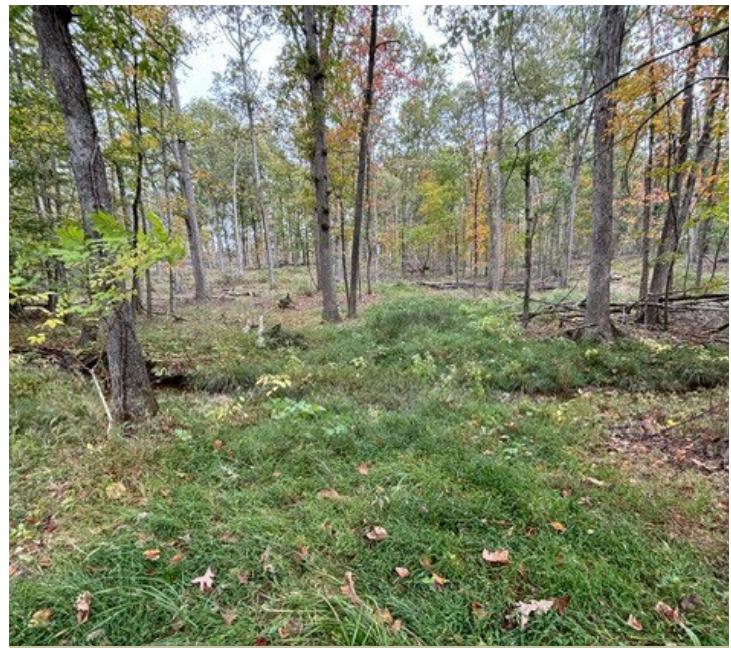
This bridge crossing was well seeded and vegetated after the harvest was completed. Photo taken on state forest property by Jennifer Sobecki, DNR.

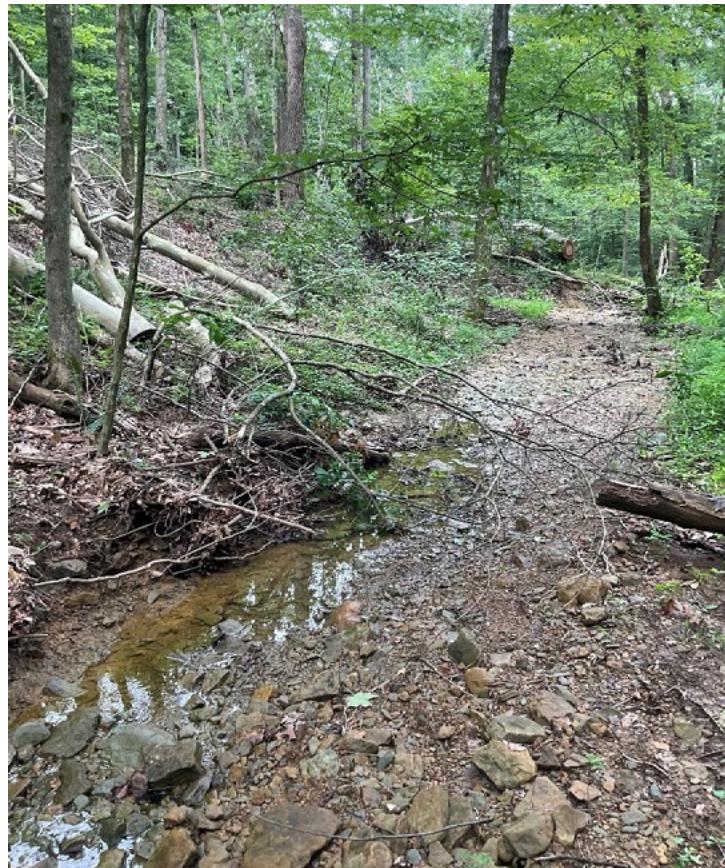
Tops have been removed from the stream in two different areas along this stream on state forest lands. Photo by: Duane McCoy, DNR

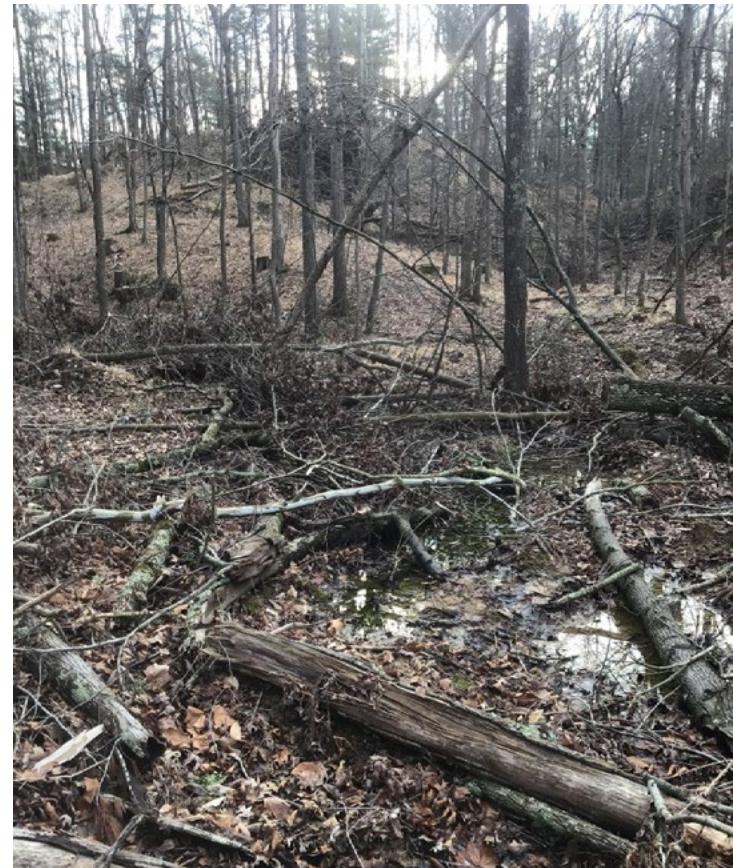
A small stream clogged with logging debris. Photo taken on private property by Duane McCoy DNR.

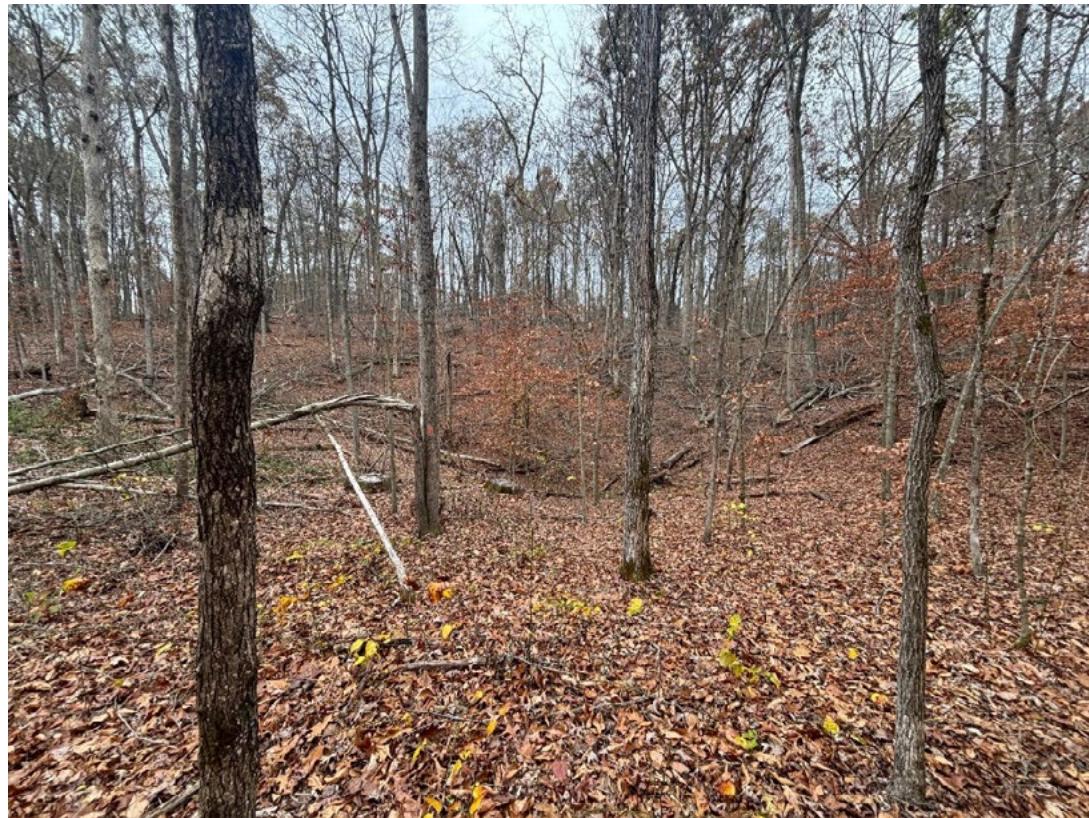
A harvest was conducted on state forest property near a sinkhole. There were no trails and no soil disturbance near the sinkhole, and tops were felled away and thus properly protected. Picture by: Jennifer Sobecki DNR
