**Indiana Forestry
Best Management Practices
Monitoring Results for
State Forest Properties**

By Jennifer Sobecki & Duane McCoy

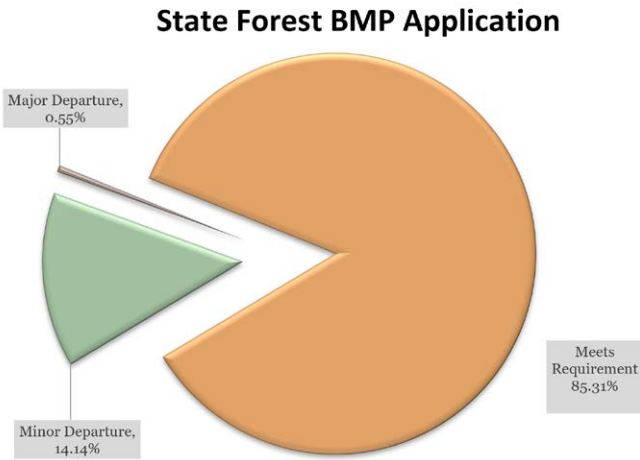
Figure 3. BMP application rates for all 804 sites monitored on state properties since 1996.

The application and effectiveness rates for BMPs used to protect sites after timber harvests are excellent for the 804 state forest sites monitored since 1996. The overall application rate is 85.31 percent, and the overall effectiveness rate is 91.59 percent.

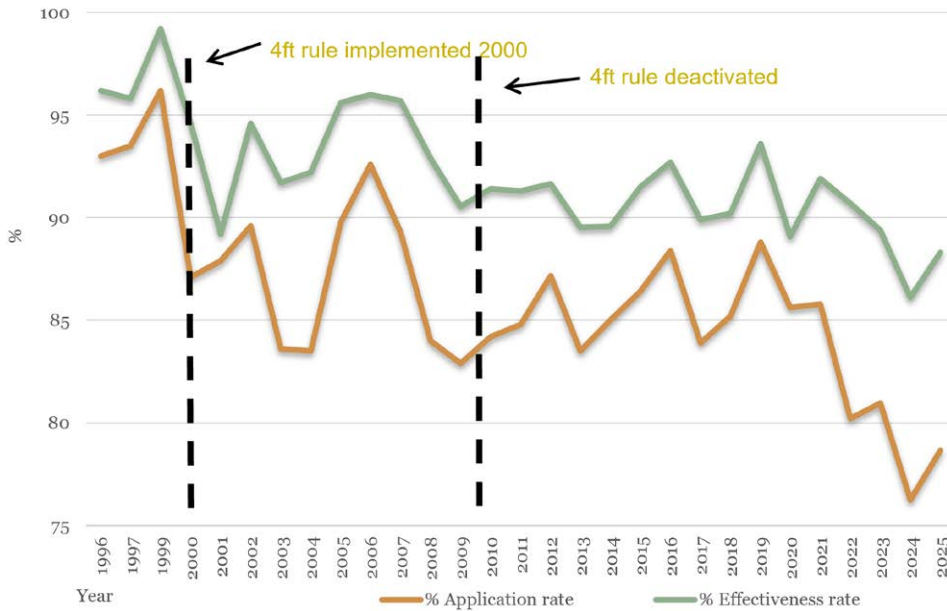
Figure 5. Yearly trends of BMP application and effectiveness on Indiana State Forests for 29 years of monitoring. These percentages are calculated for each year's data separately, not combined with the running totals from previous years.

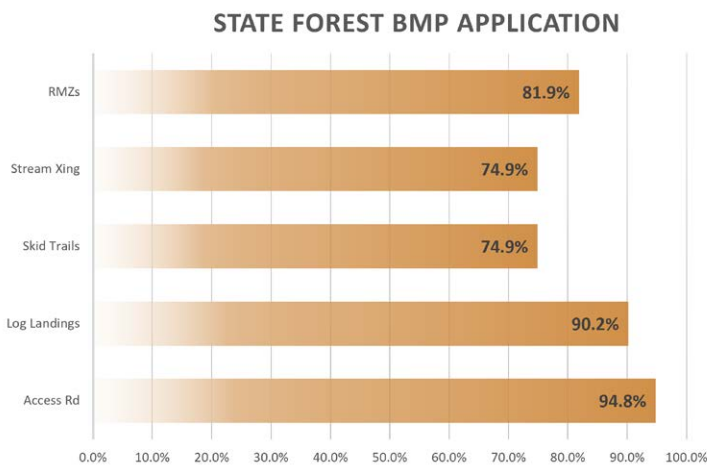
Figure 6. Overall BMP application for each of the five BMP categories.

The overall BMP application and effectiveness for the five categories was highest for access roads, which had a 94.8% application and 98.2% effectiveness rate. Second-highest was log-landing application with an application rate of 90.2% and effectiveness, 97.7%. The third-highest category was RMZs, with 81.9% application and 86.1% effectiveness rates. While skid trails rated low in application at 74.9%, the effectiveness was still good at 87.6%. Stream crossings had the lowest application rate of all categories at 74.9%. Effectiveness on stream crossings is 76.4%. The BMP area with the most difficulty was stream crossings. Because of the direct impact crossings can have on water resources, BMP application is most critical in this area. Small problems in stream crossings can lead to lower effectiveness with more direct impacts. Wet conditions can also lead to more departures in effectiveness of stream crossings.

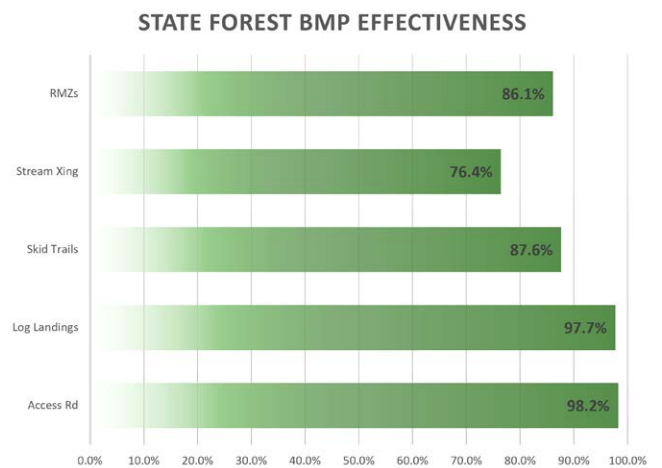
Figure 7. Overall BMP effectiveness for each of the five BMP categories.

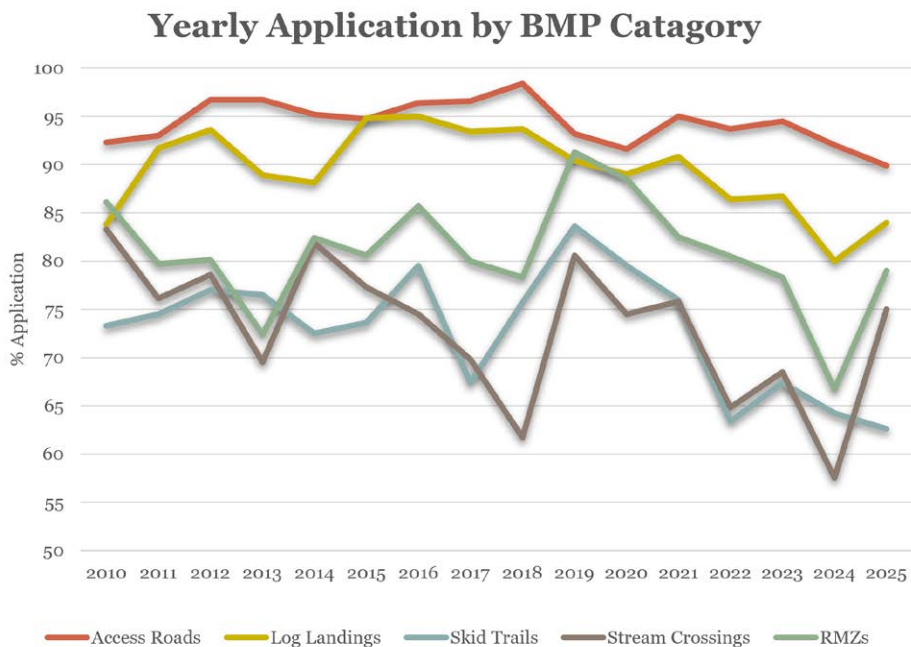
Figure 8. Yearly BMP application trends by category since 2010.

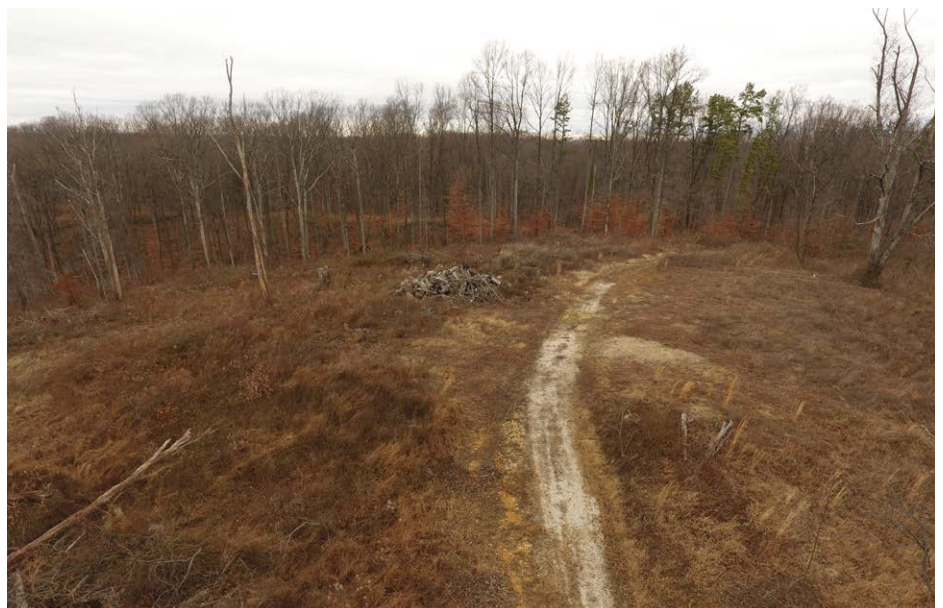
Access road is the lane that connects log landings to municipal roads. Here an access lane approaches a log landing. Drone photo taken on state forest property by Jamie Winner, DNR.

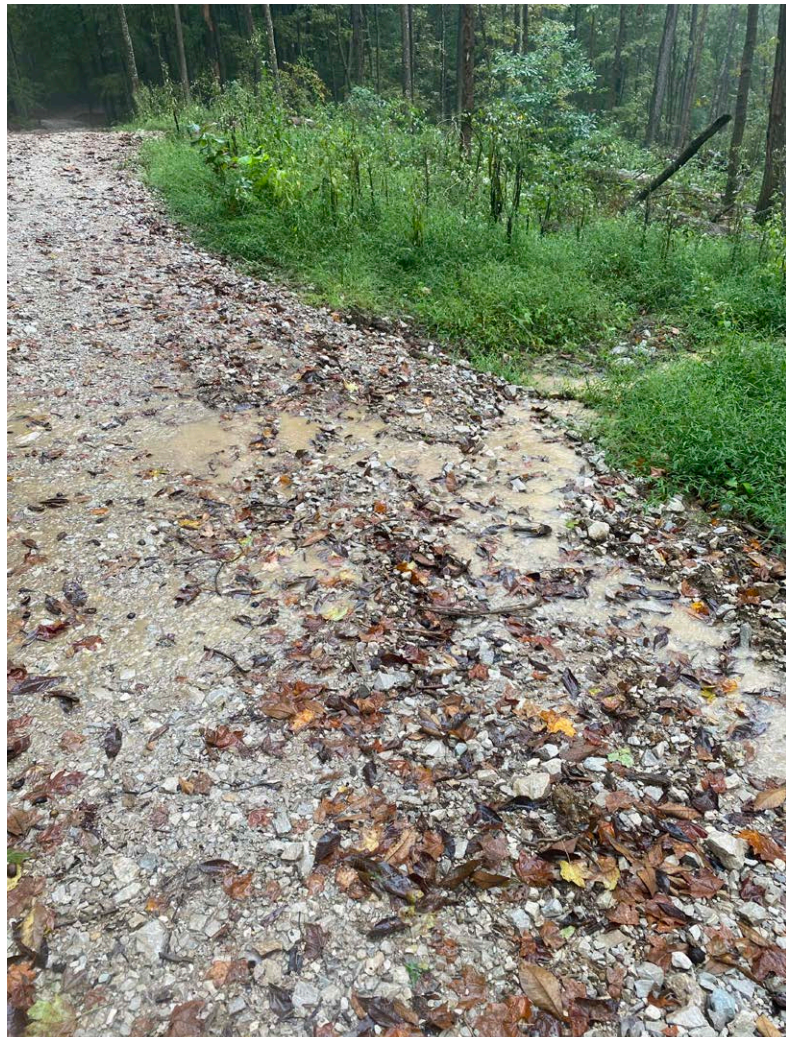
An outslope & cut out work to move runoff of an access road onto forest floor where it can be absorbed. Photo taken on state forest property by Duane McCoy, DNR.

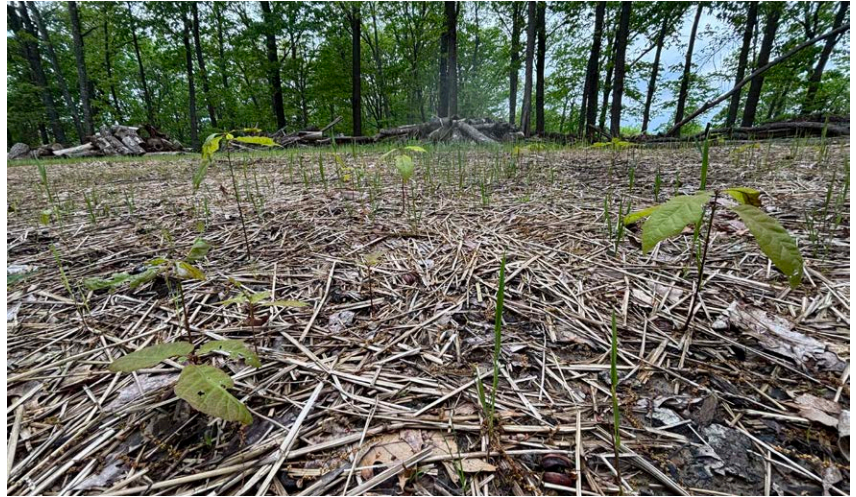
Seeding and strawing a landing after a harvest helps to quickly establish new plant growth, including oak regeneration, while providing protection to the soil surface. This reduces erosion and increases water infiltration. Photo taken on state forest. Photo by: Jennifer Sobecki DNR

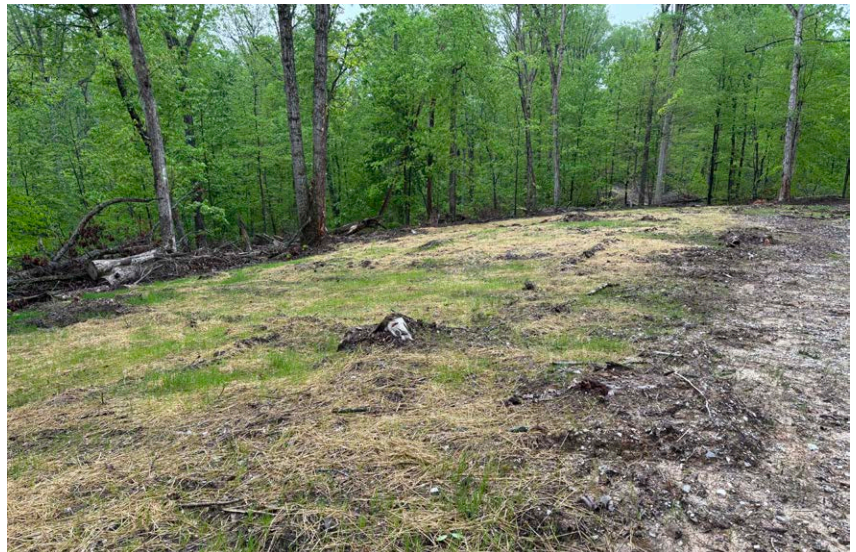
While this landing is on a fairly steep slope, it has been smoothed, mulched, and seeded, with debris placed on the downslope side to slow and filter runoff. Photo taken on state property by Jennifer Sobecki, DNR.

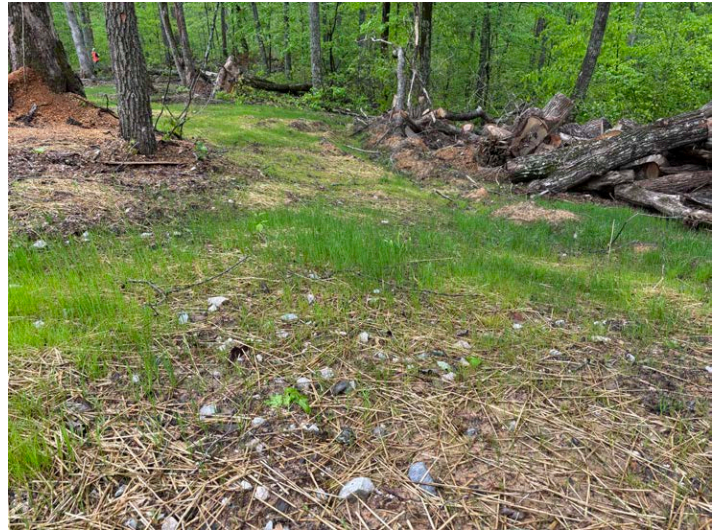
Seed & straw protecting skid trails reduces compaction and subsequent runoff. Photo on state property by Jennifer Sobecki, DNR.

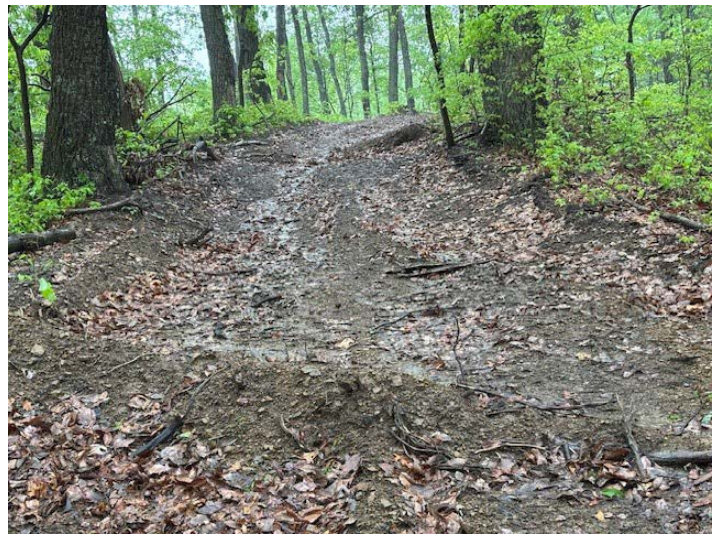
Top waterbar has been breached and water is flowing down the trail. The waterbar closest to camera is actively moving stormwater off a skid trail during a rain event. Photo taken on state forest lands by Jennifer Sobecki, DNR.

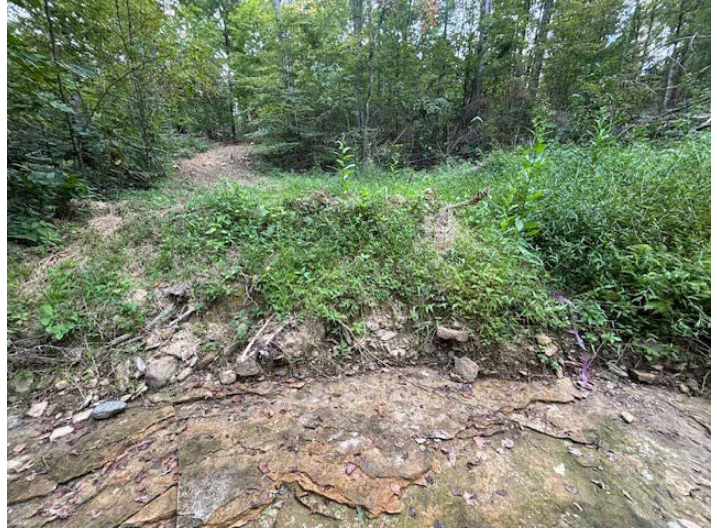
The waterbar before the crossing has revegetated well, but upon further inspection a breach has formed, allowing sediment laden runoff to enter directly from the skid trail in the stream after precipitation events (see purple tape on right side). Photo taken on state land by Jennifer Sobecki, DNR.

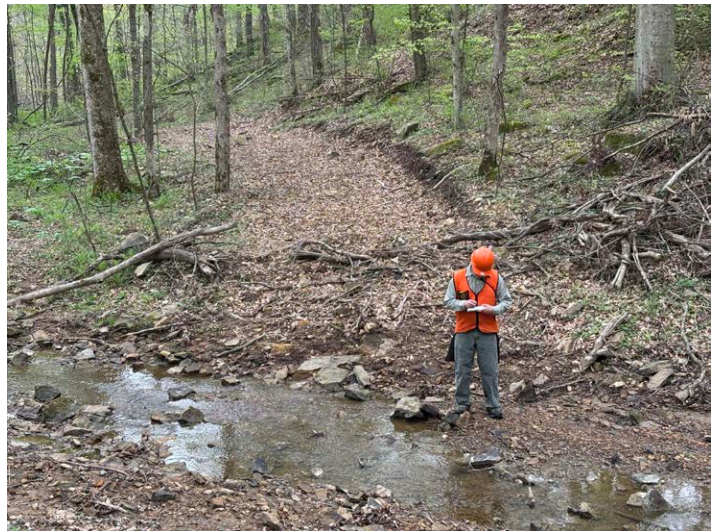
Good debris/soil waterbar prior to crossing is protecting water quality at this stream crossing. Photo taken on state forest property by Jennifer Sobecki, DNR.

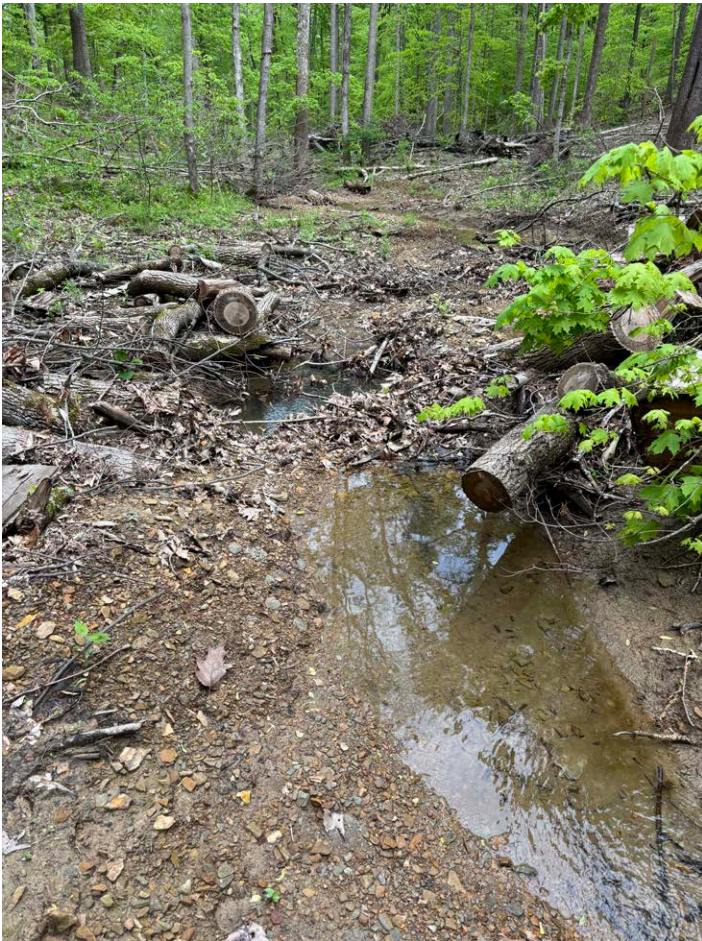
While some debris was cut out of this stream, it was not properly placed far enough from the water and will continue to cause debris to pile up and create bank erosion. Photo taken on state lands by Jennifer Sobecki, DNR.

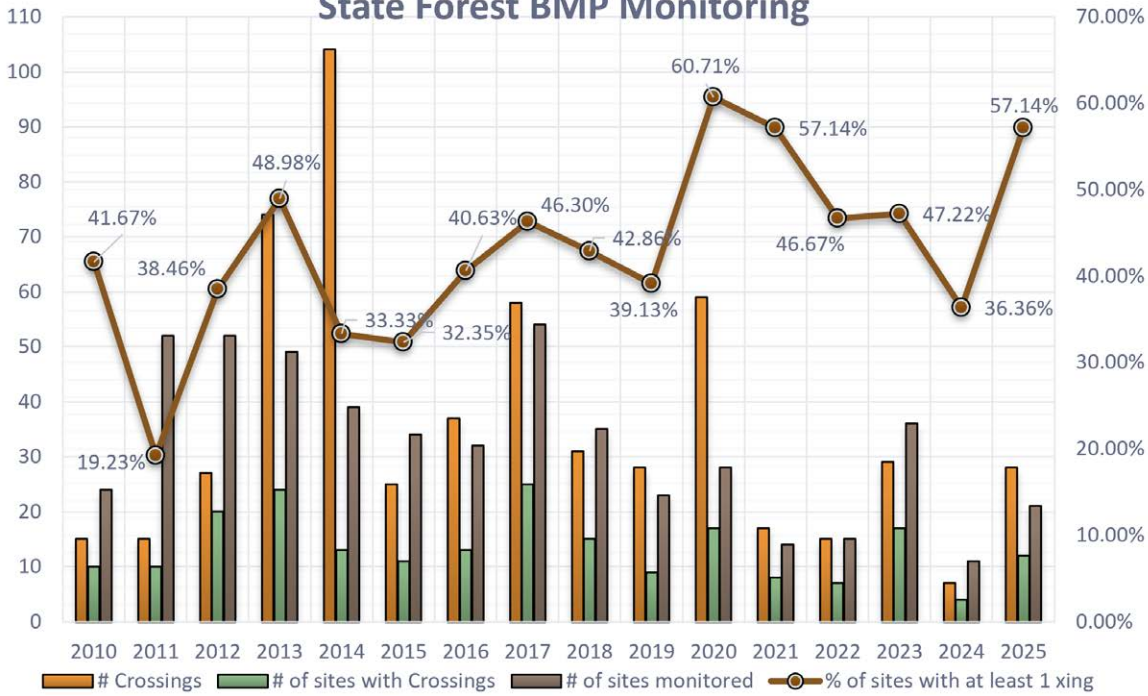
The number of crossings monitored on state forests since 2010 is seen below in Figure 10. The graph also shows the number of sites per year with at least one crossing, and the percentage of sites with crossings per year. In 2014 there were an elevated number of crossings due to a large tornado salvage harvest at Clark State Forest that accounted for 60 crossings on that large salvage harvest (800 acres). Due to numerous obstructions from the tornado, multiple crossings were necessary to access the area.

Figure 10. Number of crossings, number of sites with crossings and percentage of sites with crossings for each year of state monitoring since 2010. High crossing numbers in 2013 were partially due to the Henryville Tornado salvage harvest and a dredging of Starve Hollow Lake, In 2014 high number of crossings was due to another large salvage harvest at the Henryville tornado site monitored on Clark State Forest that year.

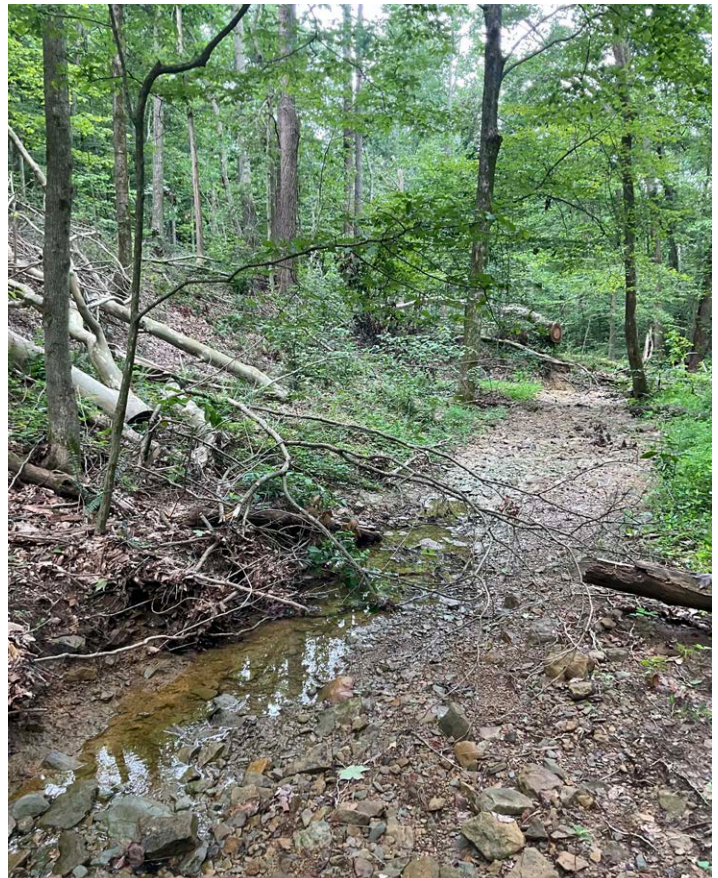
Tops have been removed from the stream in two different areas along this stream on state forest lands. Photo by Duane McCoy, DNR.

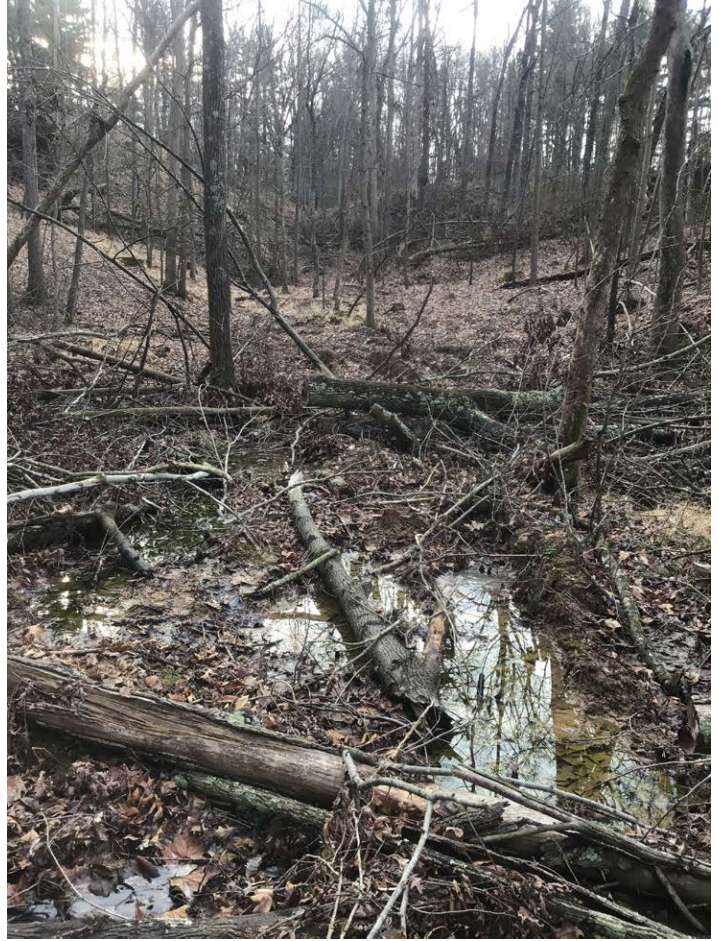
A small stream clogged with logging debris. Photo taken on private property by Duane McCoy, DNR.
