United States Department of the Interior
National Park Service**National Register of Historic Places Registration Form**

1. Name of PropertyHistoric name: South Milford I.O.O.F. Hall

2. LocationStreet & number: 8015 E 750 SCity or town: South Milford State: IN County: LaGrangeNot For Publication: ☐ Vicinity: ☐**3. State/Federal Agency Certification**

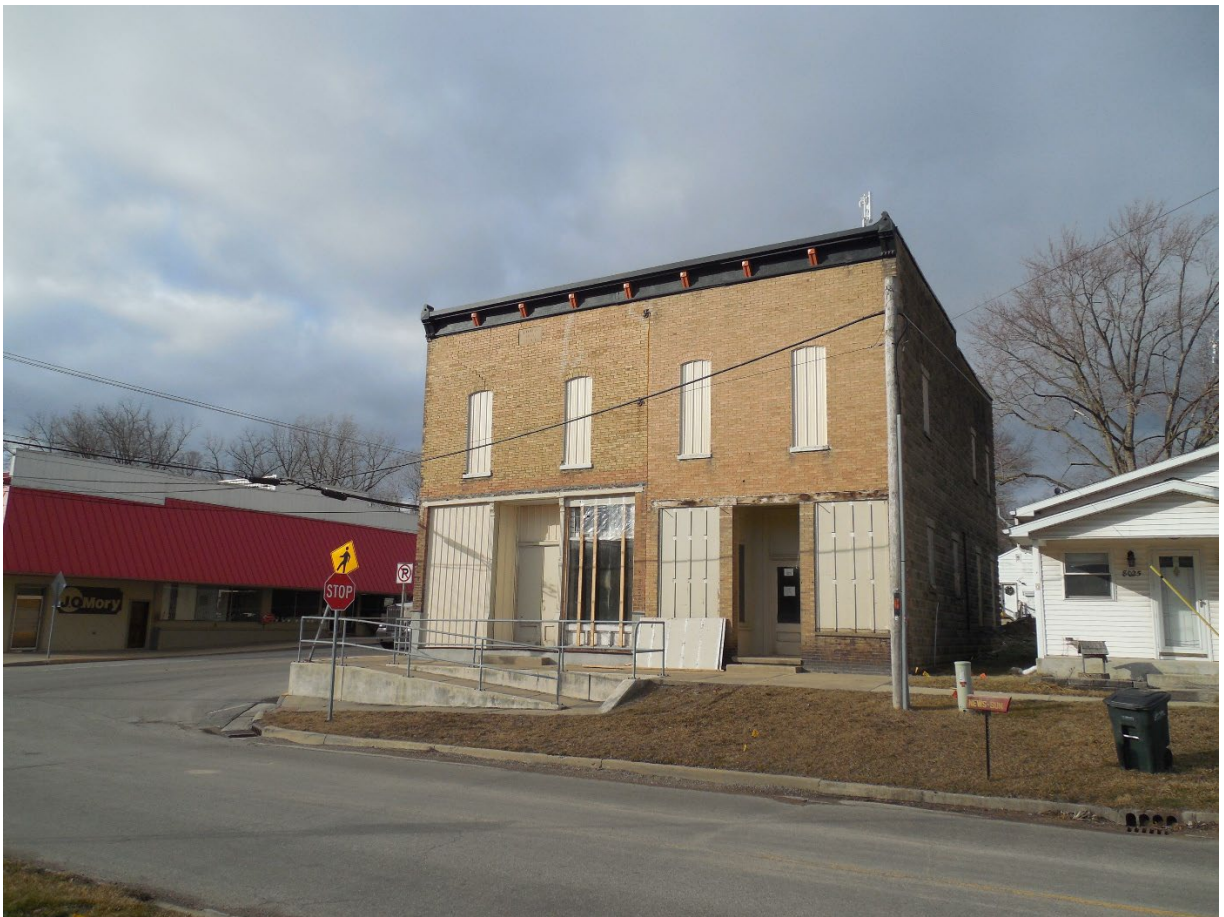
IN_LaGrangeCounty_SouthMilfordIOOFHall_0001

The Independent Order of Odd Fellows Hall (IOOF Hall) faces south on the northeast corner of Indiana State Road 3 (SR 3)/Lima Road and E 750 S, a relatively busy intersection that serves as the commercial center of the small, unincorporated town of South Milford, Indiana. Behind the building on the north is a short alley running east between SR 3 and S 805 E. The lot directly across E 750 S to the south is vacant, but the area to the east along E 750 S is developed with residential structures on both sides of the road. Buildings along SR 3 near the IOOF Hall include two churches, a gas station/convenience store, small restaurant, and a commercial structure housing the local post office and a mechanical, electrical, and plumbing contractor business (photo 1).

The 1910 structure is constructed of buff-colored brick very similar to that of the original building, but only on the south façade (photos 1 and 3) and in a running bond pattern. The east and north elevations (photo 6) are built of rock face concrete masonry units. Also similar to the original building, the south façade contains a three-bay storefront on the first story. The recessed middle bay, containing the main entrance and reached by a concrete step up from the public sidewalk, has a concrete floor. Within the doorway is a single wood-framed door with glass in the upper two-thirds and raised panel below. The glass in the transom over the door has been painted. Two tall windows, each with painted transom glass, flank the door. Within the entrance area, the ceiling is covered with painted, stamped tin tiles. Each of the two outer bays contains a

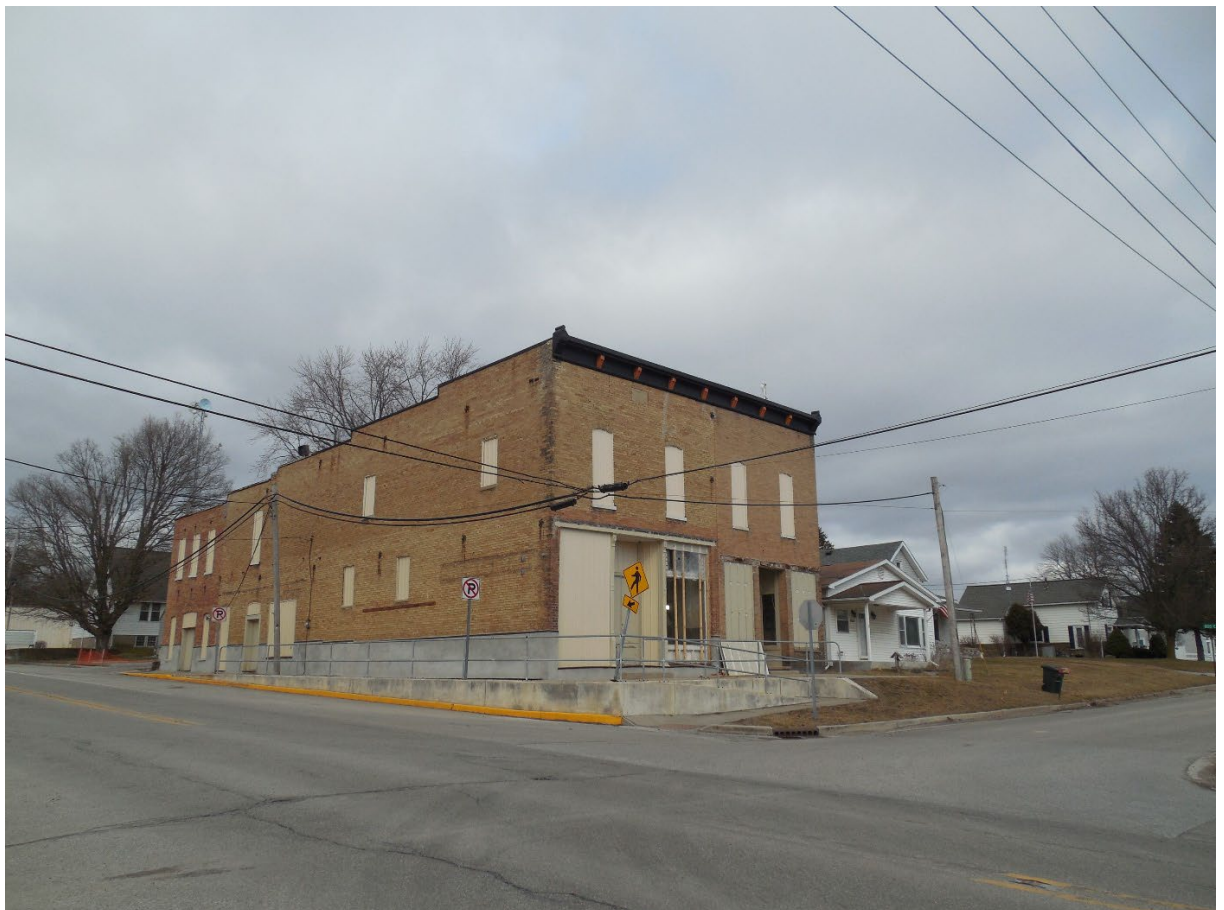
IN_LaGrangeCounty_SouthMilfordIOOFHall_0003

The foundation of the west elevation (photos 3 and 4) has also been parged with concrete. The façade itself is visually divided into three bays. On the first story of the south bay, toward the north side, there are two small, single windows placed high on the wall with sills that have been wrapped in stone-colored aluminum. In the center of the middle bay is an entrance with a solid metal door and transom topped with a brick segmental arch. To the south of this is a wide square window opening with metal sill. To the north is a narrow doorway, for access to the second story, topped with a brick segmental arch. The third bay is the portion of the building constructed with the orange brick. In its center, at grade level, is a wide doorway containing two solid metal doors. The transom over the doorway is topped with a brick segmental arch. Flanking the doorway are two narrow, segmental arched windows with painted metal sills.

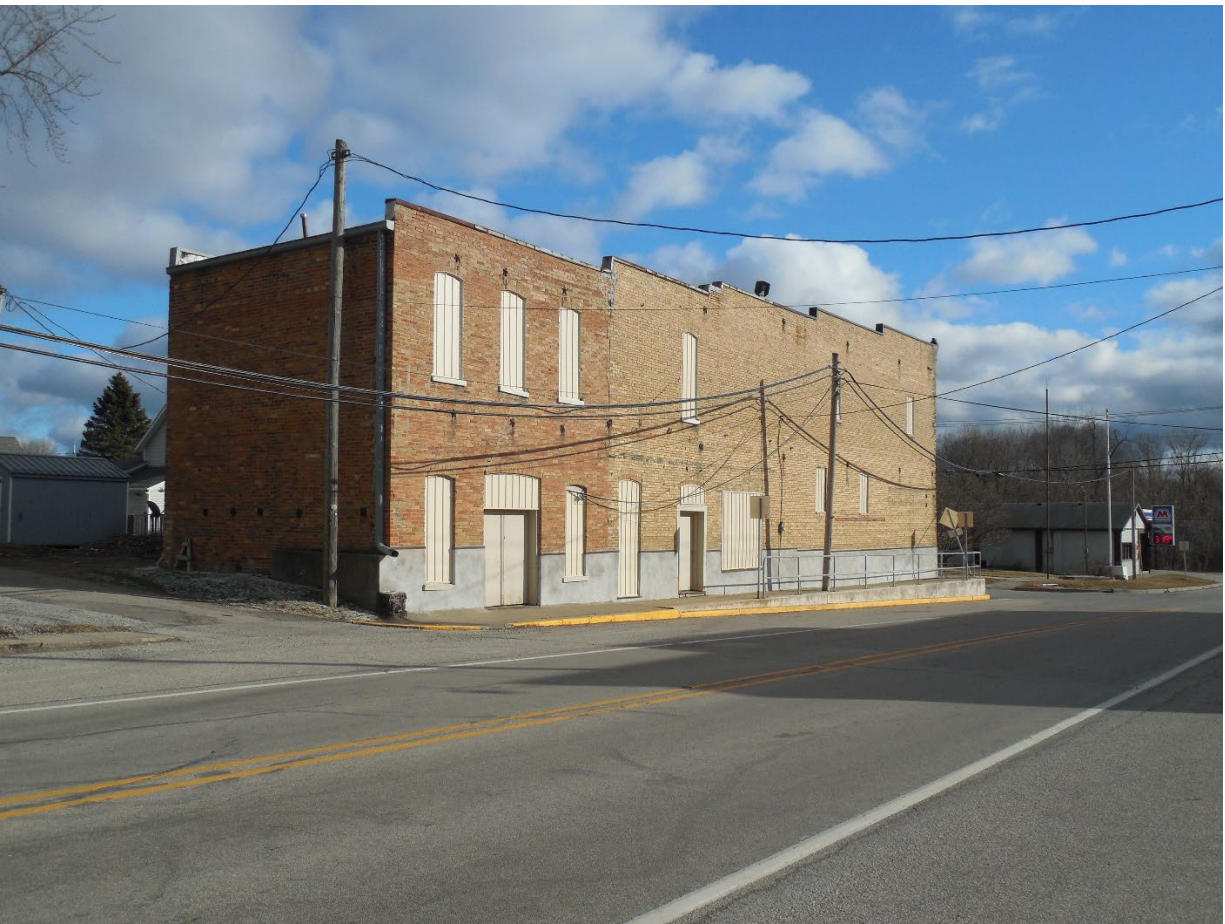
IN_LaGrangeCounty_SouthMilfordIOOFHall_0004

The foundation is not visible on the north elevation (photos 4 and 5), though there is a section of concrete retaining wall that extends from the northwest corner of the building to approximately the center of the wall. There are no openings on this elevation. Along the bottom of the north bay of the east elevation, near the south side, is a small area of wall that has been infilled with concrete block. The only openings on the entire elevation are two tall, narrow windows topped with brick segmental arches and with metal sills placed evenly within the north bay.

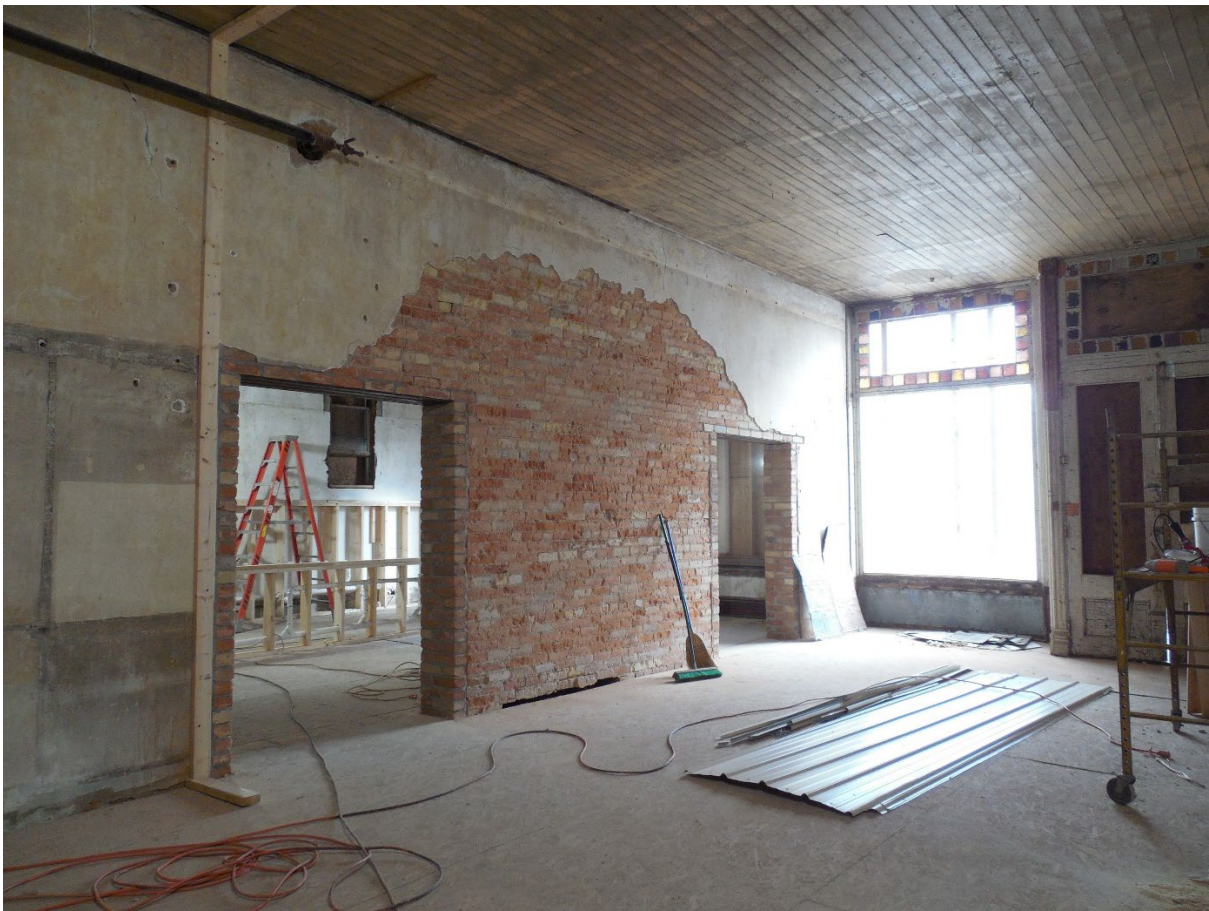
IN_LaGrangeCounty_SouthMilfordIOOFHall_0007

Long-standing water in the basement of the original building caused many of the floor joists to rot. After work was done to remediate the water, new posts and joists were constructed (photo 2). Many of the original floorboards were saved and will be re-installed. On the east wall of the first floor (photo 7), in the front of the former mercantile space, some of the plaster has been removed to reveal the brick structure. An original wide opening to the addition toward the north side of the wall remains and a new opening to match has been made toward the south side of the wall. On the south wall (photos 7 and 8), the wood surround of the storefront is painted white, and the doors are flanked by narrow, fluted wood columns. Still visible on the west wall (photo 8) are the ghost outlines of the casework used by the mercantile. Two windows, framed in wide wood molding painted white, are placed high on the wall. The ceiling of the coffee shop space is comprised of wood planks (photos 7 and 8).

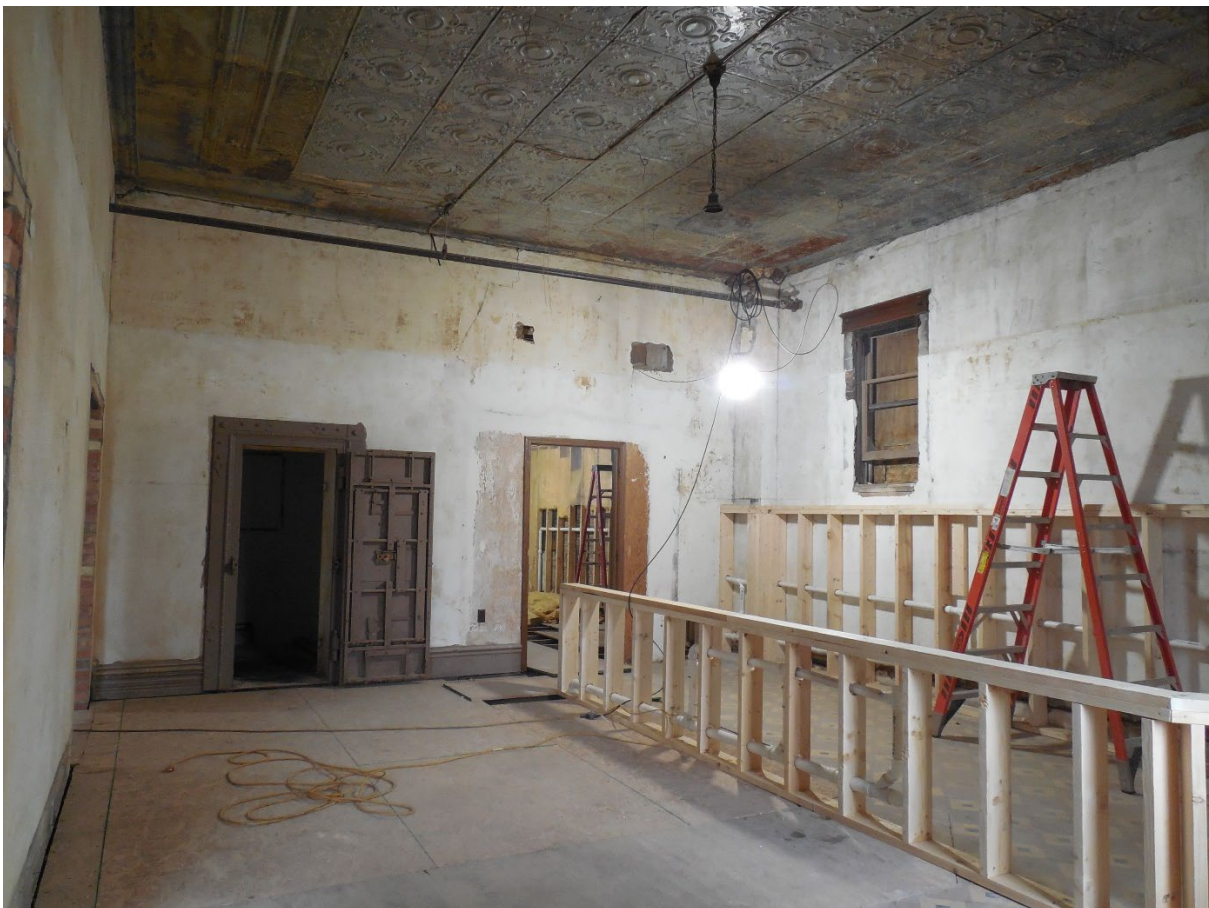
IN_LaGrangeCounty_SouthMilfordIOOFHall_0010

The first floor of the 1910 addition is divided into two rooms. The larger south room (photos 10 and 11), which functioned as the banking area, has a mix of flooring materials including narrow, wood boards and plywood on the west side, and original tile, featuring a geometric design in cream and dark brown, on the east side. On the east wall (photos 10 and 11) are two, wood-framed, one-over-one, double-hung windows. Each is topped with its original wide, brown-stained wood casing. The remaining window casing is missing. The wide, wood trim and baseboards of the storefront (photo 11), also stained dark brown, is largely intact. On the west wall are the two wide openings into the 1893 building. Toward the west side of the north wall (photo 10), with its original wide, wood baseboard which has been painted gray, is the former bank vault which still retains its ornate cast-iron surround and vault door. Toward the east side of the north wall is a doorway into a room on the north end of the addition. Covering the ceiling of the bank space are the original stamped tin tiles.

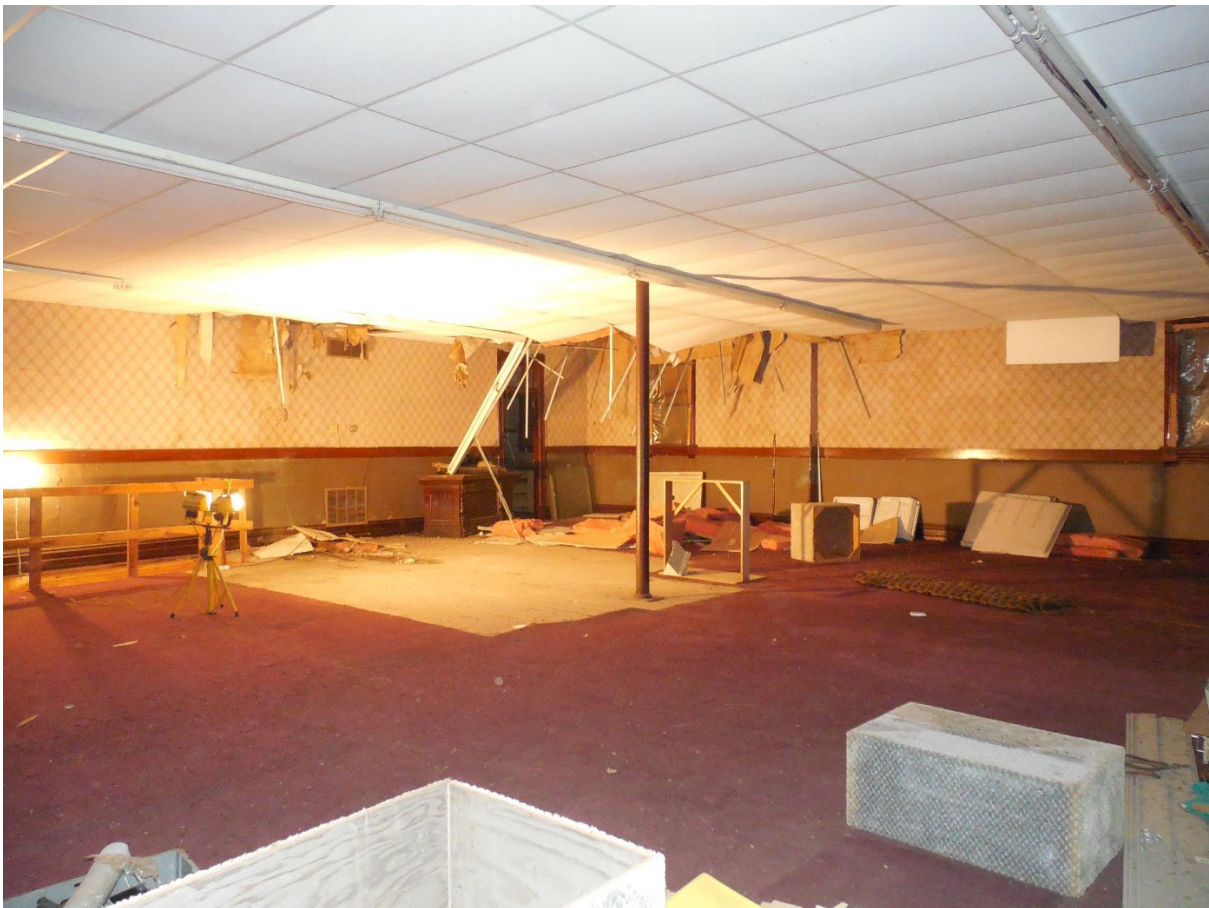
IN_LaGrangeCounty_SouthMilfordIOOFHall_0012

Off the northeastern corner of the Meeting Hall (photo 12) is a doorway with glass transom opening into a long narrow storage room that also houses mechanical equipment. There is a small double-hung window on the east wall, and on the west wall is a doorway into Room 1 that is also accessible from the Meeting Hall through a wide doorway, with pocket doors, at the top of the new stairs (photo 13). Along the west wall of Room 1 is built-in storage trimmed with beadboard. On the north wall (photo 15), a doorway leading to Room 2 is toward the west side, there is a closet in approximately the middle, and there is a doorway toward the east side leading

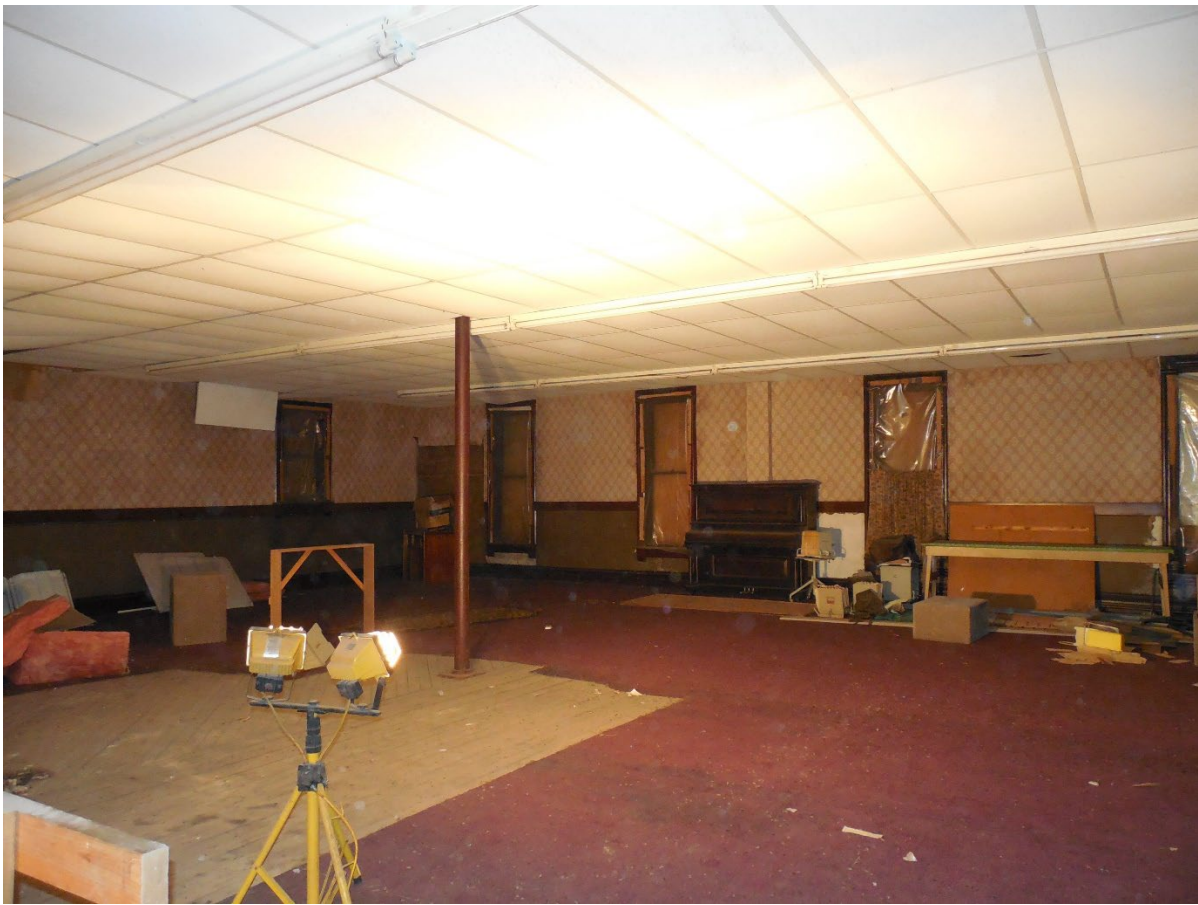
IN_LaGrangeCounty_SouthMilfordIOOFHall_0014

On the second floor, details throughout include painted and wallpapered plaster walls, wood floors, and a dropped ceiling. Small areas of the ceiling have been opened up to reveal the original plaster ceiling above. Also present are the original wide, darkly stained, wood baseboards and trim around the windows and doors. When the building was built, the only stair access to the second floor was by an exterior first floor door on the west elevation. Once the new staircase is built within the first floor space, it will lead to the Meeting Hall which spans the full width of the front of the building. In the Meeting Hall, the wood flooring is covered in red carpeting. The plaster walls are covered with wallpaper in the area above a darkly stained chair rail and painted below. The east (photos 12 and 14) and west walls (photo 13) each have two, wood-framed, one-over-one, double-hung windows. The apron of the windows is in line with the chair rail. The four windows along the south wall (photo 14) are of the same design except they extend below the chair rail.
