AML Site 882, Snow Hill

A Significant Safety Hazard

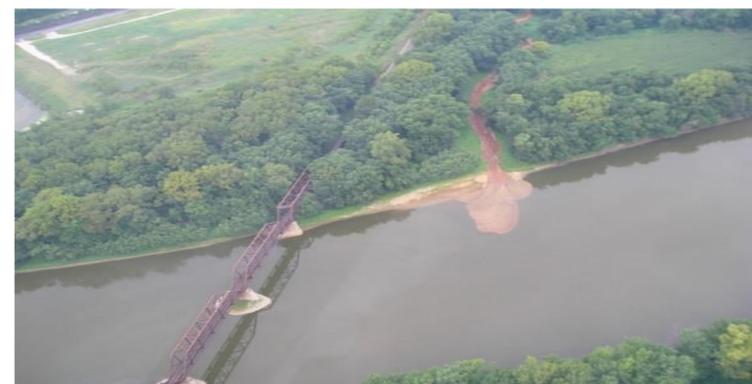
Coal Creek at confluence with the Wabash River, approximately a half mile downstream from the confluence with North Coal Creek, 2007.

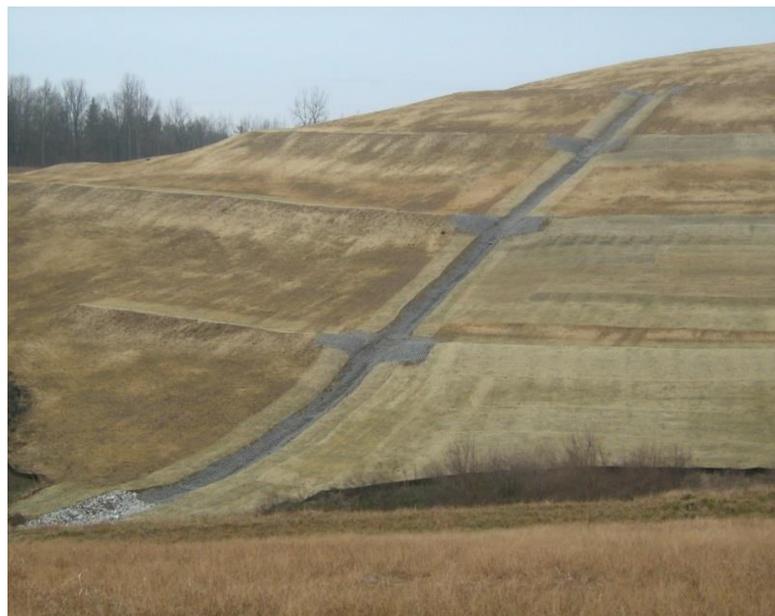
Completed project, south refuse pile, with terracing and installed Flexamat® ditch armoring.

Flexamat® ditch armoring was used instead of riprap because of the many advantages in using this material: it can handle extremely high water velocity, can be easily traversed by vehicles allowing for site maintenance, and is less expensive to install in comparison to riprap.

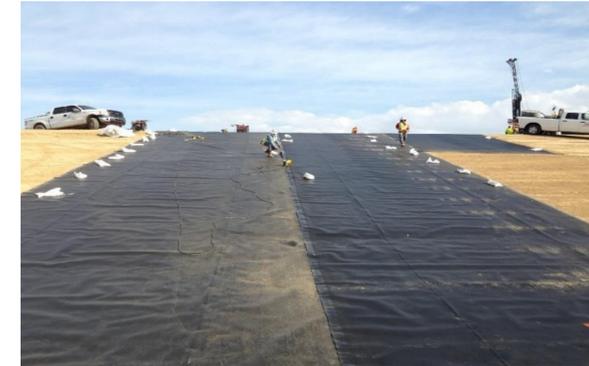
Welding of installed geomembrane sections, south refuse pile.

Indiana AML and the contractors, Kerns Excavating, LLC, and ATC Group Services, LLC, designed and installed an impermeable geomembrane overlain by a geo-composite drainage layer which limits rainfall infiltration which is commonly used in landfill designs.

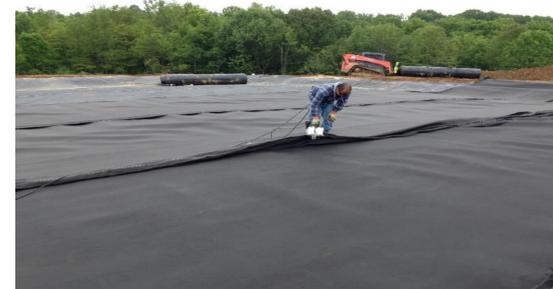
Above: Installed geo-composite drainage layer sections being sewn together, north refuse pile.

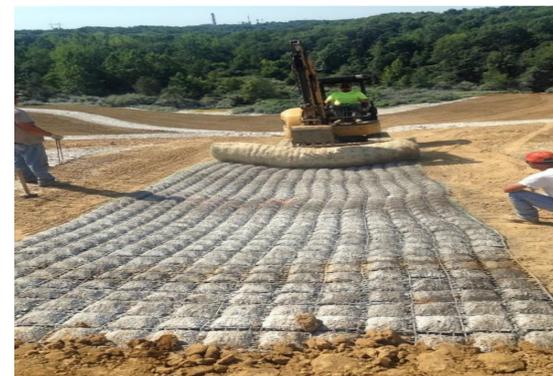
Below: Installation of Flexamat® ditch armoring, north refuse

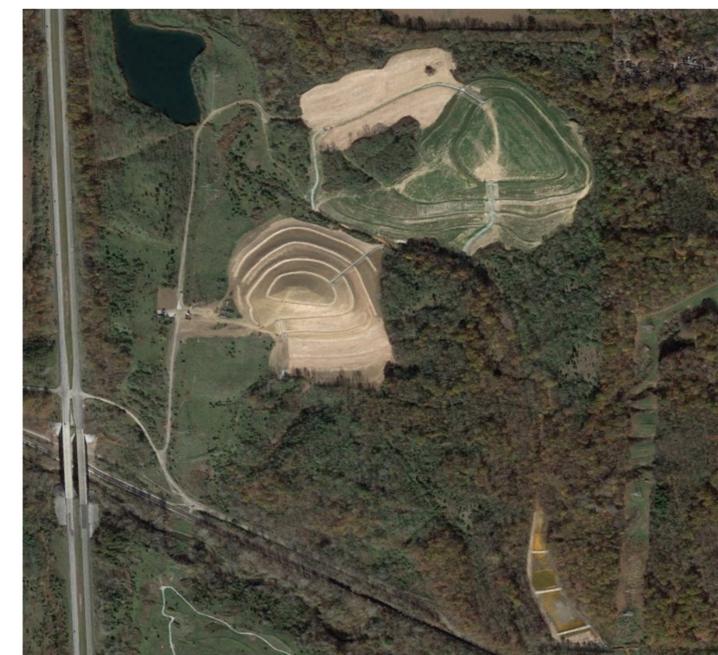
Post Construction of the project showing both of the buried gob piles and the wetland and settling pond.

A three-stage, 2.5 acre settling pond and aerobic wetland complex was built into the channel of North Coal Creek downstream of the two piles. The wetland complex can also be modified into a passive treatment system.

A preliminary assessment of the water quality of North Coal Creek indicates a substantial improvement in the average calculated net acidity. Total iron, total aluminum, total manganese and sulfate all show decreases from pre to post-construction. Continued efforts to monitor changes in water quality at the site are ongoing.
