Indiana Department of Natural Resources Division of Reclamation, Abandoned Mine Lands Section

Site 2147, Loge School Grouting

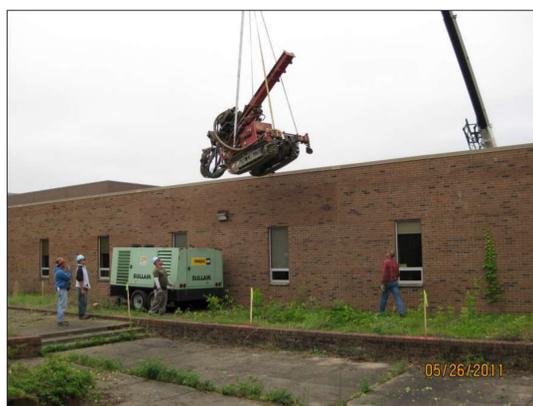
To utilize the central courtyard, the drilling equipment was lifted over the building using a large crane.

Due to the shallow void and large building footprint, the design required careful study of the building plans and foundation structure in three dimensions. While the central open courtyard provided additional access points, some of the boreholes were drilled at less than a 30 degree angle. Casing was required to ensure that the grout reached the mine void. Boreholes also had to avoid water supply, sanitary sewer, gas, electricity, and fiber optic lines serving the building.

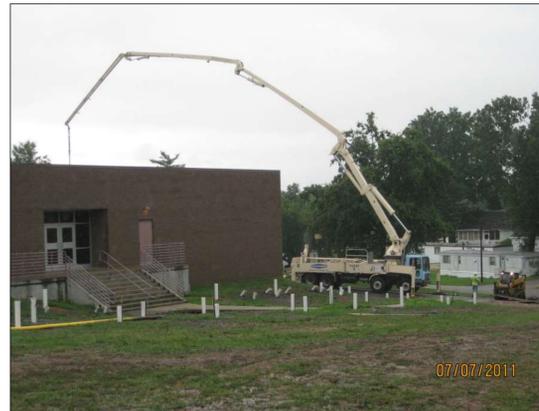
Grout was pumped from the building perimeter using a pump truck with large articulated pumping booms.

The design included barrier grouting, which involves establishing a perimeter and injecting a lower slump grout mixture to restrict flow outside the target area. The borehole pattern was laid out to target the building's column footers, which are structural load points throughout the building interior. An engineering study revealed that a subsidence event affecting four columns would cause major structural failure.

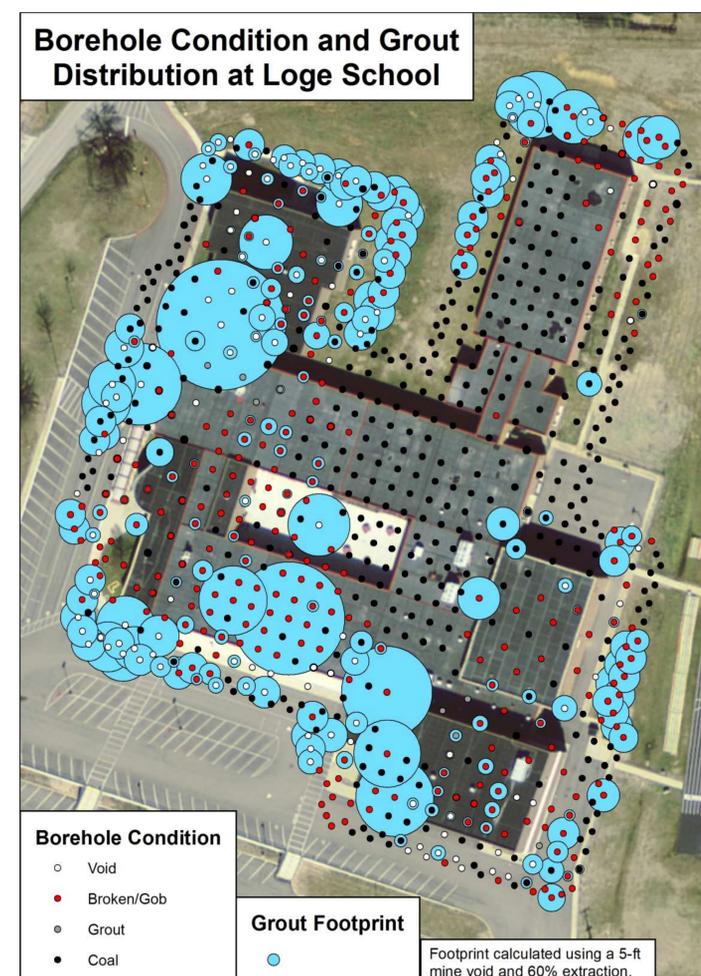
The size of the blue circles represents the area of grout coverage if dried into a cylindrical column.

A total of 10,177 cubic yards of grout were injected into the mine void. There were 144 barrier holes, 301 vertical holes on the perimeter and in the courtyard, and 400 angled boreholes targeting the building itself. Grout takes were very high in some areas, indicating large void spaces highly vulnerable to subsidence.

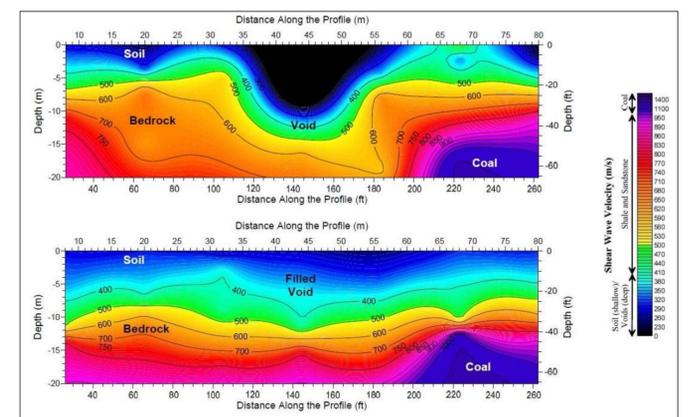
The pre-injection (top) and post-injection (bottom) profile lines indicate that the existing mine void was filled during grouting. This survey ran southwest to northeast.

The success of both the drilling and the grouting were evaluated using independent analyses. A gyroscopic instrument was used to survey select boreholes, and they were not more than 2 feet off target. Eight confirmation boreholes were drilled, and they all encountered grout. Refraction Microtremor surveys were performed both before and after grouting to confirm its effectiveness. This technology utilizes the dispersive property of surface vibrations to detect anomalies in the bedrock.
