Indiana Department of Natural Resources

Division of Reclamation, Abandoned Mine Lands Section

Site 2083, Sugar Ridge Fish & Wildlife Area 2

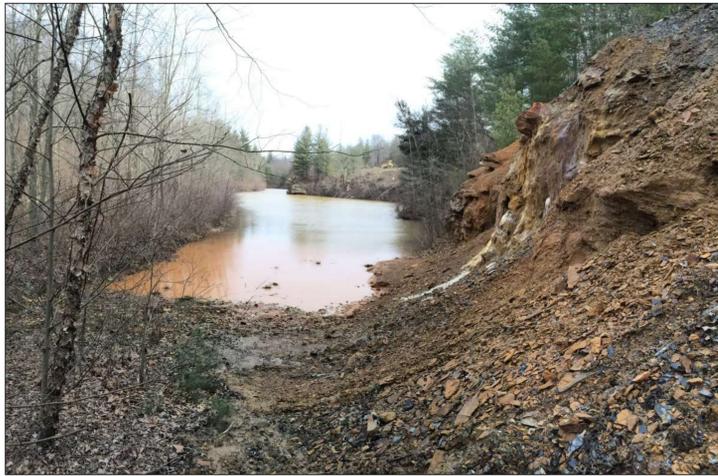
A dangerous highwall 3,500 feet in length was located along the eastern edge of Pigeon Pit in Sugar Ridge Fish & Wildlife Area 2. The highwall was 25-35 feet tall with a slope of more than 50 degrees along most of its length. There was evidence of frequent visitation on top of the highwall, including trails and campsites.

The highwall along Pigeon Pit was steep and unstable.

The highwall was backfilled to eliminate the safety hazard. Geomorphic landform grading techniques were used to tie the backfill material into the natural landscape behind the highwall, which had been covered in overburden that was restricting drainage. The gob pile was buried in the bottom of the pit to isolate the acid-forming material from exposure to oxygen. The area where the coarse refuse was removed and the existing drainage channel were regraded using geomorphic ridges and valleys.

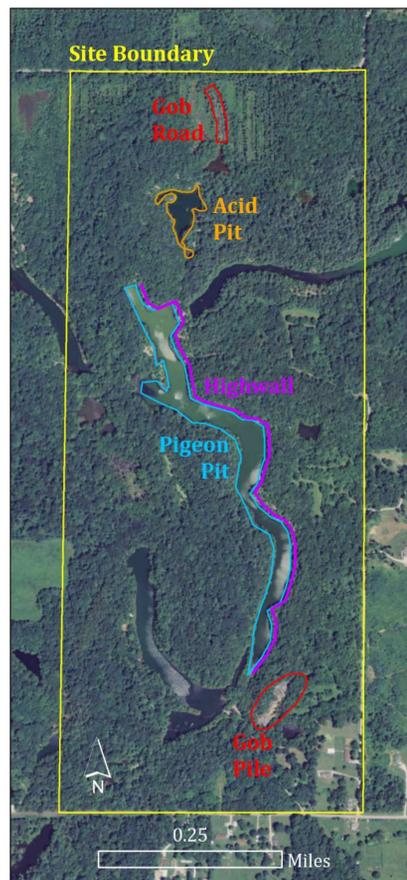
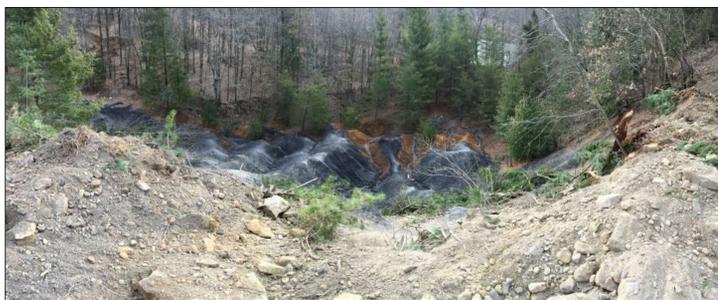
A pile of coarse refuse was located at the south end of the highwall. Some of the gob was exposed near a channel that drained into the pit, causing iron staining after heavy rains dissolved acid salts originating from the refuse. At the north end of the project site, there were 500 feet of gob road through a wetland and an acid pit.

The eroding gob pile (below) is on the south end of the project area (above).

The gob road was removed to 4 feet below the water level and replaced with a riprap access road. The design involved burying the coarse refuse in the acid pit, eliminating the acid pit, and using geomorphic landform grading techniques for the area including a sinusoidal drainage channel. Native wetland species were planted along the edges of water bodies for wetland enhancement.

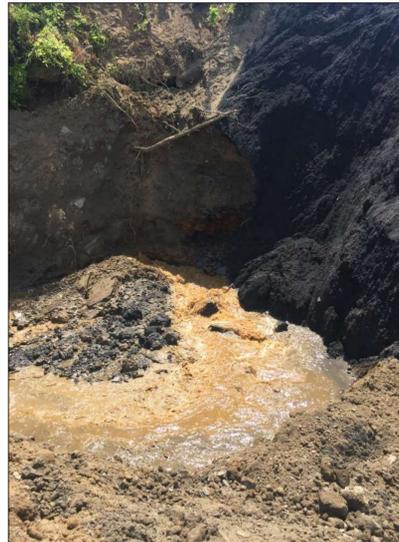
The disposal of the coarse refuse material at the bottom of Pigeon Pit presented quite a challenge. Due to the adjacent underground mine, Pigeon Pit was connected to another water body named Whitney Pit. Three mains acted like culverts and pulled water from Whitney Pit, causing blowouts into the gob disposal area at the bottom of Pigeon Pit.

Dewatering efforts caused blowouts due to the volume of the mine pool.

An outlet was quickly placed at Whitney Pit to prevent a storm water surge from overtaking the temporary dams in Pigeon Pit. Failure of these dams would have resulted in a sudden drop in Whitney Pit and endangered boaters. Project Management worked with the contractor to install a series of temporary dams and plugs to stabilize the blowouts. Finally, cells could be created for the placement of the coarse refuse material.

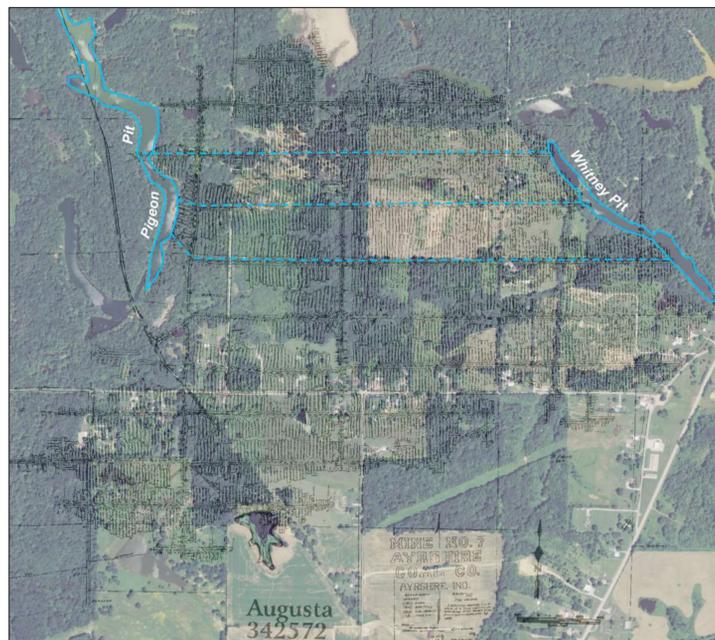
This georeferenced mine map shows how the underground workings formed direct conduits between Pigeon Pit and Whitney Pit.

Subsidence problems in the area between Whitney Pit and Pigeon Pit could be at least partially attributed to the constant flow of water from Whitney Pit through the underground works to its outlet at Pigeon Pit. Now, the outlets of the two pits have been matched in order to stagnate the mine pool both for the stability of the highwall and in an effort to prevent future subsidence.

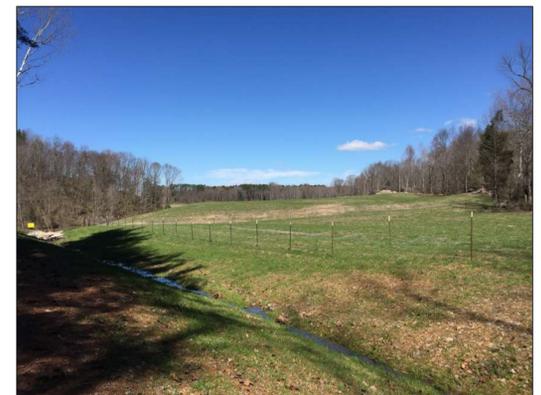
While this project primarily took place on a state Fish & Wildlife Area, part of the gob pile and most of the acid pit were on private land. The landowner plans to graze cattle on an area formerly covered by coal refuse, and the acid pit has been replaced with upland game habitat planted in warm season grasses and forbs.

This privately-owned part of the site will be used as pasture land in the future.
