Vehicle Collision With Student Pedestrians Crossing  
High-Speed Roadway to Board School Bus  
Rochester, Indiana  
October 30, 2018

**Accident Report**

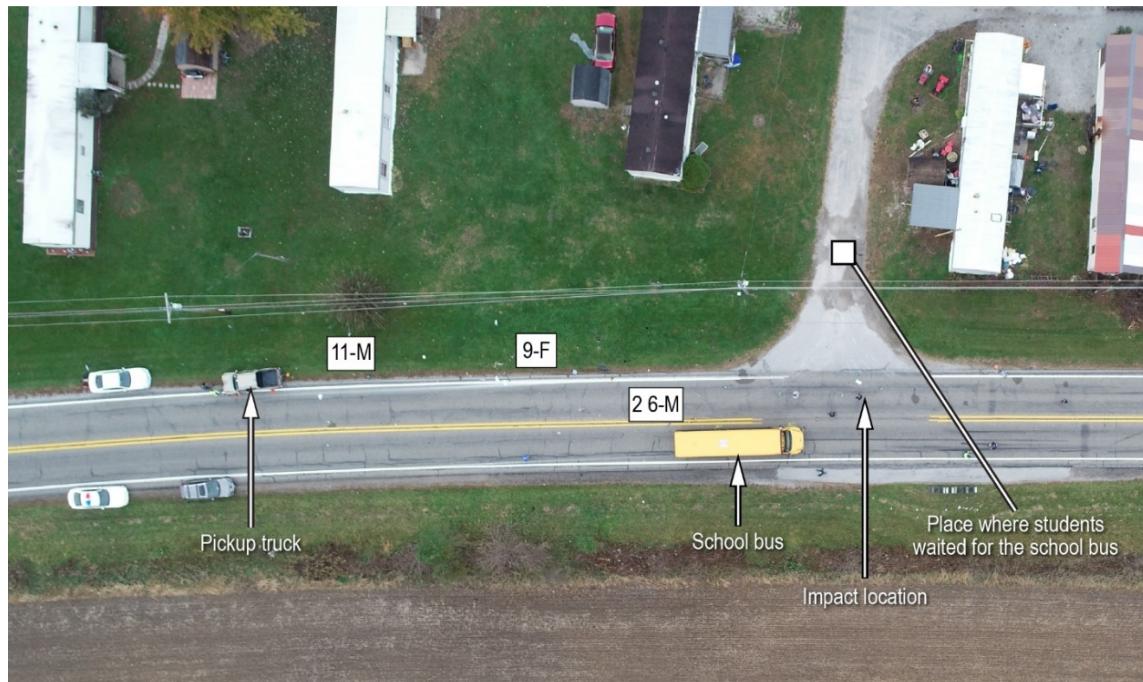
**Figure 2.** Postcollision site photograph showing the postcollision positions of the school bus, pickup truck, and four struck student pedestrians. (The students are indicated by age and gender (that is, "age-gender.") (Source: Indiana State Police, modified by the NTSB)

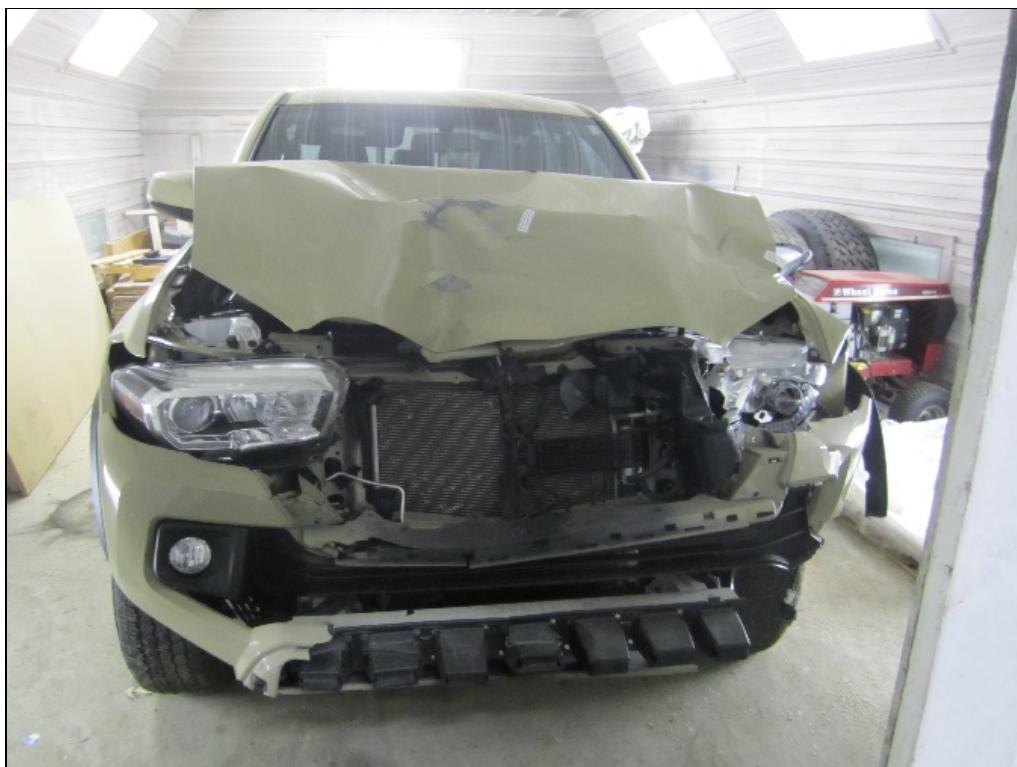
**Figure 6.** Frontal damage to pickup truck.

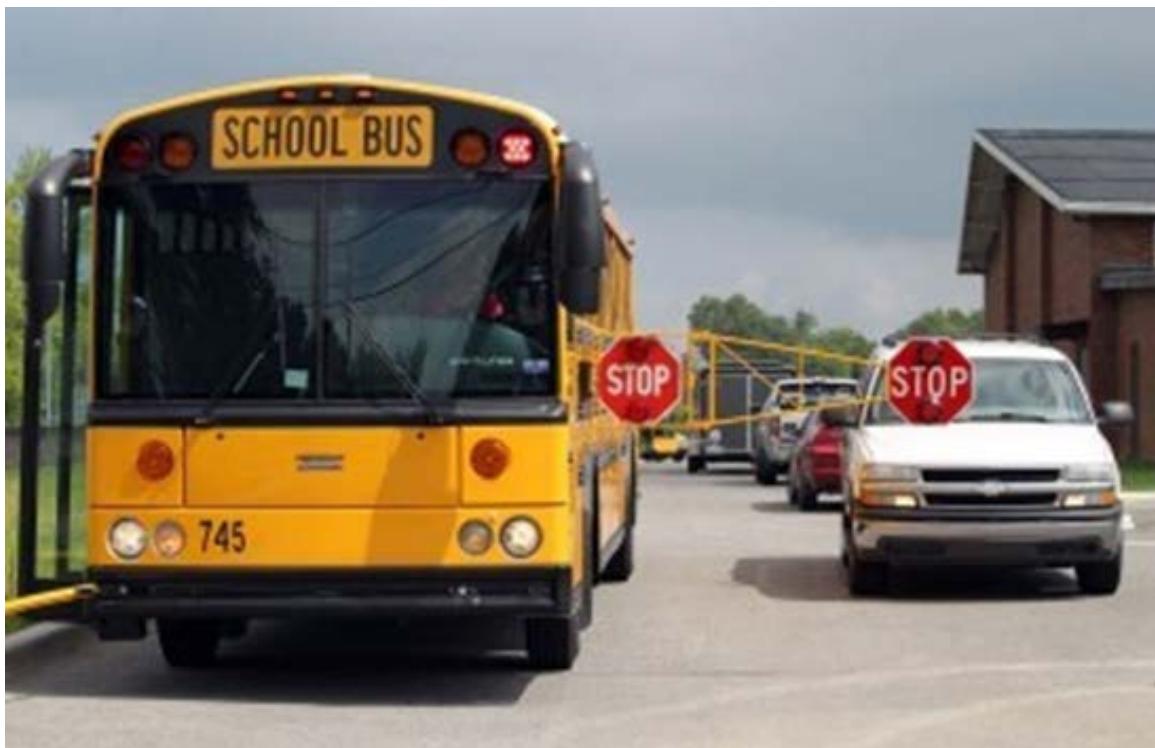
**Figure 8.** Extended stop arm with two stop signs on school bus. (Source: Bus Safety Solutions)

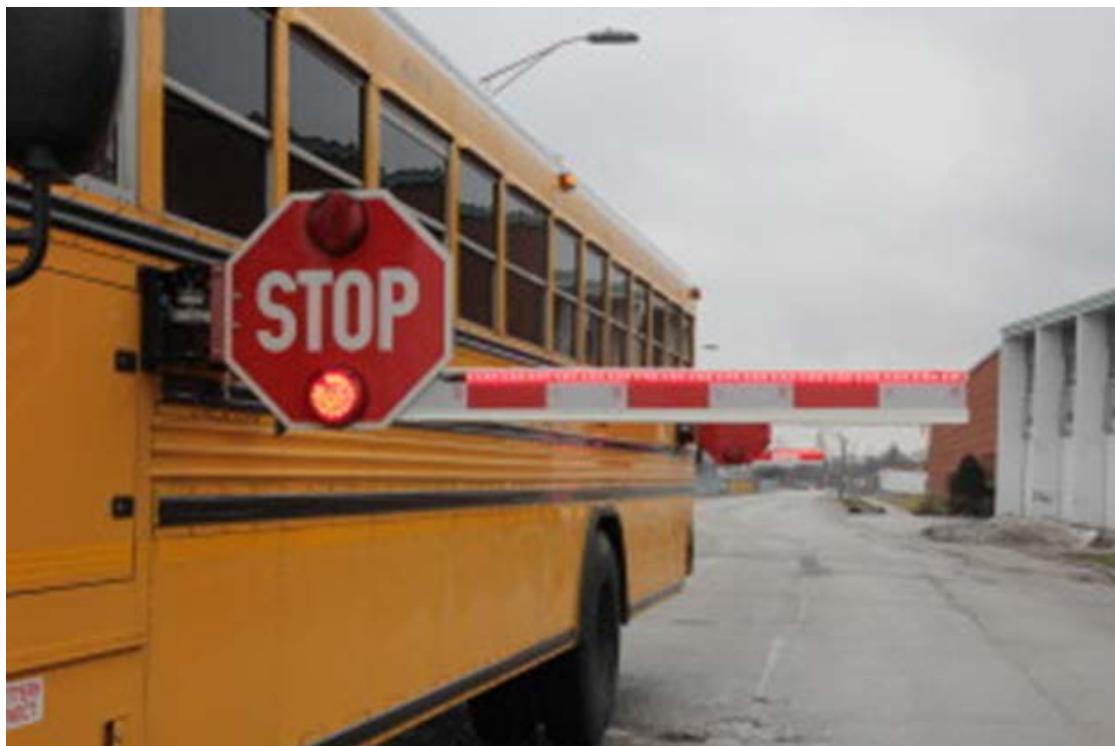
**Figure 9.** Close-up view of extended stop arm with single stop sign and horizontal stop bar. (Source: S.A.F.E. Gates)
