February 6, 2018

Indiana Bridge Inspection Workshop

Kate Francis, Mona Davis, & Bill Dittrich
INDOT Central Office Bridge Inspection

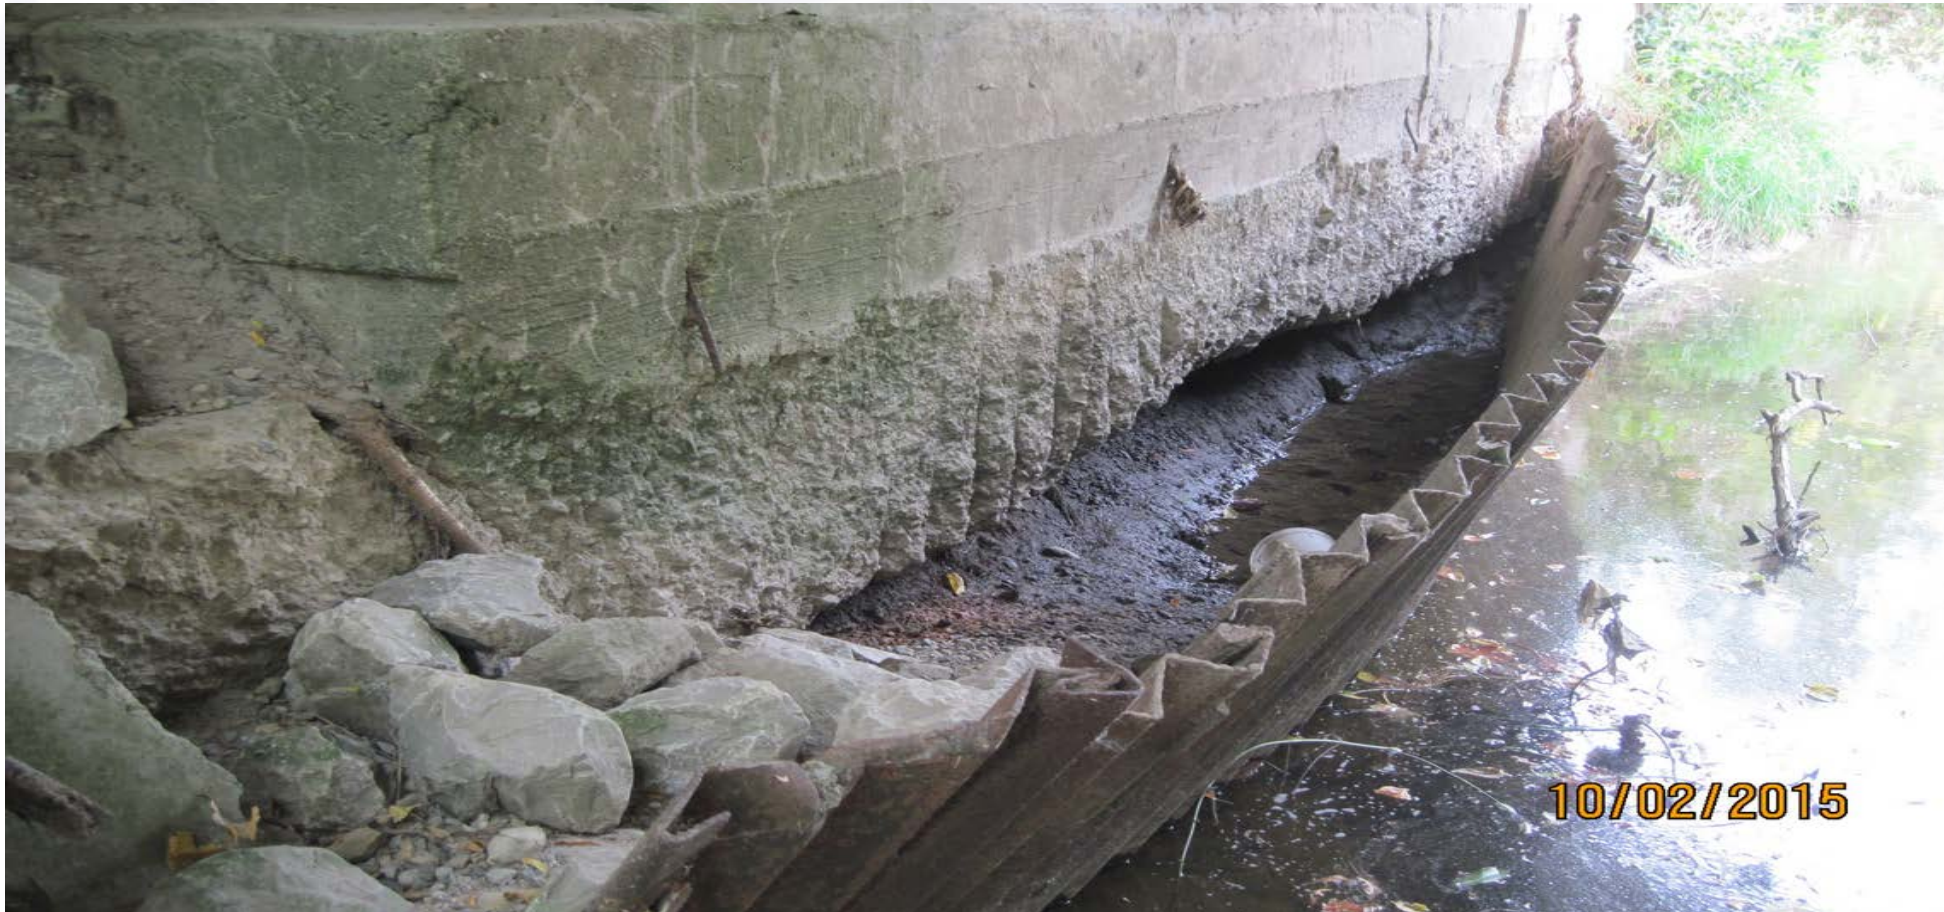
- The situation below has existed for years

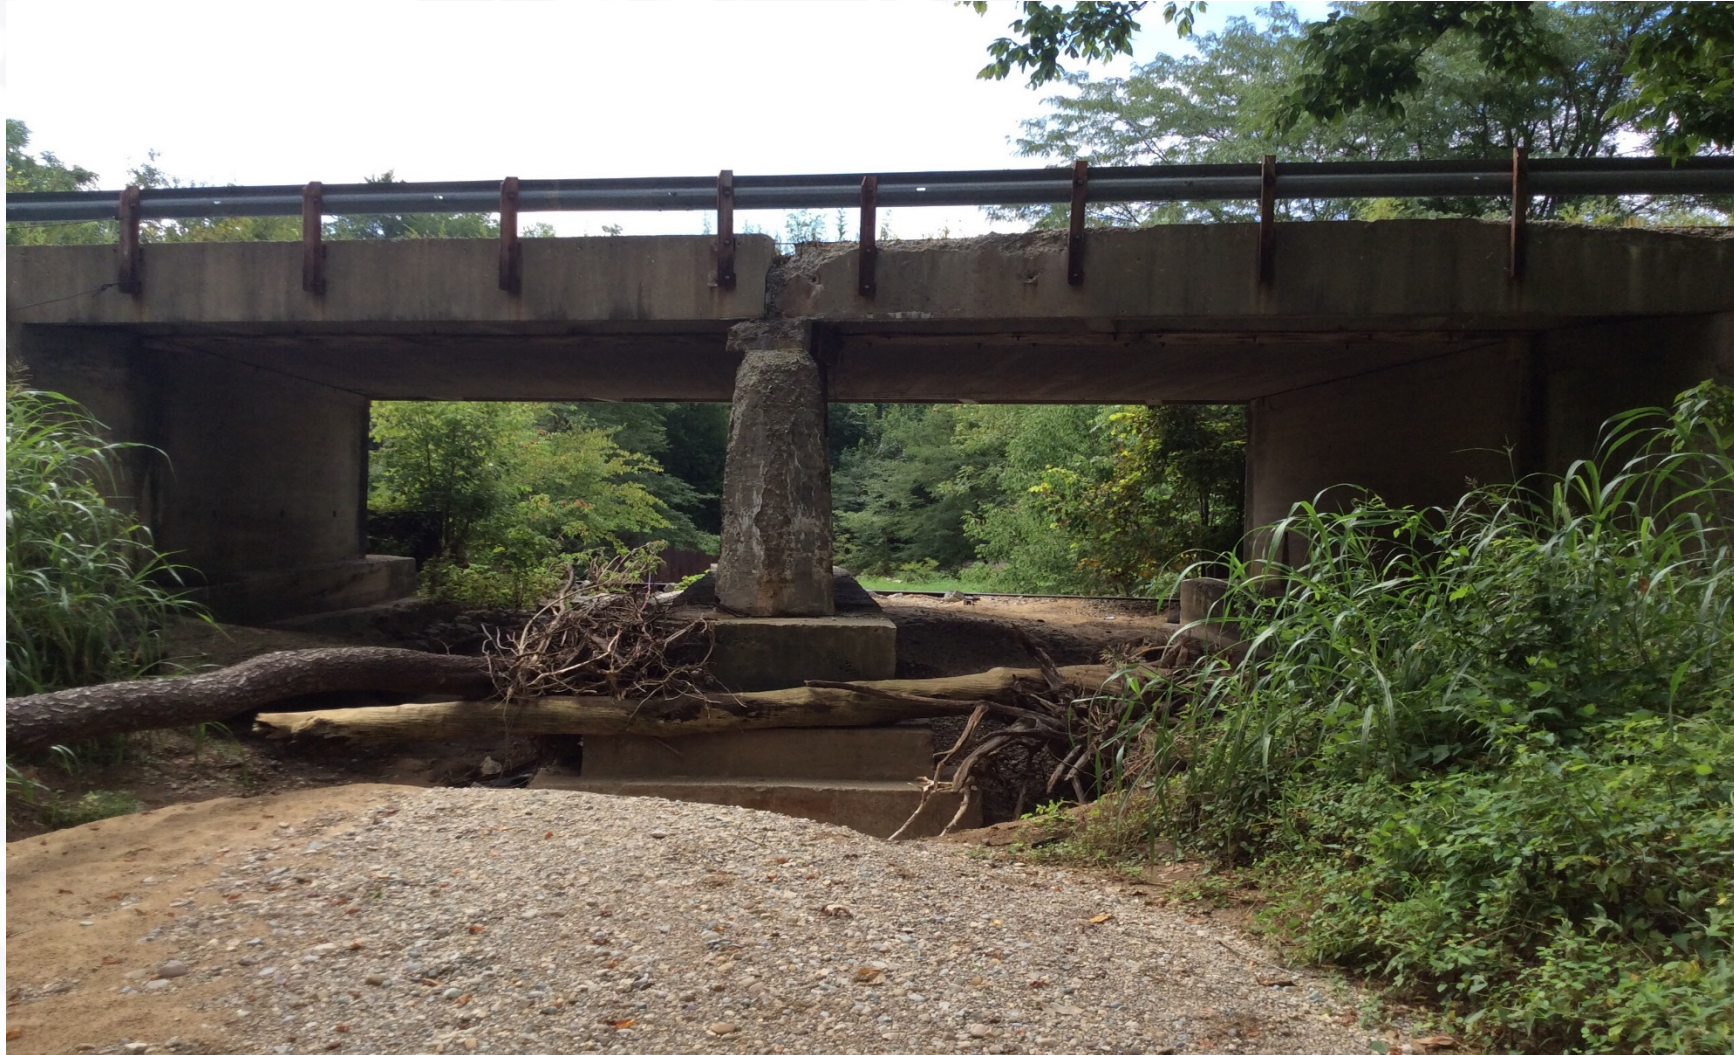
Is this a Critical Finding? How many Footings does this bridge have??

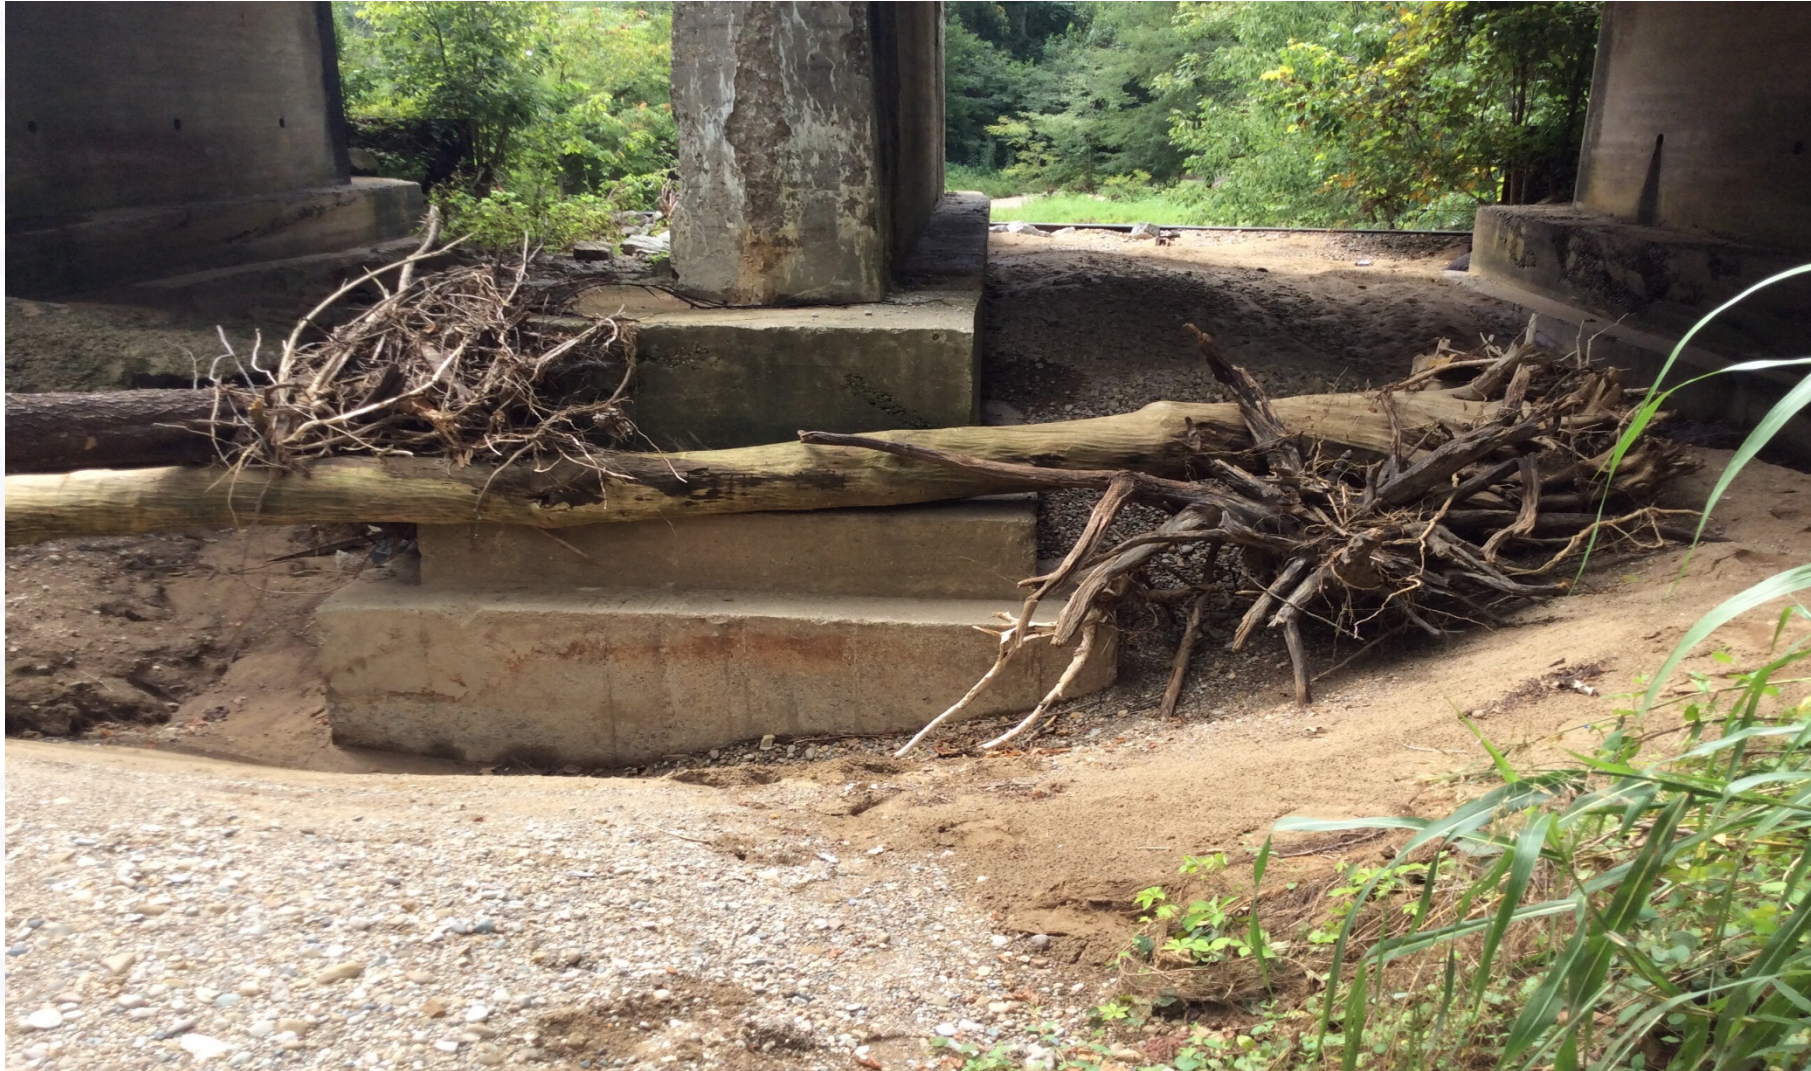
How many Footings does this bridge have??
