# Pack Rust Identification and Mitigation Strategies for Steel Bridges

Mark D. Bowman, Prof. of Civil Engineering, Purdue University  
Chintan Patel, HDR, Indianapolis, Bridge EIT

JTRP Research Study SPR-4121

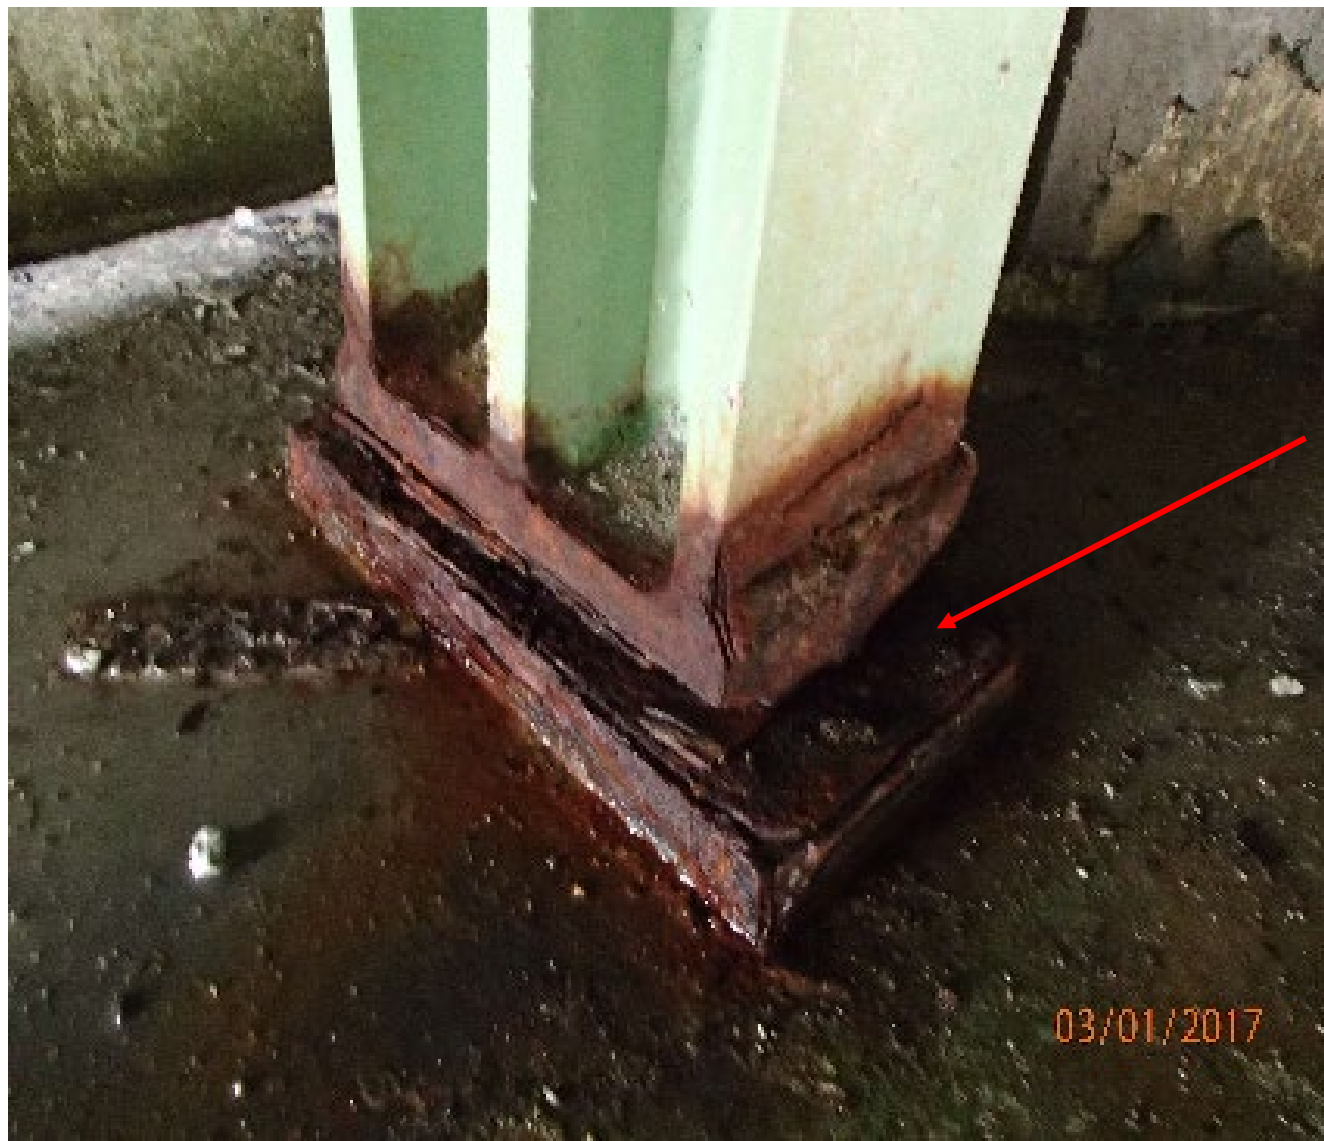
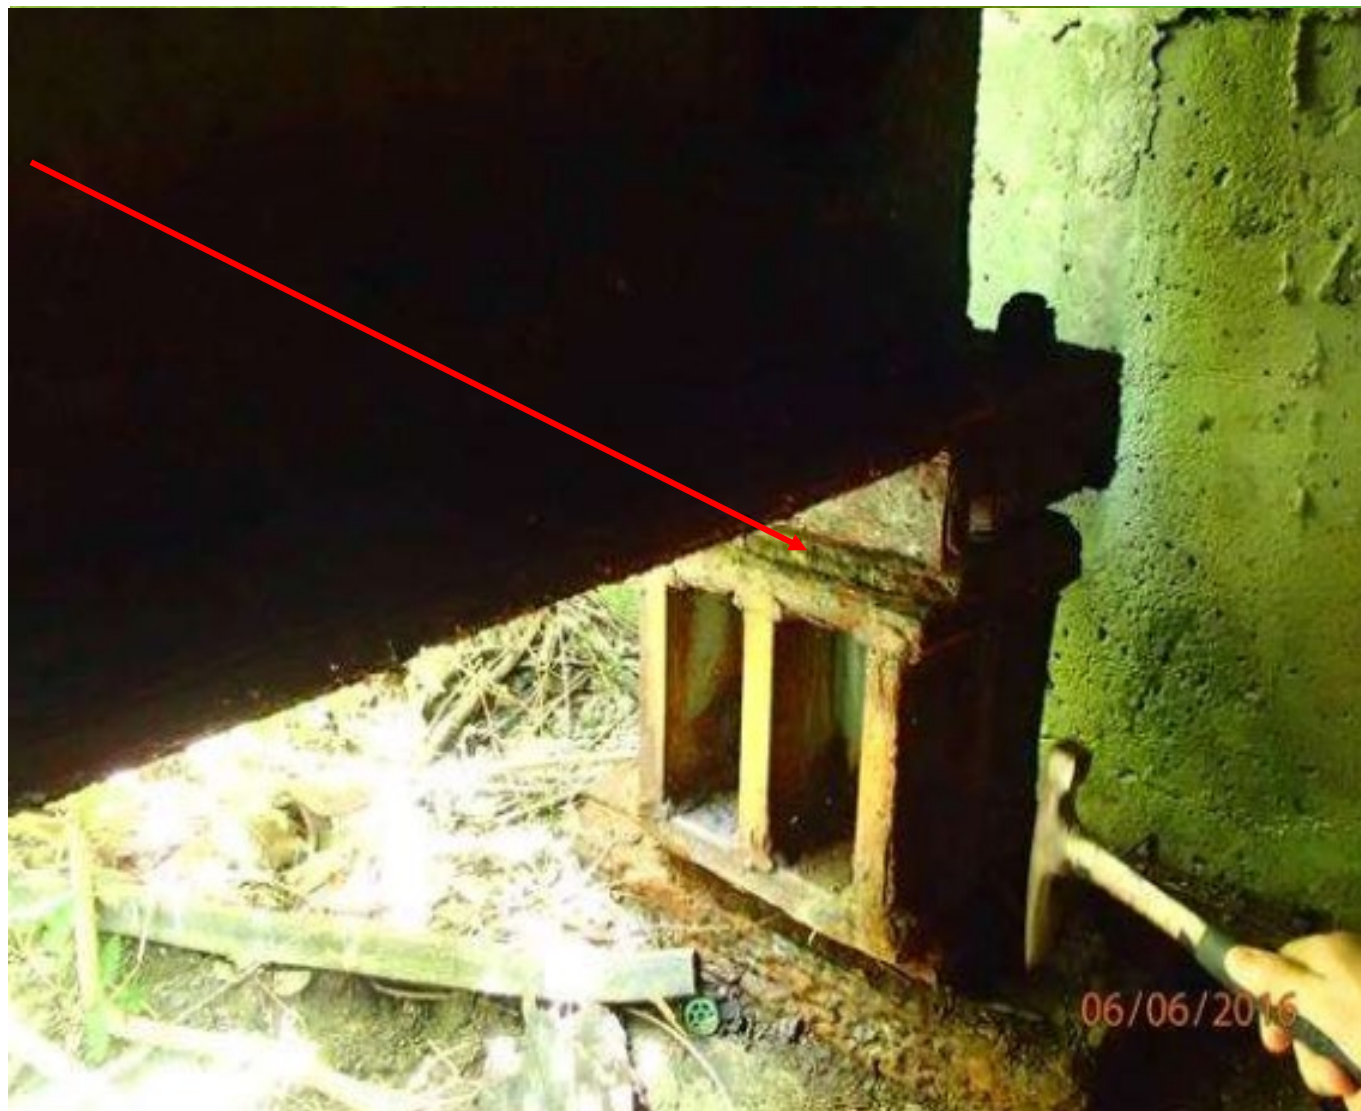
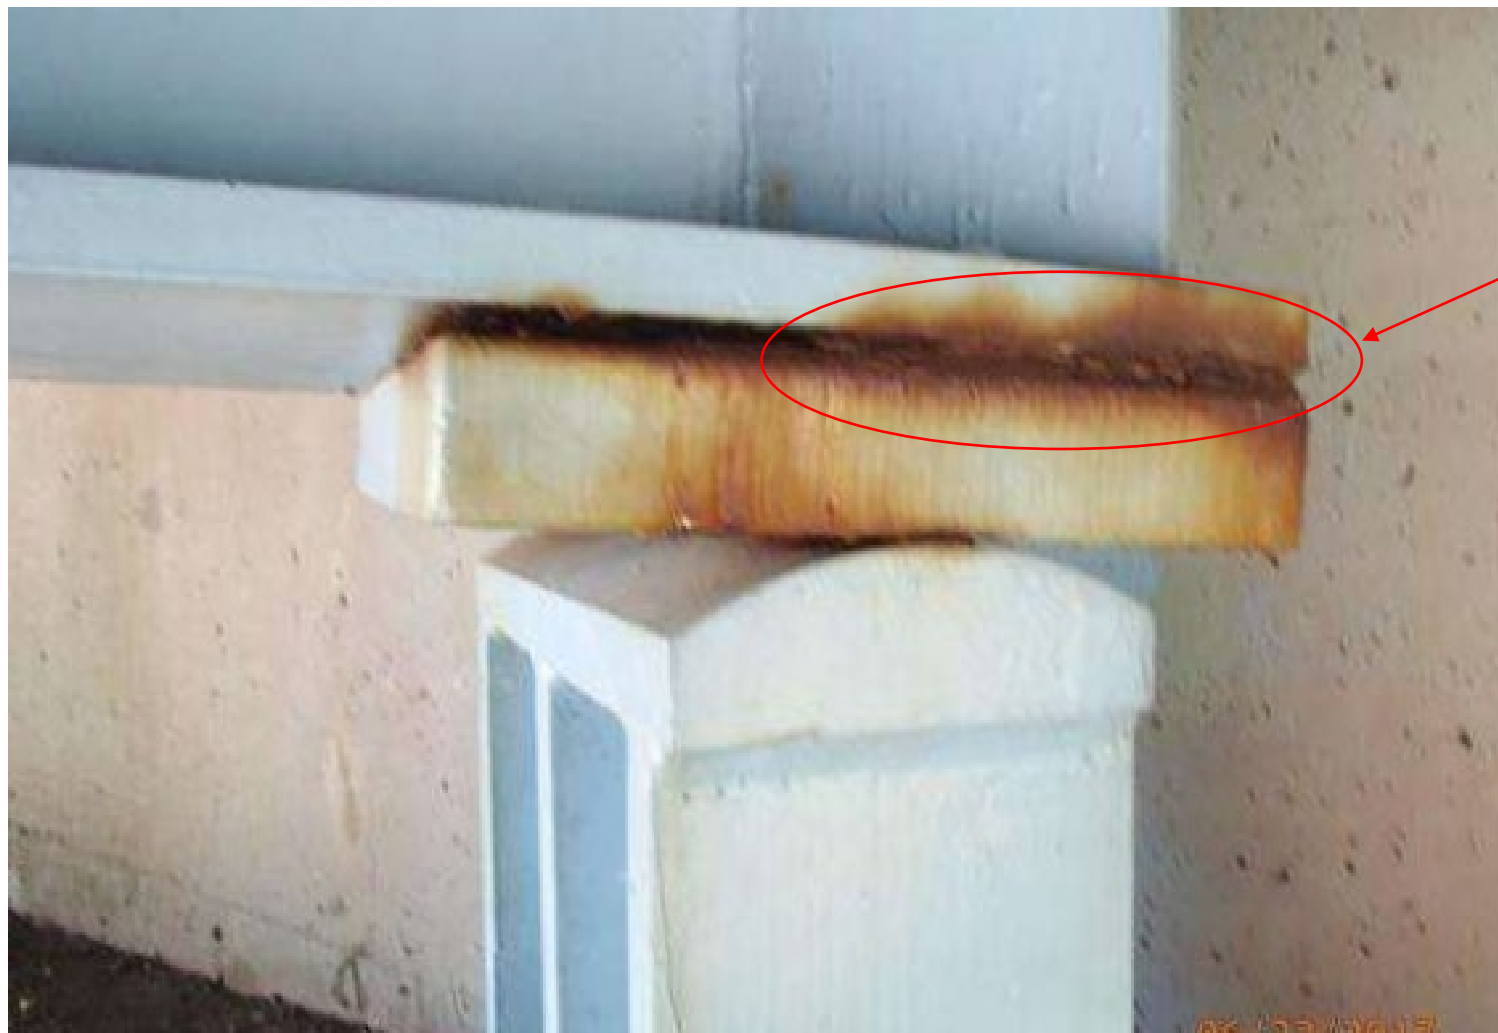
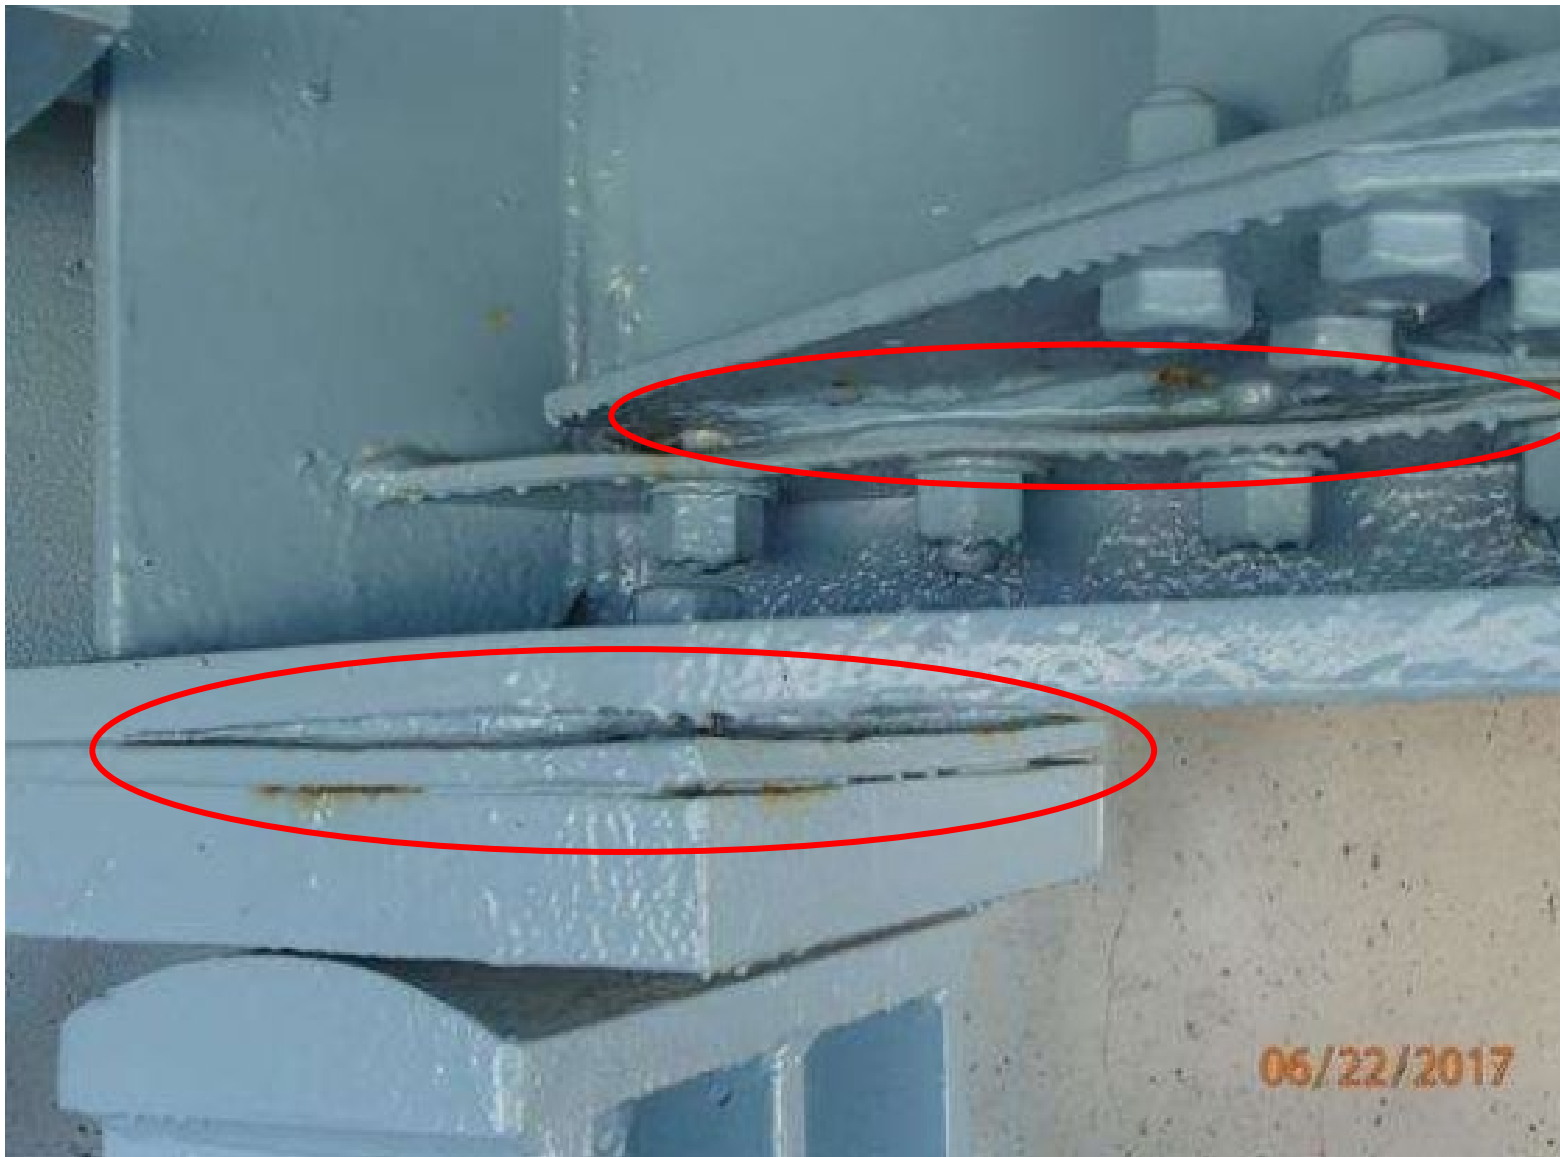
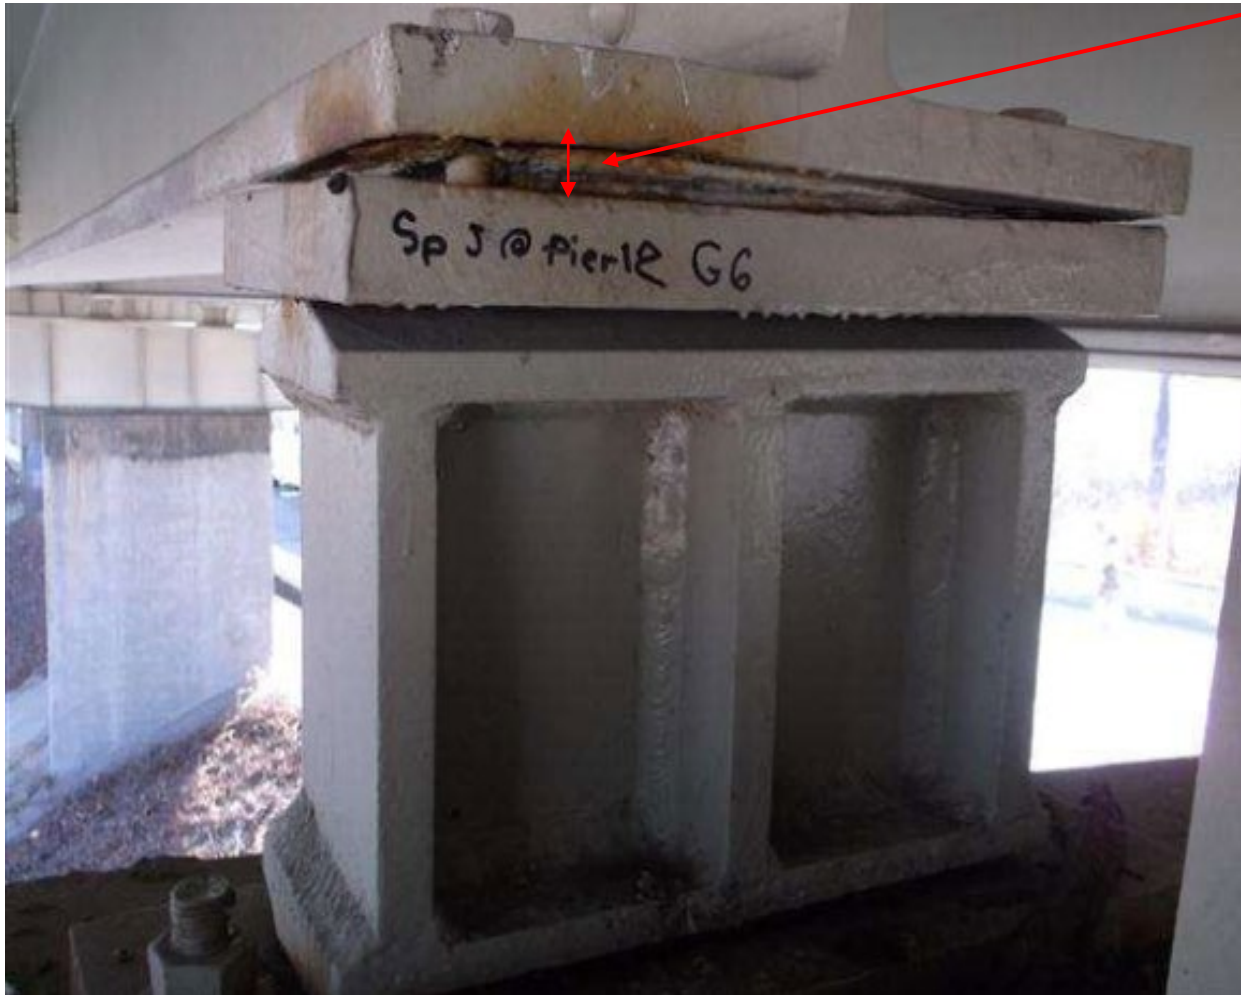
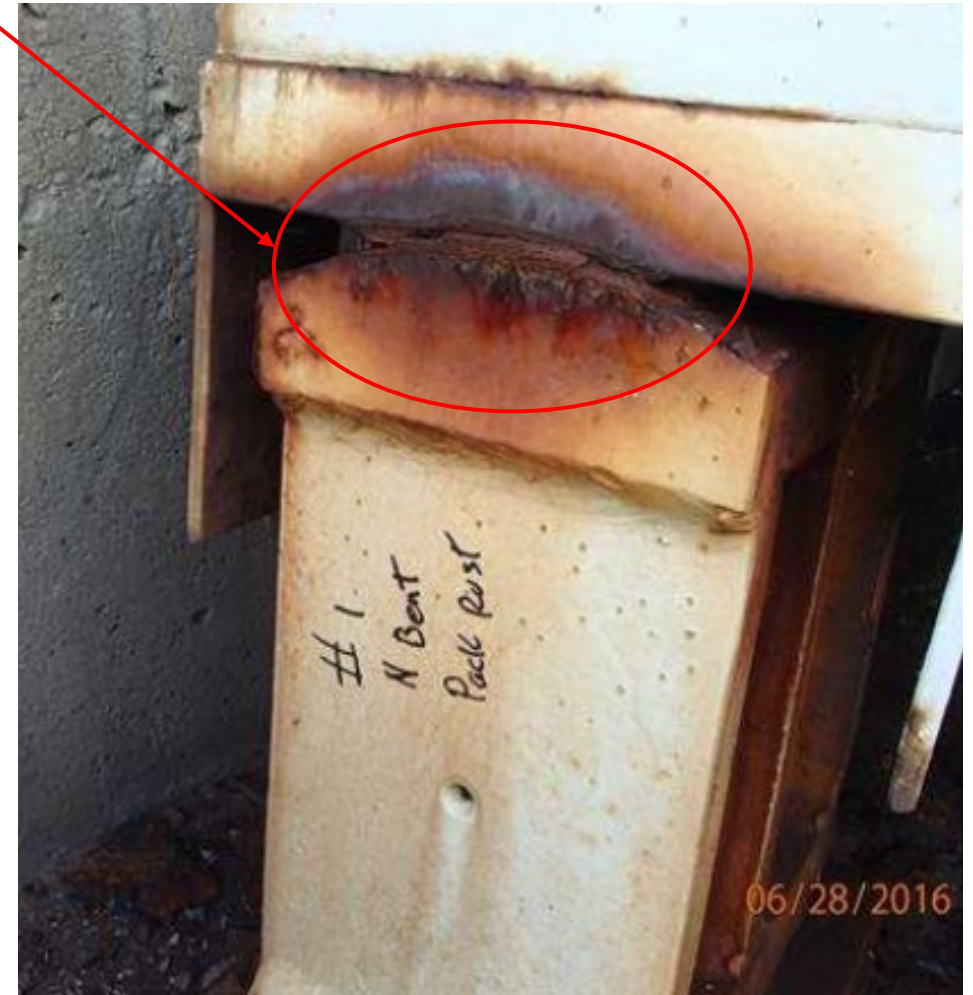
# Bearings

Pack Rust

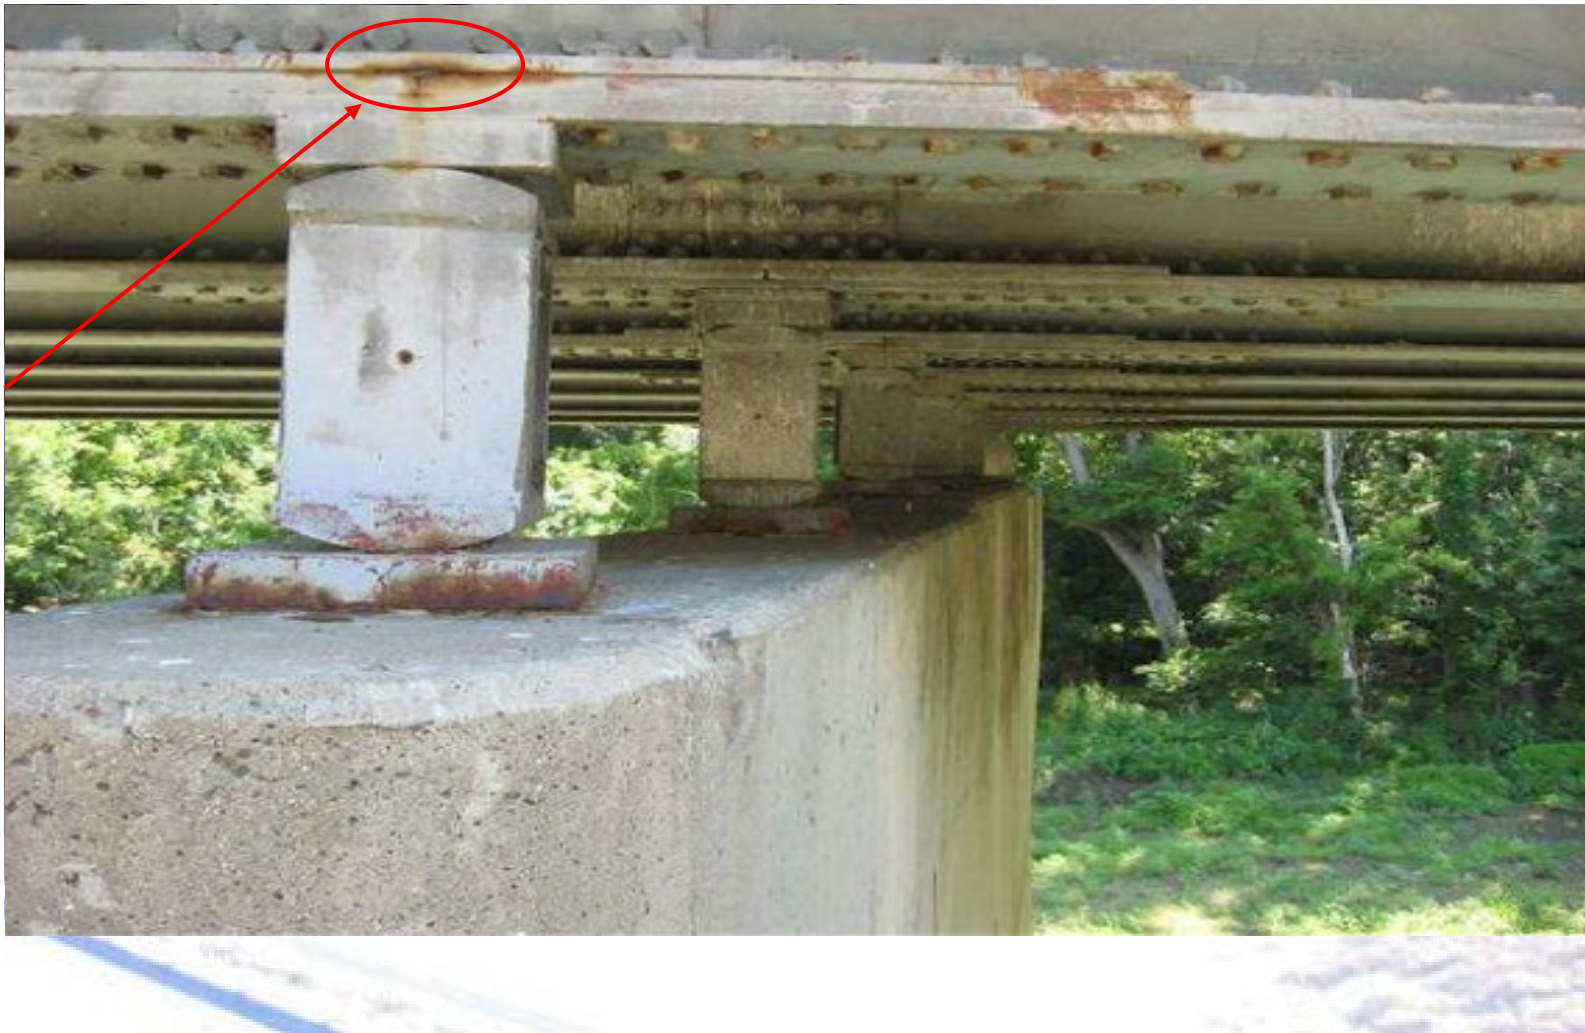
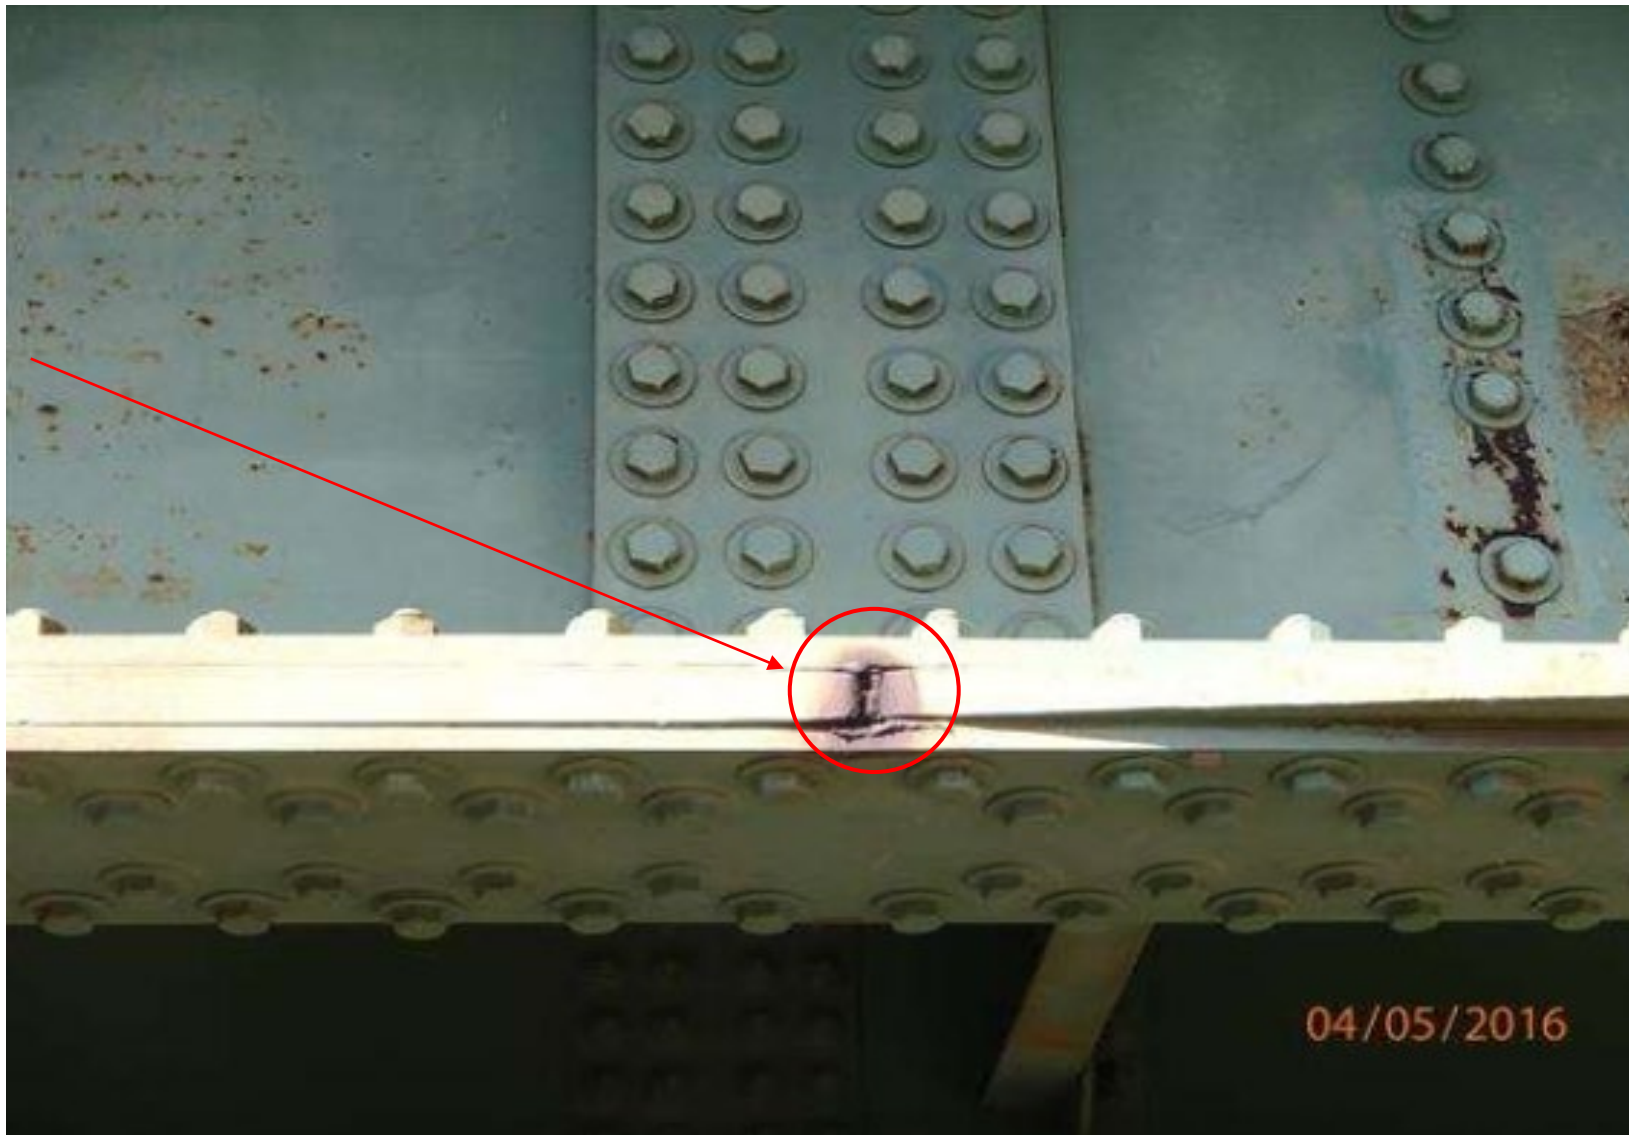
# Splice plates

Pack rust

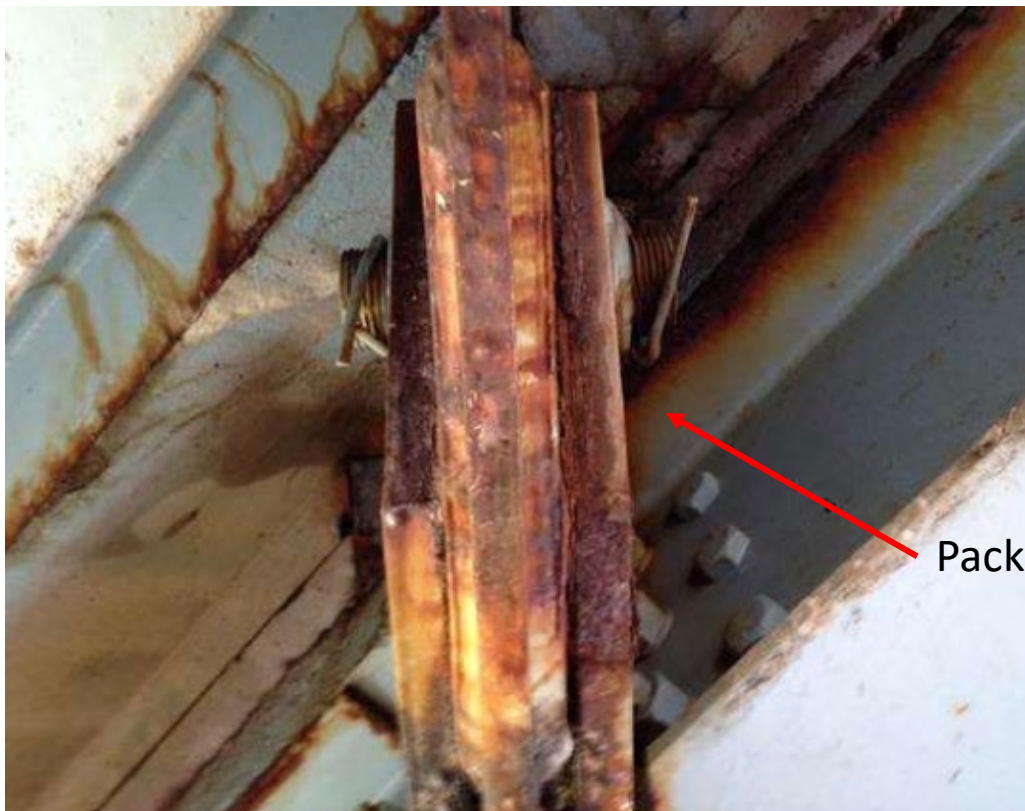
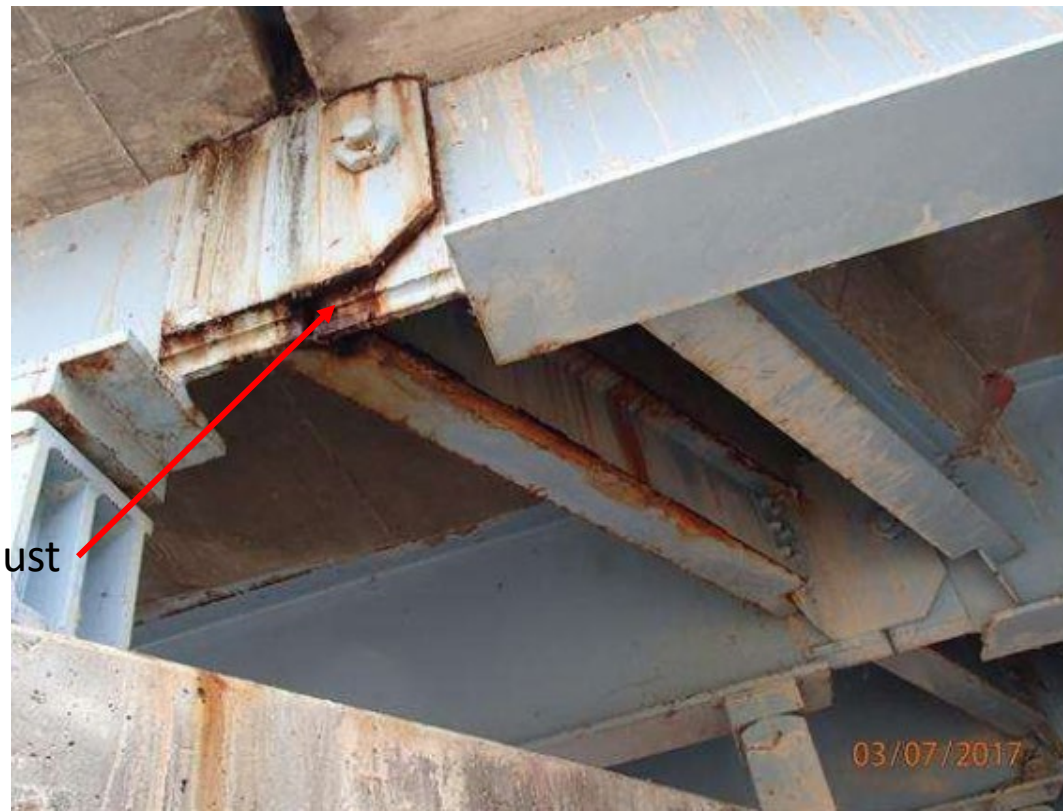
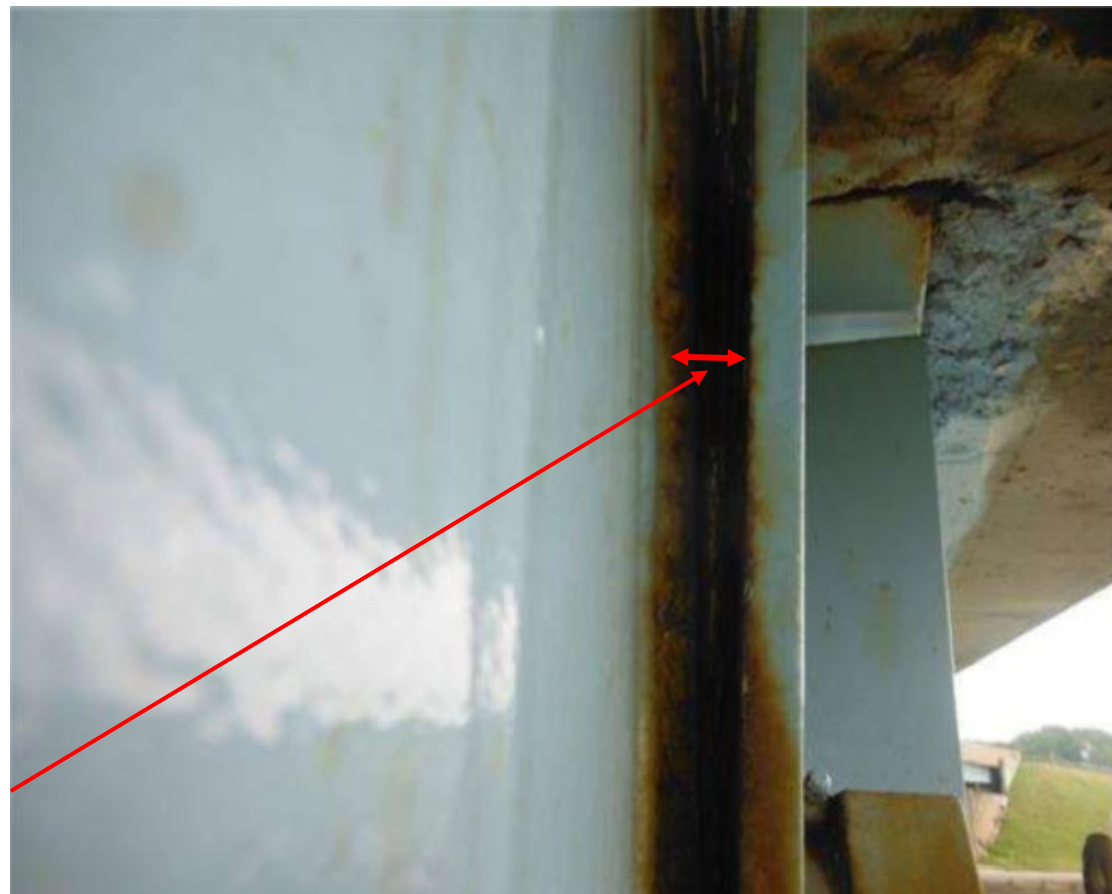
# Hinge-pin connection

Pack Rust

Pack rust

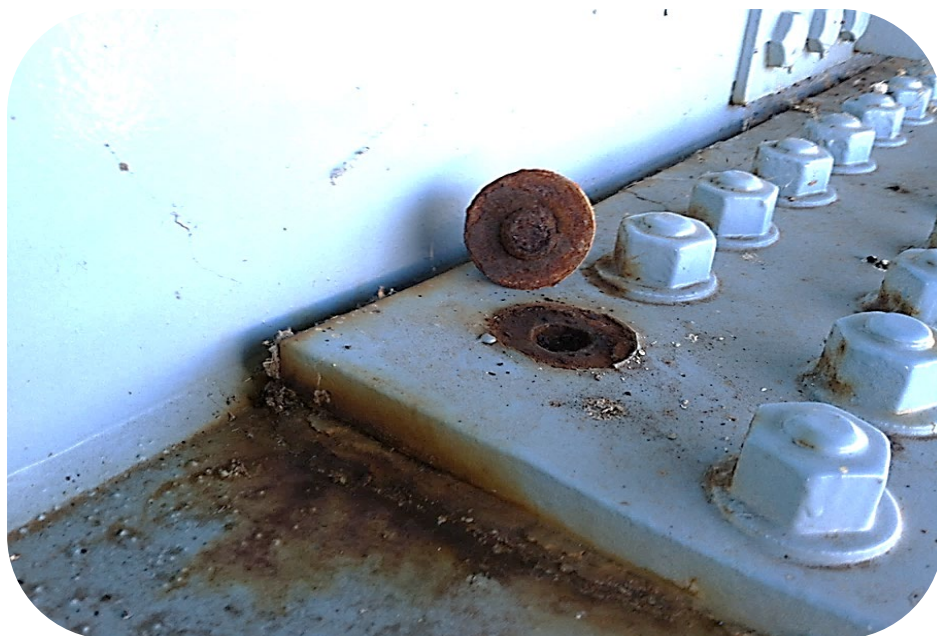
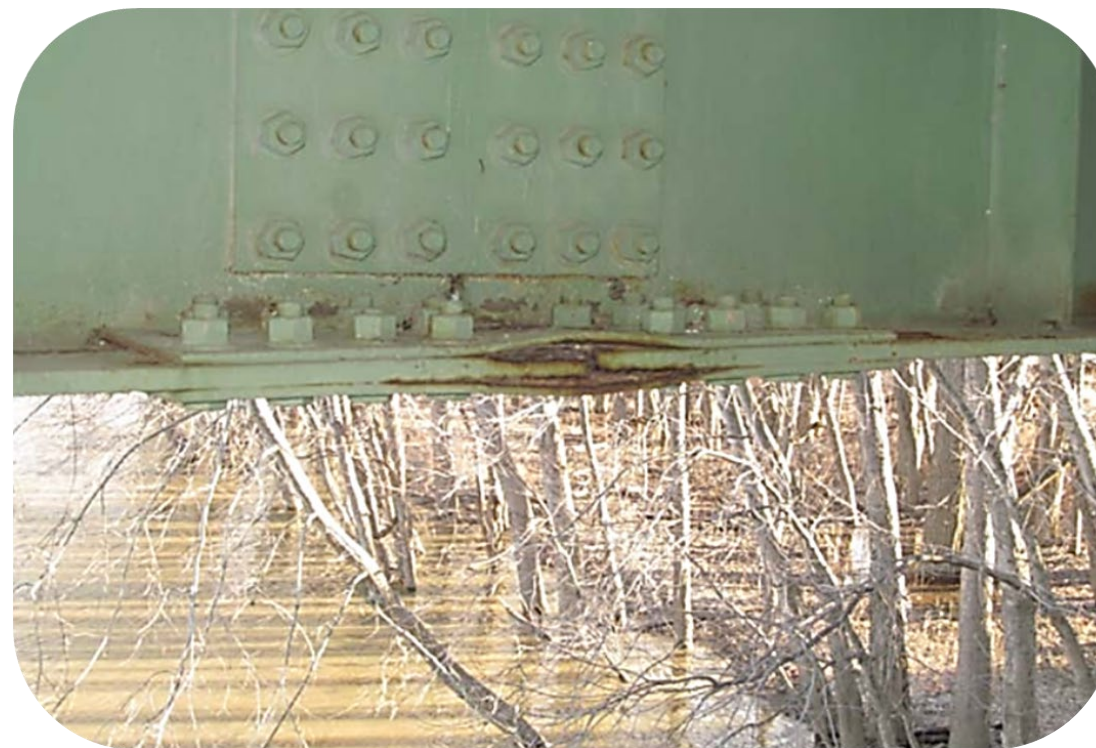
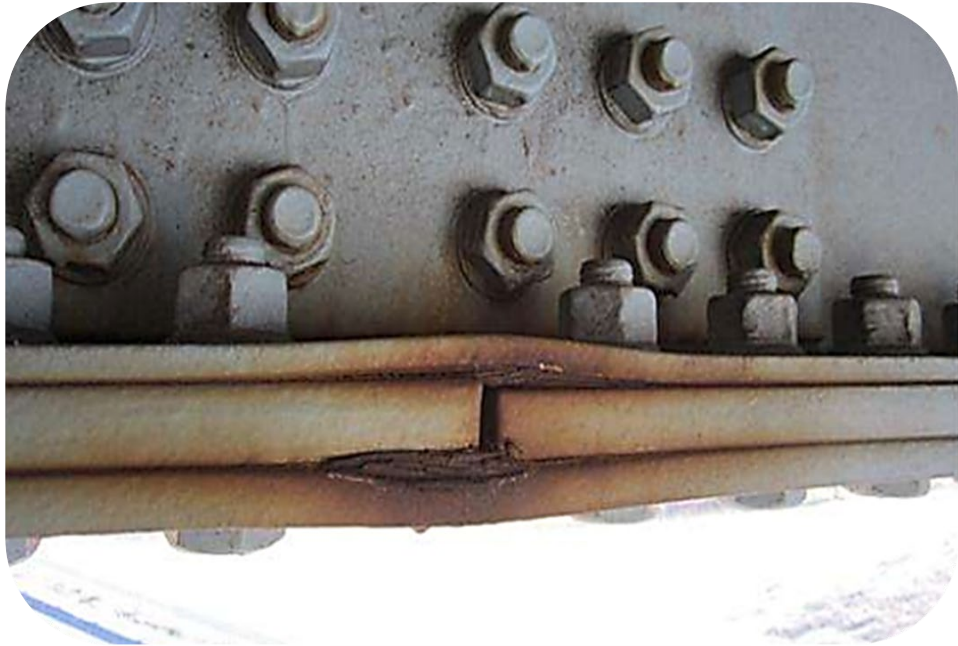
## Rating 1

Severe PR -  $> \frac{3}{4}$  inch bowing of splices or bolt failure

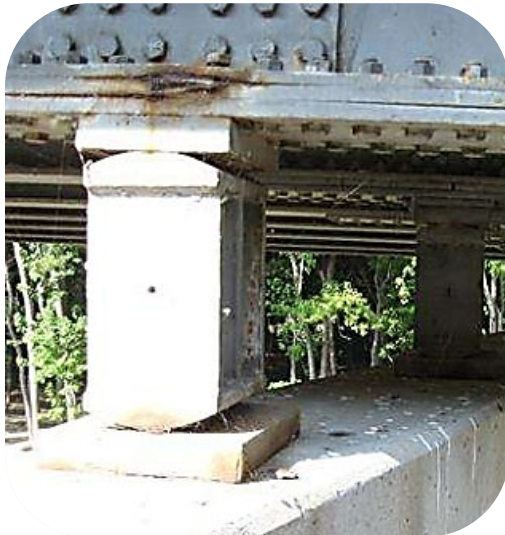
## Rating 2

Moderate to severe PR -  $\frac{1}{4}$  to  $\frac{3}{4}$  inch  
bowing of the splice plates

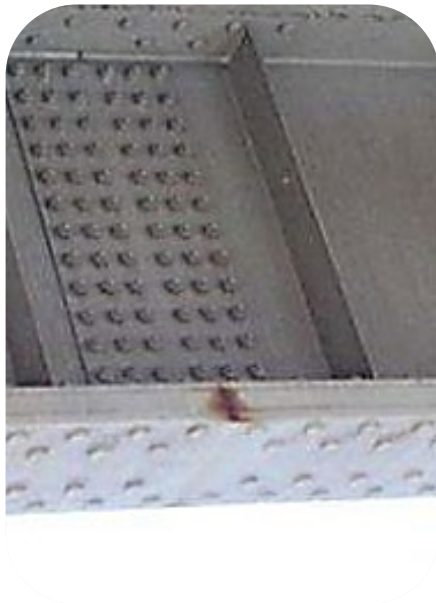
Rating 4  
Minor to moderate PR - Visible corrosion @ middle of splice Connection.
