ADJACENT PRESTRESSED, PRECAST BOX BEAM BRIDGES

RYAN WHELCHER, Purdue University
 RYAN MOLLEY, KPFF
 LUIS FELIPE URREGO, Universidad de los Andes
 ROBERT FROSCH, Purdue University
 CHRISTOPHER WILLIAMS, Purdue University

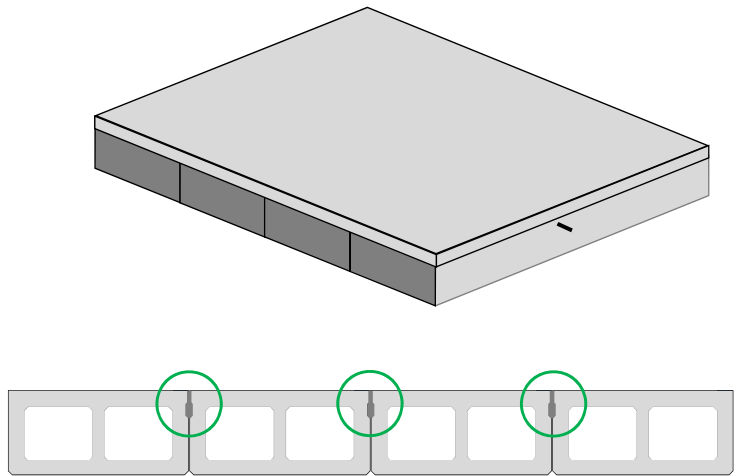
AN ADJACENT BOX BEAM BRIDGE

- Box Girders
- Shear Keys
- Tie Rods
- Wearing Surface

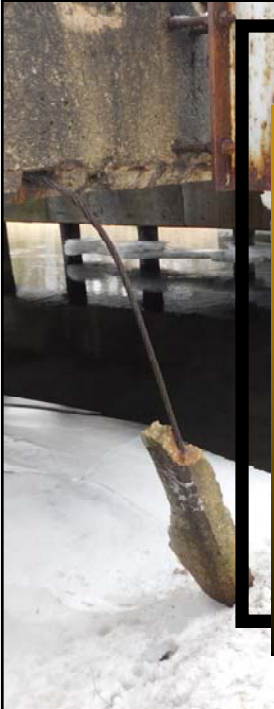
COMMON DETERIORATION

- Longitudinal Cracking
- Exposed or Broken Strand

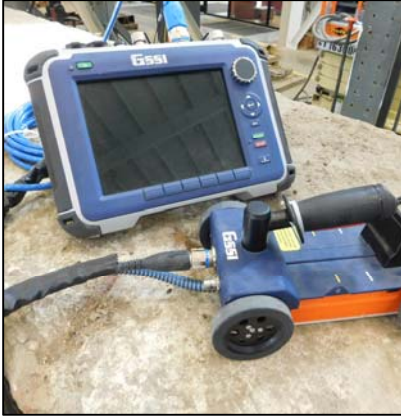
Ground Penetrating Radar (GPR)

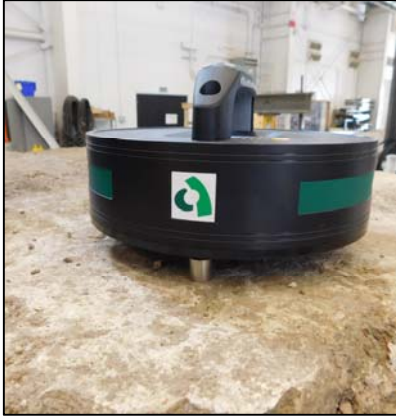
Connectionless Electrical Pulse Response Analysis (CEPRA)

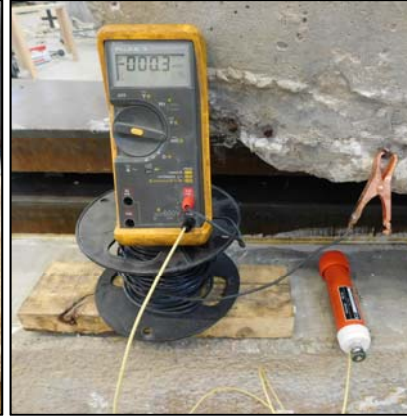
Half-cell potential measurement

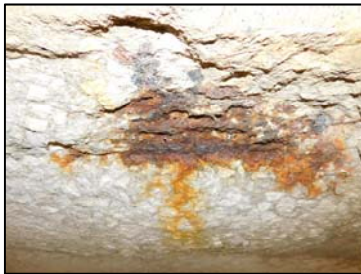
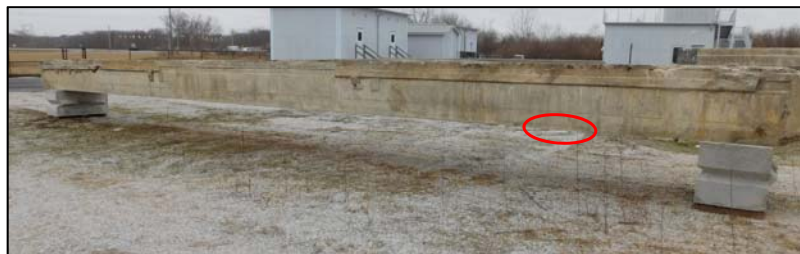
Specimen 409-1-ES

PRELIMINARY NDE RESULTS

Span: 50'
Depth: 29"
Width: 36"

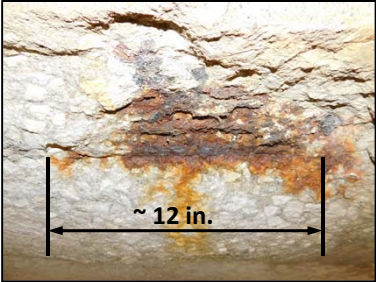
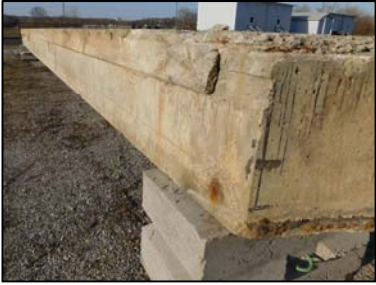
BEAM TEST

Specimen 409-1-ES

- Three exposed strands at L/8 from support

Specimen 409-2-UD

- No damage

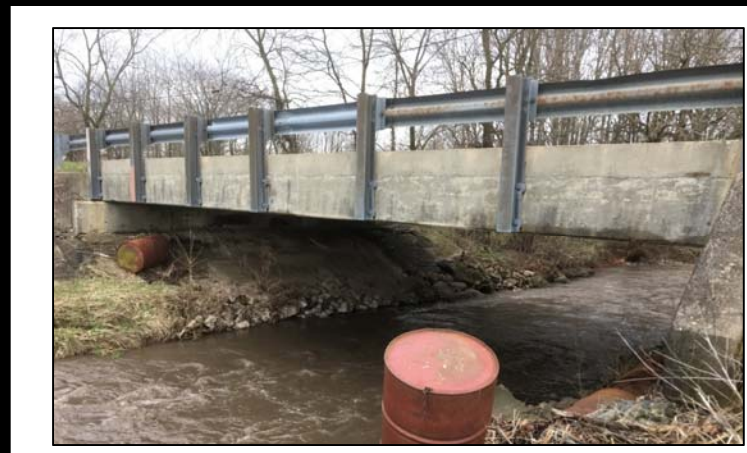
TIPPECANOE COUNTY BRIDGE 115

- Built: 1957
- Rehabilitated: 1993
- Span: 40 ft
- Beam Depth: 21 in.
- Beam Width: 45 in.
- 7 Beams

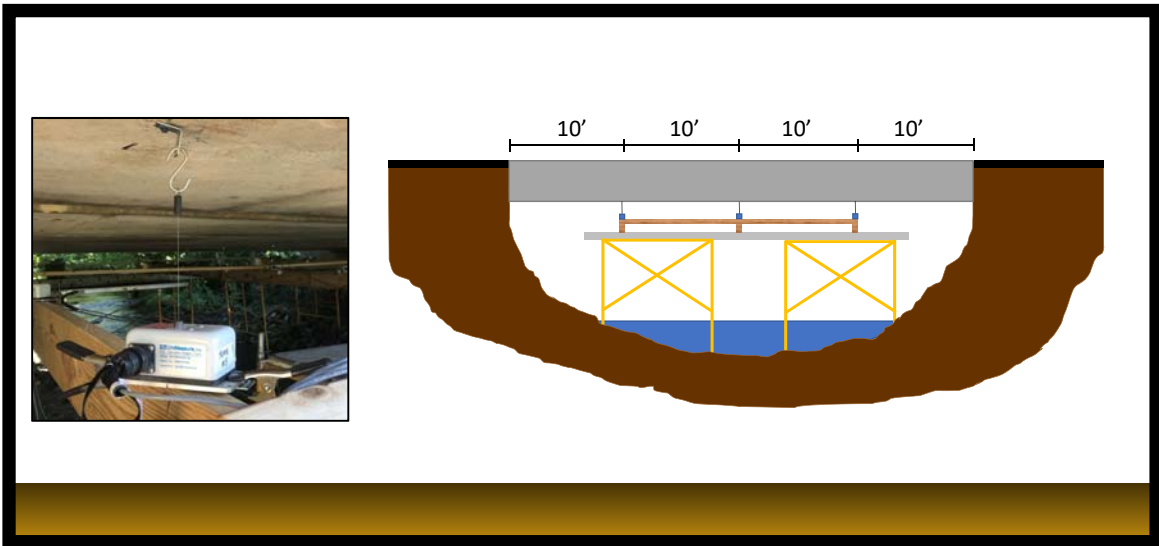
INSTRUMENTATION

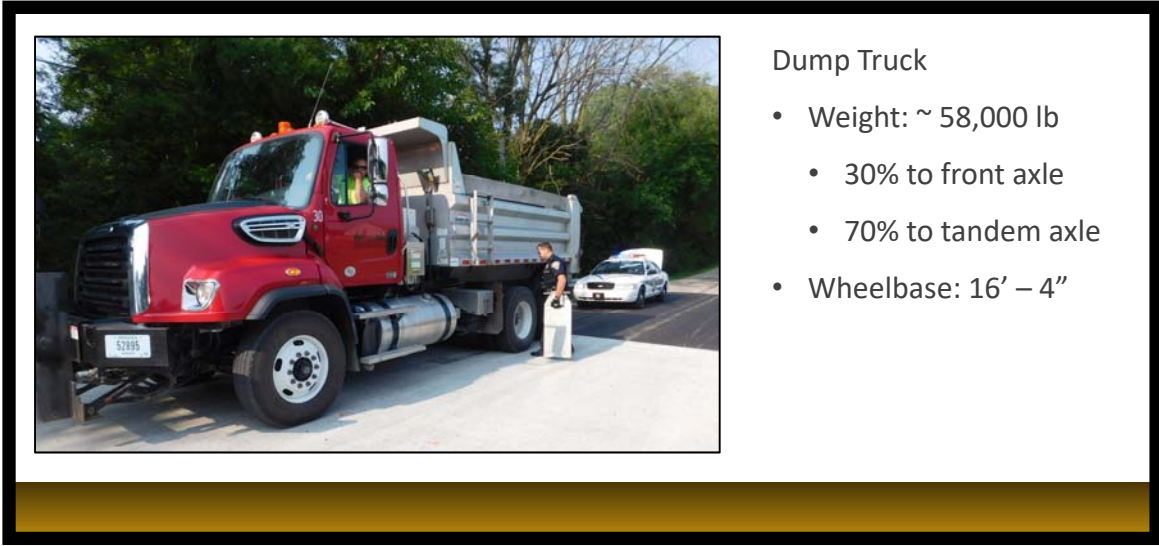
LOADING

Dump Truck

- Weight: ~ 58,000 lb
- 30% to front axle
- 70% to tandem axle
- Wheelbase: 16' – 4"

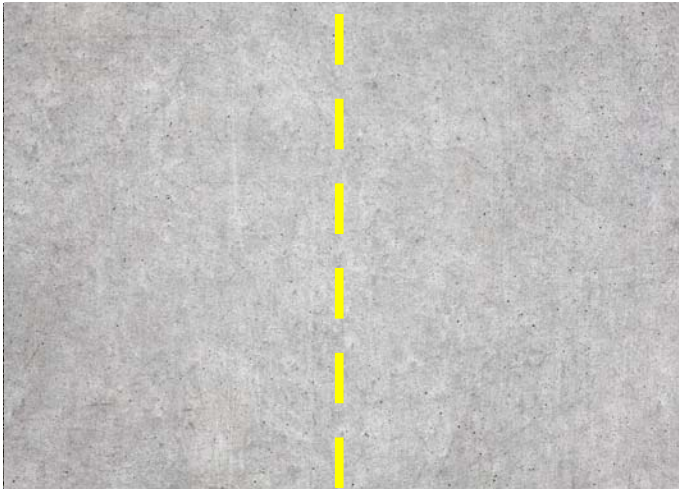
TEST 1

Q ← → V

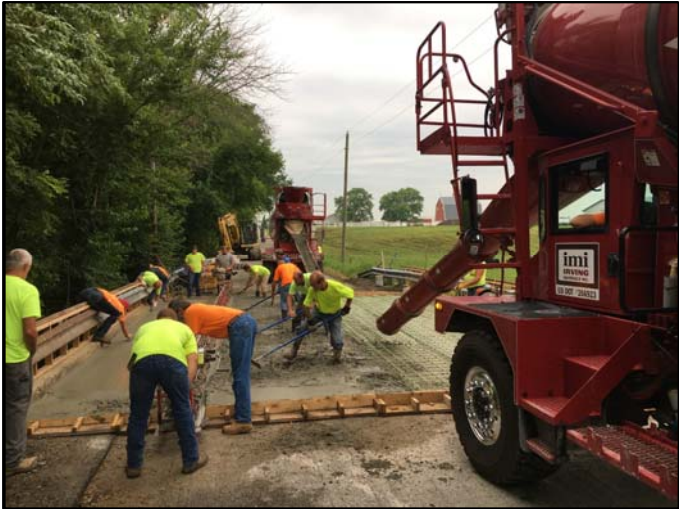
FIELD TESTING

Bridge Deck Modifications

- Milling
- Shear Key Cutting
- Surface Preparation
- Bridge Deck Cast

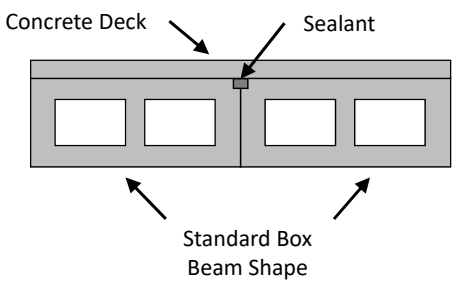
- Recommend all new construction use concrete decks
- Potential new design of adjacent box beam bridges without shear keys

Concrete Deck

Sealant

Standard Box Beam Shape
