Lyles School of Civil Engineering

BACKGROUND AND MOTIVATION

OUTLINE

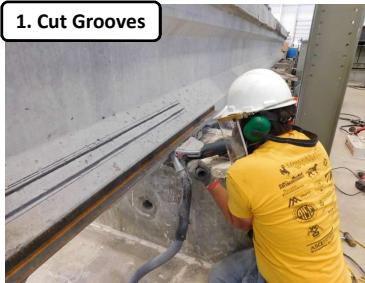
1. Cut Grooves

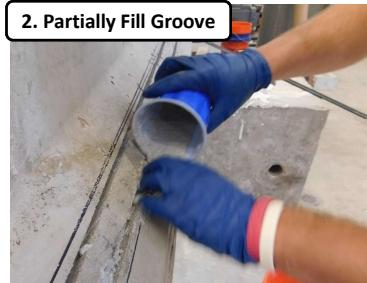
2. Partially Fill Groove

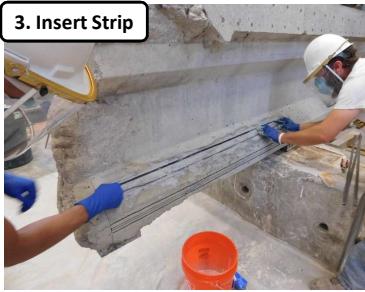
3. Insert Strip

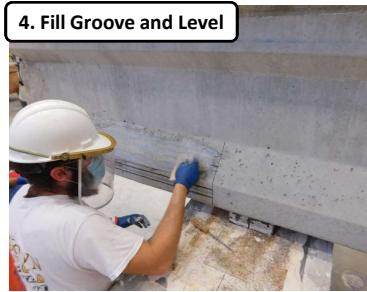
4. Fill Groove and Level

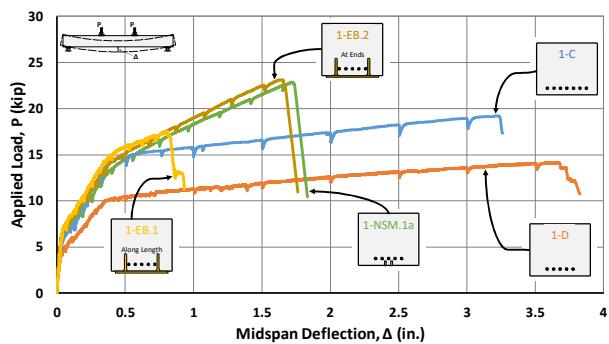
Key Results

- Strengths of Spec. 1-EB.2 & 1-NSM.1a exceed control
- Stiffness restored (before yielding of steel)
- Decreased ductility; increased post-yielding stiffness
- Experimental strengths exceed calculated strengths

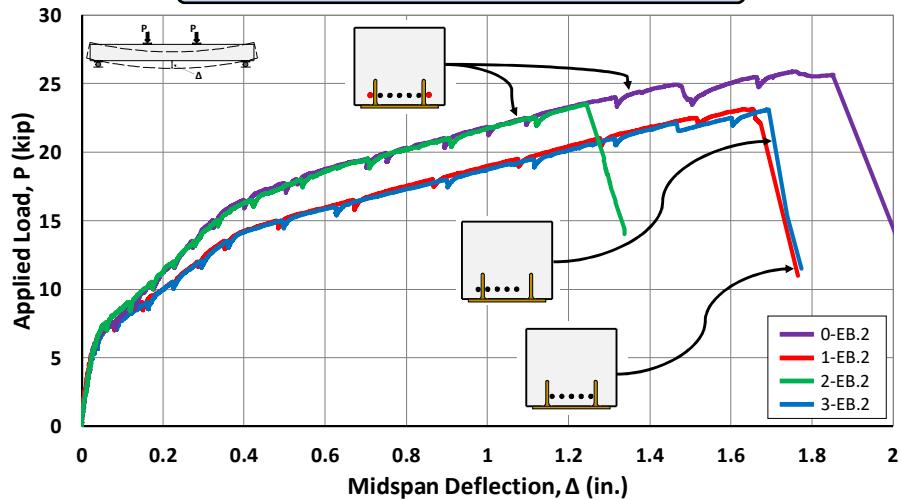
Anchors Along Length

FRP spike anchors should not be placed along the length of the FRP sheet; place at the ends of the FRP sheet and avoid regions of high moment demand.

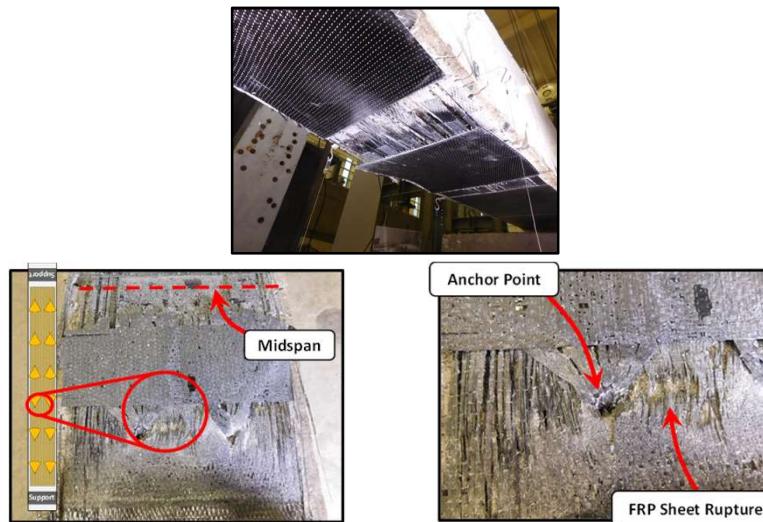
Premature Rupture Near Anchor

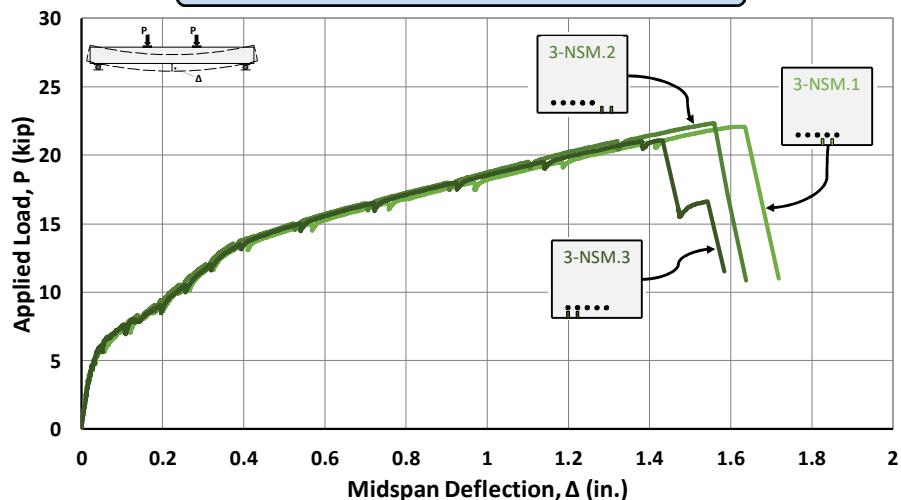
Effect of Eccentricity

Eccentricity of the longitudinal steel and relative placement of NSM strips did not play a significant role in the effectiveness of the system.

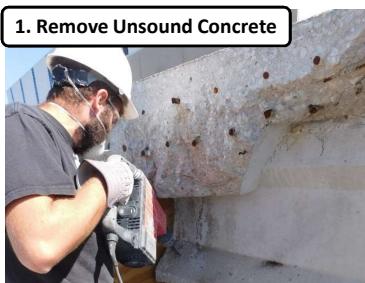
1. Remove Unsound Concrete

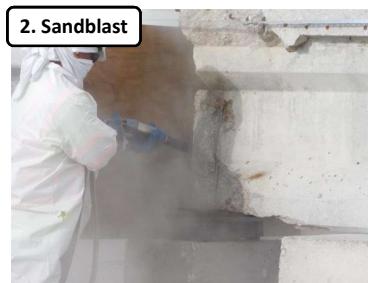
2. Sandblast

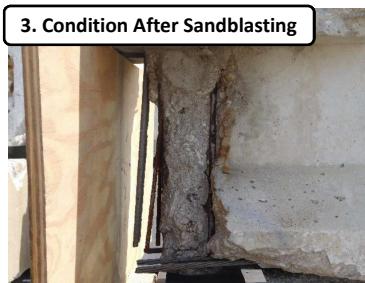
3. Condition After Sandblasting

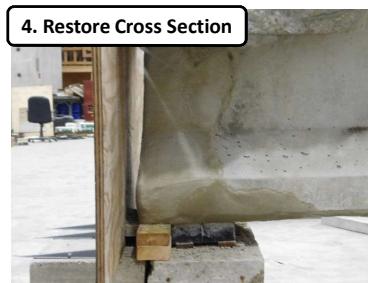
4. Restore Cross Section

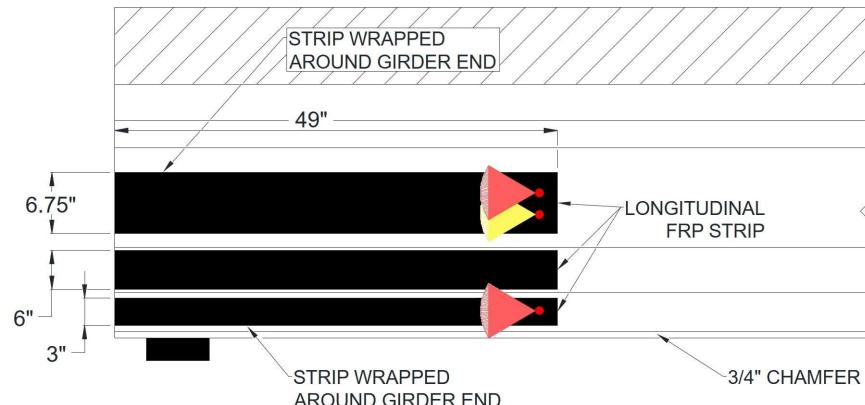
Elevation View: Layer 1

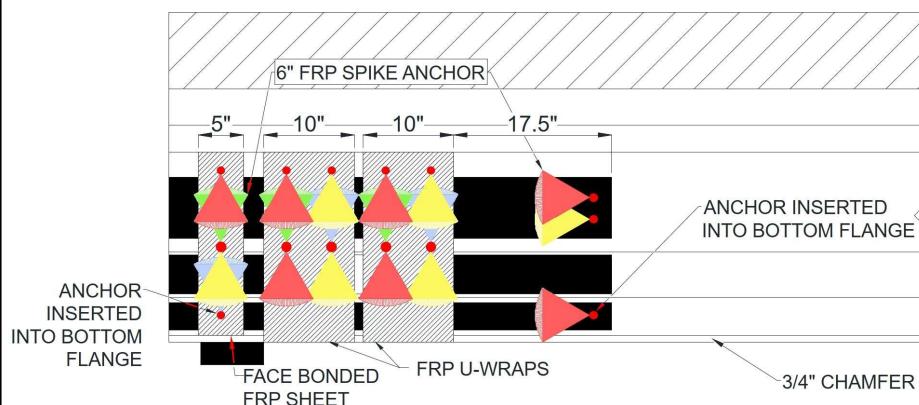
Elevation View: Layer 2

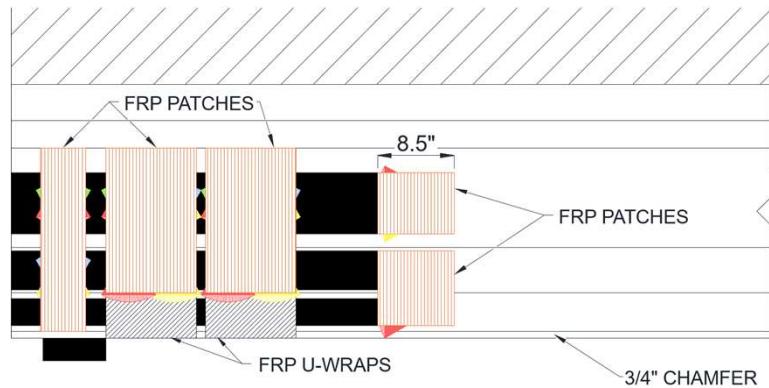
Elevation View: Layer 3

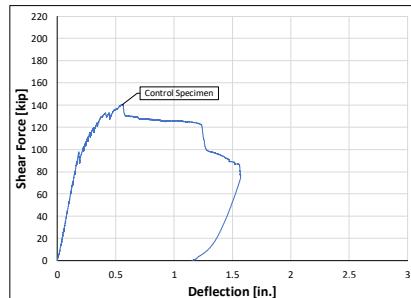
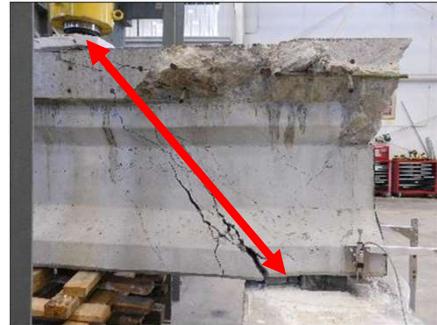
- Peak Shear = 141 kips
- Failure controlled by the formation of a diagonal strut.
- No abrupt drop in load.
- Slip of prestressing strands in the bottom flange.

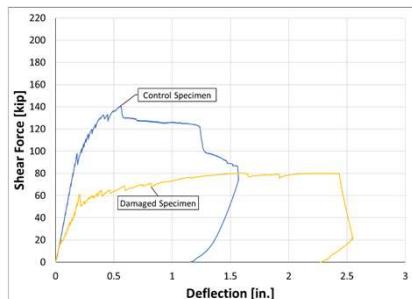
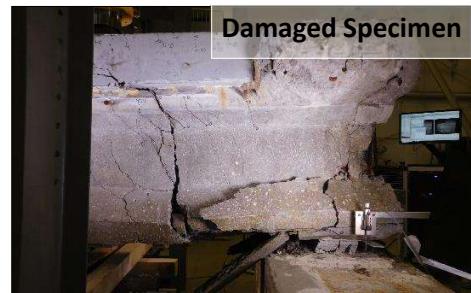
- $V_{\text{test}}/V_{\text{control}} = 0.57$

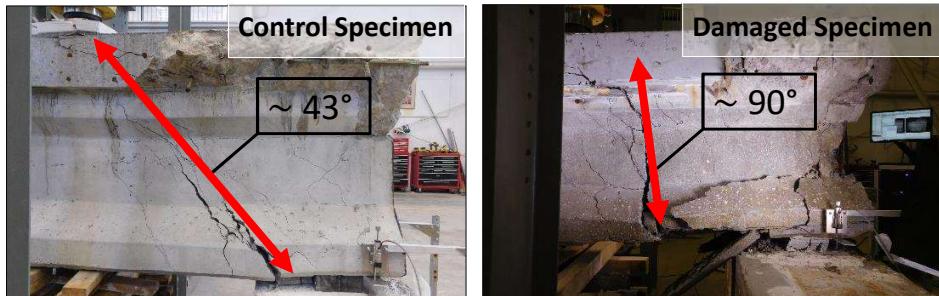
- $V_{\text{test}}/V_{\text{control}} = 0.57$
- Different failure mechanism.
- The crack angle increased to nearly 90°.

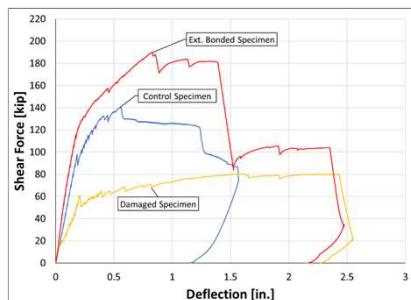
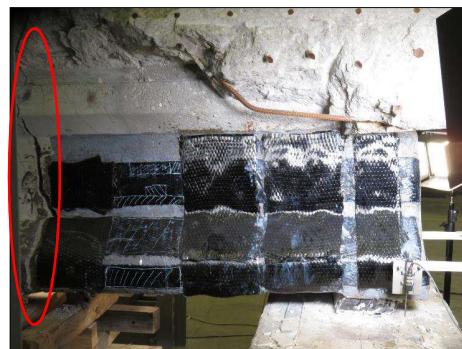
- $V_{\text{test}}/V_{\text{control}} = 1.34$
- Increased stiffness.
- Flexural failure at the end of the repair → strand fracture.

The externally bonded system is a viable repair option.

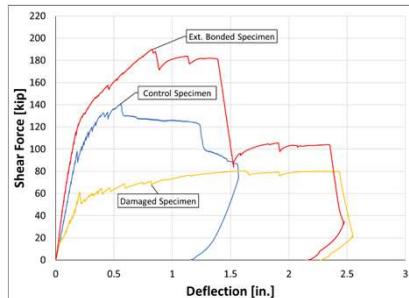
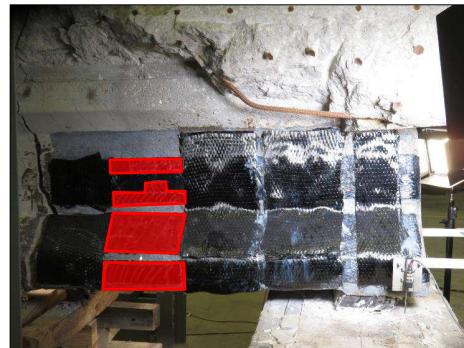
- $V_{\text{test}}/V_{\text{control}} = 1.34$
- Increased stiffness.
- Flexural failure at the end of the repair → strand fracture.
- Minimal delamination of the FRP was observed.

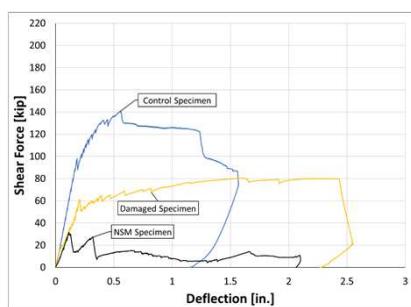
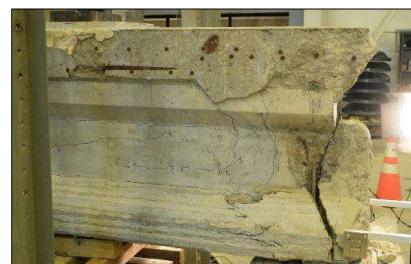
- $V_{\text{test}}/V_{\text{control}} = 0.22$
- Similar initial stiffness to damaged specimen.

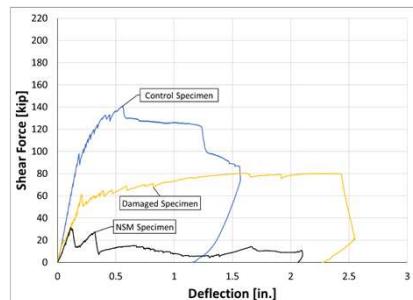
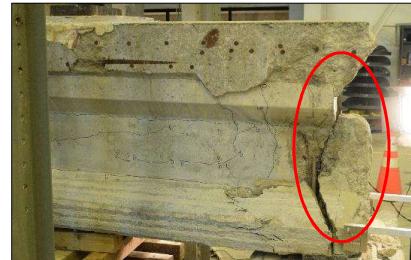
- $V_{\text{test}}/V_{\text{control}} = 0.22$
- Similar initial stiffness to damaged specimen.
- Cracking/splitting at the notch above the bearing location.

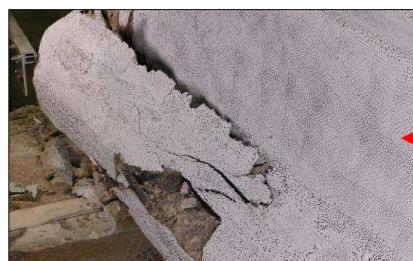
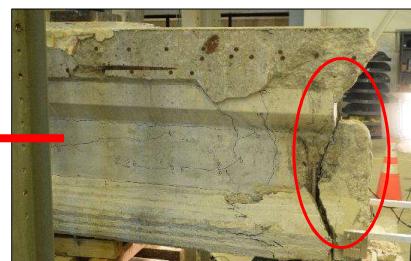
- $V_{\text{test}}/V_{\text{control}} = 0.22$
- Similar initial stiffness to damaged specimen.
- Cracking/splitting at the notch above the bearing location.
- Bottom flange separated from the web.

The NSM system did not perform adequately. A hybrid system using both NSM and externally bonded elements may be a viable repair solution.
