FIBER WRAP FOR BEAM END REPAIR

CHRIS WILLIAMS, Ph.D.
Assistant Professor of Civil Engineering
Purdue University
February 22, 2022

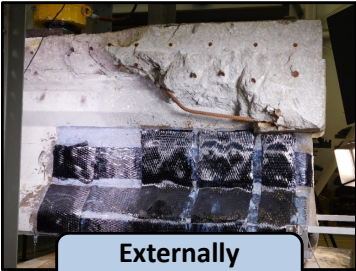
Externally Bonded FRP

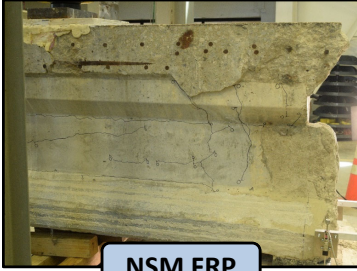
NSM FRP

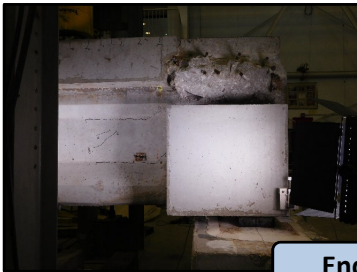
End Block

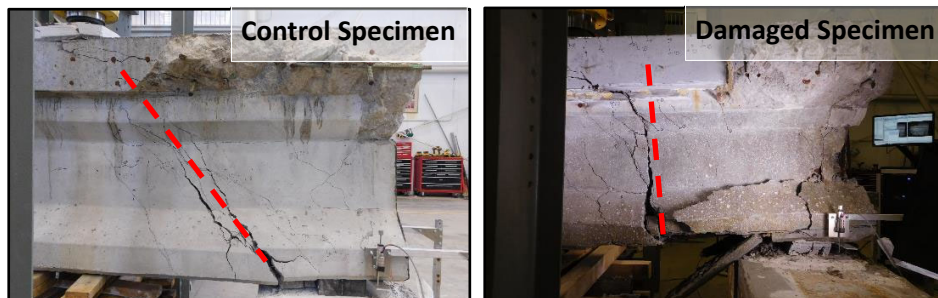
TEST RESULTS – TESTED IN DAMAGED STATE

Observations

- $V_{\text{test}}/V_{\text{control}} = 0.57$
- Different failure mechanism.

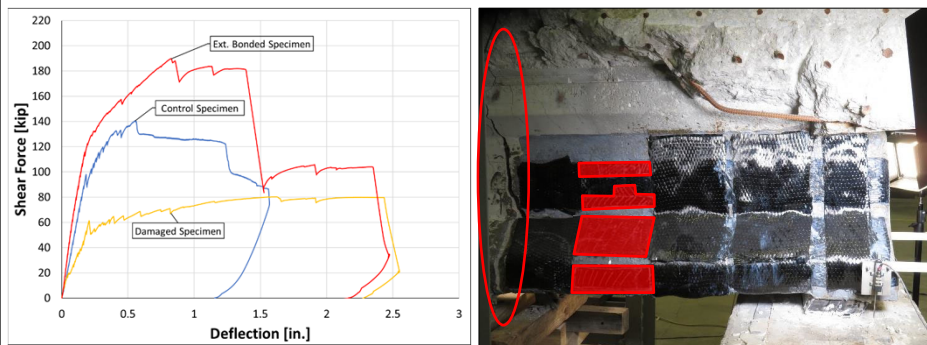
TEST RESULTS – EXTERNALLY BONDED FRP

Observations

- Exceeded strength of control specimen.
- Restored stiffness.
- Flexural failure at the end of the repair → strand fracture.
- Some debonding of the FRP was observed.

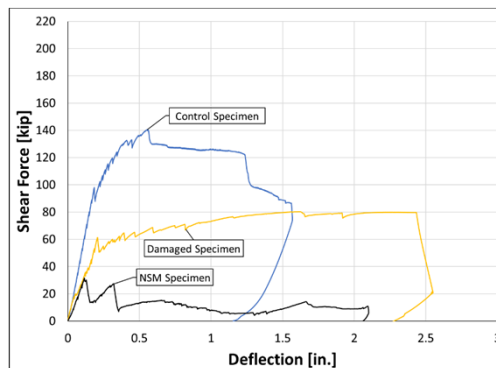
TEST RESULTS – NSM FRP

Observations

- Premature failure.
- Cracking/splitting at the notch above the bearing location.
- Bottom flange separated from the web.

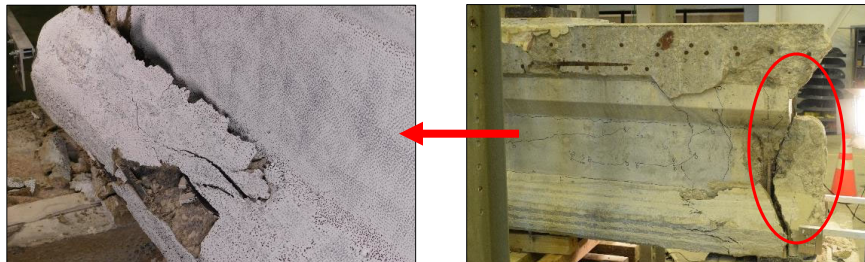
TEST RESULTS – NSM FRP

Observations

- Premature failure.
- Cracking/splitting at the notch above the bearing location.
- Bottom flange separated from the web.

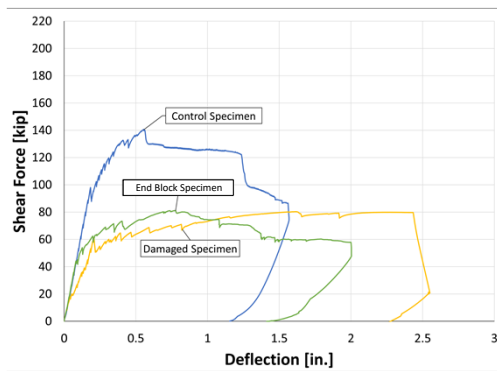
TEST RESULTS – END BLOCK

Observations

- Similar initial stiffness to control specimen.
- Cracking/splitting of the diaphragm.
- Interface failure → diaphragm rotation.

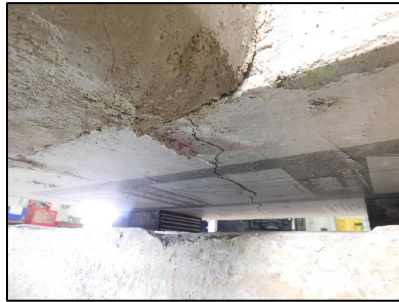
TEST RESULTS – END BLOCK

Observations

- Similar initial stiffness to control specimen.
- Cracking/splitting of the diaphragm.
- Interface failure → diaphragm rotation.

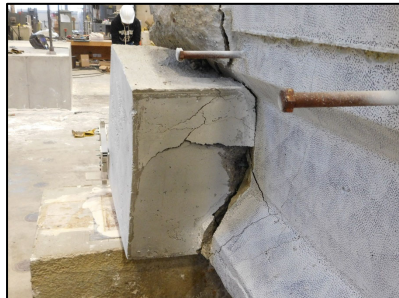
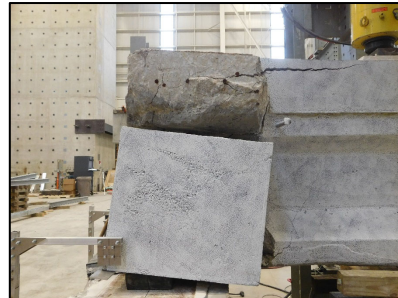
TEST RESULTS – END BLOCK

Observations

- Similar initial stiffness to control specimen.
- Cracking/splitting of the diaphragm.
- Interface failure → diaphragm rotation.

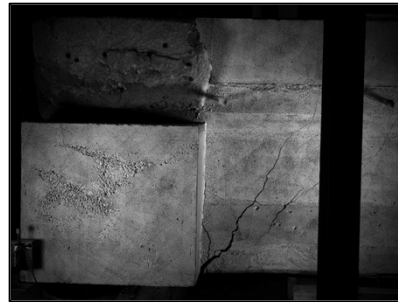
TEST RESULTS – END BLOCK

Observations

- Similar initial stiffness to control specimen.
- Cracking/splitting of the diaphragm.
- Interface failure → diaphragm rotation.

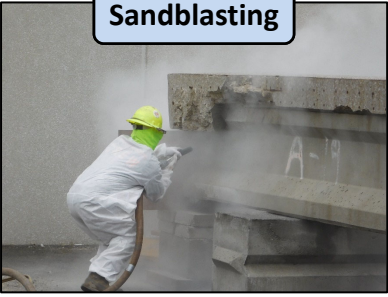
Sandblasting

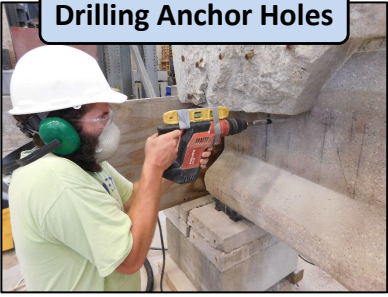
Drilling Anchor Holes

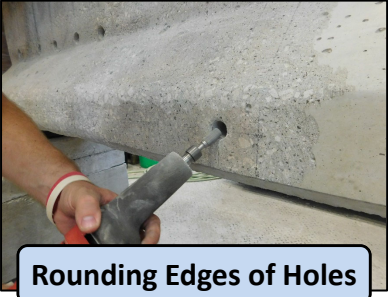
Rounding Edges of Holes

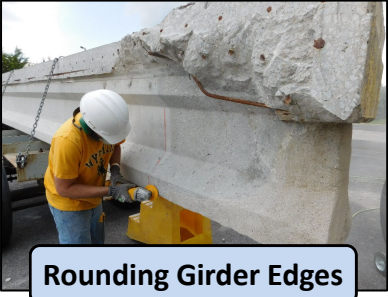
Rounding Girder Edges

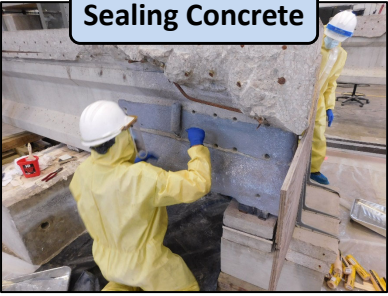
Sealing Concrete

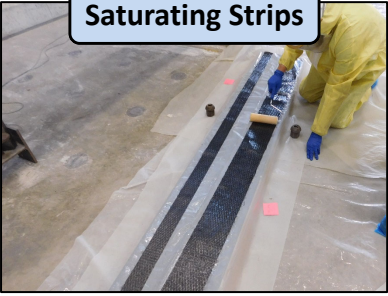
Saturating Strips

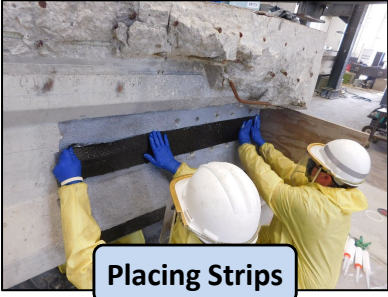
Placing Strips

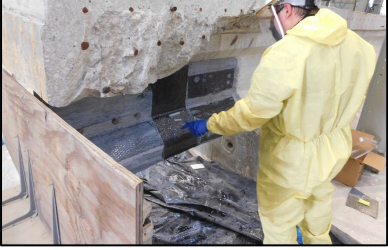
Removing Excess Epoxy

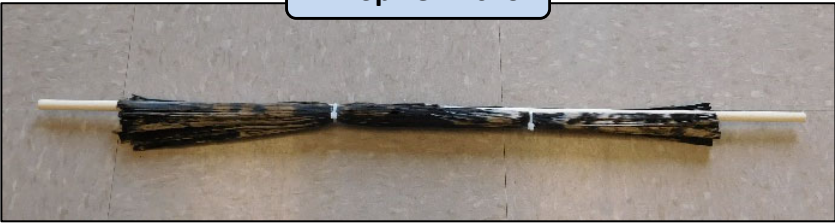
FRP Spike Anchor

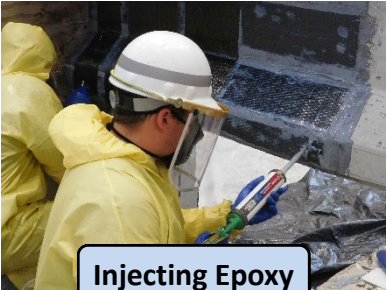
Injecting Epoxy

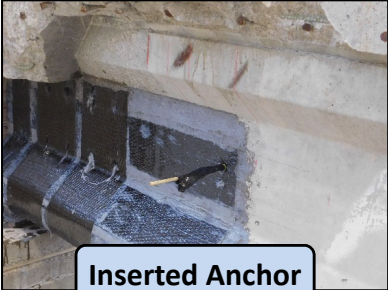
Inserted Anchor
