Water Facts #6

Protecting Wells with Sanitary Well Caps and Grouting

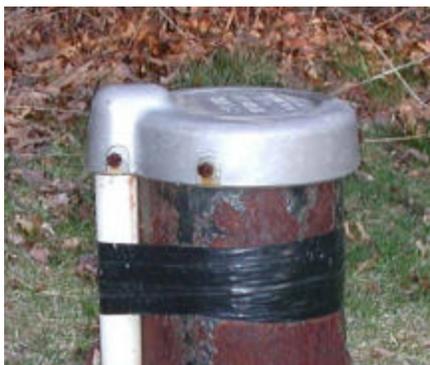
Figure 1. A standard well cap similar to those found on most Pennsylvania wells (note the bolts around the outside of the well cap).

Most existing and new wells in Pennsylvania have a standard well cap similar to the one shown in Figure 1. Standard well caps usually have bolts around the side of the cap that loosely hold the cap onto the top of the casing. The small airspace between the well cap and the casing can allow for insects, small mammals, or surface water to enter the well.

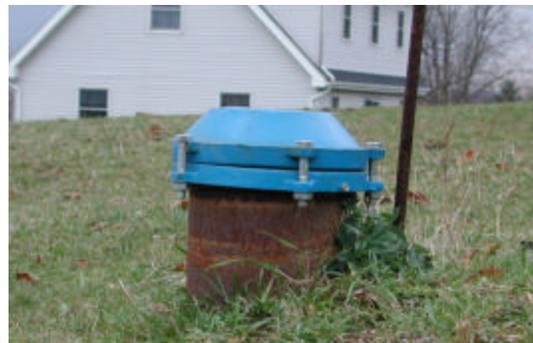
Figure 2. A sanitary well cap installed on a well casing. Note the bolts on the top rather than around the sides of the cap.

A “sanitary” well cap (sometimes referred to as a “vermin-proof” well cap) looks similar to a standard well cap but usually has bolts on the top of the well

cap as shown in Figure 2. Most sanitary well caps include an airtight rubber gasket seal to prevent insects, small mammals, or surface water from entering the well and a small, screened vent to allow for air exchange (Figure 3).

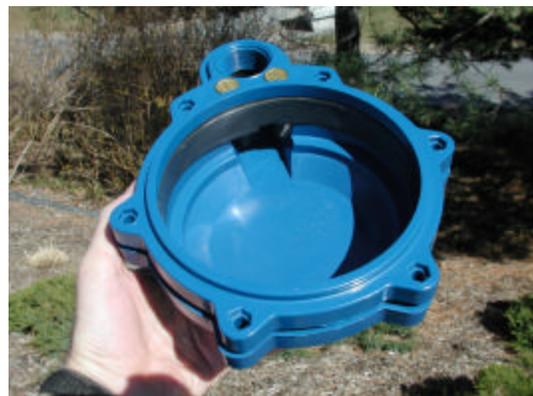
Figure 3. A sanitary well cap showing the rubber gasket, hole for electrical conduit, and screen holes for ventilation.

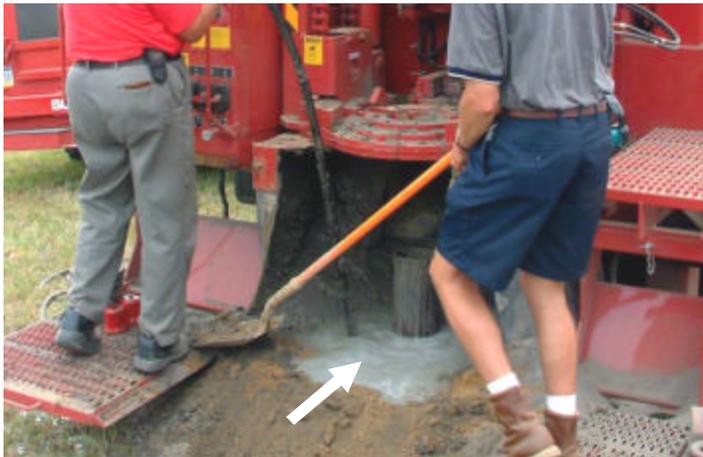
**Figure 5. Well drillers use a tremie pipe to pump grout into the well. Note that the grout is now appearing at the surface of the ground around the well casing—see arrow (Photo by Dr. Todd Giddings).**

pumped into the annular space starting from the bottom of the casing using a tremie pipe until it appears at the surface of the ground (Figure 5). Grout is usually not used on private wells in Pennsylvania unless it is required by local ordinances or requested by the homeowner.
