Notice of 30-Day Period for Public Comment

**A Total Maximum Daily Load Report
for the
Maria Creek Watershed**

Draft TMDL for Public Comment

July 12, 2021

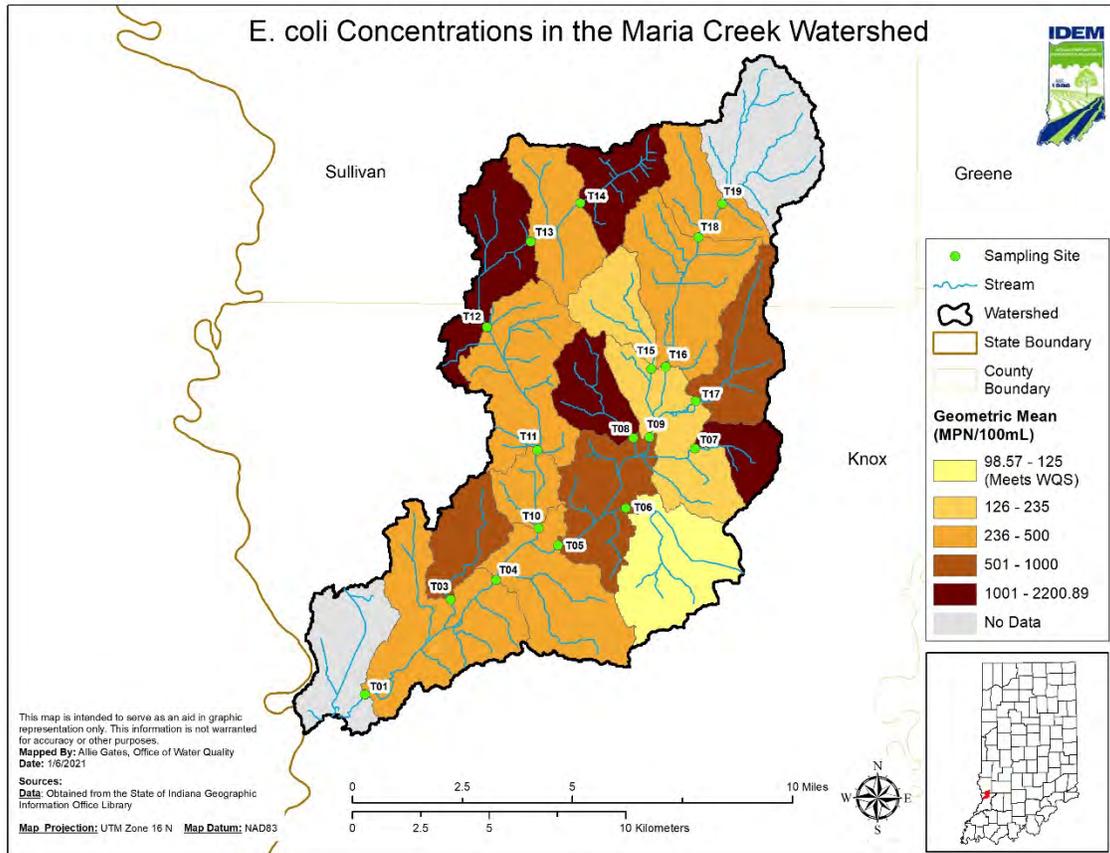
Figure 6: *E. coli* concentrations based on 5-week geometric mean (MPN/100 mL) and sampling site drainage areas for 2019 and 2020. Values over 125 MPN/100 mL are not meeting the water quality standard for *E. coli*.

- Reductions of 99 percent or greater are needed to meet the TMDL target values for *E. coli* in Cotton Branch.
- Reductions of 99 percent or greater are needed to meet the TMDL target values for *E. coli* in Tilley Ditch.
- Reductions of 99 percent or greater are needed to meet the TMDL target values for *E. coli* in Marsh Creek.
- Reductions of 90 percent or greater are needed to meet the TMDL target values for *E. coli* in Headwaters Maria Creek.

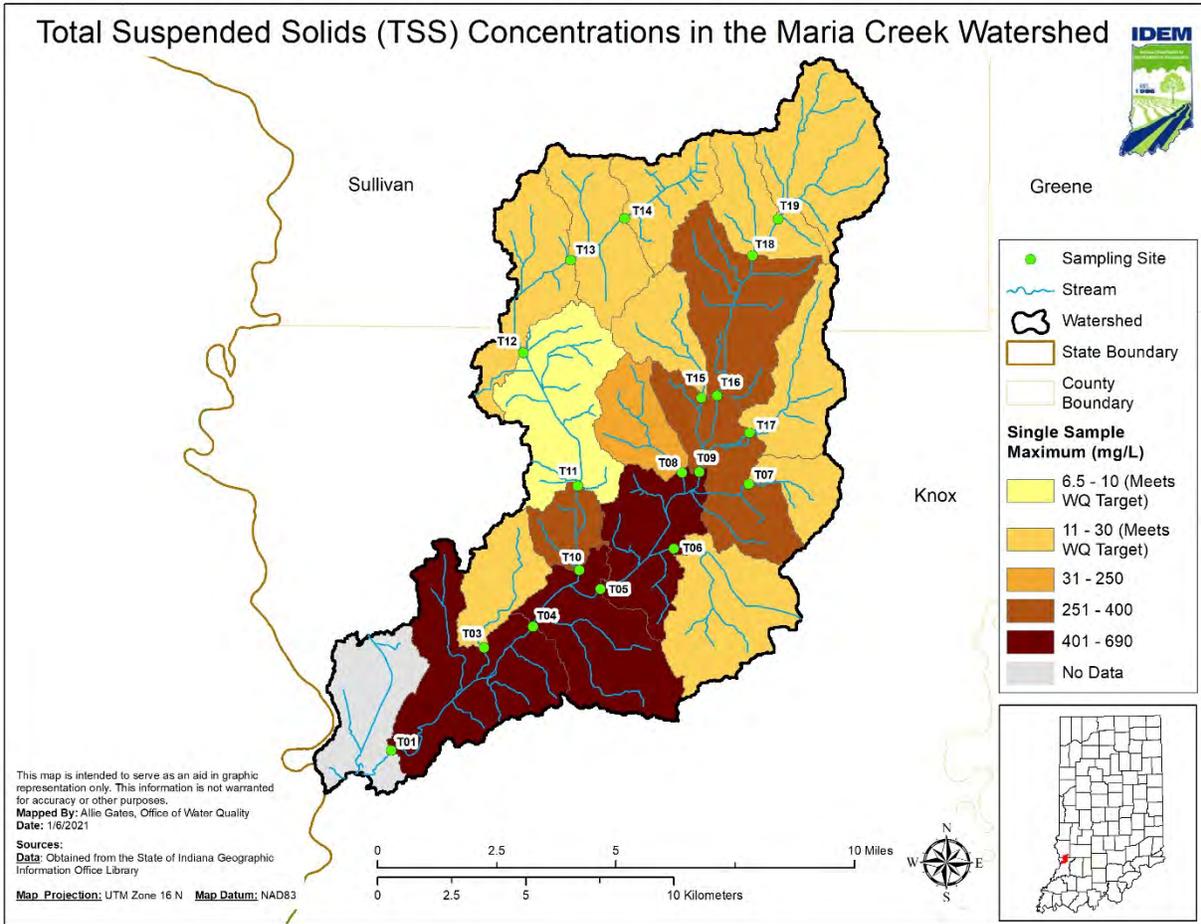
Figure 7: Total suspended solids concentrations based on single sample maximum concentration (mg/L) and sampling site drainage areas for 2019-2020. Values over 30 mg/L are not meeting the water quality target value for TSS.

- Reductions of 96 percent or greater are needed to meet the TMDL target values for TSS in Cotton Branch.
- Reductions of 93 percent or greater are needed to meet the TMDL target values for TSS in Tilley Ditch.
- Reductions of 92 percent or greater are needed to meet the TMDL target values for TSS in Marsh Creek.
- Reductions of 93 percent or greater are needed to meet the TMDL target values for TSS in Headwaters Maria Creek.

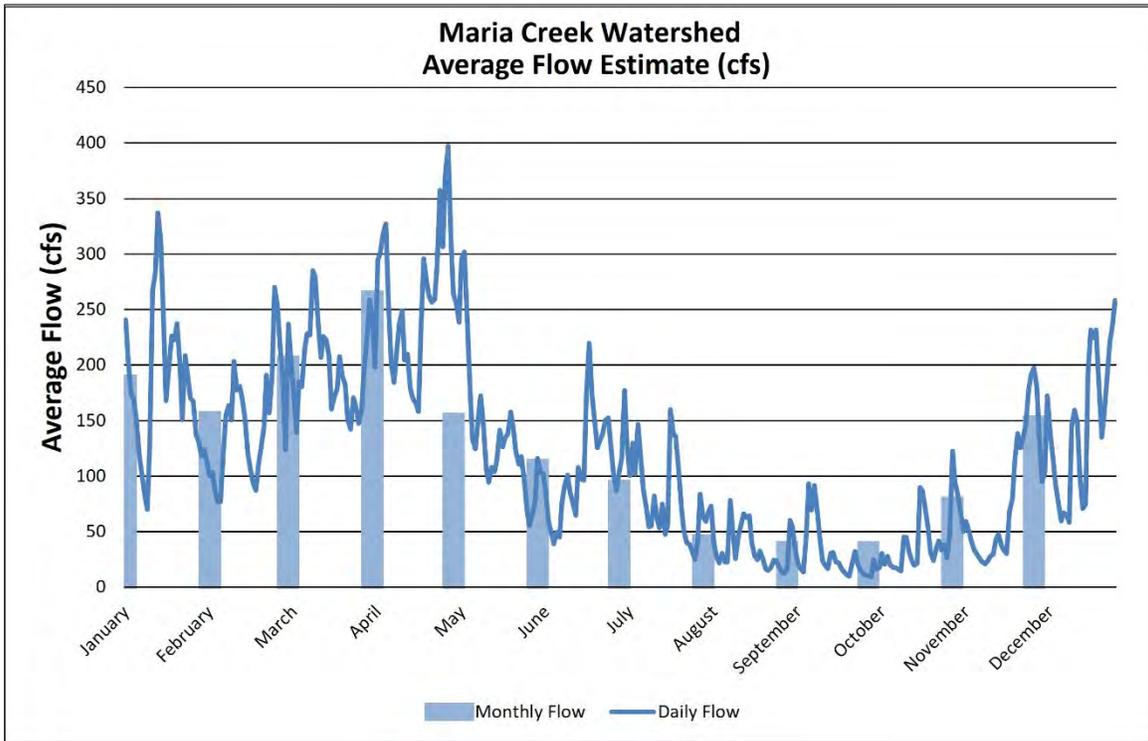
Figure 25: Average Daily Flow Estimate for the Maria Creek Watershed for data from 2011-2020

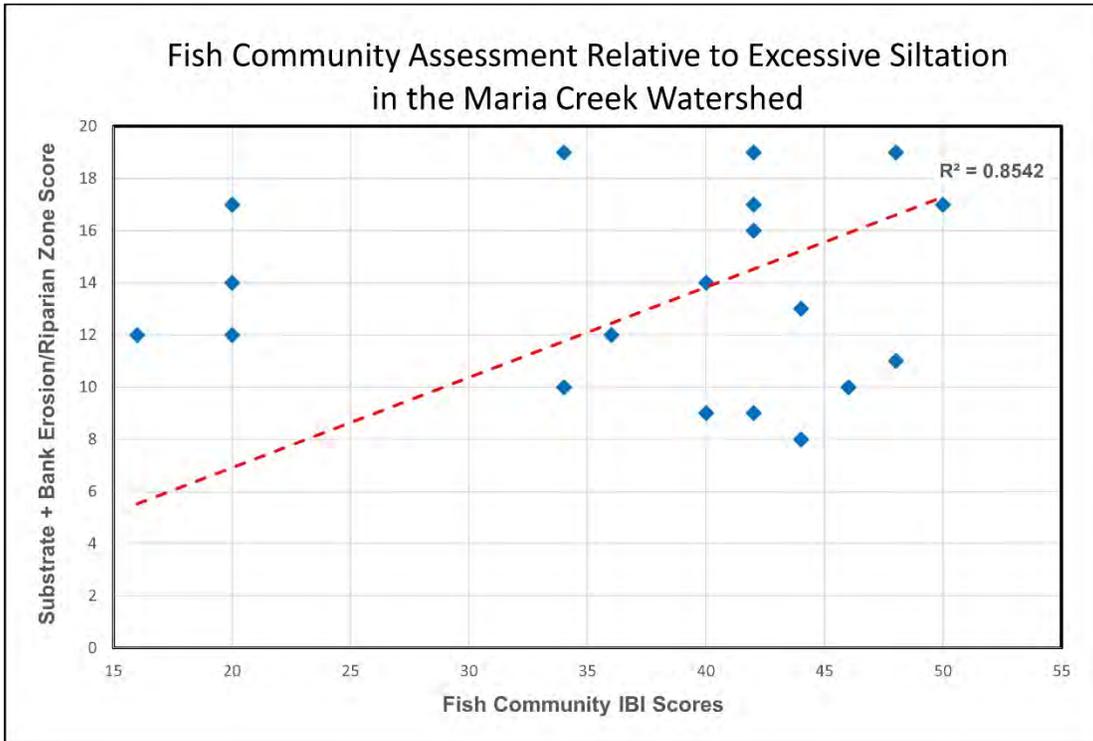
Figure 26: Substrate + Bank Erosion/Riparian Zone Score in Relation to Fish Community IBI Scores in the Maria Creek Watershed

Substrate and bank erosion/riparian zone metric scores were totaled and plotted against both fish community IBI scores and macroinvertebrate community mIBI scores (Figure 26 and Figure 27). Lower values for the substrate and bank erosion/riparian zone metrics indicate greater observed siltation within the stream and/or lower riparian and flood plain quality. Lower IBI and mIBI scores indicate fewer individuals and/or low species diversity was observed within a stream. The R^2 value for the fish community analysis was approximately 0.85, and the R^2 value for the macroinvertebrate community was approximately 0.88. These values indicate a strong positive correlation between excessive siltation and low IBI and mIBI scores. This analysis provides additional evidence that excessive siltation within a stream is linked to impaired biotic communities throughout the Maria Creek watershed in addition to elevated TSS monitoring data.

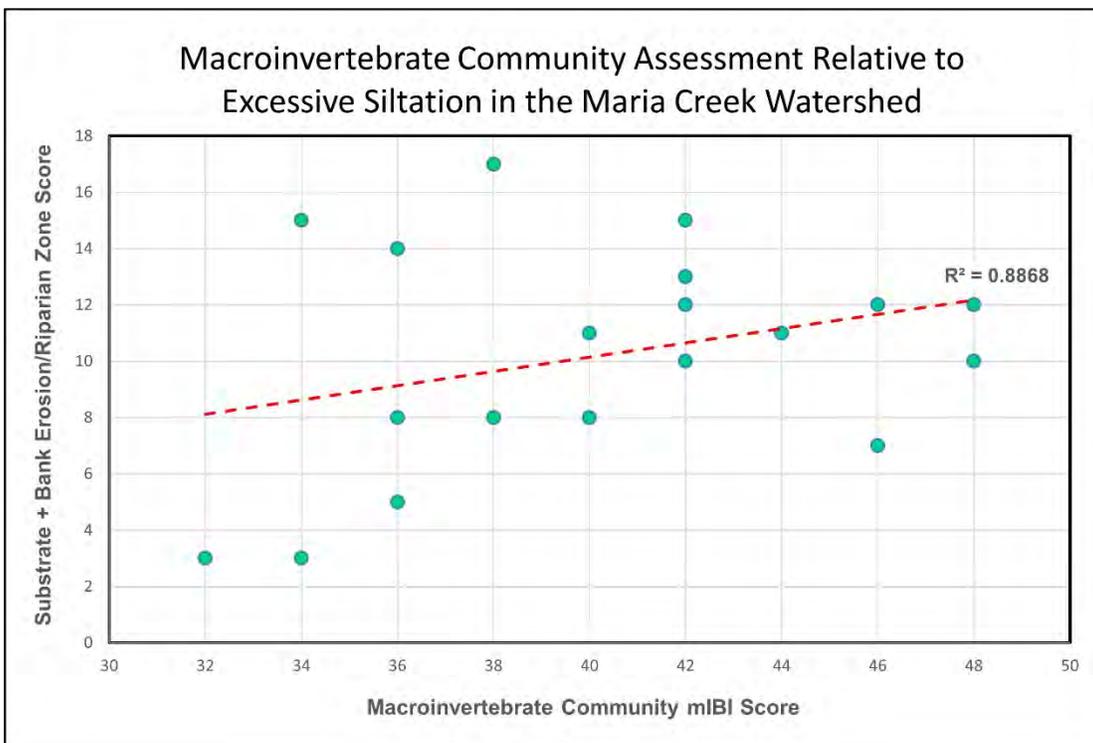
Figure 27: Substrate + Bank Erosion/Riparian Zone Score in Relation to Macroinvertebrate Community mIBI Scores in the Maria Creek Watershed

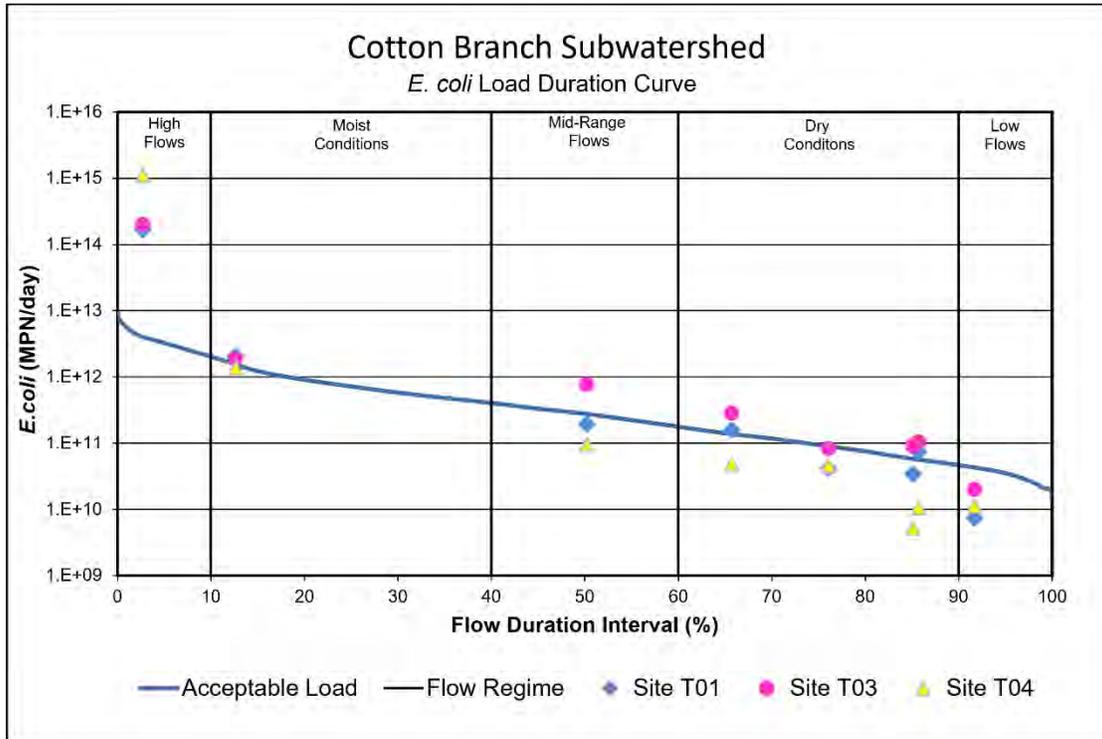
Figure 29: *E. coli* Load Duration Curve for Cotton Branch Subwatershed

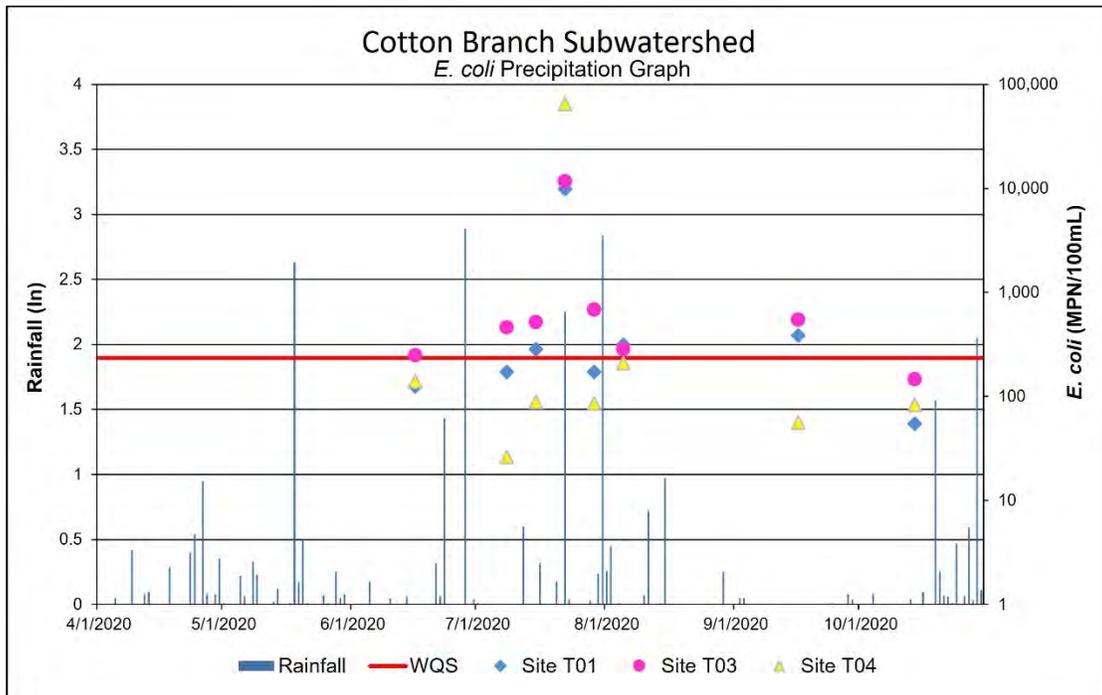
Figure 30: Graph of Precipitation and *E. coli* Data for Cotton Branch Subwatershed

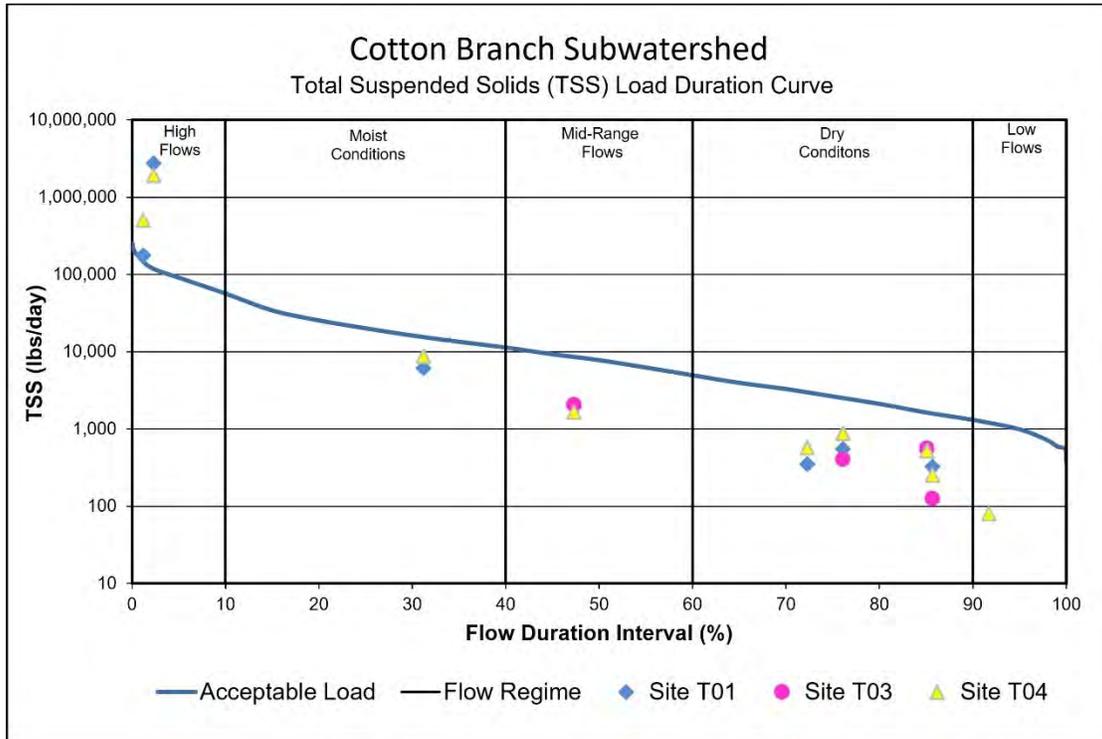
Figure 31: Total Suspended Solids (TSS) Load Duration Curve for Cotton Branch Subwatershed

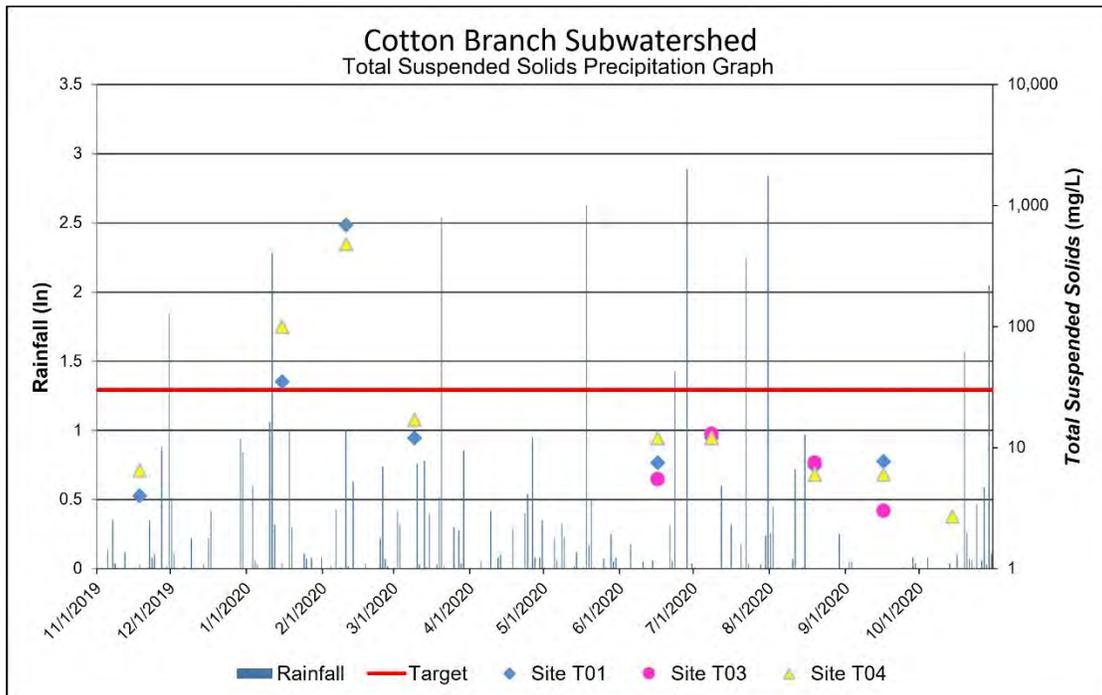
Figure 32: Graph of Precipitation and Total Suspended Solids (TSS) Data for Cotton Branch Subwatershed

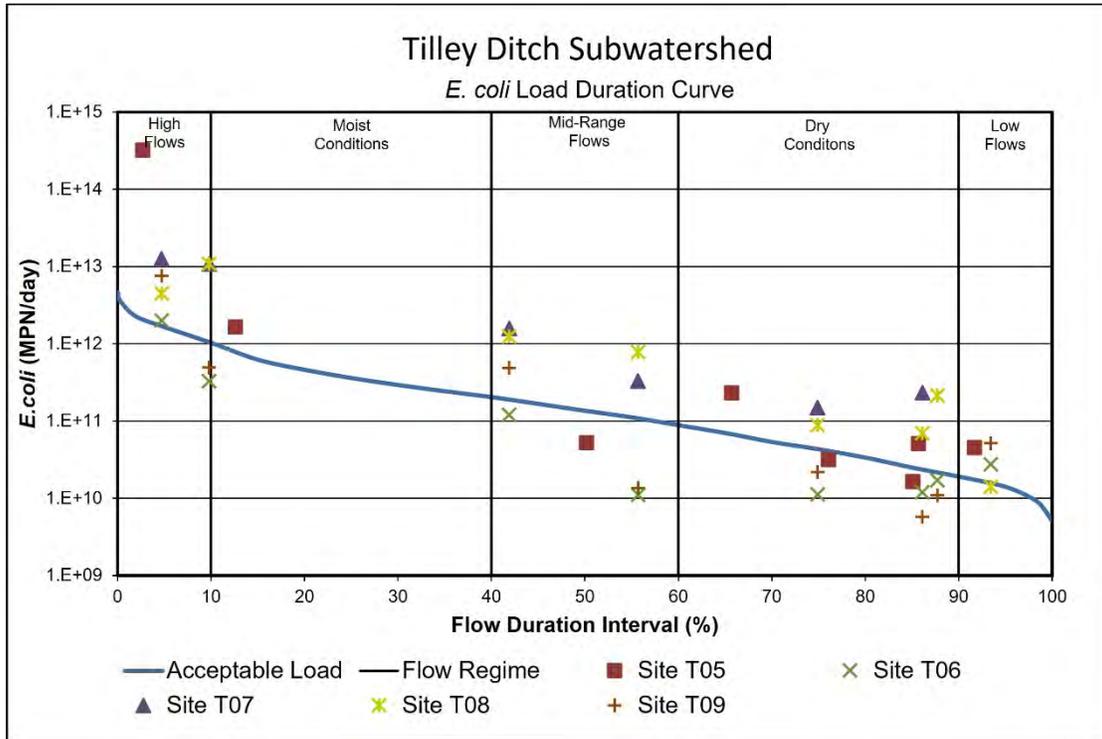
Figure 34: *E. coli* Load Duration Curve for Tilley Ditch Subwatershed

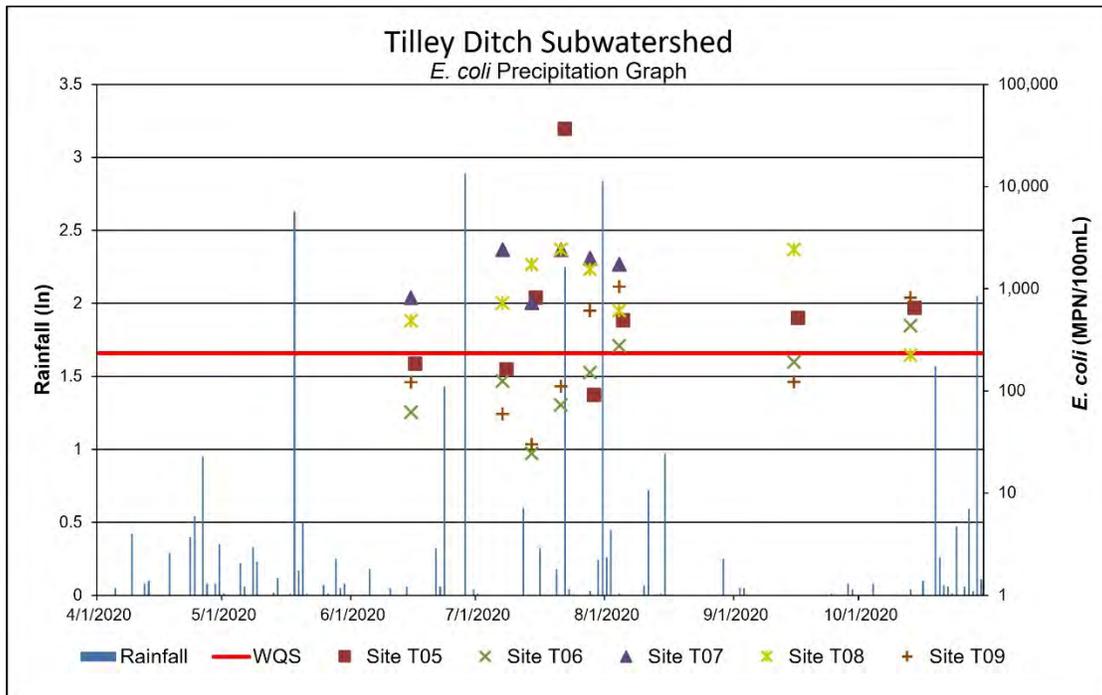
Figure 35: Graph of Precipitation and *E. coli* Data in Tilley Ditch Subwatershed

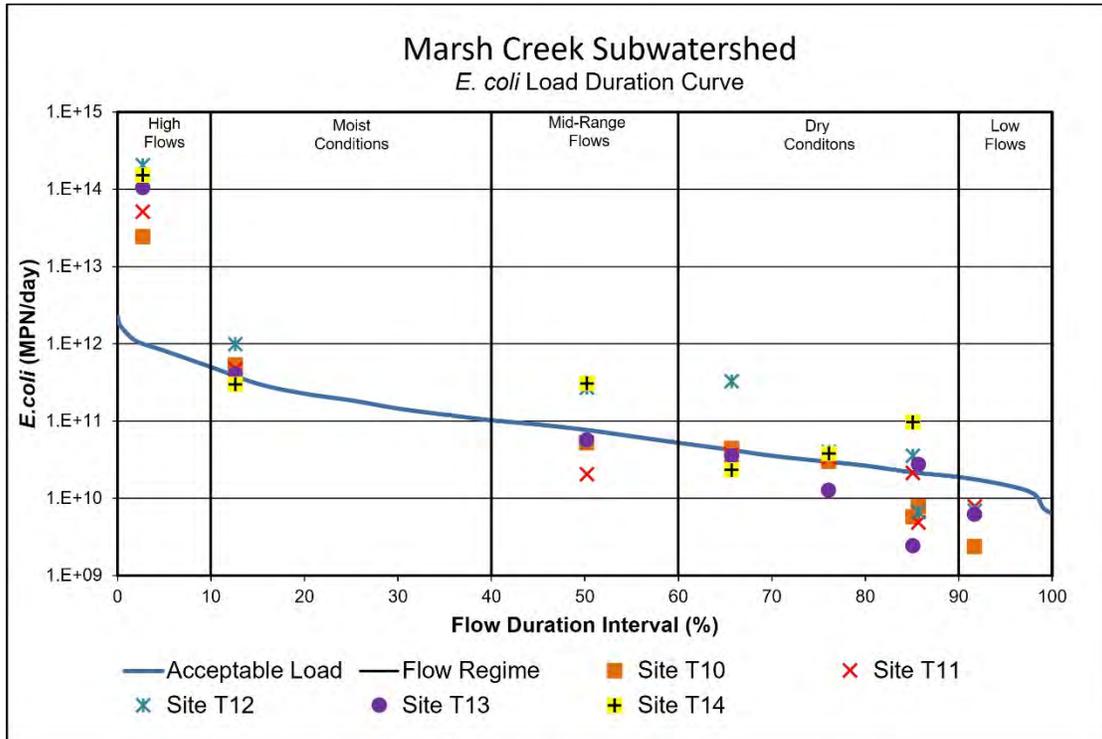
Figure 37: *E. coli* Load Duration Curve for Marsh Creek Subwatershed

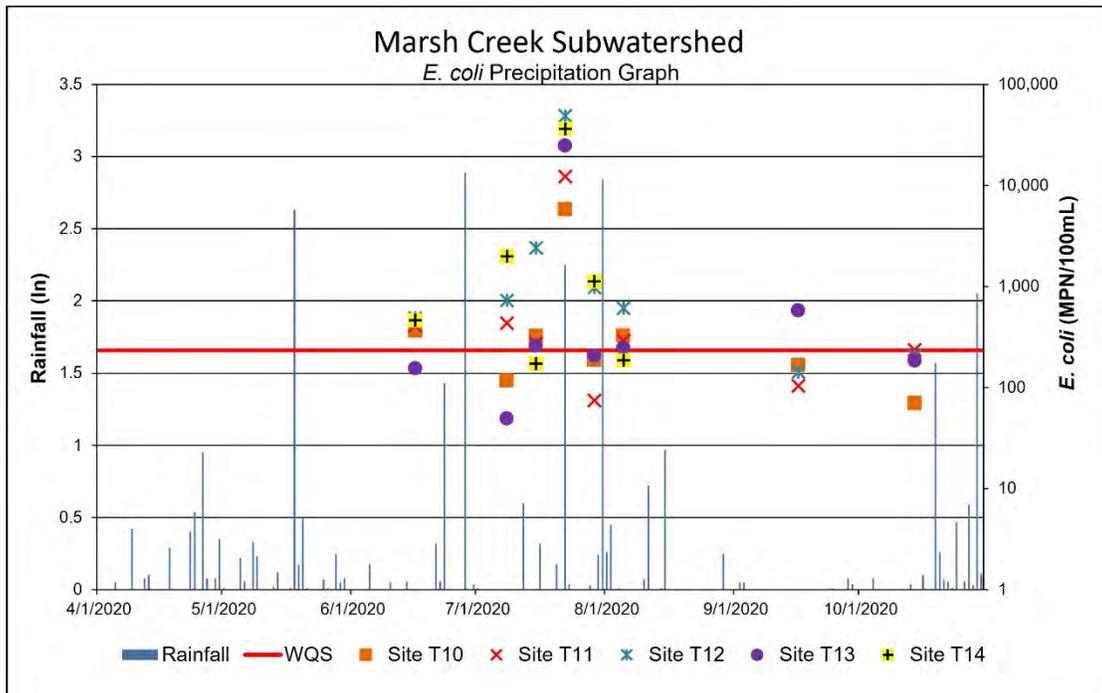
Figure 38: Graph of Precipitation and *E. coli* Data at Marsh Creek Subwatershed

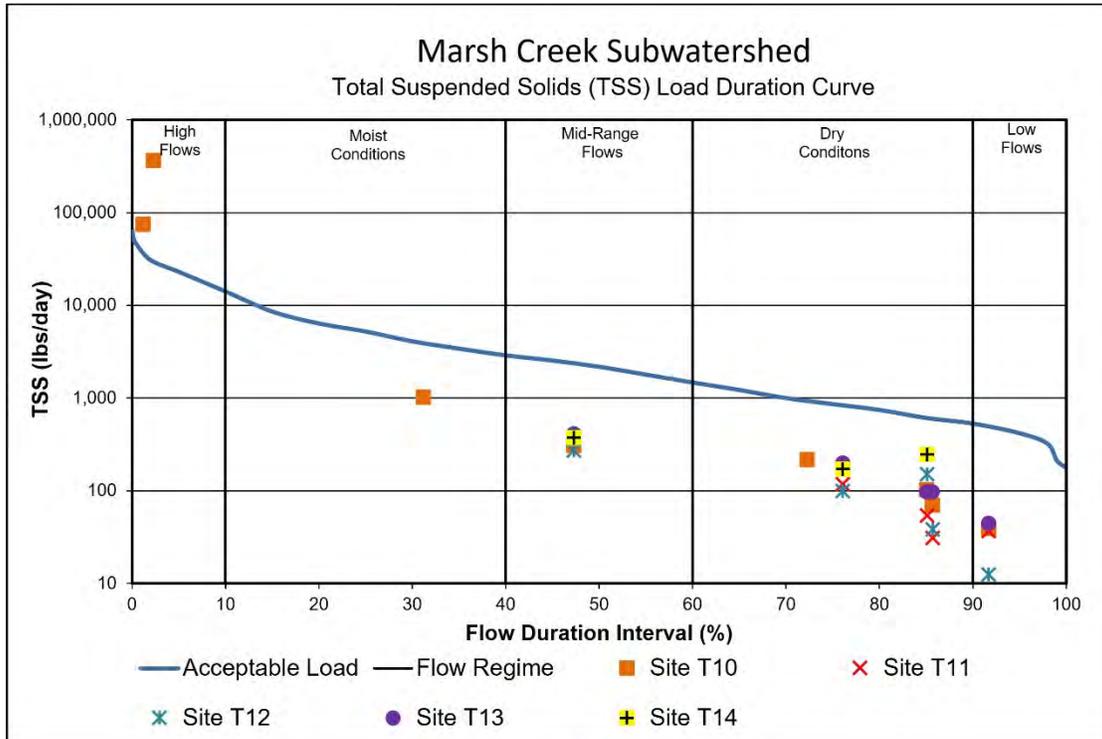
Figure 39: Total Suspended Solids (TSS) Load Duration Curve for Marsh Creek Subwatershed

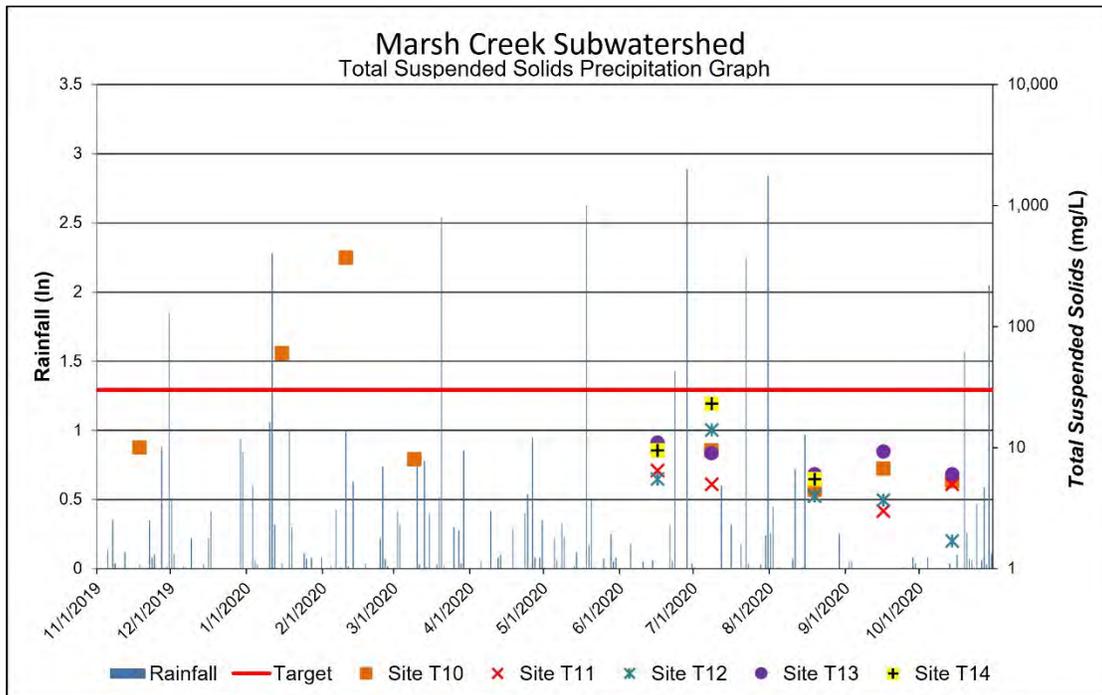
Figure 40: Graph of Precipitation and Total Suspended Solids (TSS) Data at Marsh Creek Subwatershed

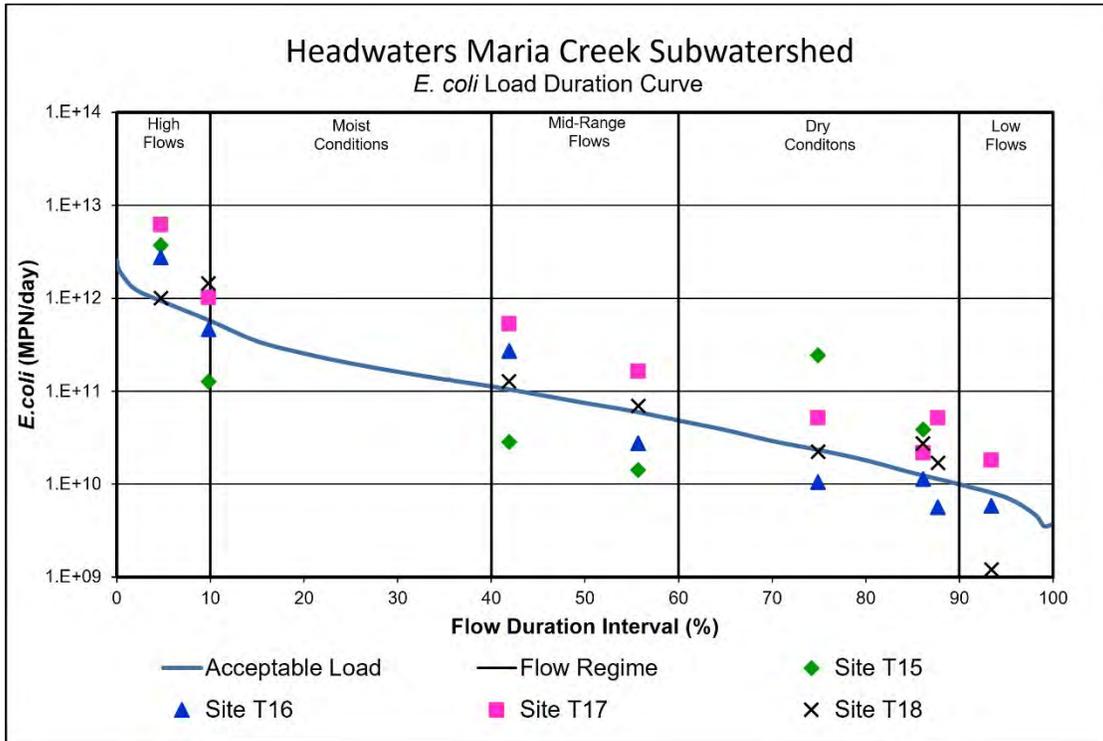
Figure 42: *E. coli* Load Duration Curve for Headwaters Maria Creek Subwatershed

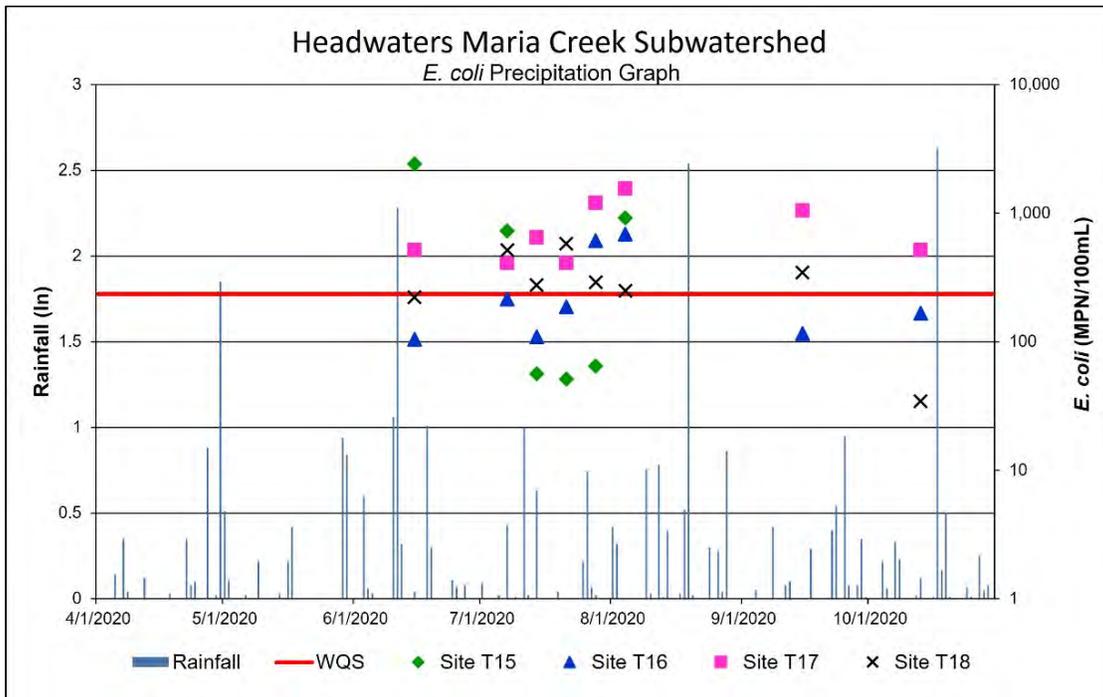
Figure 43: Graph of Precipitation and *E. coli* Data at Headwaters Maria Creek Subwatershed

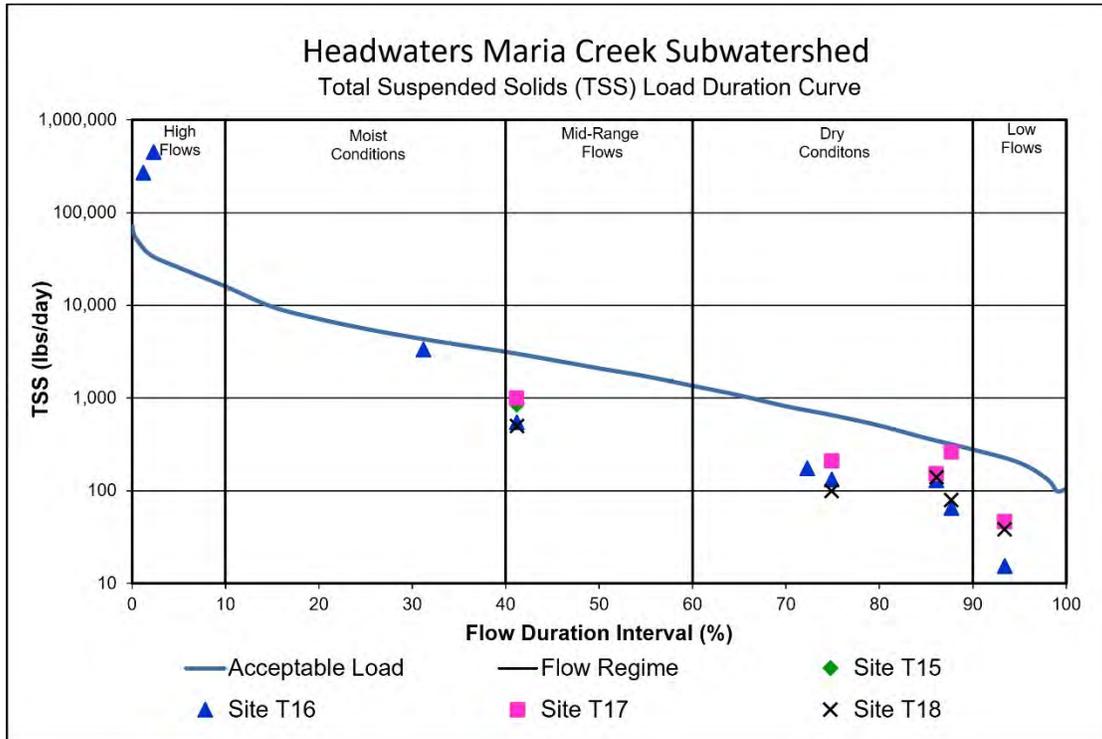
Figure 44: Total Suspended Solids (TSS) Load Duration Curve for Headwaters Maria Creek Subwatershed

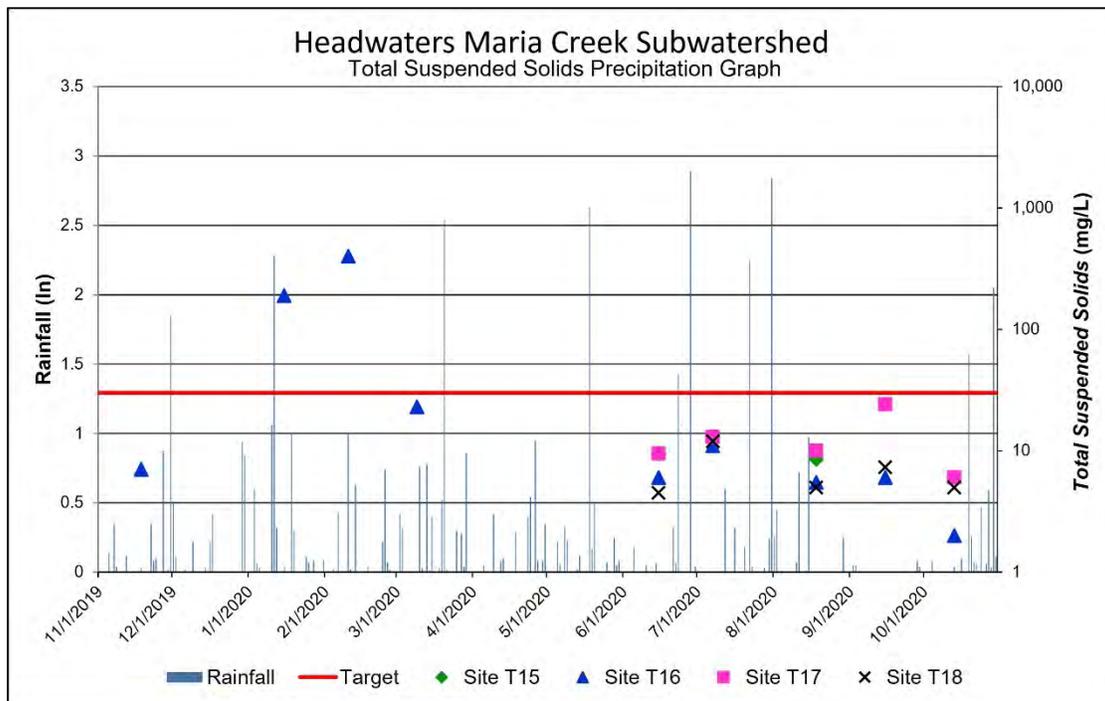
Figure 45: Graph of Precipitation and Total Suspended Solids (TSS) Data at Headwaters Maria Creek Subwatershed

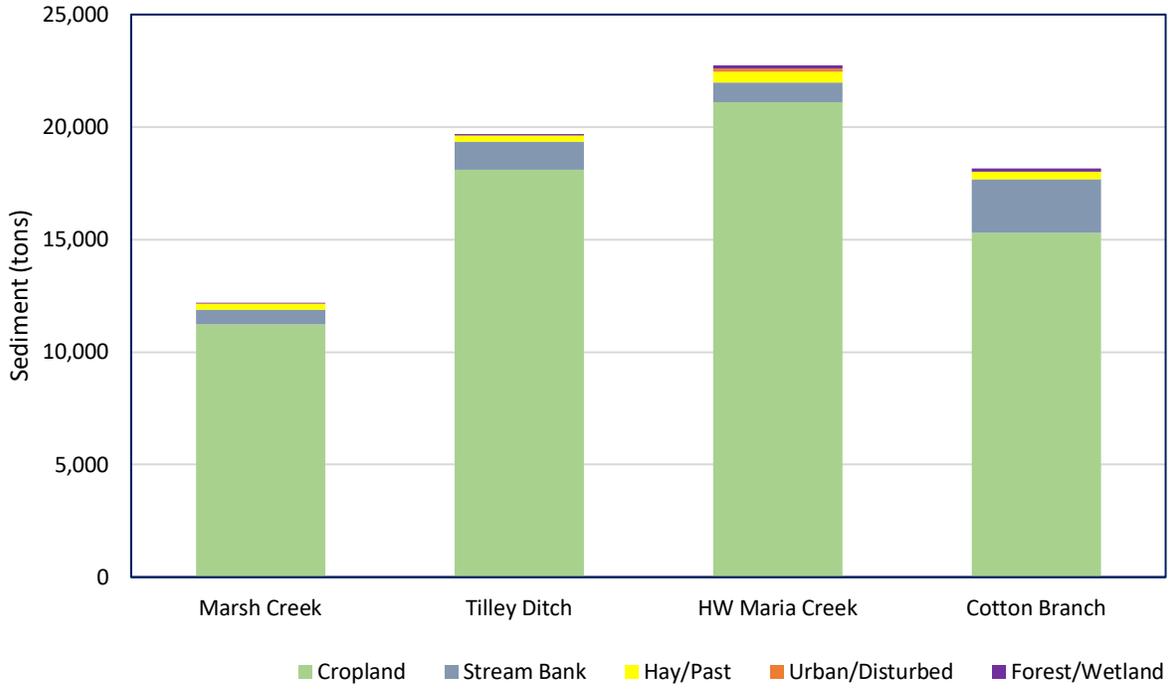
Figure 46: Average Annual Sediment Loading from Sources in the Maria Creek Subwatersheds

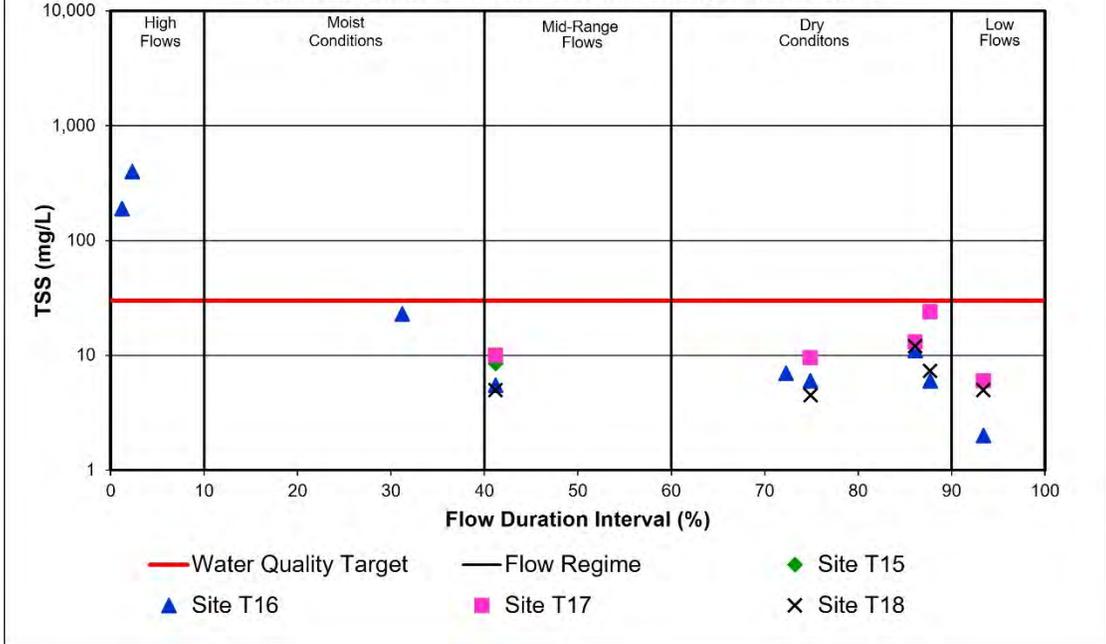
Headwaters Maria Creek Subwatershed Total Suspended Solids (TSS) Water Quality Duration Curve

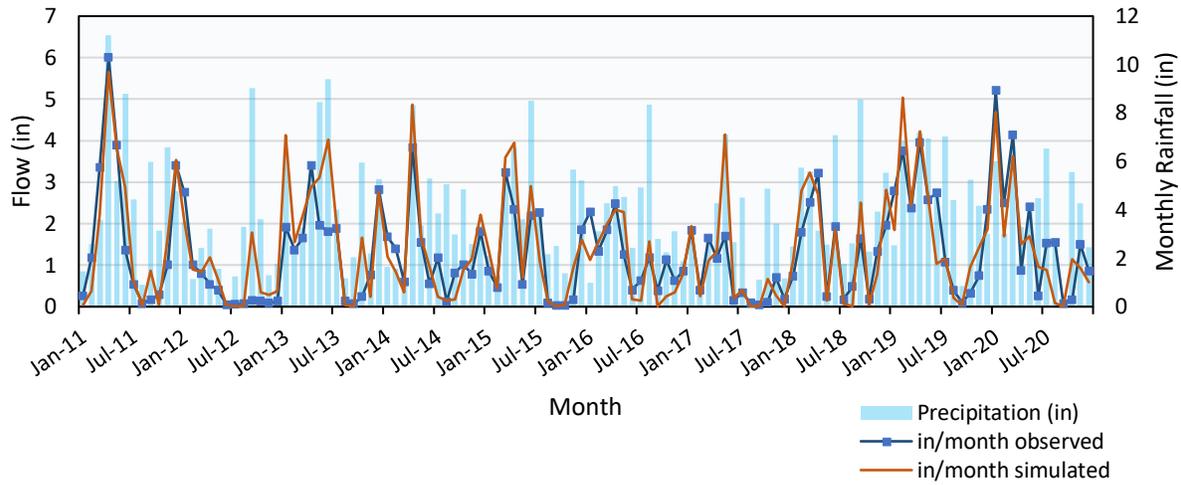
Figure 3. Time series hydrologic calibration results for Maria Creek Watershed (January 1, 2011 to December 2020)

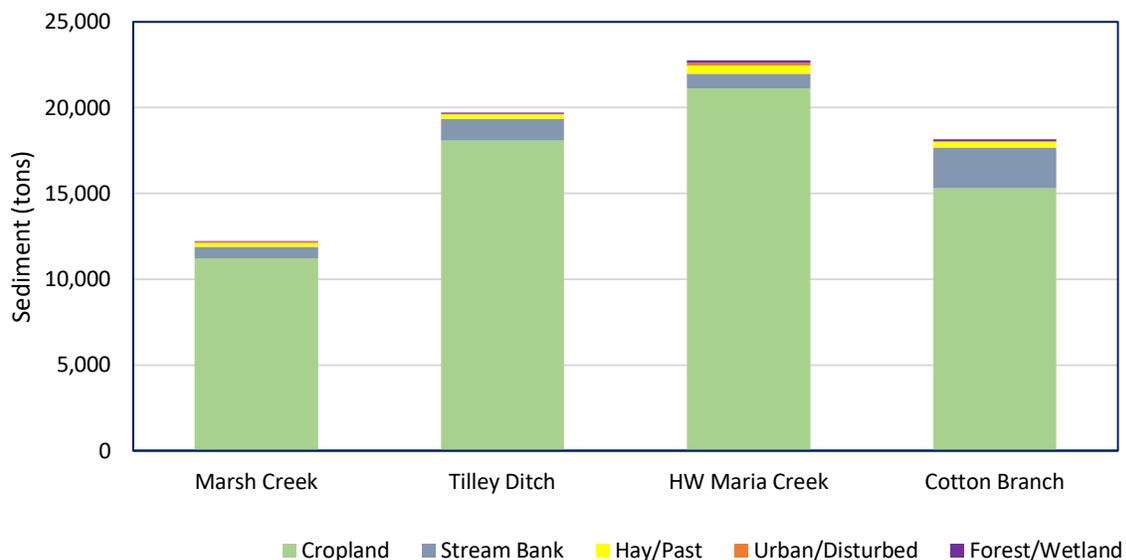
Figure 5. Modeled sediment loads (in tons) for the Maria Creek watershed from 2011 to 2020.
