# Baugo Creek Watershed Management

## *Plan—I Baugo Creek/Wisler Ditch Sub-watershed*

St. Joseph and Elkhart Counties, Indiana

June 2004

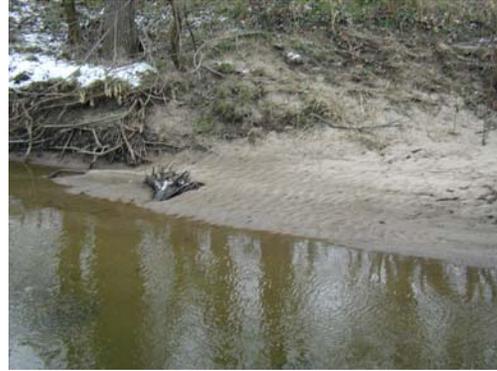
Soils in the northern portion of the Watershed characteristically have higher potential for erosion and sloughing. Evidence of erosion is present even in locations surrounded by forested land.

In addition, in some areas the banks have steep slopes, which further reduces the stability of the overall waterway.

Erosion of banks associated with natural meander of Baugo Creek

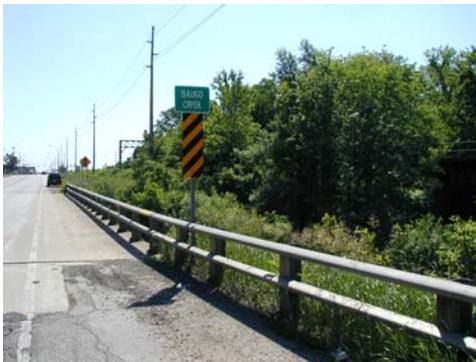
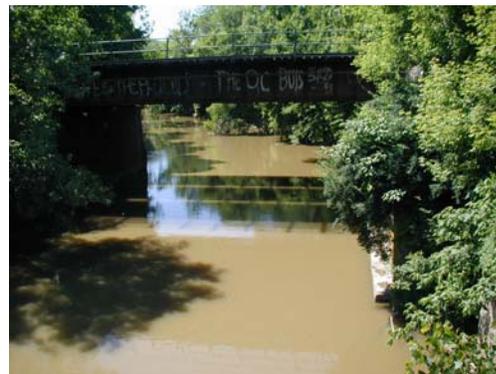
One of the leading concerns citizens expressed about the Watershed was sediment coming through the system depositing and causing flow restrictions or depositing at the discharge of Baugo Creek into the St. Joseph River.

Baugo Creek at the Lincolnway East Bridge after a 2.5-inch rain

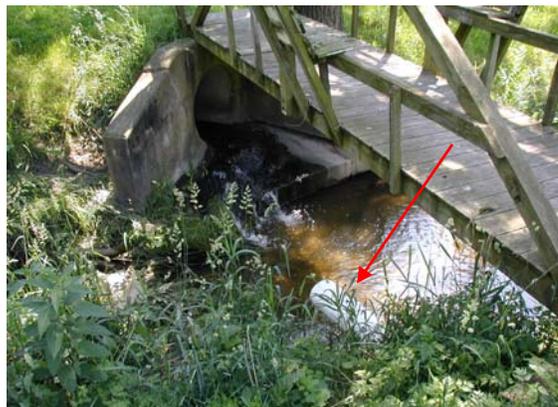
- Illicit discharges. The Town of Wakarusa has identified 99 tiles or pipes that enter the Wertz Ditch which discharges to the Wisler Ditch. A one-time sampling identified 24 sites over the *E. coli* standard. In all 45 tiles were discharging at the time of the Wakarusa study ranging in *E. coli* levels of <1 to 14,100 colonies per 100 ml. Source of the pipes and continual discharges have not been identified to date.

Discharge pipe with unknown source to Wertz Ditch

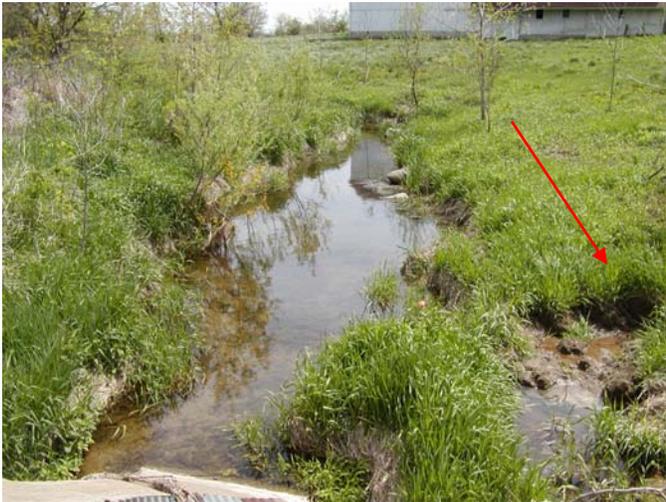
- Identification of other illicit discharges in the Baugo-Wisler Ditch Watershed. 14 of 34 sites within the sub-watershed inventory had tiles noted. Once again it is important to note that the observations were made at stream-crossings and may not represent all discharges to the neighboring waterbodies.

Tile from sheep pasture area

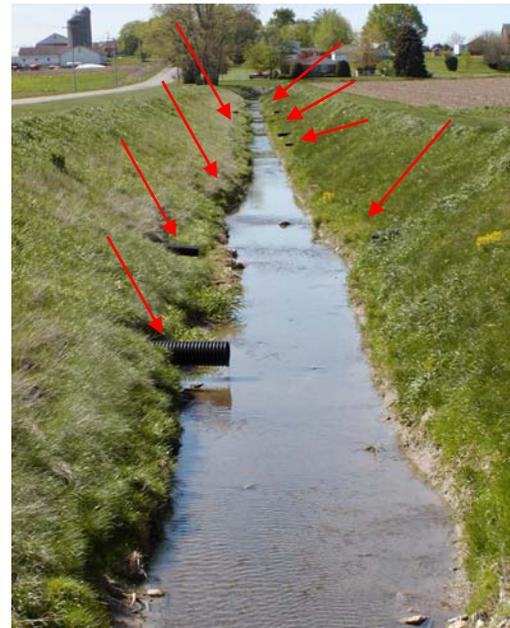
Field tiling along newly constructed ditch

Historically, soil types and landuse dictate where some tiling may be installed specifically for lowering seasonal high water tables or discharges from sump-drains associated with building footing drains. Tiling in itself does not result in elevated levels of *E. coli*. However, it may serve as a conduit in areas where manure is applied or connections are made to onsite wastewater systems. Further water quality analysis, may link potential sources of *E. coli* with some of these discharges.

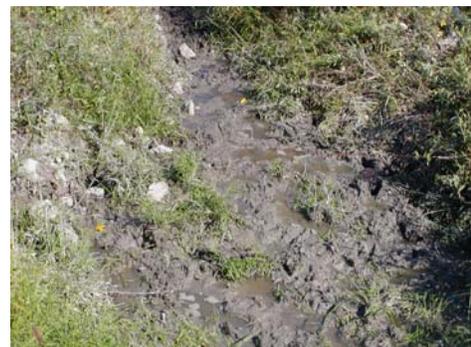
- Livestock access to the neighboring waterway, discharge of livestock operations wastes or livestock fenced to top of banks. There was at least one large livestock operation observed on the west side of Wakarusa where livestock had access to the waterway. Several smaller operations in the overall watershed were also observed. Three other operations observed had livestock fenced to the top of the bank, with no filter strips or buffers to control runoff.

Livestock prints in ditch going through pasture

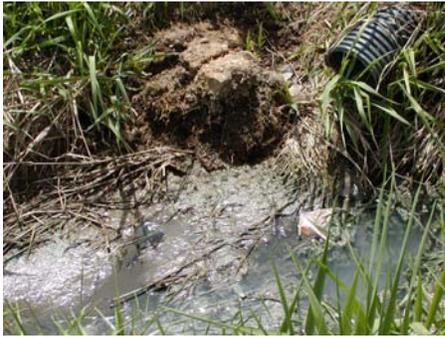
Discharge pipe from barnyard area

Additionally, tiling in at least three locations in the sub-watershed were discharging material other than groundwater.

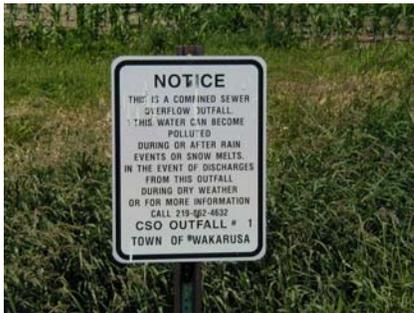
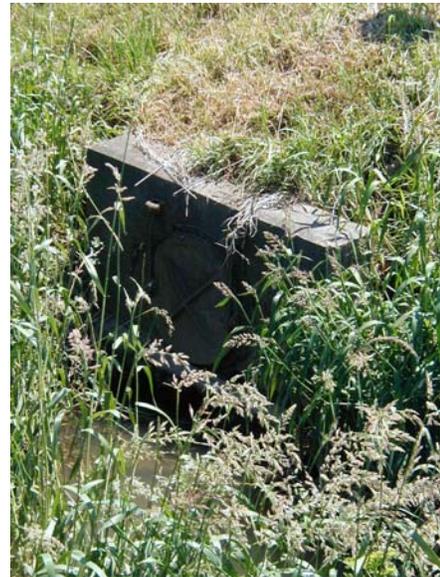
- Combined Sewer Overflows and illicit discharges. The Town of Wakarusa has six combined sewer overflows that discharge to Wertz Ditch eventually discharging to the Wisler Ditch. Only one consistently discharges, and the Town has currently submitted its Long Term Control Plan (June 2004) to the Indiana Department of Environmental Management.

Combined Sewer Overflow

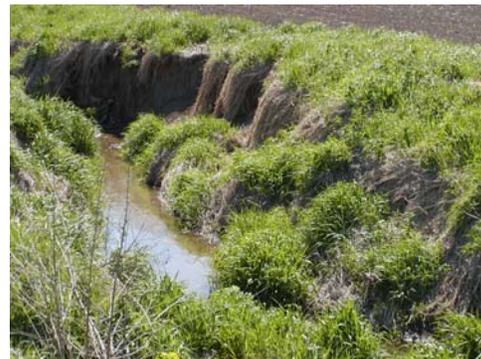
- Bank erosion and lack of stream buffers. Erosion was observed at seventeen stream-crossing sites evaluated in the Wisler Ditch portion of the Watershed. Erosion in a portion of the watershed is a function of steep banks and soils in some portion of this watershed. As a result complete elimination of erosion may not be possible. Stabilization and decreased deterioration through buffering may reduce increased breakdown of banks, since actual rehabilitation or restoration is difficult.

Sloughing banks

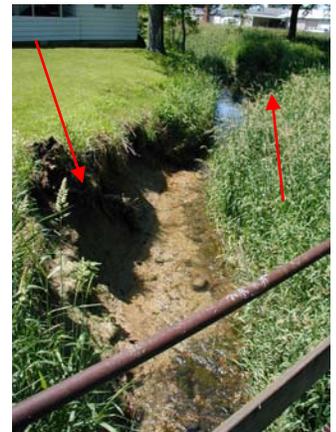
Patches of erosion in the watershed as small as this picture are seen throughout the watershed and contribute a cumulative amount of sediment.

$$15 \text{ ft. x 2 ft. x 0.5 ft. x .04} = \mathbf{0.6 \text{ tons of sediment}}$$

Erosion and bank sloughing along Wertz Ditch

**Multiply these two examples by numerous reaches throughout the watershed and it is safe to say that hundreds of tons of sediment regularly move through the system, increasing after high-energy storm events occur.**
