APPENDIX D

***SANITARY SURVEY INSPECTION
SHEETS AND RESULTS***

Turkey Creek/Yellow Creek
Sanitary Survey Inspection Form

Yellow Creek Sanitary Survey – Yellow Creek (lower)
CR 28 to CR 13
July 25, 2003

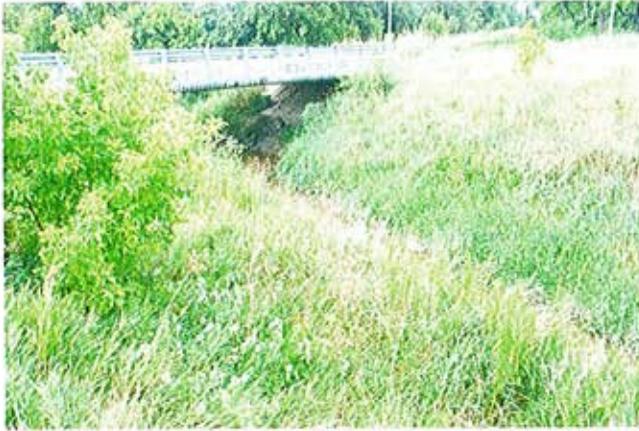
Type of Outfall / Pipe Material: CMP Size: 24"

Other Notes: Might be diversion since it's just downstream of the bridge

STR 001, 24" CMP @ CR 28

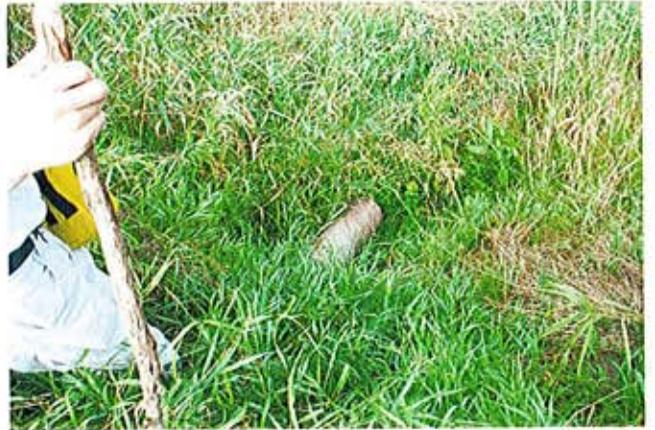
Type of Outfall / Pipe Material: Clay Size: 10"

DT 002, 10" Clay

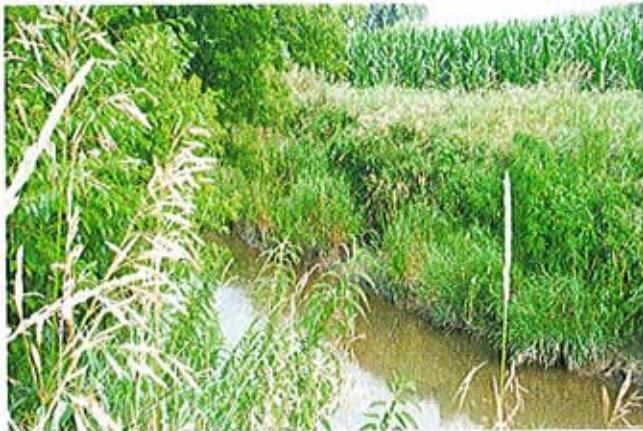
Vegetation Conditions: (excessive growth, inhibited growth)
Description: normal erosion due to drainage

Type of Outfall / Pipe Material: Clay Size: 12"

Other Notes: corn field behind drainage tile

DT 003, 12" Clay

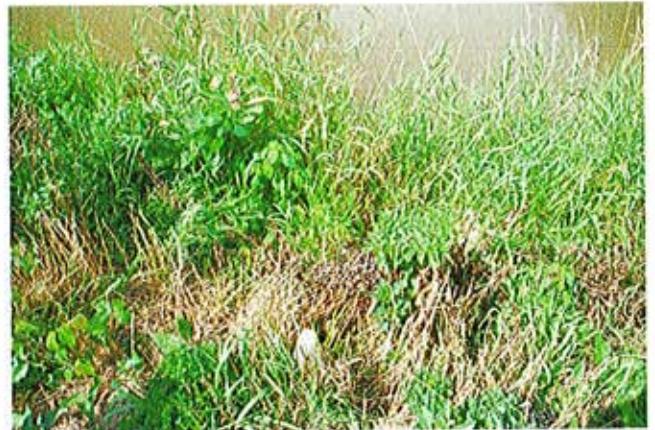
Type of Outfall / Pipe Material: PVC Size: 2"

Other Notes: Could be sump pump outfall

DT 006, 2" PVC

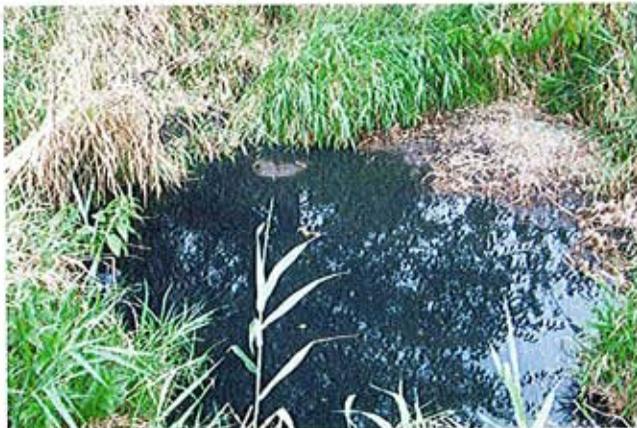
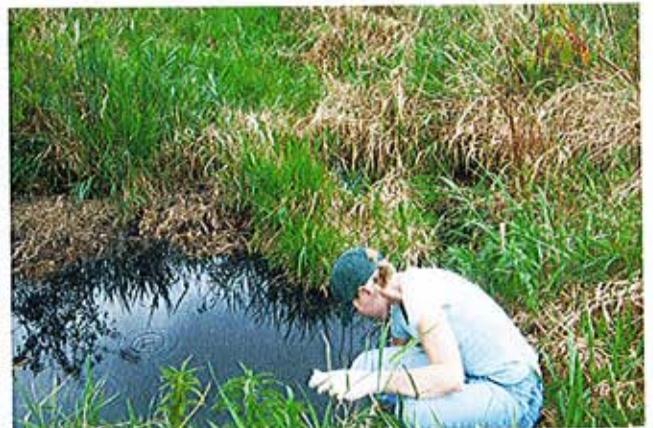
EIS Lab Number	Client Description	Sample Date	Parameter	Result	Units	RDL	Test Date	Analyst ID	Method
083395	STR 007	7/17/02	Coliform,E.Coli	41,000	col/100ml	1	7/17/02	E25	40CFR141
083396	DT 009	7/17/02	Coliform,E.Coli	8,600	col/100ml	1	7/17/02	E25	40CFR141
083397	DT 010	7/17/02	Coliform,E.Coli	1,000	col/100ml	1	7/17/02	E25	40CFR141
083631	YC Trib	7/25/02	Coliform,E.Coli	780,000	col/100ml	1	7/25/02	E25	40CFR141

Yellow Creek – Tributary CR 126 Ditch, E. Coli = 780,000 cfs/100 mls.
