2014 Pigeon Creek Watershed Management Plan

Steuben, LaGrange, DeKalb & Noble Counties
Indiana

Prepared By: Northwater Consulting

Prepared For: Steuben County Soil
and Water
Conservation District

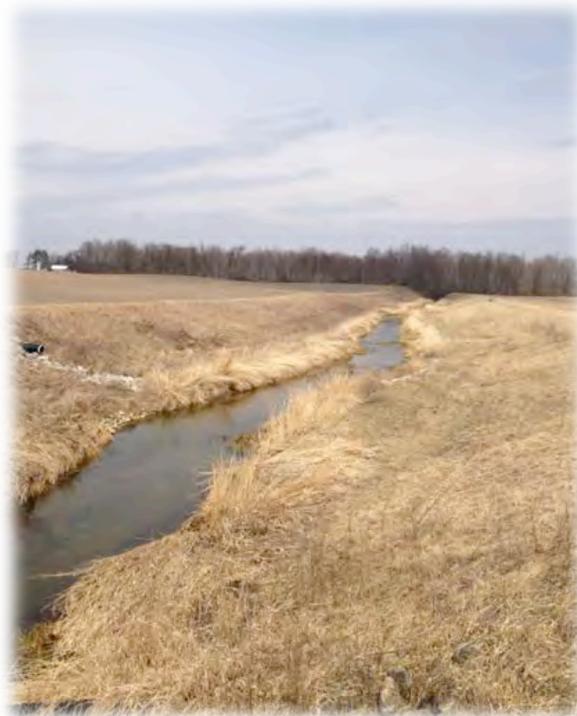
Two-Stage Ditch; Pigeon Creek Watershed

One of the plan's best management practices, for example, is the two-stage ditch that benefits both agriculture and the environment. The design of the two-stage ditch mirrors the natural processes of stable streams to reduce erosion, sediment and nutrients runoff, and flooding that conventional ditches can cause. The floodplain that runs alongside the ditch allows the water to have more area to spread out. This decreases the velocity of the flow while increasing the volume of water the ditch can process - improving drainage, water quality, and habitat and agricultural conditions.

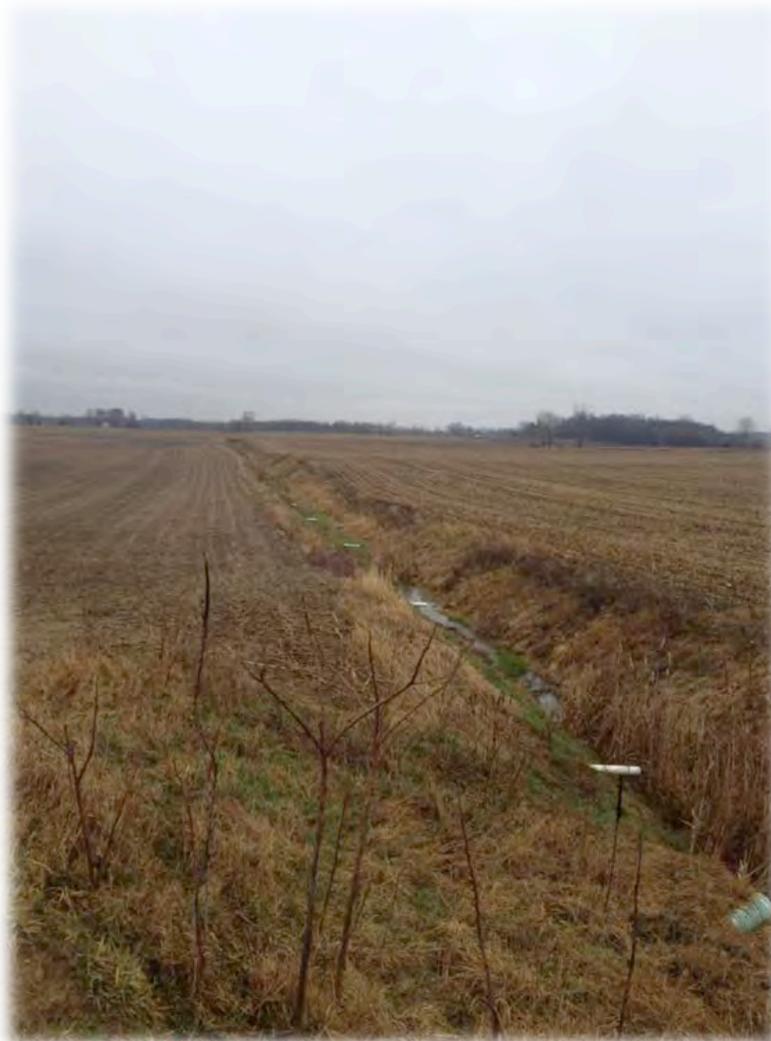
Drainage Ditch; Upper Pigeon Creek Watershed

Like most agricultural watersheds throughout the Midwest, the hydrology of Pigeon Creek has been altered to accommodate for urban development and agricultural production. Natural waterways have been modified or channelized, extensive underground tile systems installed and natural wetlands converted or impacted to improve drainage. Recent drought conditions and local soil conditions have also led to an increase in irrigation systems on agricultural land. Table 9 lists the extent of hydrologic modifications by subwatershed, length of channelized streams, length of known drainage tile lines, area of legal ditches, and the area of irrigated crop ground. It should be noted that legal ditches were available in a rough format and were modified or adjusted for the creation of a custom watershed landuse/landcover layer. As a result, only the total area is provided and the locations presented in Figures 5 and 6 may not represent the true extent of all legal ditches in the watershed. Figures provided for length of drainage tiles include only known/mapped lines, which greatly underestimates the total length of drainage tiles in the watershed.

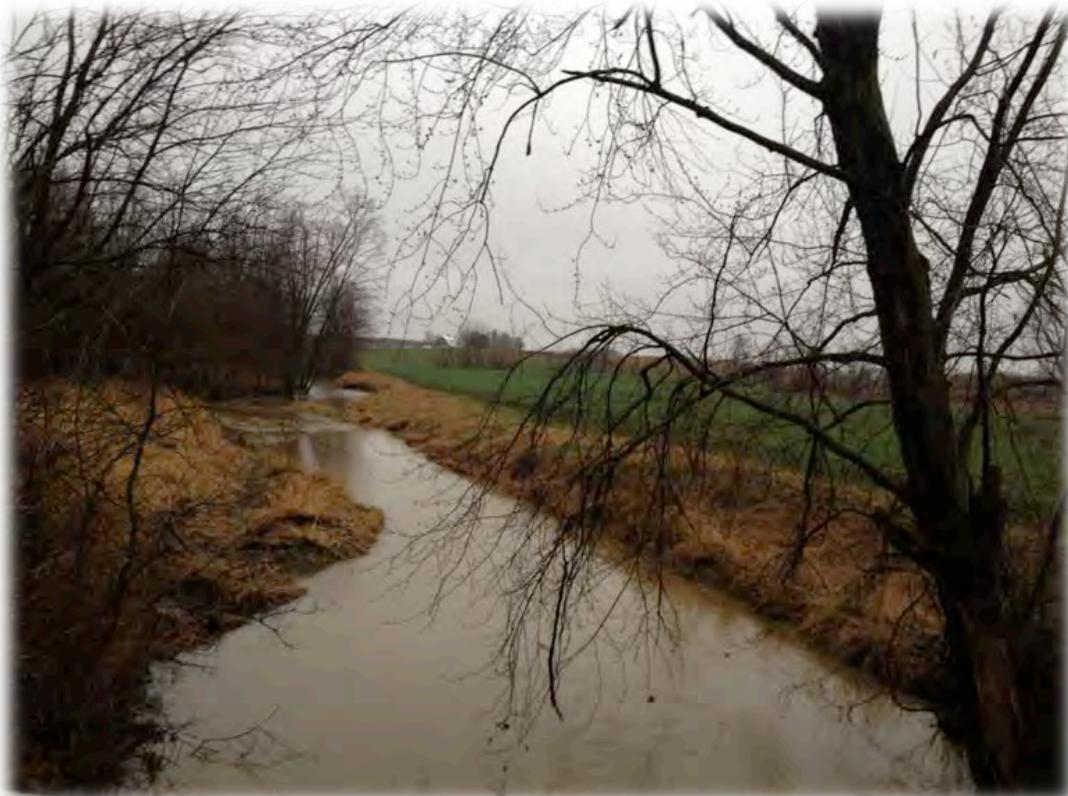
In 2011, the IDNR, Office of Water published maps showing unconsolidated aquifer systems throughout the state. The maps, with accompanying text and tables, describe characteristics such as geologic materials, thickness of confining units, aquifer thickness, static water levels, well yield, typical well depths, and depth to the aquifer resource. According to the maps, there are three unique unconsolidated aquifer systems in the watershed: the Howe Outwash, Kendallville, and Natural Lakes and Moraines system. The Kendallville system covers 104,115 acres, or 76% of the watershed; the Howe Outwash system includes 31,079 acres, or 23%; and Natural Lakes and Moraines covers the remaining 1%, or 622 acres. Figure 11 shows the location on these unconsolidated aquifers in Pigeon Creek.

The Howe Outwash System consists of surficial outwash sand and gravel up to 145 feet thick overlying till with interbeds of sand and gravel. Aquifer thickness in the Howe Outwash system sand and gravel ranges from 15 – 50 feet; interbed sand and gravel typically 5 – 25 feet thick. Water yield can range from 10 gallons per minute to 1,200 gallons per minute in high-capacity wells. The Kendallville system consists of isolated near-surface sand and gravel, but mostly deeper interbed sand and gravel at various depths. In this system, aquifer depth ranges from 3 – 95 feet and commonly 5 – 20 feet. Aquifer yield ranges from 10 to 1400 gallons per minute for high-capacity wells. The Natural Lakes and Moraines system includes near surface sand and gravel, and deeper interbed sand and gravel. Near- surface depths range from 10 – 50 feet with deeper interbed depths of 10 – 30 feet. Aquifer yield ranges from 25 to 2000 gallons per minute for high-capacity wells.

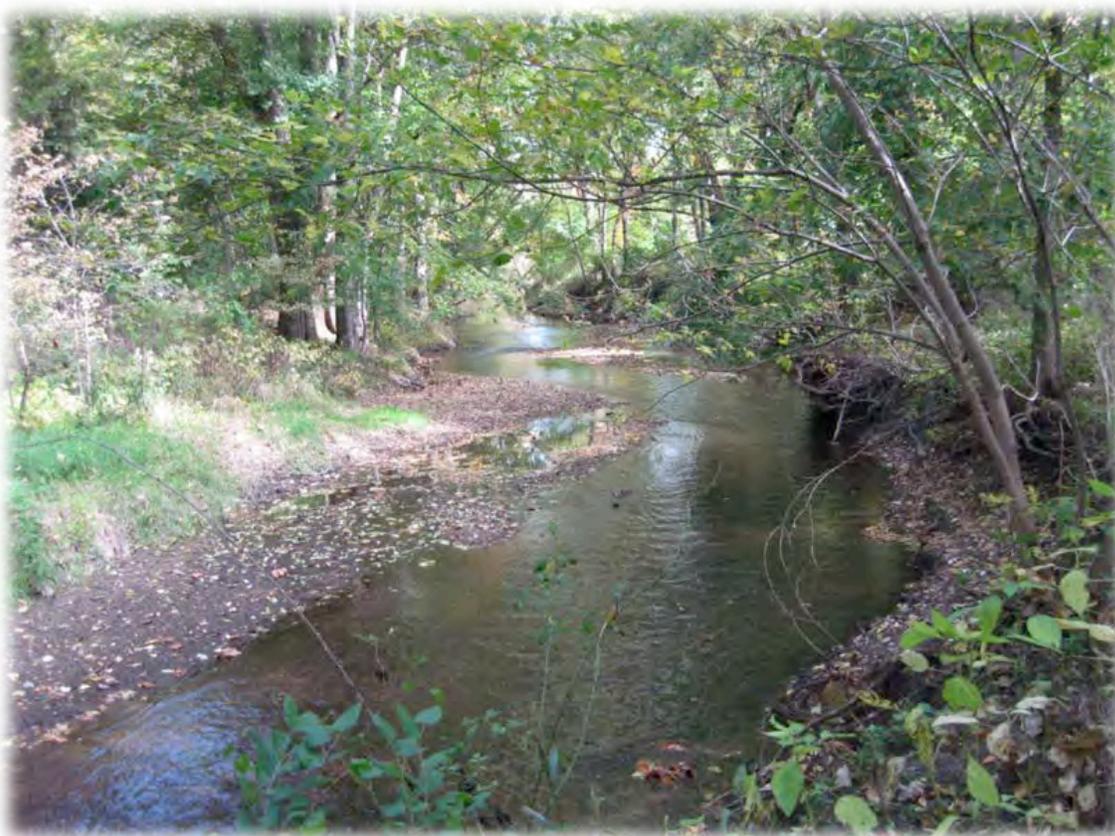
Water quality can be evaluated using biological indicators such as fish and macroinvertebrates. IDEM completed biological sampling in 2005 for Turkey Creek, and in 2010 for Pigeon Creek. A total of 3 sites were sampled for fish and 5 for macroinvertebrates. Table 37 lists the results of these samples in terms of their Index of Biological Integrity (IBI) and macroinvertebrate Index of Biological Integrity (mIBI) scores. Fish quality scores range from poor to good and macroinvertebrate scores from slight to moderately impaired. Figure 34 shows biological sample sites and the corresponding index scores.

Stream Name	Station Code	IBI	mIBI	Rating
Turkey Creek	LMJ110-0080	36	N/A	Fair (35-44)
Pigeon Creek	LMJ110-0003	34	N/A	Poor (23-34)
Pigeon Creek	LMJ110-0128	46	N/A	Good (45-52)
Pigeon Creek	LMJ110-0001	N/A	4.6	Slightly Impaired (4-6)
Pigeon Creek	LMJ110-0026	N/A	3.4	Moderately Impaired (2-4)
Turkey Creek	LMJ110-0027	N/A	3.6	Moderately Impaired (2-4)
Pigeon Creek	LMJ110-0028	N/A	2.8	Moderately Impaired (2-4)
Turkey Creek	LMJ110-0025	N/A	2.2	Moderately Impaired (2-4)
