Watershed Performance Benchmarks

Current Water Quality Data

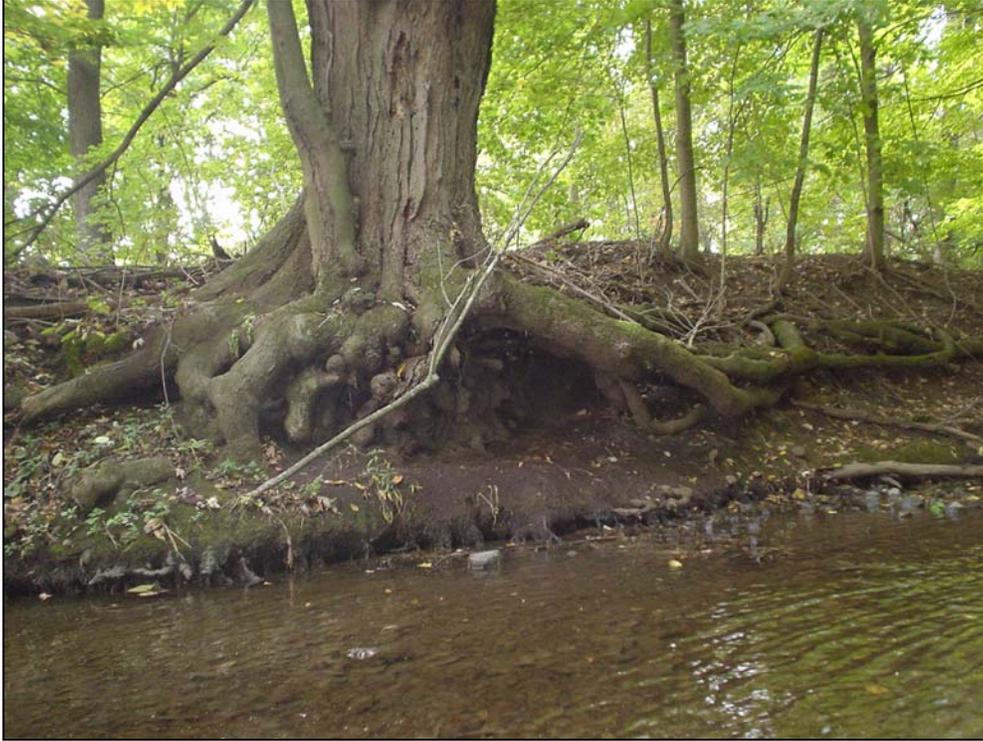
Figure 19: Eroded Channel Bank in Upper Watershed.

Steering Committee members Beth Williams (Steuben County SWCD), Chad Hoover (Steuben County GIS Coordinator), Greg Wolterstorff and Ed Belmonte (both of V3) toured the Pigeon Creek watershed by canoe on October 1, 2004. This vantage point allowed for the observation of the prevalence of instream erosion. The stream bank source of erosion along with agricultural land use runoff provide the two most significant contributors to the watershed's erosion problems.

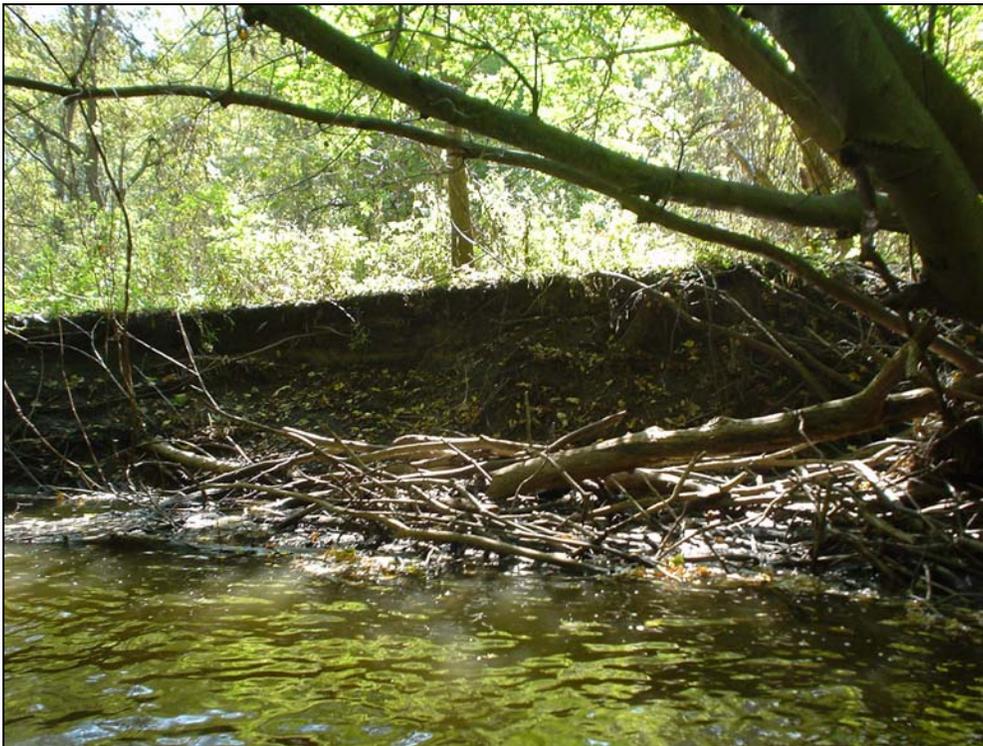
Figure 20: Eroded Channel Bank in Upper Watershed.
