Selecting Measures for Improvement

Multiple improvement measures have been identified for implementation in order to improve the Pigeon Creek Watershed. The measures are divided into items pertinent to each of the three subwatersheds, as well as a list of improvements practical for all of the subwatersheds. Each measure is presented with information detailing proposed location, historical background (if any), level of expected improvement, impacts created by implementation, construction feasibility, and a recommendation for course of further evaluation. Implementation sites were selected through Steering Committee participation, Public Meeting input, discussion with the Steuben County Surveyor's Office (January 21, 2005), Canoe Survey by V3 and the Steuben SWCD (October 1, 2004), and Windshield Survey by V3 and the Steuben SWCD (Spring 2005). Additional source control measures can be implemented subject to land owner participation.

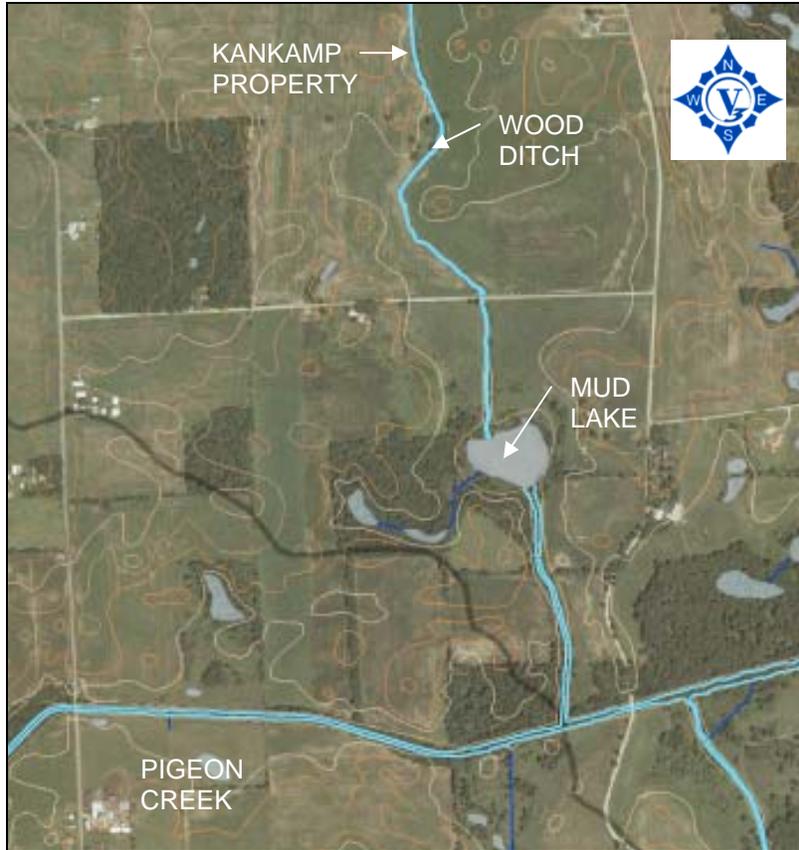
Kankamp Property (10) – In 2001, Tri-State University students developed a preliminary design for a detention facility along Wood Ditch, which connects the Angola WWTP to Pigeon Creek upstream of Long Lake. The study identified a low-lying area north of Mud Lake that can provide storage for approximately 620 acre-feet of flood water with the construction of an embankment along the downstream bank. The proposed facility will also provide additional treatment for the Angola WWTP effluent and local runoff. The project has been under consideration for ten years, and due to the hydrologic and water quality benefits provided is included in this plan. Sediment removal (dredging) of nearby Mud Lake would also provide a stormwater storage benefit to the watershed. The location of this project is shown in Figure 24. This measure will specifically improve water quality and reduce flood potential downstream of the project.

Figure 24: Location of Kankamp Property.

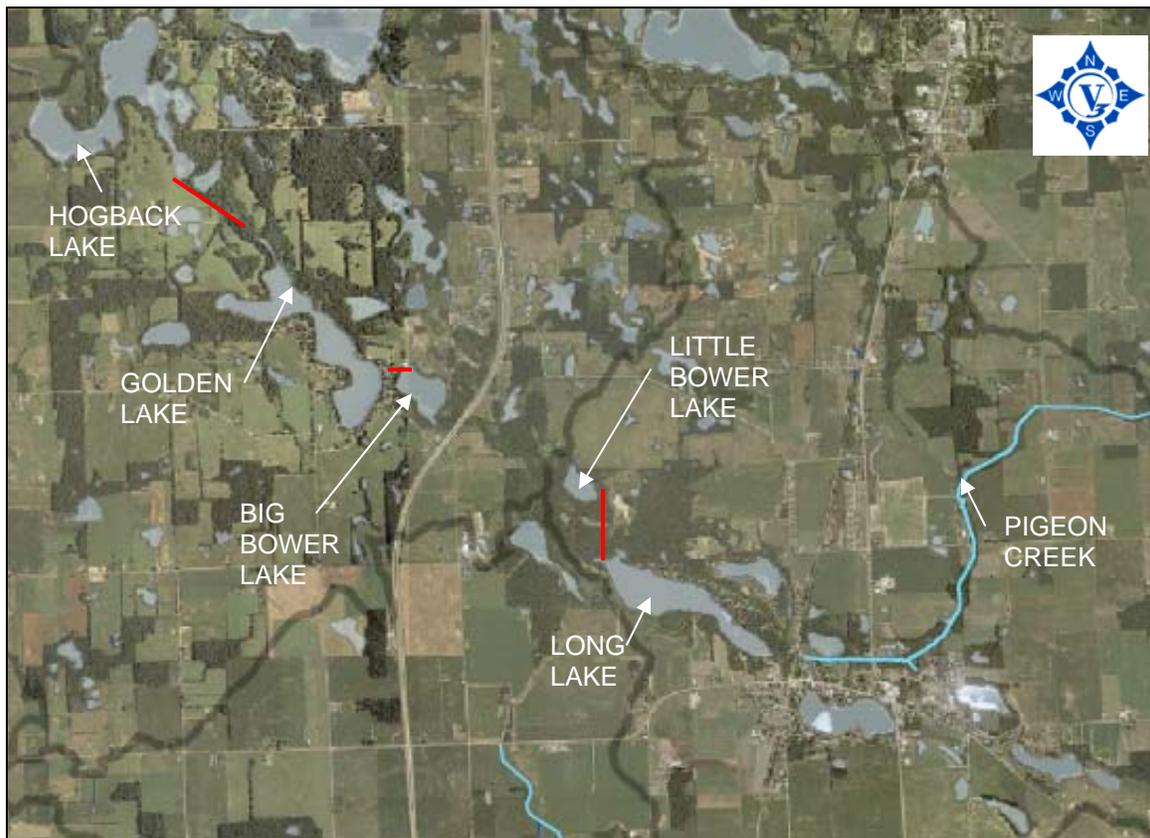
Shoreline Stabilization (17) – Shoreline erosion is a major concern of lake homeowners. The loss of property over time can be extremely costly and may threaten trees or even homes near the water. This measure provides for stabilization or eroding shorelines with vegetative or engineered methods, as dictated by the individual site requirements. Locations identified for shoreline stabilization include:

Locations of potential shoreline stabilization projects in the Lake Chain subwatershed are shown in Figure 31. Stabilization will reduce erosion at the project site.

Figure 31: Location of Potential Shoreline Stabilization in the Lake Chain.

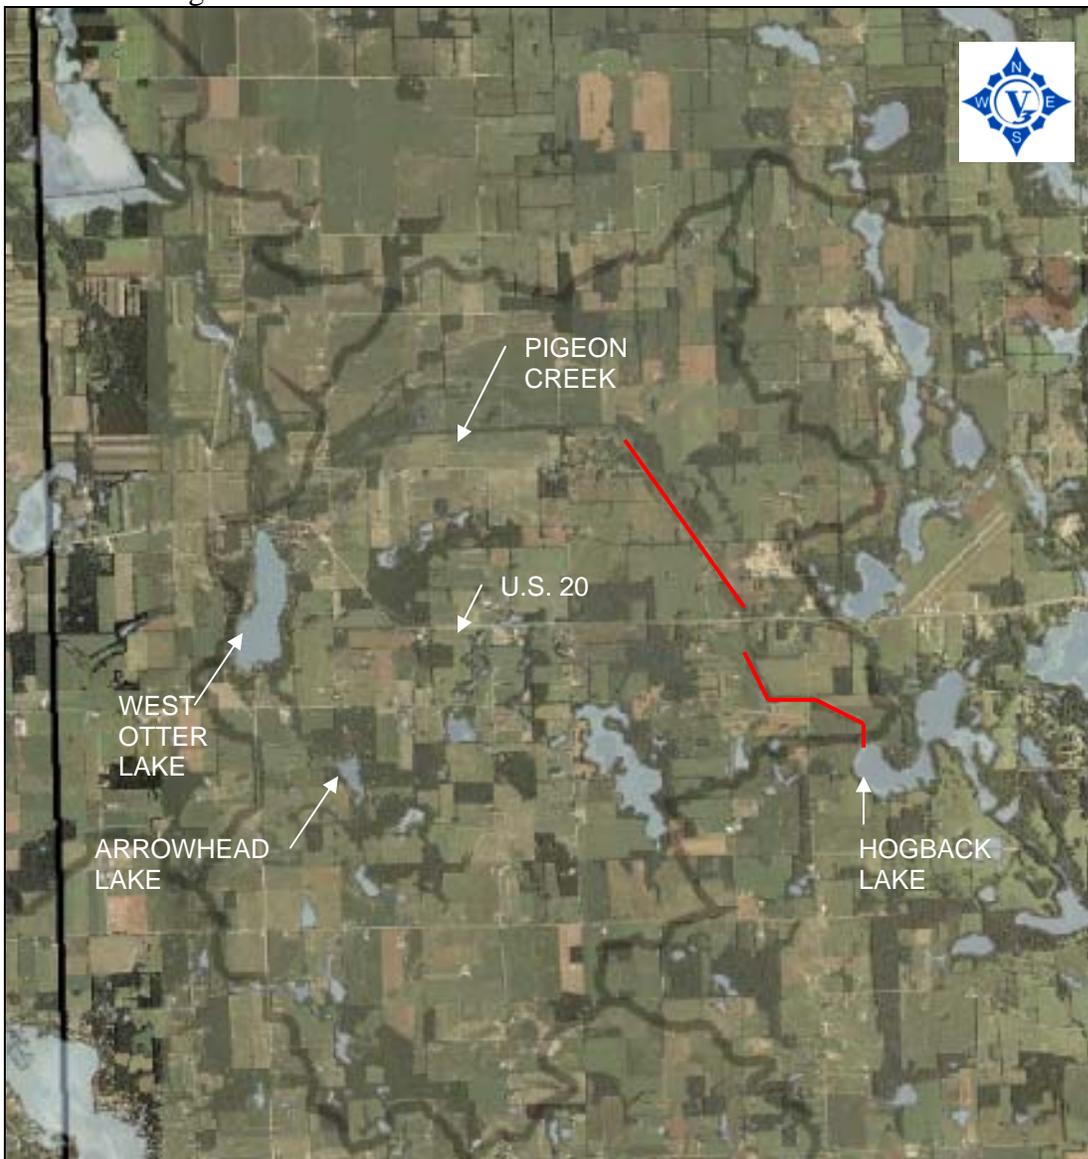
Locations of potential filter strips were identified during windshield and canoe surveys and include large areas of unfiltered channel overbanks adjacent to agricultural properties as shown in Figure 36.

Figure 36: Location of Potential Filter Strips in the Lower Watershed.

Filter Strips or vegetated buffers (15) are established vigorous vegetative cover that is adjacent to a water body (either stream or lake) and provides the following benefits to the watershed: slows the velocity of overland flow, which reduces erosional damage and provides for the deposition of transported sediment; provides an opportunity for binding nutrients in the plant's tissues; prevents streambank and shoreline erosion; and provides wildlife habitat including travel corridors, nesting sites and food sources.

The establishment of dense grasses will provide a sediment trap and will absorb sheet flow from overland flow. The establishment of woody vegetation provides for deeper roots of trees and shrubs which consolidate bank soil and prevent erosion.

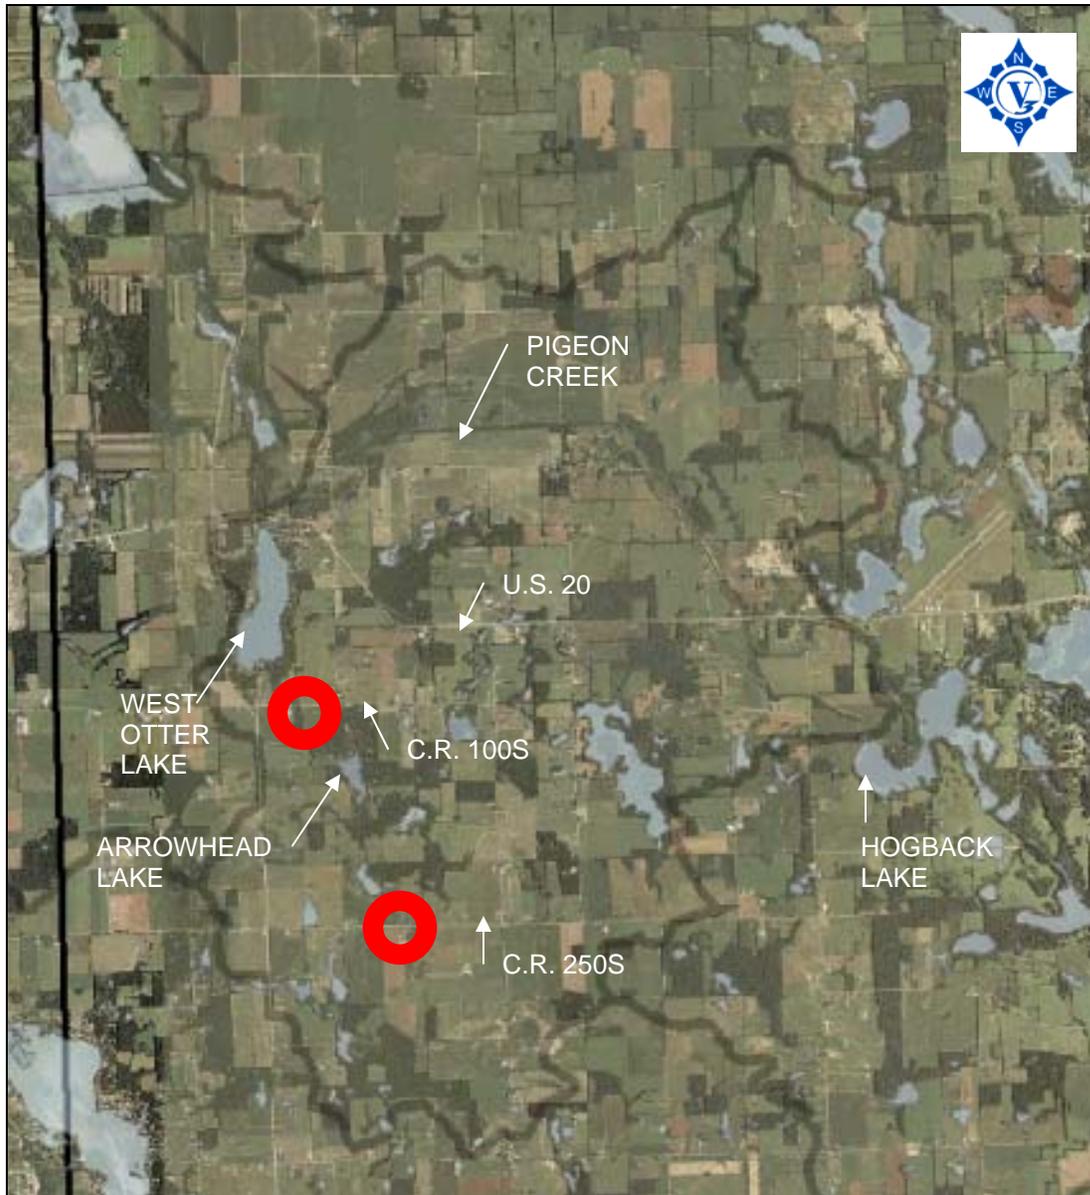
Hammond Ditch Culvert Modifications (20) – Areas along Hammond Ditch near 100S and 250S appear to offer additional storage volume for flood water without negatively impacting adjacent properties. Projects would involve constructing a control structure at the inlet to the culvert to backup flood waters to utilize the additional storage area without negatively impacting adjacent property owners. The roadway is elevated high above the channel, so road overtopping is not anticipated.

Figure 37: Location of Potential Hammond Ditch Culvert Restriction.
