Headwaters Yellow River Watershed Management Plan

Prepared for Marshall County Soil and Water Conservation District
Project Name Headwaters Yellow River Watershed Management Plan
Project Number 130701101
Project Manager Tom Estrem
Date May 2018

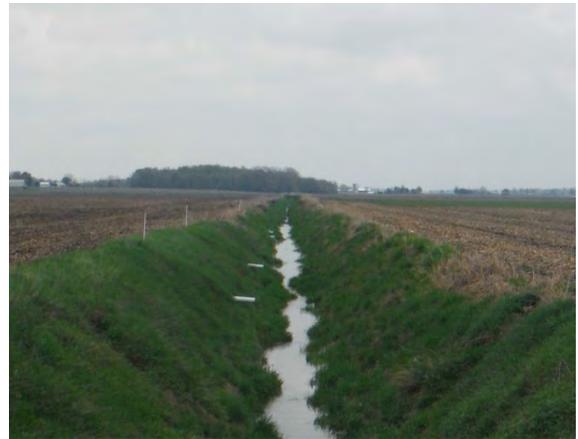
Photo: Stream in the Arme y Ditch subwatershed that has been channelized and contains no stream buffer.

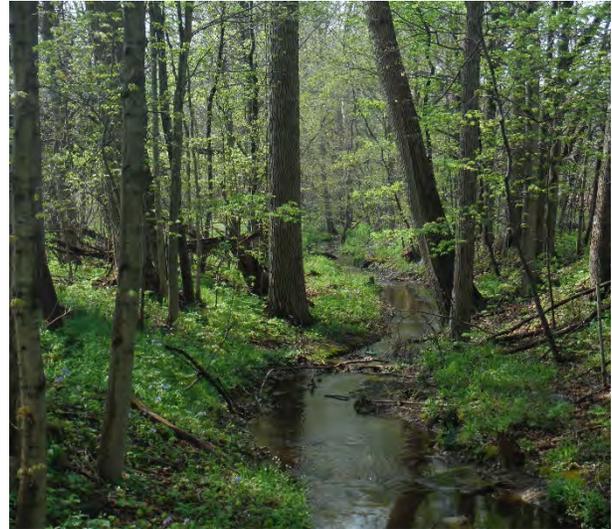
Photo: Stream in the Milner Seltenright Ditch subwatershed with stream buffers and in-stream cover.
