# In-Line Rinse Water Reduction Project

# Project Details

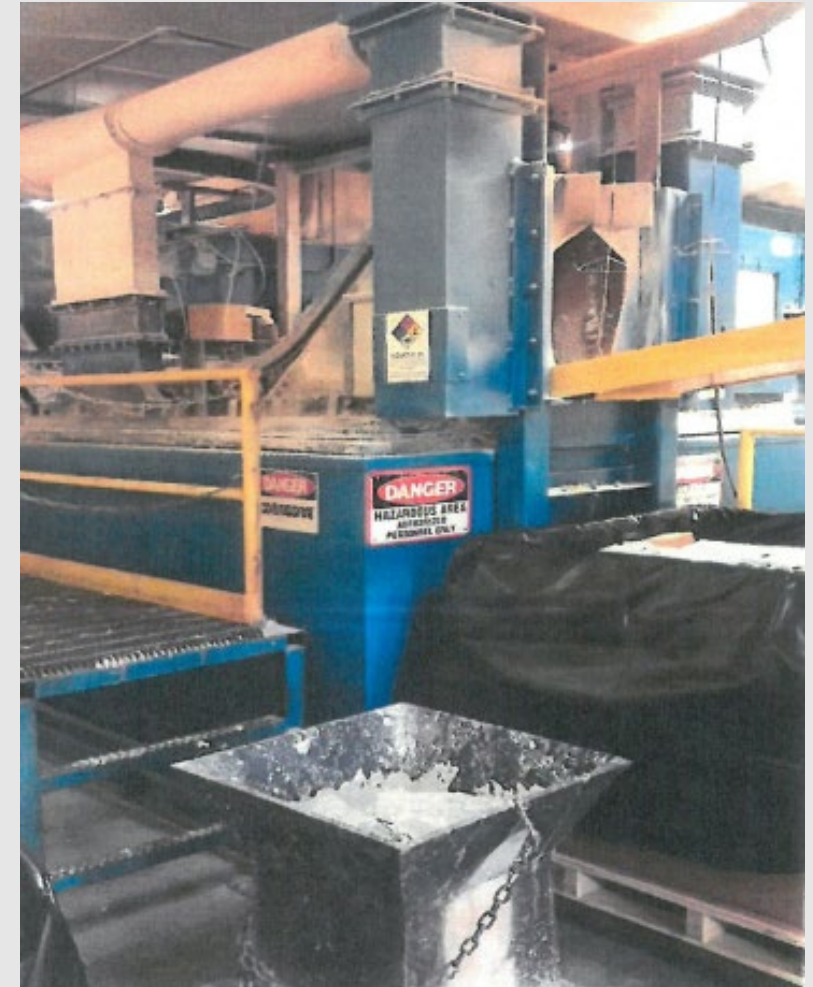
Molten Caustic Salt Bath

- Door cylinders and other related parts are placed on a closed-loop conveyor system running through a powder coat booth and cure oven to apply finish of the customer's choice.
- Clean hooks are required in order for new powder to electrostatically adhere to the door closer parts.
- Powder coat is removed by running the conveyor line and hooks through a molten caustic salt bath set at 900 degrees.
- Corrosive salt must then be removed from the hooks by passing through the in-line rinse water tank immediately following the caustic salt bath.
- The entire process emits a corrosive exhaust which is created from the molten caustic salt bath.
- The corrosive exhaust is captured and cleansed through an air scrubber.
- This is accomplished when water flows over a series of balls, cleansing the air before released.

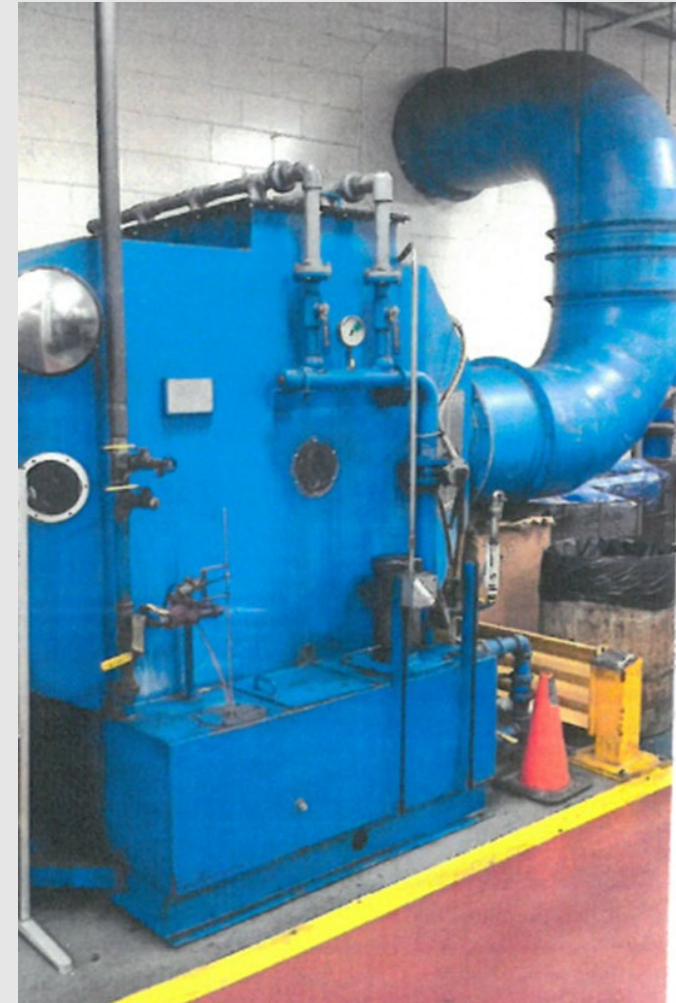
Air Scrubber

- Air scrubber is designed to remove carbon dioxide and corrosives by forcing the exhaust through a series of scrubber balls showering the air with water
- Manufacture recommends an overflow rate of .9 – 1.5 gpm to maintain the bath pH at or near incoming city water pH
- Normal operation – 1.5 gpm would result in 2,160 gallons of overflow water daily
- Discovered the scrubber was actually over flowing at a rate of 3.0 gpm resulting in 4,320 gallons / daily
- All scrubber water is treated by on-site waste water treatment
- Immediately scaled back the overflow rate to the manufacture recommendation and pH monitored

- Sent sample out to laboratory for testing – was it safe for human contact?
- Results were favorable! The team immediately re-directed the water to the in-line rinse tank vs. Waste Water Treatment
- Water flow was set to 1.5 gpm resulting in a 2,160 gallon flow rate daily
  - Results – 776,600 water reduction annually
  - Water reduction in the rinse tank – auto fill was no longer needed
  - Avoided the use of sulfuric acid risk and associated cost
  - Eliminated the need of additional PPE

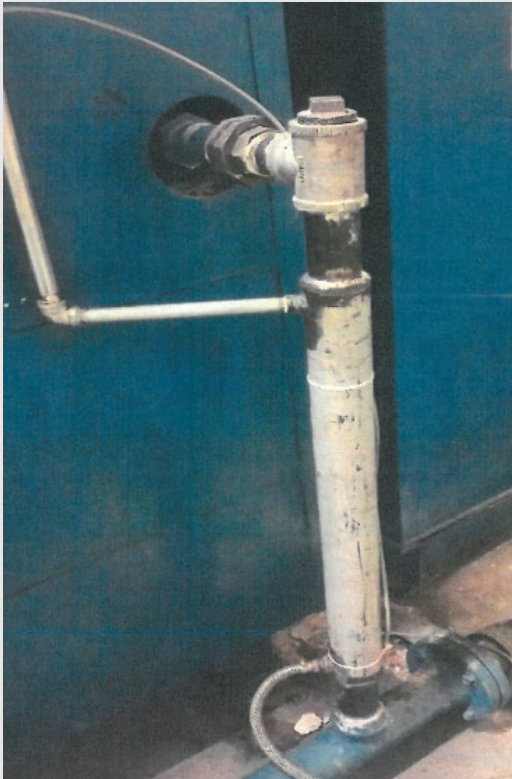
- Heat exchanger built in-house  
'Tube within a Tube'
- Hot water overflowing from the  
rinse tank travels down the  
center, warming up incoming  
scrubber water prior  
to entering the rinse tank

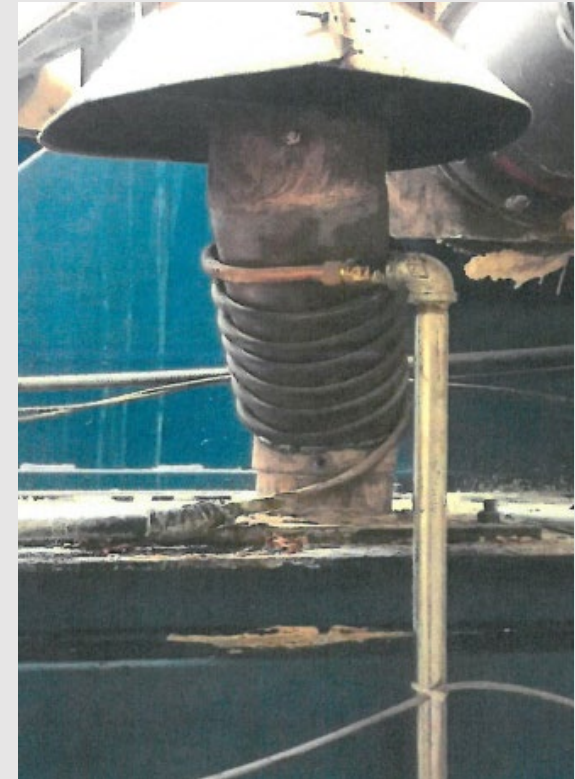
- Coil made in house to  
utilize the heat from the  
equipment to assist the  
scrubber water prior to  
entering  
the rinse tank
