Lessons From the Pandemic: Building Water Safety in Schools, Offices, and Beyond

Andrew J. Whelton, Ph.D.

Building water system public health risks

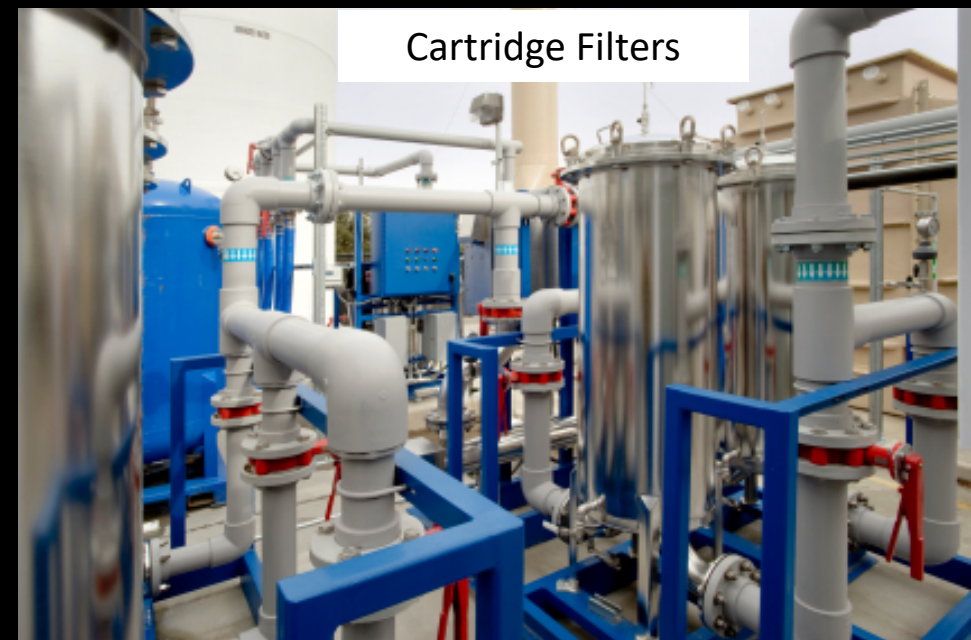
Cartridge Filters

Example: A 3 story office building with 3 risers and a centralized water heater

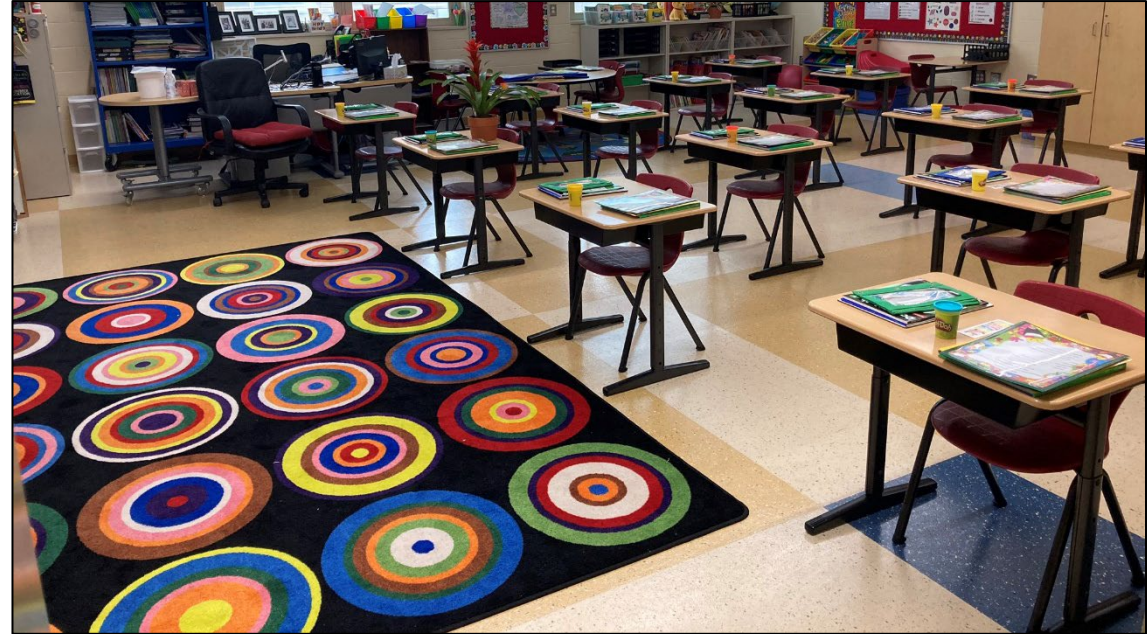
11 buildings across 4 studies

All free chlorine disinfectant

3-5 months of low/no water use

Some served by the same utility

Some have recirculation loops, in-
building storage, showers

All had indoor copper pipe

Up to 400 water outlets/building

Not all had as-built drawings

1. Elementary school, Indiana (Ra et al.)
2. Large residential building, Indiana (Angert et al., led by Proctor, Ph.D.)
3. Institutional buildings, Indiana (Ra et al.)
4. Elem/mid/high school, Ohio (Ley et al.)

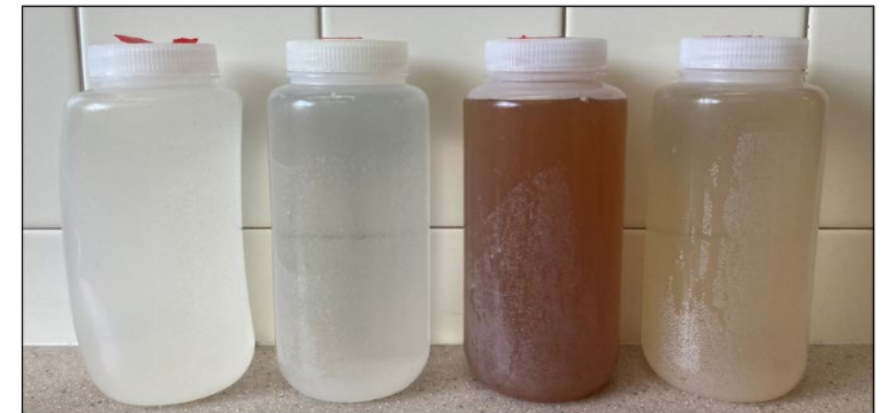
Metal levels were not consistent across the school, were impacted by flushing, and the 8 year old hot water system was excessively corroding

Some **Cu** levels exceeded the acute health-based limit of 1,300 µg/L, while others did not

Zn exceeded the USEPA health advisory level at 1 cafeteria soup filling station because of nonuse and stainless steel piping

Nonpotable fixtures used for potable purposes

Hot water system had excessive corrosion.
Discolored water was observed

1,641 Fe	223 Fe	21,759 Fe	1,851 Fe
155 Zn	18 Zn	1,303 Zn	243 Zn
544 Cu	63 Cu	6,301 Cu	1,319 Cu
20 Pb	3 Pb	248 Pb	24 Pb
15 Al	3 Al	235 Al	129 Al

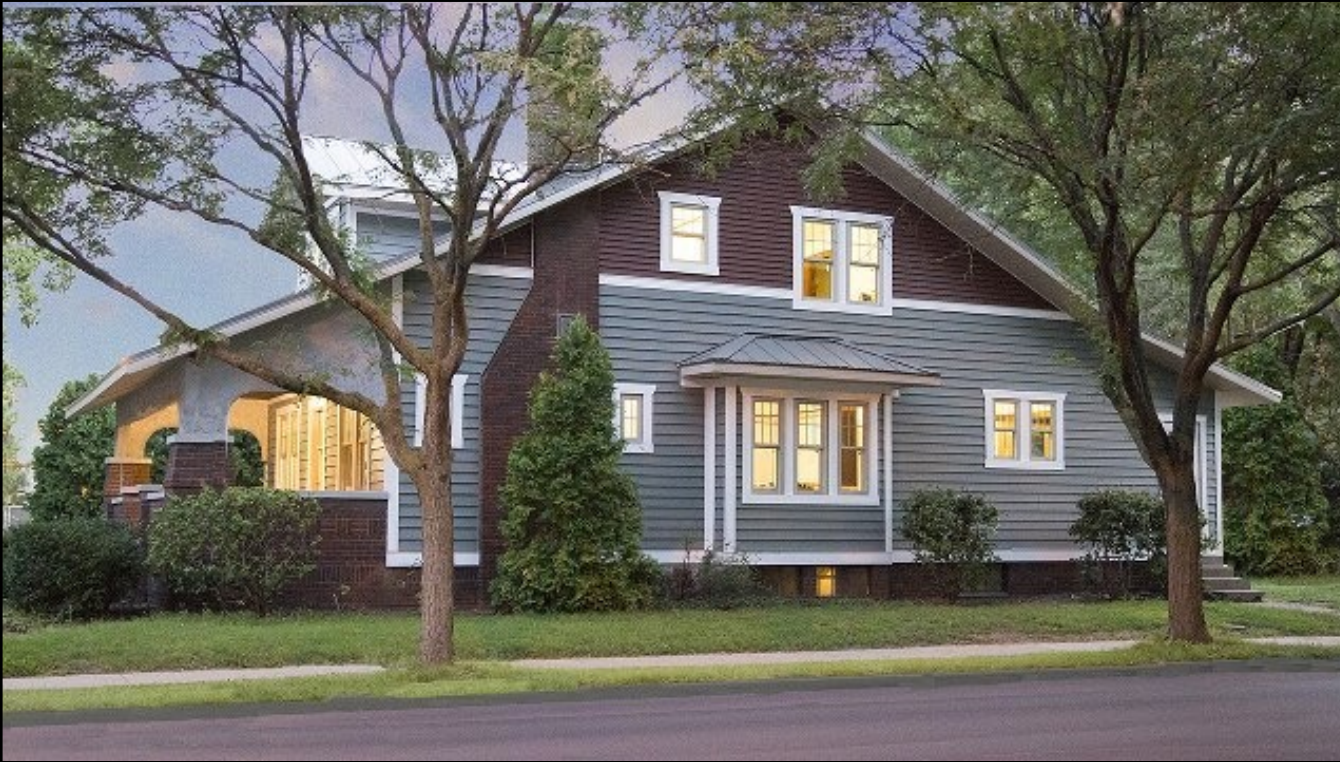
Thermocouples throughout piping, 1x /sec
Indoor air temperature, 1x /sec
Flowrates at every fixture, 1x /sec
Energy use per device, 1x /sec

The Most Monitored Home in America

West Lafayette, Indiana
Less than 100 yards from Purdue
3 Bedroom, 1.5 baths
Water saving fixtures
Trunk-and-Branch design
PEX piping
Renovated in 2014

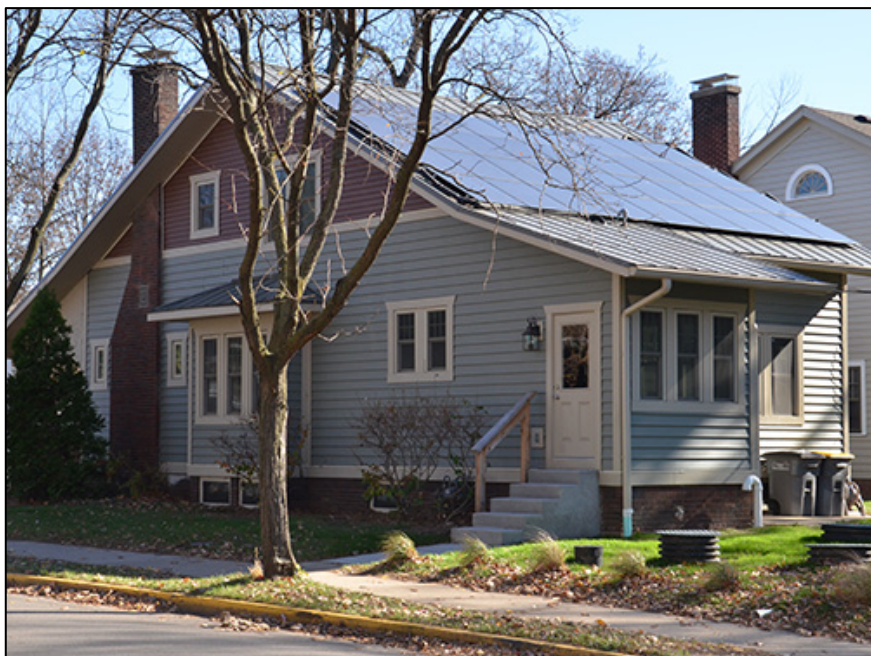
Results Coming Soon:
EPANET Model for Predicting Water Quality at the Faucet

4 Seasons (Summer, Fall, Winter, Spring)	2 Systems (Hot, Cold)
4 Service Line Length (1' (As is), 25', 50', 100')	2 Free Chlorine at service line (As is, 2x)
2 Pressure boundary conditions (35/40psig (As is cold/hot), 80psig)	4 Conservation Scenarios (25%, 50%, 100%(As Is), 200%)
