INDIANA WETLAND COMPENSATORY MITIGATION: INVENTORY

Final Report

**EPA Grant #
CD985482-010-0**

**Revised
May 2000**

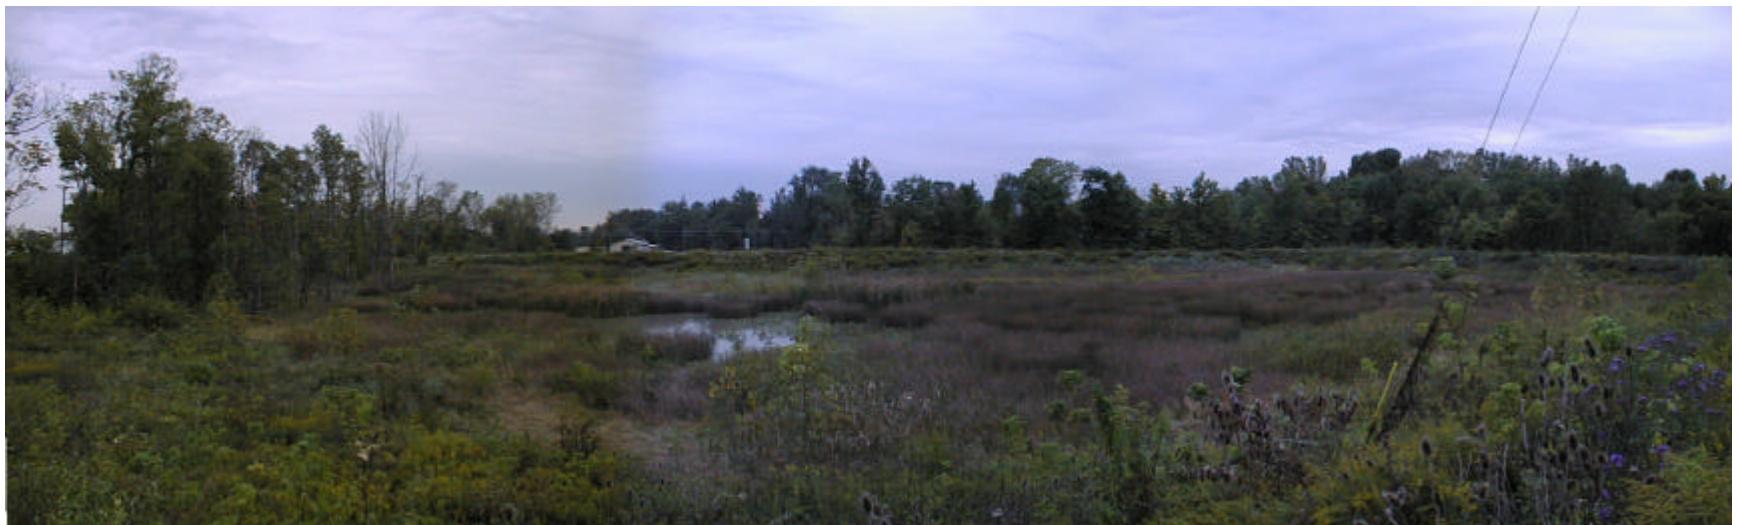
Photo 1: Site # 1994029M01. Constructed with no apparent problems. Hydrophytes were well established with several macrophyte communities. 9/24/1998

The photographs in Appendix A illustrate the sometimes subtle differences between these categories. Photographs one and two depict constructed mitigation sites with no apparent problems. Photograph three was also categorized as constructed but looked very similar to both photographs four and five, all of which resembled ponds rather than wetland mitigation.

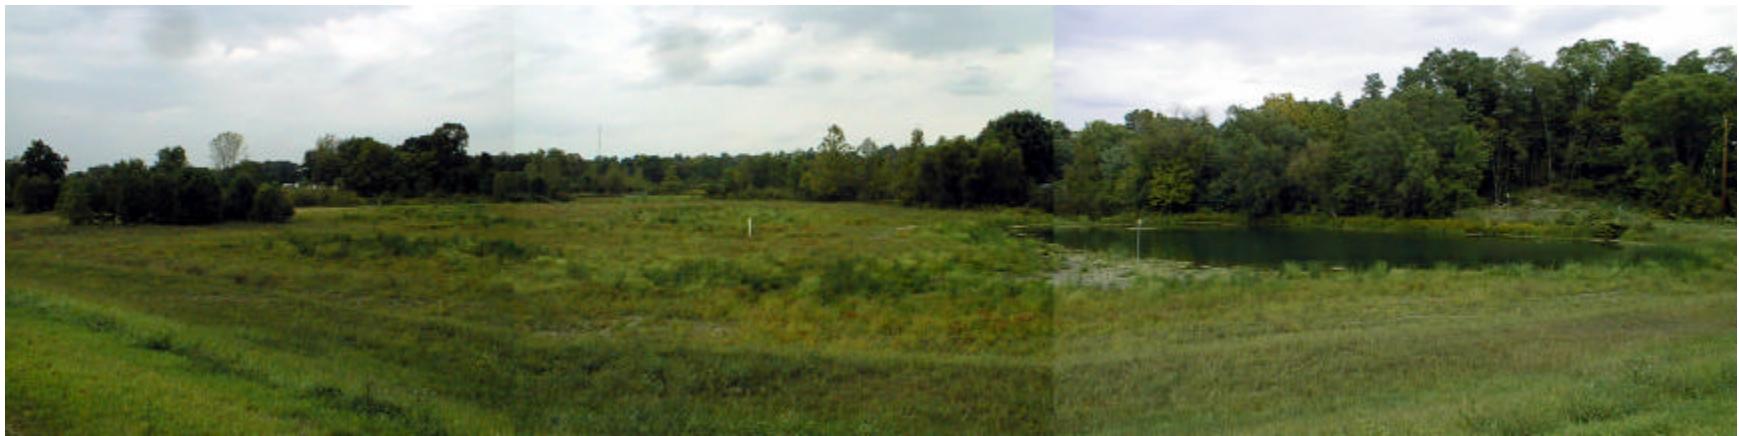
Photo 2: Site # 1996089M01. Constructed with no apparent problems. Vegetation establishing well in this very young site. 9/15/1998.

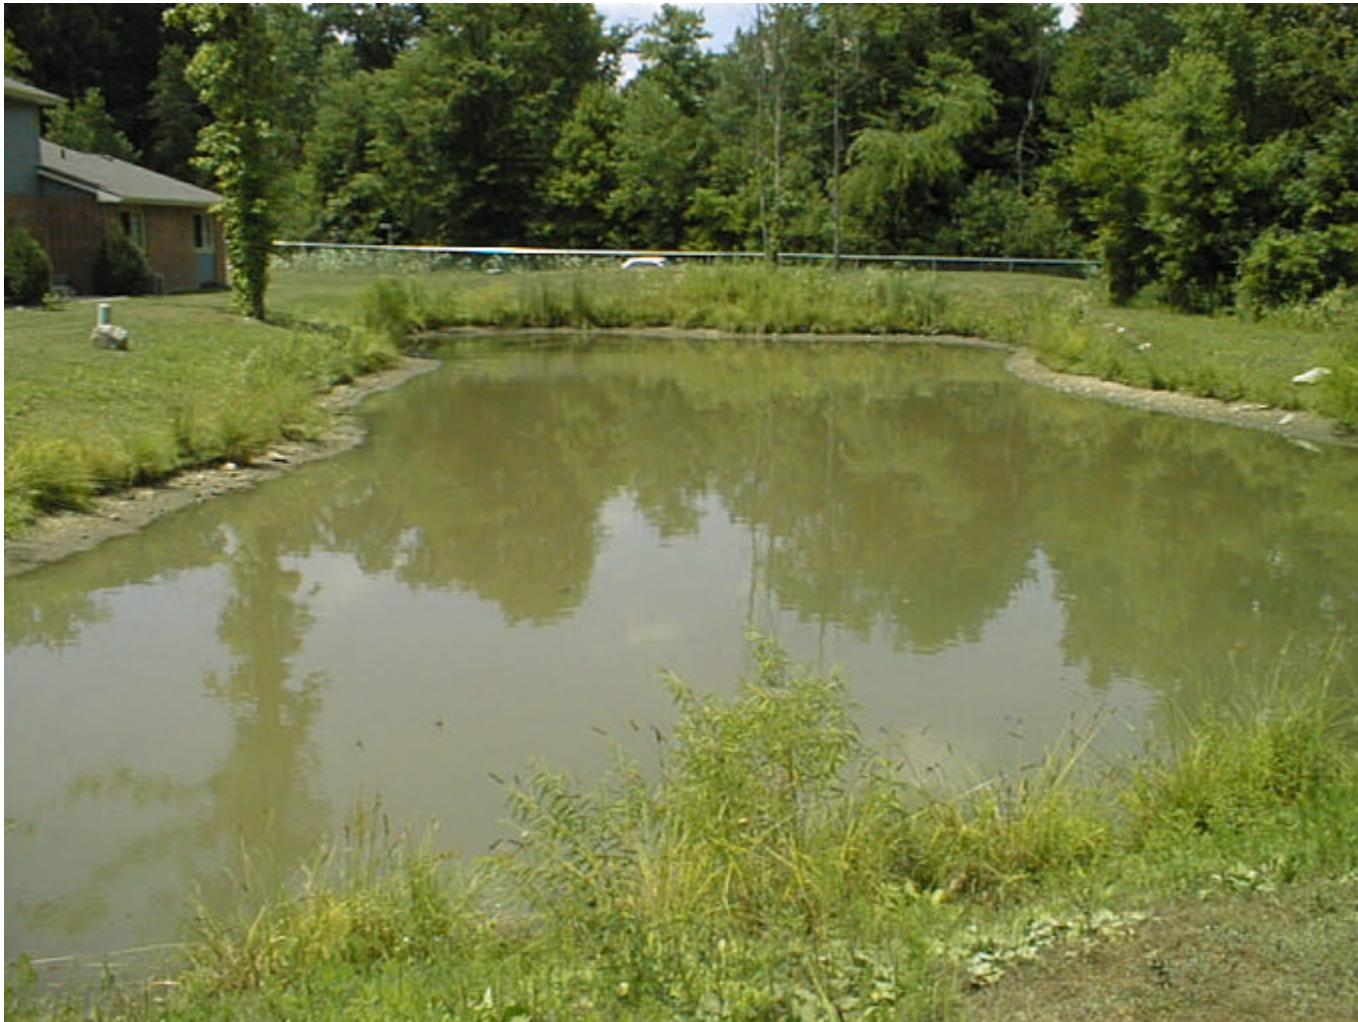
Photo 3: Site # 1994012M01. Constructed but failing. Presence of Carex, and Scirpus evidence of planting. This site suffers from either poor planning, poor hydrological engineering or poor grading. The result is steep slopes, flashy hydrology, open water and a 2-foot wide band of vegetation.

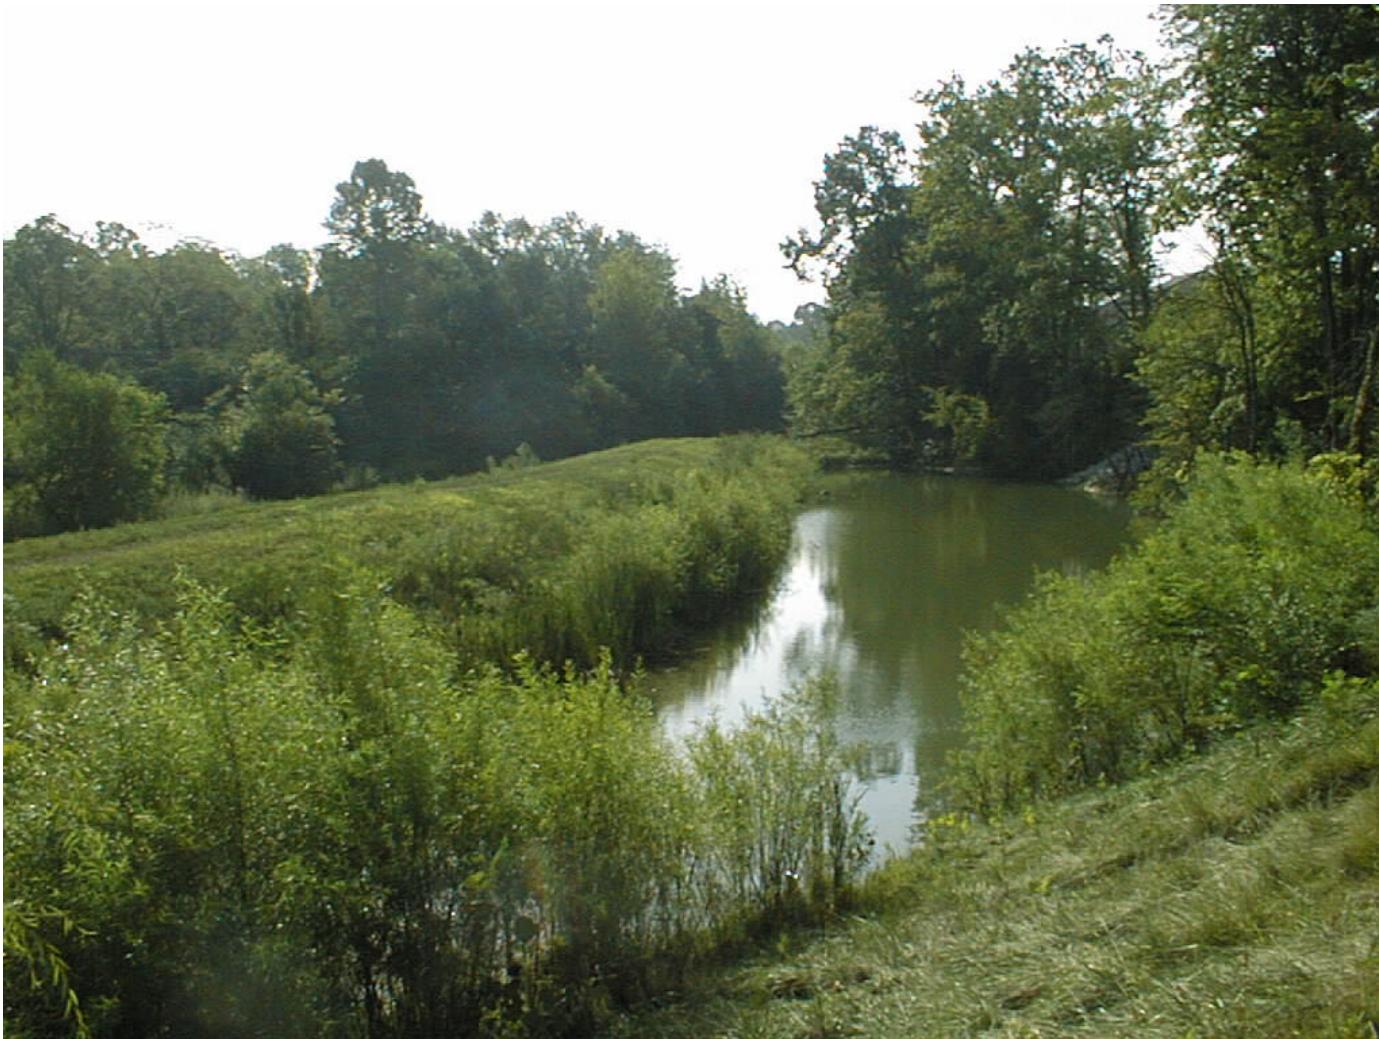
Photo 4: Site # 1995054M01. Obviously constructed incorrectly. The mitigation plan for this site called for the expansion of an existing wetland. The adjacent creek was to supply water during flood events. Instead the site was surrounded by berms, thereby isolating it from the adjacent stream. Hydrology was piped in from the development.

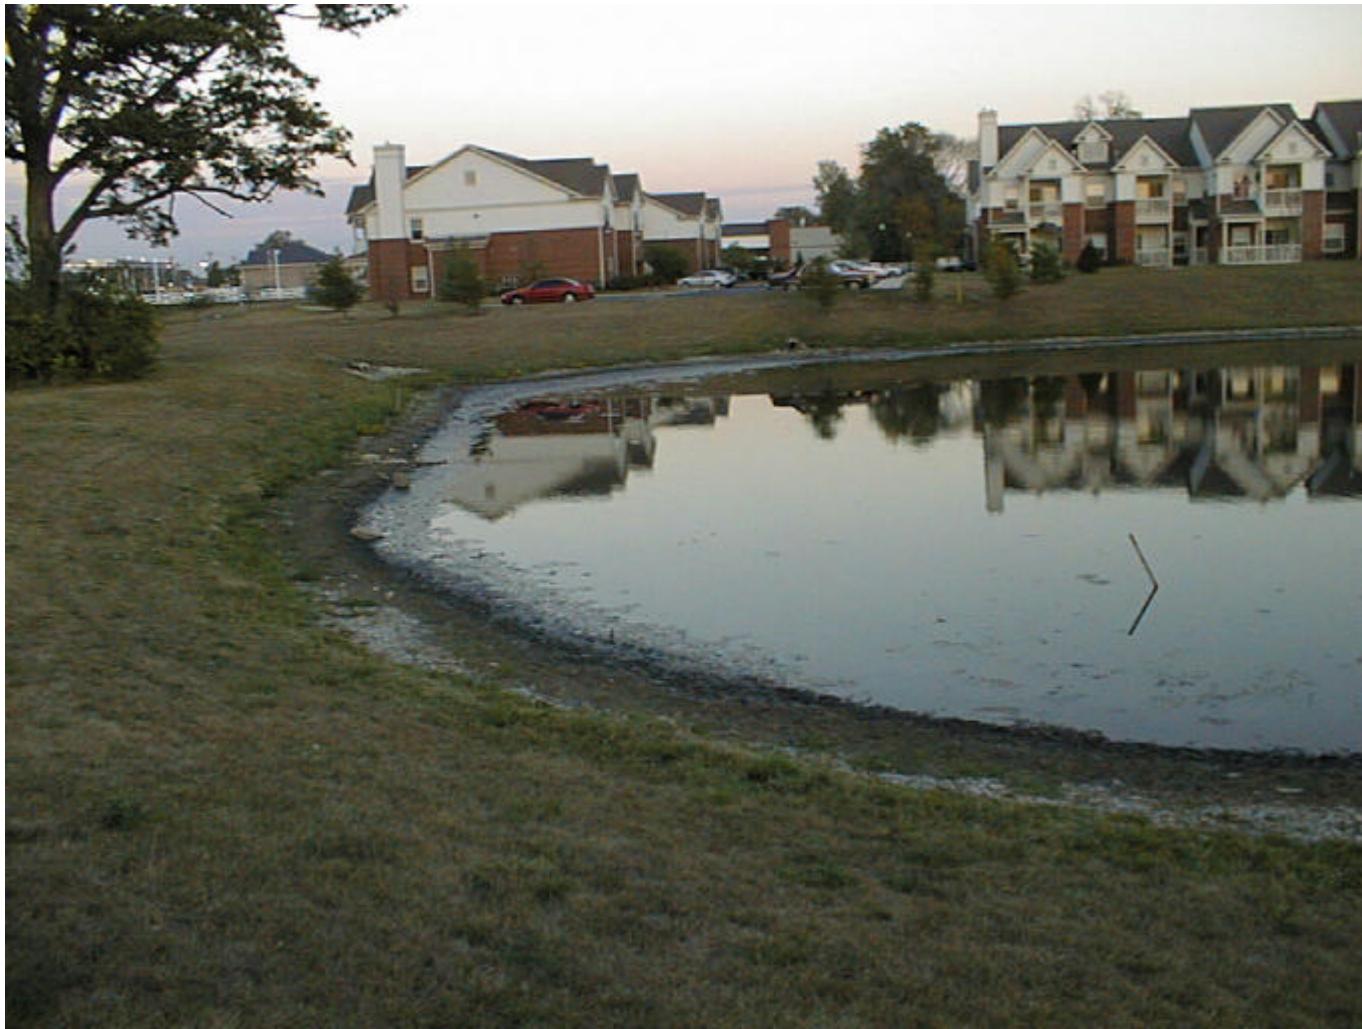
Photo 5: Site # 1993011M01. Incomplete. Open water meets bare ground. What few hydrophytes may exist on the site have been mowed down. No sign of the species listed on the planting list.

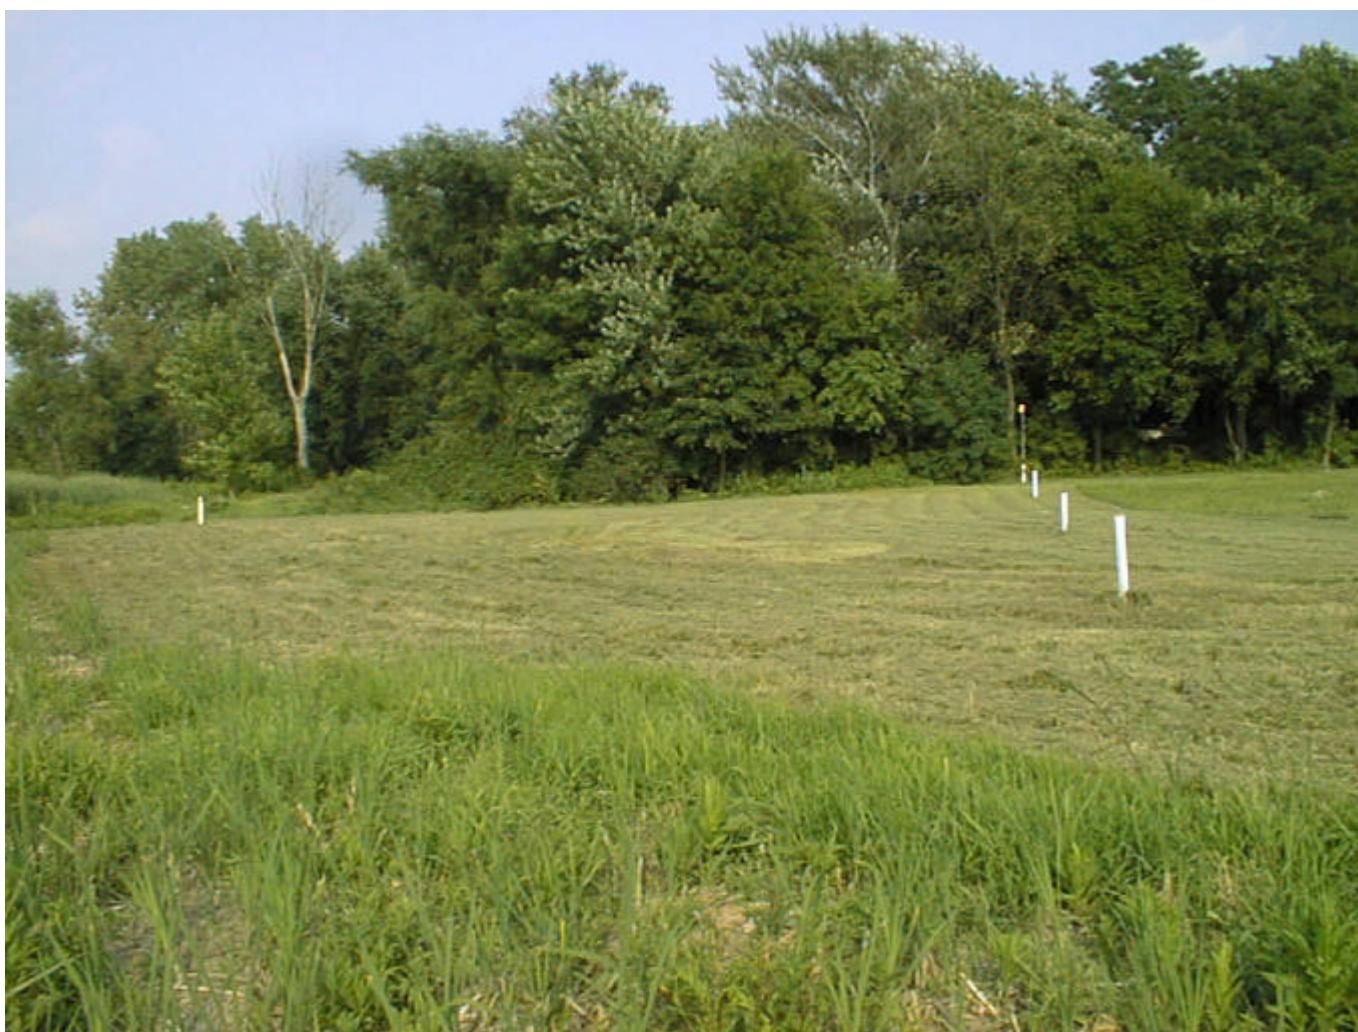
Photo 6: Site # 1996071M01. No attempt. The area delineated by white stakes was to be graded to the elevation of the adjacent wetland.

No Attempt: Sites that exhibited no signs of mitigation construction activity fell into this category (Photo 6).
